# Site Investigation Report

143197.1.USI

Auger were commissioned by Crawford & Co to undertake a site investigation and CCTV inspection of the underground drainage within the area of concern (AOC) at the property.

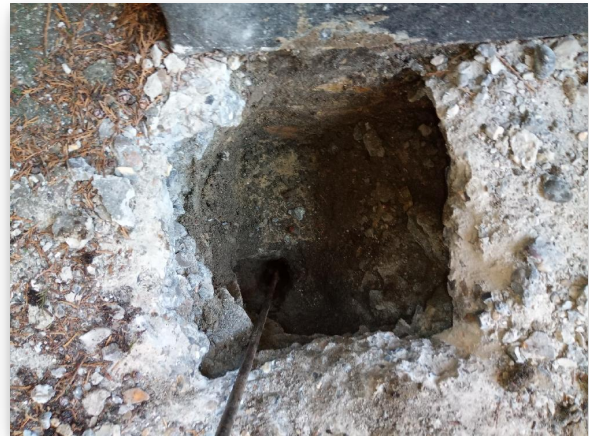
Within TH1 we revealed the footing and augered to the required depth (3m) in the proposed location. We took soil and root samples. These measurements are shown in Trial Hole Log 1 below.

Fig 1.2: Trial Hole 1 Footing

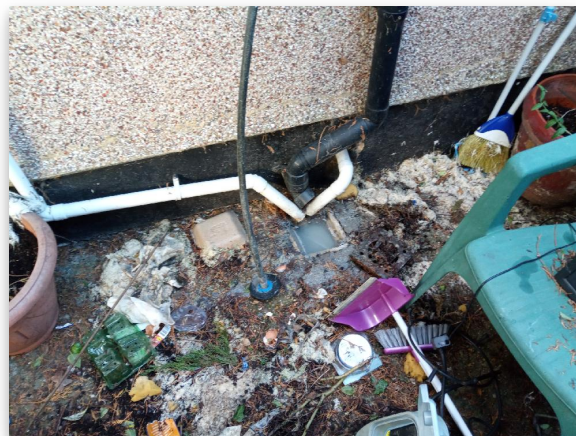
No CCTV survey of the underground drainage was undertaken whilst on site because there is only WG1 at the rear of the property which is fully blocked with foul waste. We carried out high pressure water jetting in order to clear a soft blockage from within the underground drainage system. Our jetting was unsuccessful and we were unable to restore full flow to the system.

The gully pot is cracked which will be allowing an escape of water to the surrounding area.

Fig 2.1: Blocked WG1

Excavate and replace WG1 and 1m of 100mm pipework at a depth no greater than 1.0m through concrete.

We will then need to conduct a further CCTV investigation downstream on this line.

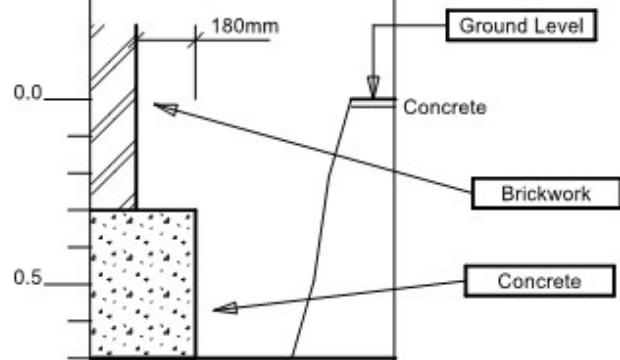
# Trial Hole Log No.1

| Depth<br>(m) | Symbolic Log | Strata Description | Insitu Tests | | Soil<br>Sample | Root<br>Sample |
|---|---|---|---|--|---|---|
| 1.0 | | Moist Brown fine to medium<br>gravelly silty CLAY | 84kpa | | Soil<br>@ 0.7m | Root<br>@ 0.7m |
| 1.5 | | Moist Brown silty CLAY | 86kpa | | Soil<br>@ 1.2m | Root<br>@ 1.2m |
| 2.0 | | | 88kpa | | Soil<br>@ 1.7m | Root<br>@ 1.7m |
| 2.5 | | Moist Brown fine to medium<br>gravelly silty CLAY | 92kpa | | Soil<br>@ 2.2m | |
| 3.0 | | TRIAL HOLE TERMINATED | 94kpa | | Soil<br>@ 2.7m | |
