# Arboricultural Appraisal Report

## Subsidence Damage Investigation at:

154 Morley Avenue  
London  
N22 6NT

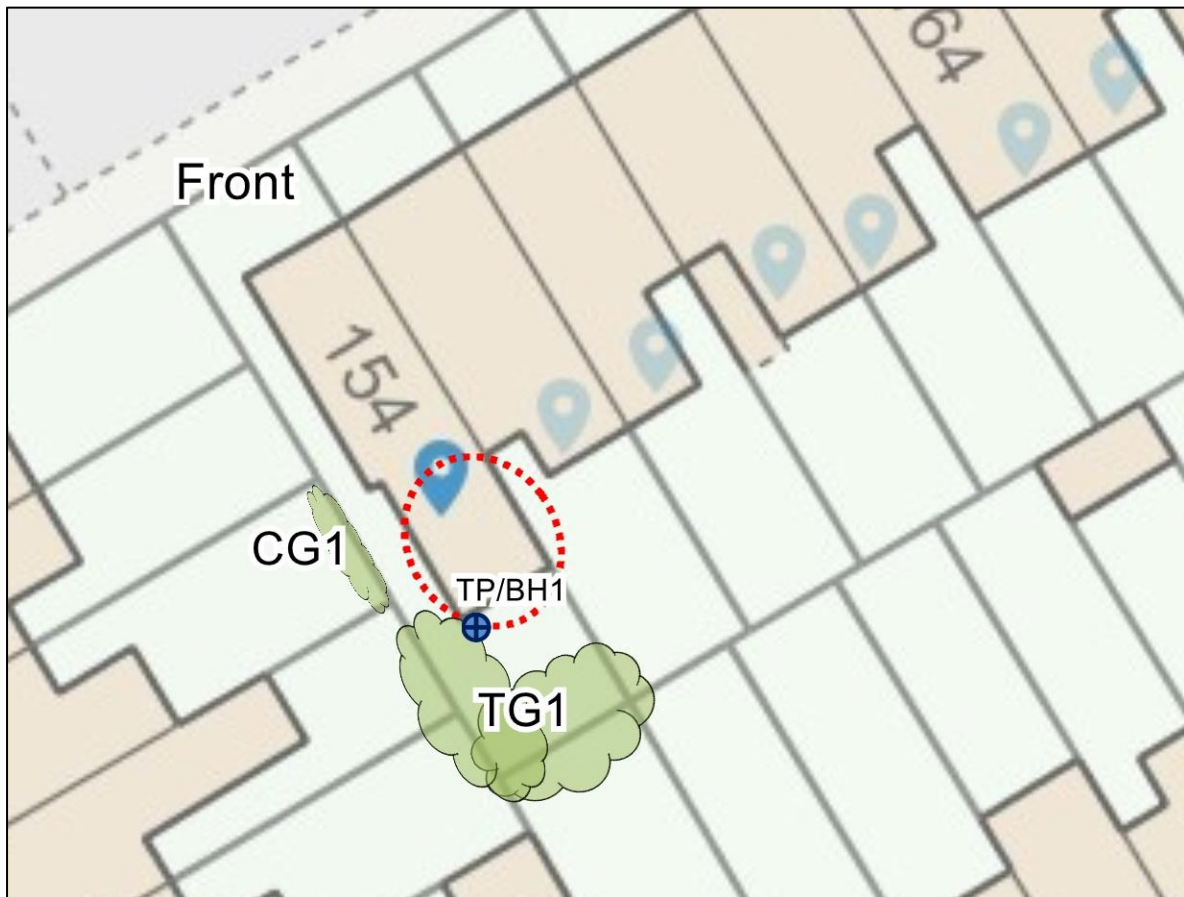
## Site Plan

Approximate areas of damage

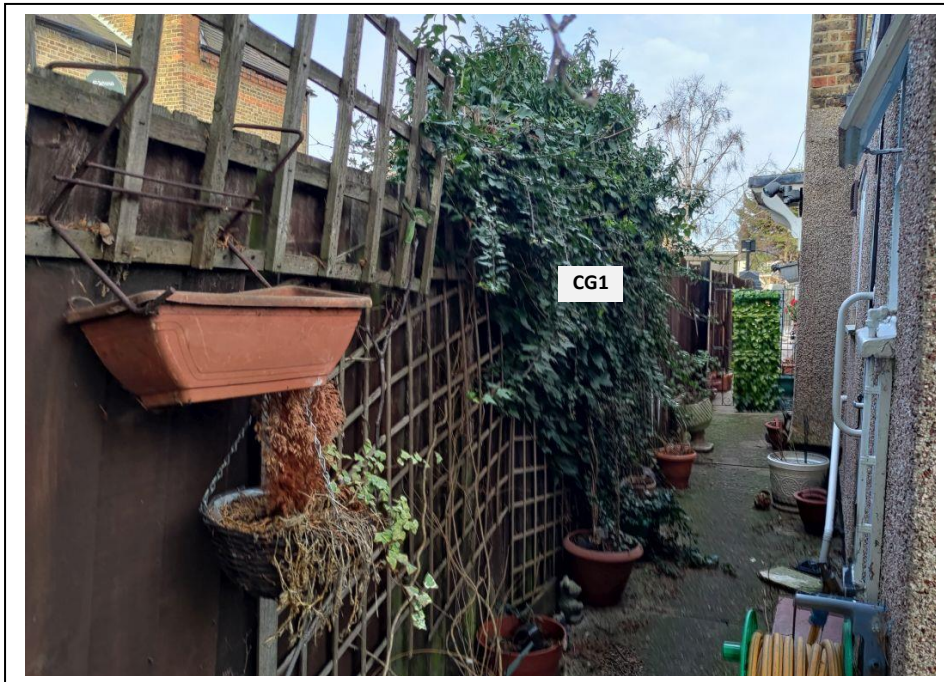
Irrespective of the identification of recovered root samples, the roots of the Apple and Elder elements of TG1 group as well as the Ivy group CG1 are also likely to be present below foundation level in proximity to the area of movement/damage and contributing to the influence of soil moisture and volumes.

View of CG1 Ivy group

If an arboricultural solution is to be implemented to mitigate the influence of the implicated trees/vegetation we recommend that TG1 group and CG1 Ivy growth is removed. Recommended tree works may however be subject to change upon receipt of additional information.

| Tree No. | Species | Ht (m) | Dia (mm) | Crown Spread (m) | Dist. to building (m) | Age Classification | Ownership |
|---|---|---|---|---|---|---|---|
| Recommendation | | Remove (fell) to near ground level and treat stump to inhibit regrowth. | | | | | |

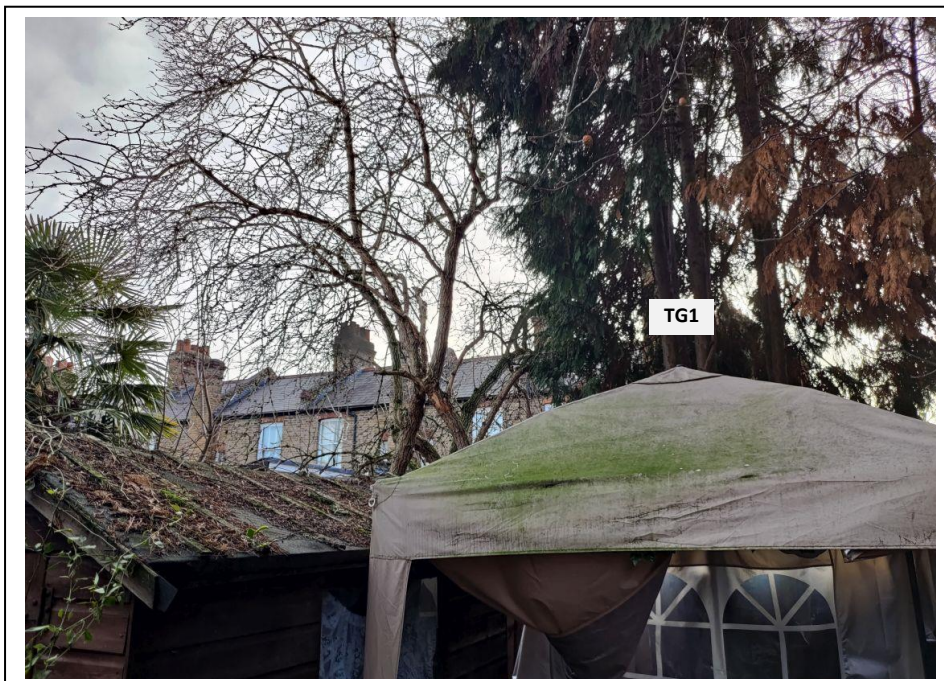
Roots were observed to a depth of 1.7m bgl in TP/BH1, and recovered samples have been positively identified (using anatomical analysis) as Cupressaceae spp.; the origins of which will be the Cypress of TG1 group which surround the property rear garden.

View of rear boundary elements of TG1 group

| Tree No. | Species | Ht (m) | Dia (mm) | Crown Spread (m) | Dist. to building (m) | Age Classification | Ownership |
|---|---|---|---|---|---|---|---|
| Recommendation | | Remove (fell) to near ground level and treat stump to inhibit regrowth. | | | | | |

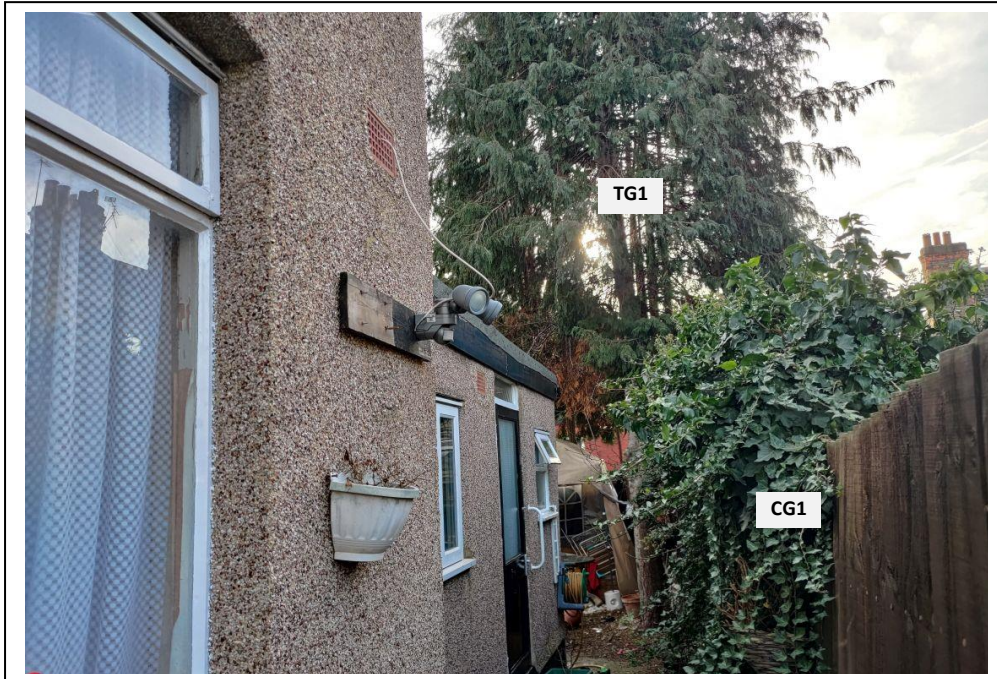
View from right-hand flank of TG1 group, with CG1 Ivy to foreground

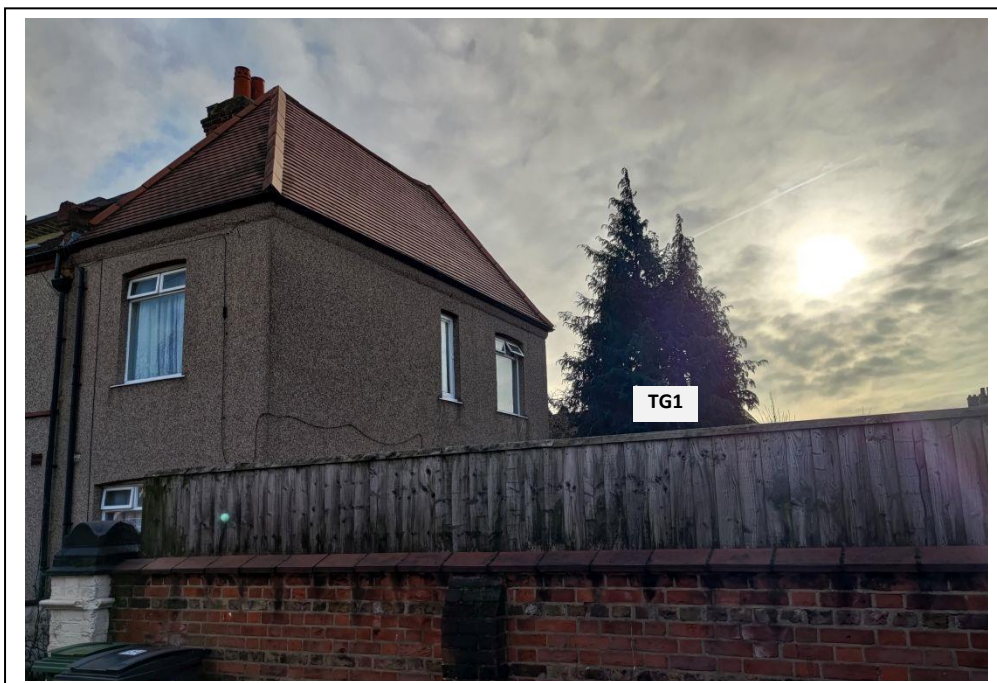
View from property frontage of TG1 group
