## Room: G.57 Assembly Hall [plate 95, 95A]

## First Floor

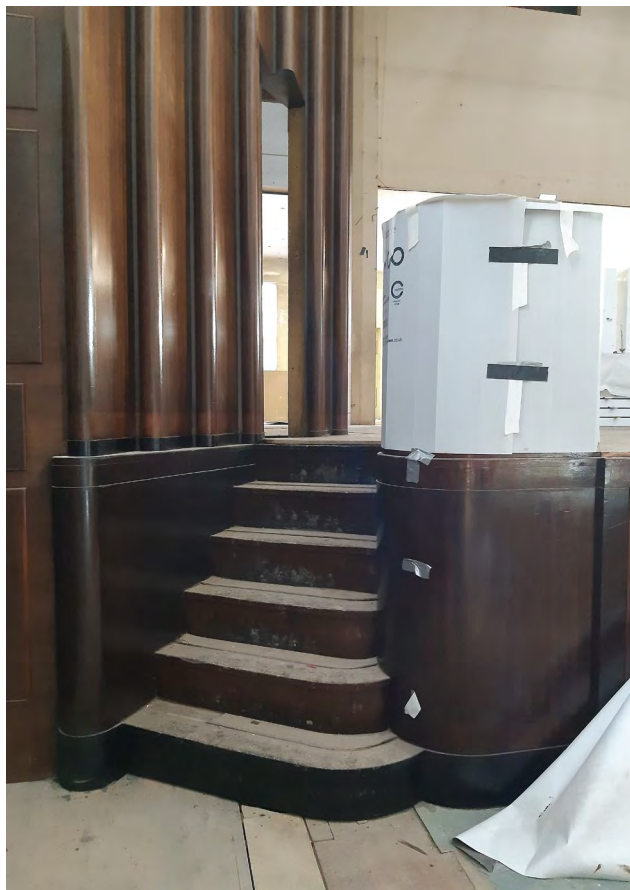
**95C** G.57 Assembly Hall, showing timber stairs up to stage and part of proscenium

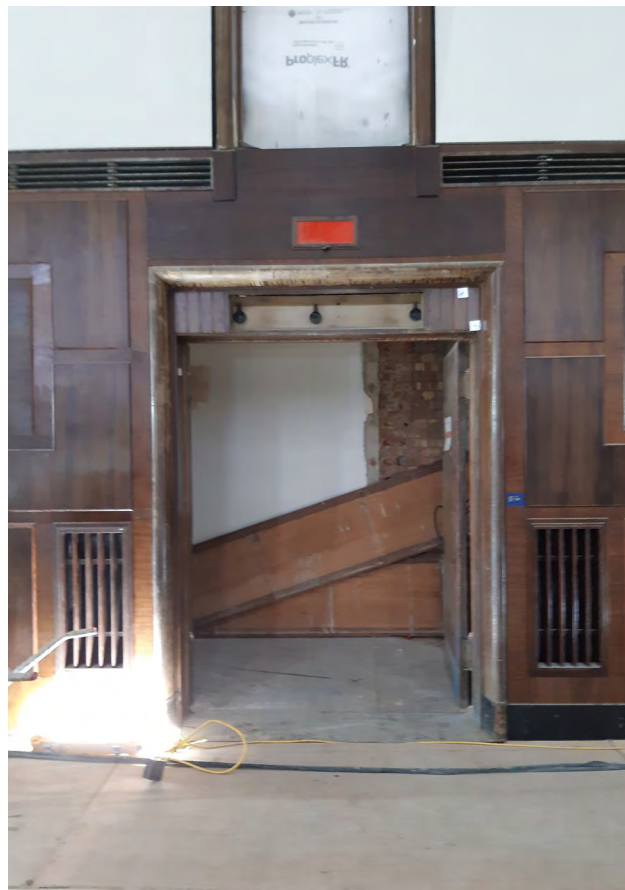
**95D** G.57 Assembly Hall panelled fire exit doors

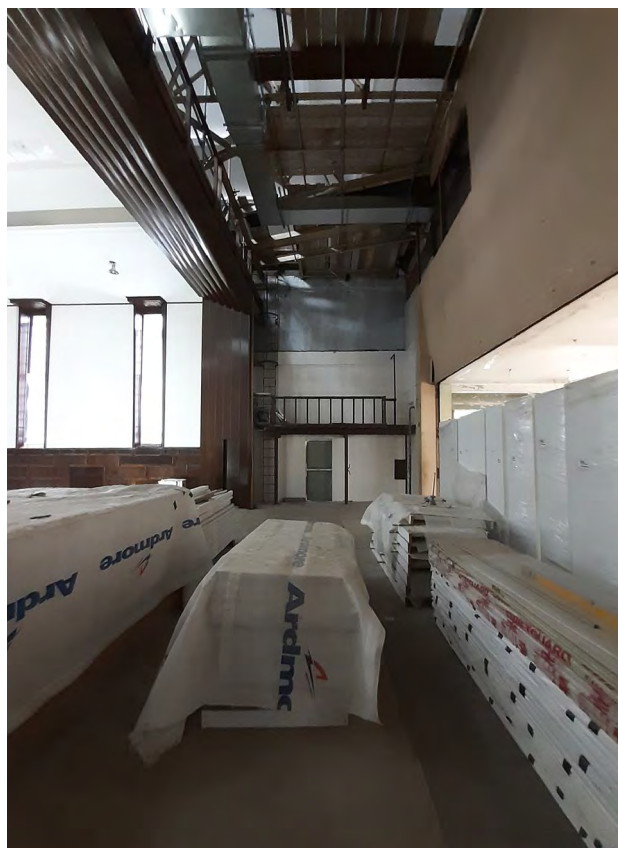
96 G.62 Stage looking north to G.63 Stage Wing

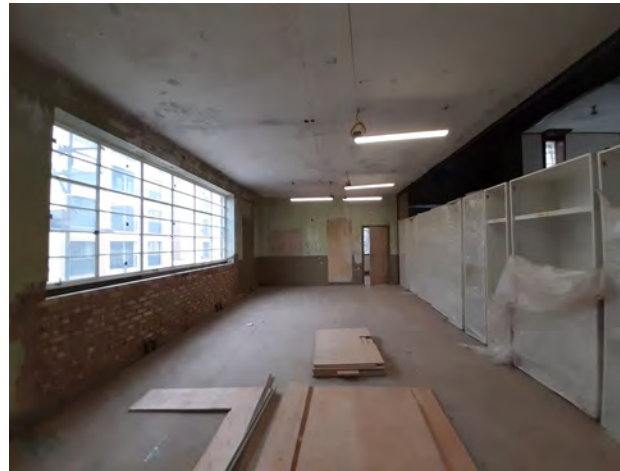
97 G.61 Green Room looking south, with G.62 Stage on the right of the image

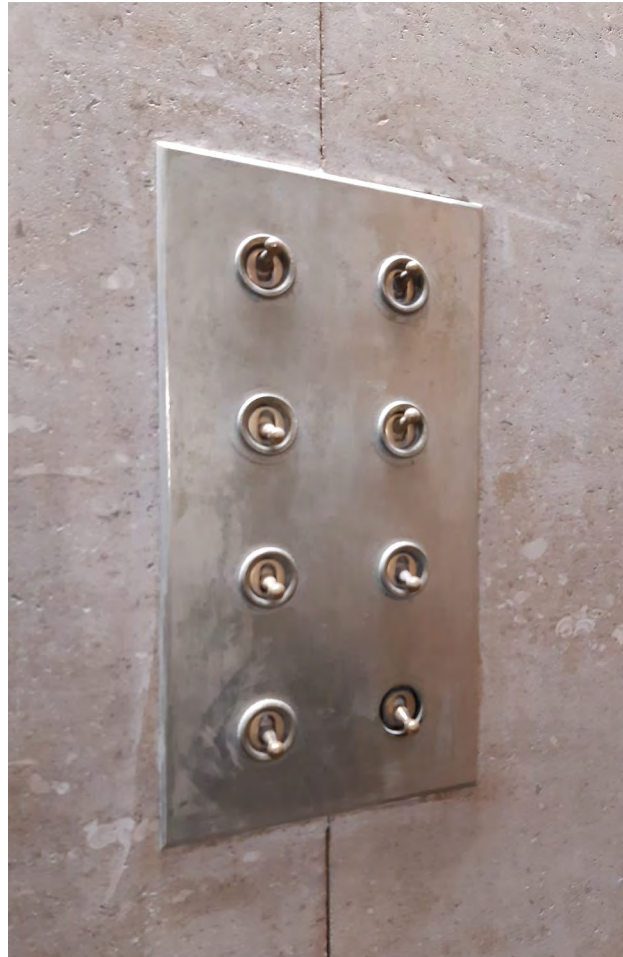
**Fittings:** There is a range of original light fittings and switch plates [plate 119C], including flush lighting panels beneath the stair and over doorways and squat domed ceiling lights. Two bronze plaques flank the door to the Mayor's Parlour; containing lists of past mayors [plate 119D]. There is a Second World War memorial at the centre of the south wall, from Hornsey County School (installed in the 1980s, covered during site visit). The lift is fronted by walnut doors and retains its lift car. There is a range of original furniture in this space, including the reception desk from the Entrance Hall, leather-covered benches and velvet-covered bucket seats, all of which were not inspected (covered during site visit).

**119C** F.44 First floor landing fittings

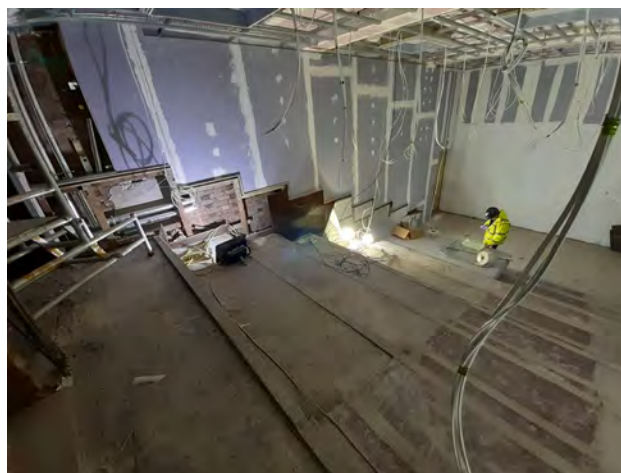
122 F.50a Cinema

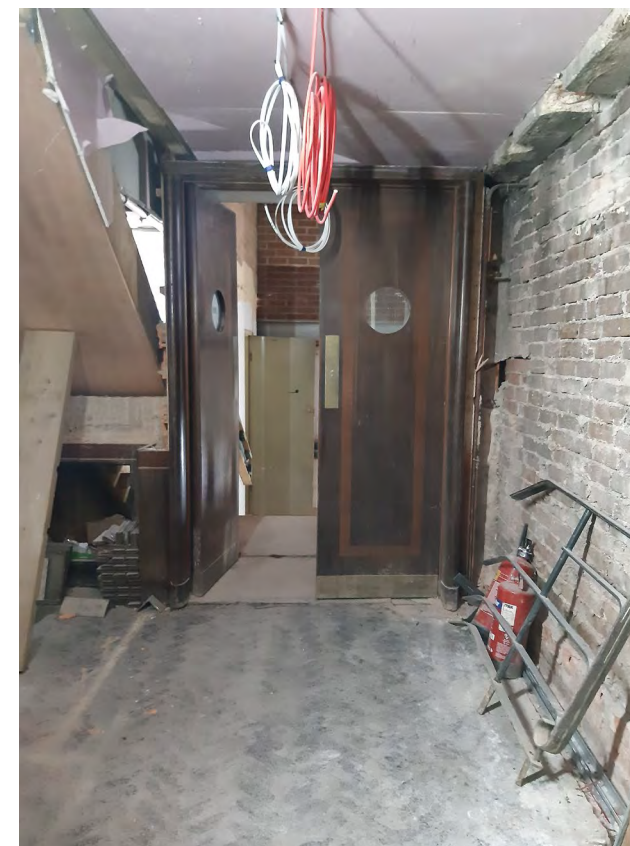
122A F.50c Cinema Foyer lobby doors (parquet floor lifted)

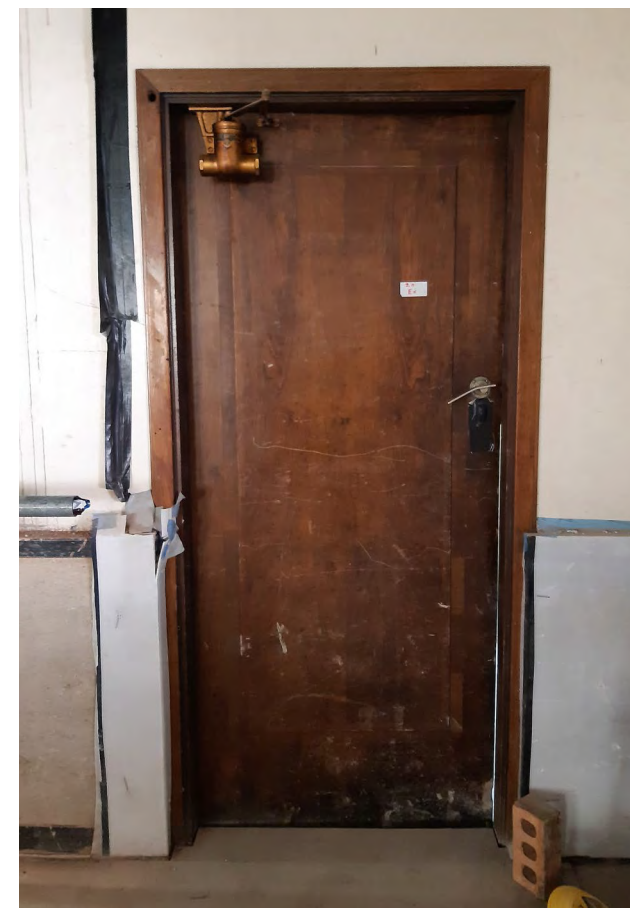
**140** S.31 Cleaners Room doors to Open lightwell doors with original ironmongery and muted wall colours

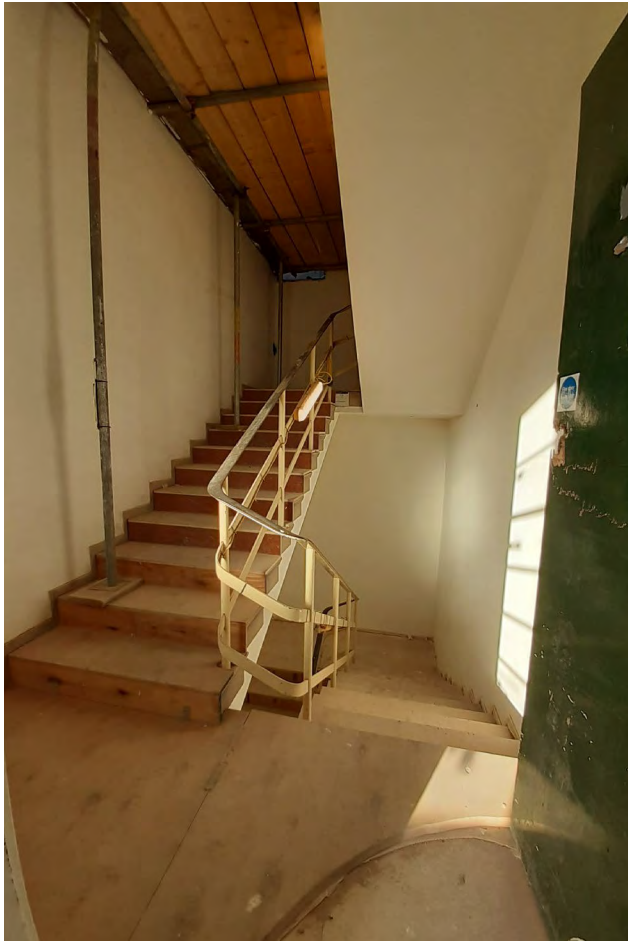
**152A** ST.04 first floor (stair closed off at second floor)
