**Project Name:** N10\_2PU

**Project Description:** WinCan Import in Miraculix WRc4 Standard

**Project Date:** 22/10/2021

Project: 40 DUKES AVENUE  
LONDON N10 2PU

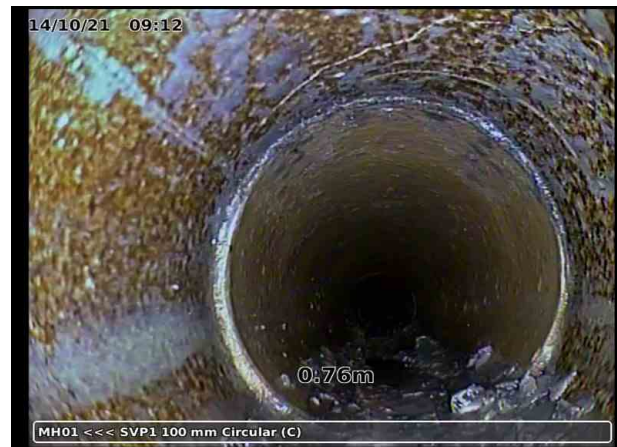
| Scale: | 1:50 | Position [m] | Code | Observation | MPEG | Photo | Grade |
|---|---|---|---|---|---|---|---|
| | 0.76 | CM | CM | Cracks, multiple from 10 o'clock to 3 o'clock | 00:00:22 | SVP1X_6a e17ec4-04 10-47f2-bb | 3 |

SVP1X\_6ae17ec4-0410-47f2-bb4d-7cc238f35450\_20211022\_125822\_076.jpg, 00:00:22, 0.76 m  
Cracks, multiple from 10 o'clock to 3 o'clock

| <b>Recommendations:</b> | Jet clean line & Re Survey | | | | |

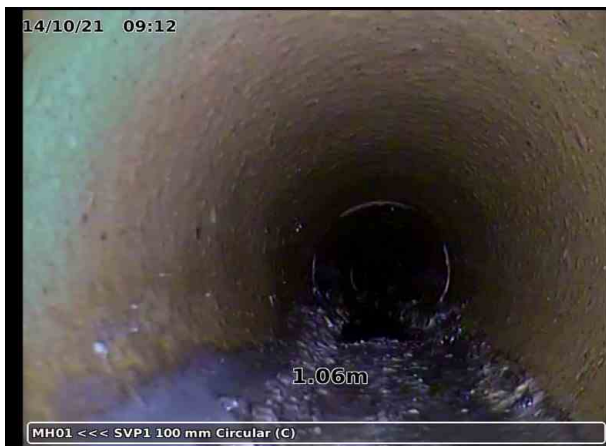
| Scale: | 1:50 | Position [m] | Code | Observation | MPEG | Photo | Grade |
|---|---|---|---|---|---|---|---|
| | 1.06 | S02 | DEF | Attached deposits, fouling from 4 o'clock to 8 o'clock, 10% cross-sectional area loss, start | 00:00:31 | SVP1X_32 79481a-6e bf-45f4-9a | |
| | 3.76 | F02 | DEF | Attached deposits, fouling from 4 o'clock to 8 o'clock, 10% cross-sectional area loss, finish | 00:01:21 | | 3 |

SVP1X\_3279481a-6ebf-45f4-9add-3eb2347fad0f\_20211022\_125852\_614.jpg, 00:00:31, 1.06 m  
Attached deposits, fouling from 4 o'clock to 8 o'clock, 10%

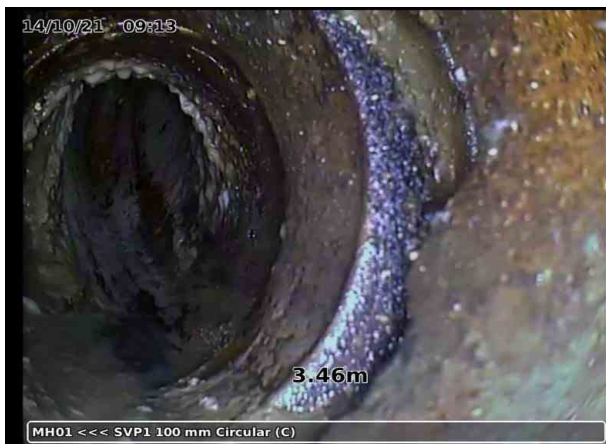
| Scale: | 1:50 | Position [m] | Code | Observation | MPEG | Photo | Grade |
|---|---|---|---|---|---|---|---|
| | 3.46 | JDM | JDM | Joint displaced, medium | 00:01:10 | SVP1X_74 e076ed-97 d1-4dff-ad | 1 |

SVP1X\_74e076ed-97d1-4dff-ad26-a122c59b6a12\_20211022\_125958\_433.jpg, 00:01:10, 3.46 m  
Joint displaced, medium

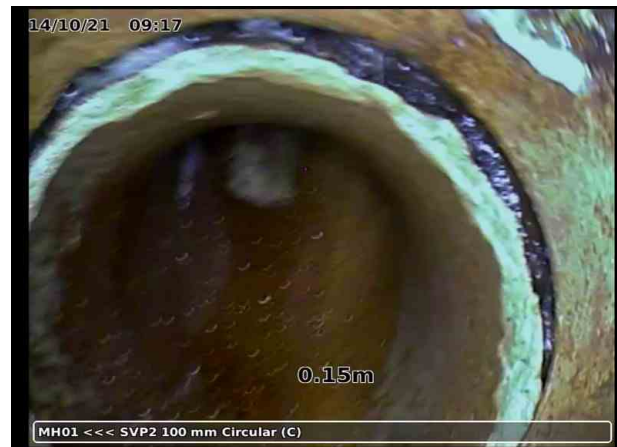
| Scale: | 1:50 | Position [m] | Code | Observation | MPEG | Photo | Grade |
|---|---|---|---|---|---|---|---|
| | | 0.20 | JDM | Joint displaced, medium | 00:00:07 | SVP2X_0a 6b6b05-b7 83-422c-a | 1 |

SVP2X\_0a6b6b05-b783-422c-a79e-3e20b094f40f\_20211022\_130152\_770.jpg, 00:00:07, 0.20 m  
Joint displaced, medium

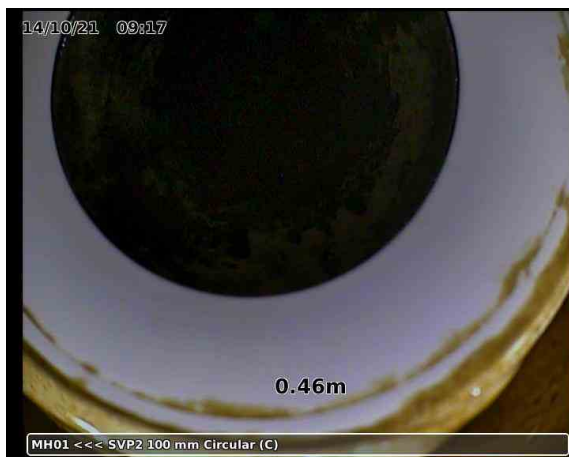
| <b>Comments:</b> | First floor flat SVP - Appears to be a pipe reducer wedged in pipe | | | | |

| Scale: | 1:50 | Position [m] | Code | Observation | MPEG | Photo | Grade |
|---|---|---|---|---|---|---|---|
| | | 0.38 | OBX | Other obstacles in invert from 12 o'clock to 12 o'clock, 20% cross-sectional area loss: PIPE REDUCER? | 00:00:12 | | 5 |

20211014-091654-snap0001.jpg, 00:00:17, 0.46 m  
Survey abandoned, REDUCER

| <b>Recommendations:</b> | Attempt to manually retrieve pipe reducer- Urgent | | | | |

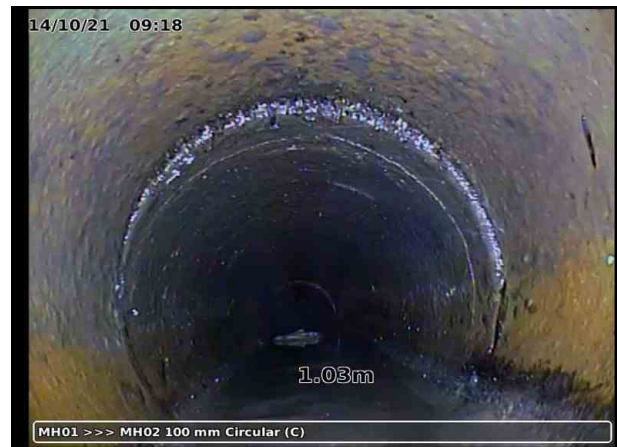
| Scale: | 1:90 | Position [m] | Code | Observation | MPEG | Photo | Grade |
|---|---|---|---|---|---|---|---|
| | | 1.03 | CC | Crack, circumferential from 9 o'clock to 3 o'clock | 00:00:20 | MH01X_4 0a3c49b-4 962-4c0f-b | 2 |

MH01X\_40a3c49b-4962-4c0f-bb8d-987e9e914974\_20211022\_130436\_754.jpg, 00:00:20, 1.03 m  
Crack, circumferential from 9 o'clock to 3 o'clock

| <b>Recommendations:</b> | Jet clean line & Re Survey | | | | |

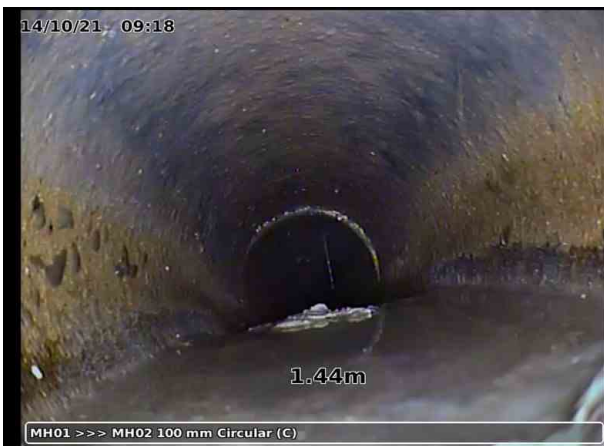
| Scale: | 1:90 | Position [m] | Code | Observation | MPEG | Photo | Grade |
|---|---|---|---|---|---|---|---|
| | | 1.44 | DEF | Attached deposits, fouling from 4 o'clock to 8 o'clock, 20% cross-sectional area loss | 00:00:32 | MH01X_9 5c10f1f-f9 dc-46dc-a | 3 |

MH01X\_95c10f1f-f9dc-46dc-ab4a-b366b9cac30f\_20211022\_130502\_471.jpg, 00:00:32, 1.44 m  
Attached deposits, fouling from 4 o'clock to 8 o'clock, 20%

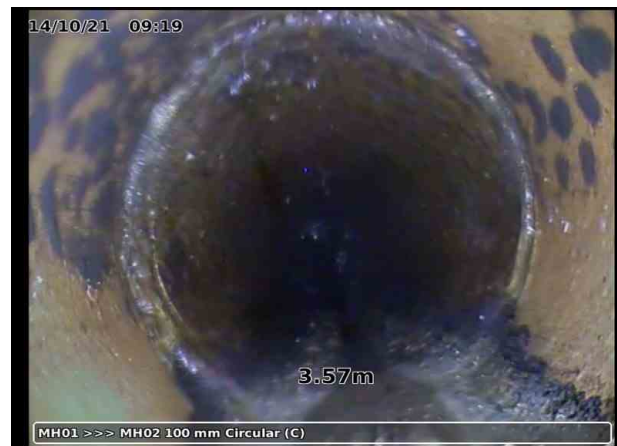
| Scale: | 1:90 | Position [m] | Code | Observation | MPEG | Photo | Grade |
|---|---|---|---|---|---|---|---|
| | | 3.57 | JDM | Joint displaced, medium | 00:01:00 | MH01X_1 27c206e-3 bd1-4cde- | 1 |

MH01X\_127c206e-3bd1-4cde-be04-58b3ed858ab7\_20211022\_130538\_274.jpg, 00:01:00, 3.57 m  
Joint displaced, medium

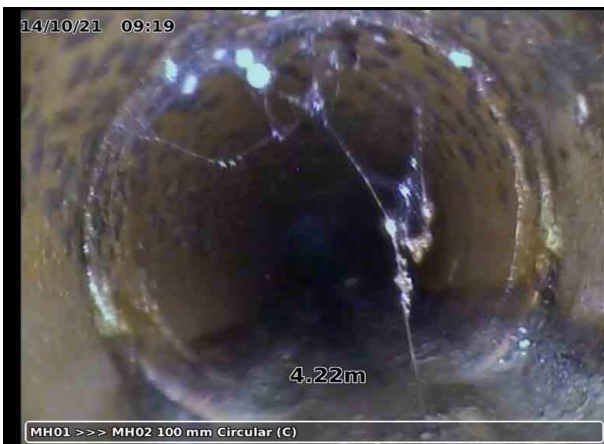
| Scale: | 1:90 | Position [m] | Code | Observation | MPEG | Photo | Grade |
|---|---|---|---|---|---|---|---|
| | | 4.22 | CC | Crack, circumferential from 2 o'clock to 9 o'clock | 00:01:13 | MH01X_fa 3bcc3c-5d b5-4e46-bf | 2 |

MH01X\_fa3bcc3c-5db5-4e46-bf14-4a3987bf9fd1\_20211022\_130600\_679.jpg, 00:01:13, 4.22 m  
Crack, circumferential from 2 o'clock to 9 o'clock

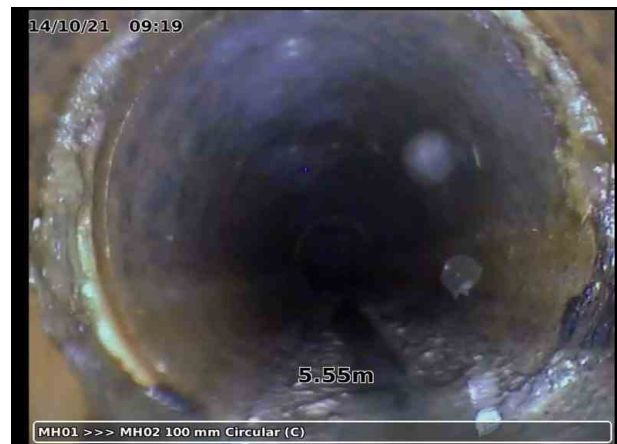
| Scale: | 1:90 | Position [m] | Code | Observation | MPEG | Photo | Grade |
|---|---|---|---|---|---|---|---|
| | | 5.55 | JDM | Joint displaced, medium | 00:01:31 | MH01X_3 ab42e01-a 17c-47f4-9 | 1 |

MH01X\_3ab42e01-a17c-47f4-9851-177cd20dd02f\_20211022\_130637\_479.jpg, 00:01:31, 5.55 m  
Joint displaced, medium

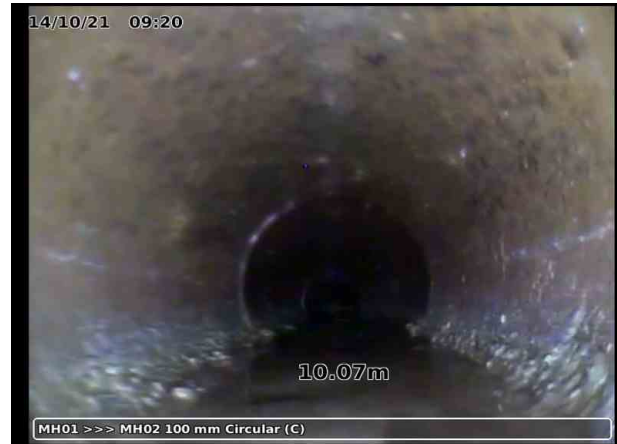
| Scale: | 1:90 | Position [m] | Code | Observation | MPEG | Photo | Grade |
|---|---|---|---|---|---|---|---|
| | | 10.07 | S02 | DEF Attached deposits, fouling from 4 o'clock to 8 o'clock, 15% cross-sectional area loss, start | 00:02:28 | MH01X_2 2aa77ff-57 50-454c-9 | |

MH01X\_22aa77ff-5750-454c-9cb3-709c4c8e094d\_20211022\_130923\_143.jpg, 00:02:28, 10.07 m  
Attached deposits, fouling from 4 o'clock to 8 o'clock, 15%

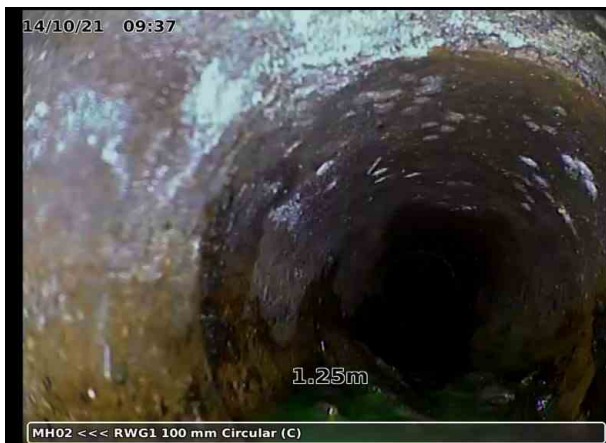
RWG1X\_4afa57d1-a2a6-4006-9afd-5d33a941c063\_20211022\_131215\_028.jpg, 00:00:21, 1.25 m  
Settled deposits, coarse, 10% cross-sectional area loss, start

| <b>Recommendations:</b> | Jet clean & Re Survey (Urgent) | | | | |

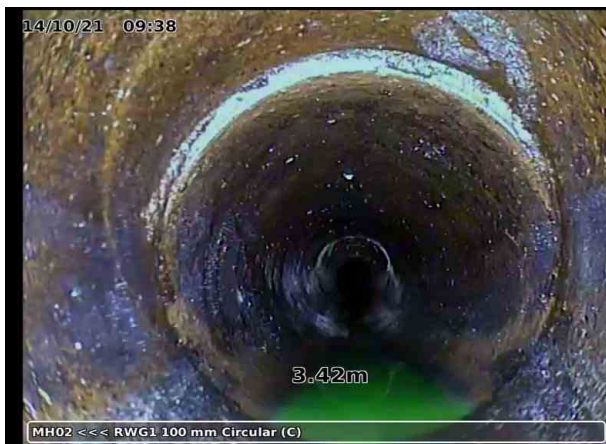
RWG1X\_ad2f2bef-33b2-4de1-8ac0-2b11f80f40b4\_20211022\_131333\_502.jpg, 00:01:08, 3.42 m  
Joint displaced, medium

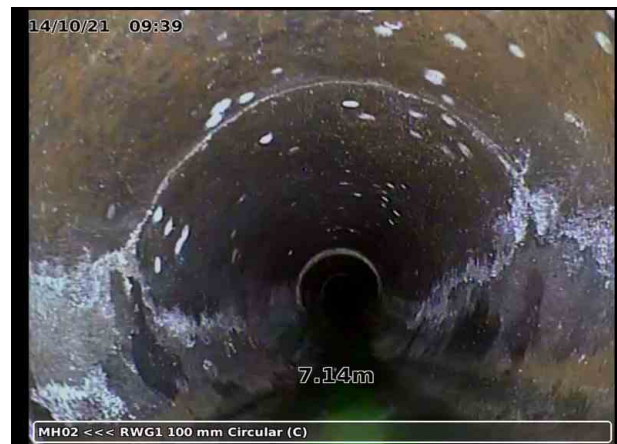
| Scale: | 1:97 | Position [m] | Code | Observation | MPEG | Photo | Grade |
|---|---|---|---|---|---|---|---|
| | | 7.14 | CC | Crack, circumferential from 8 o'clock to 3 o'clock | 00:02:01 | RWG1X_c c64321a-3 fd3-4177-8 | 2 |

RWG1X\_cc64321a-3fd3-4177-847a-eb47fd4d81d5\_20211022\_131454\_008.jpg, 00:02:01, 7.14 m  
Crack, circumferential from 8 o'clock to 3 o'clock

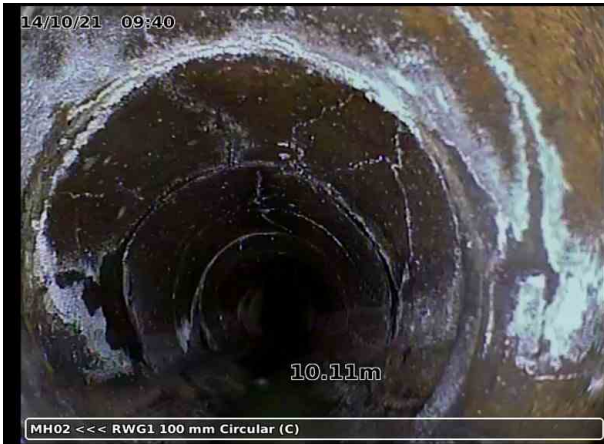
| Scale: | 1:97 | Position [m] | Code | Observation | MPEG | Photo | Grade |
|---|---|---|---|---|---|---|---|
| | | 10.11 | S03 | FM Fracture, multiple from 12 o'clock to 12 o'clock, start | 00:02:50 | RWG1X_c ebd6cdf-c7 5f-408e-8e | |
| | | 10.37 | F03 | FM Fracture, multiple from 12 o'clock to 12 o'clock, finish | 00:03:03 | | 4 |

RWG1X\_cabd6cdf-c75f-408e-8e86-cf633b5b3d51\_20211022\_131612\_092.jpg, 00:02:50, 10.11 m  
Fracture, multiple from 12 o'clock to 12 o'clock, start

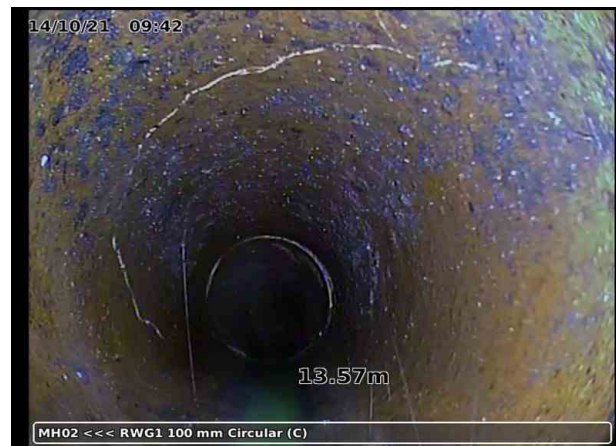
| Scale: | 1:97 | Position [m] | Code | Observation | MPEG | Photo | Grade | | |
|---|---|---|---|---|---|---|---|---|---|
| | | 13.57 | CS | Cracks, spiral from 7 o'clock to 1 o'clock | 00:03:48 | RWG1X_0 cad6a68-5 0c9-4388- | 3 | | |

RWG1X\_0cad6a68-50c9-4388-9716-e4322f79b848\_20211022\_131737\_055.jpg, 00:03:48, 13.57 m  
Cracks, spiral from 7 o'clock to 1 o'clock

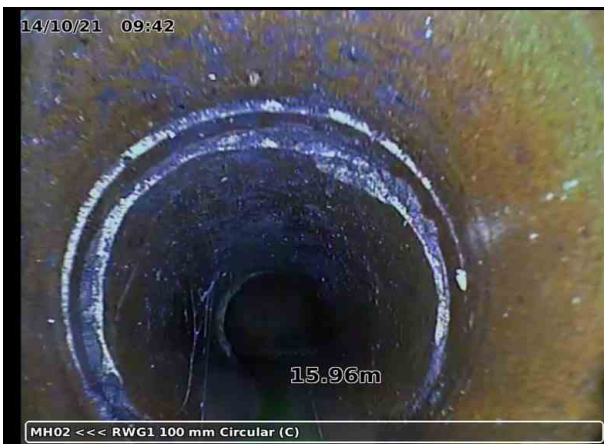
| Scale: | 1:97 | Position [m] | Code | Observation | MPEG | Photo | Grade | | |
|---|---|---|---|---|---|---|---|---|---|
| | | 15.96 | FCJ | Fracture, circumferential at joint from 8 o'clock to 3 o'clock | 00:04:18 | RWG1X_d 583655e-d efa-4b63-b | 3 | | |

RWG1X\_d583655e-defa-4b63-ba67-2d9d5e2d6ecb\_20211022\_131816\_478.jpg, 00:04:18, 15.96 m  
Fracture, circumferential at joint from 8 o'clock to 3 o'clock

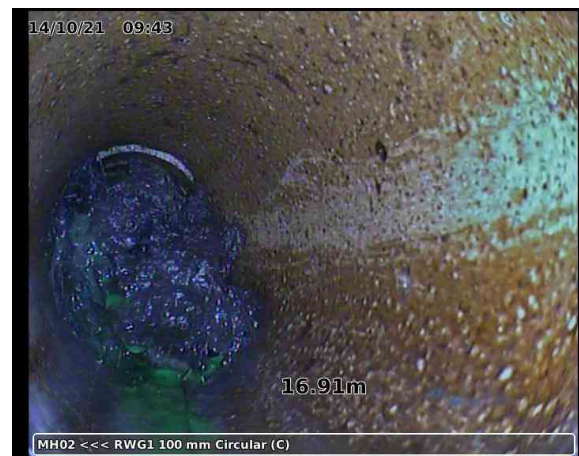
| Section | PLR | Grade | Description |
|---|---|---|---|
| 4 | RWG1X | 5 | Settled deposits, fine, 90% cross-sectional area loss |

20211014-093650-snap0004.jpg, 00:04:56, 16.91 m  
Survey abandoned, MASS OBSTRUCTION
