**Re: Your Insurance Claim**

## **Initial Customer Appraisal Report**

# Site Investigation Report

## Subsidence Damage Investigation at:

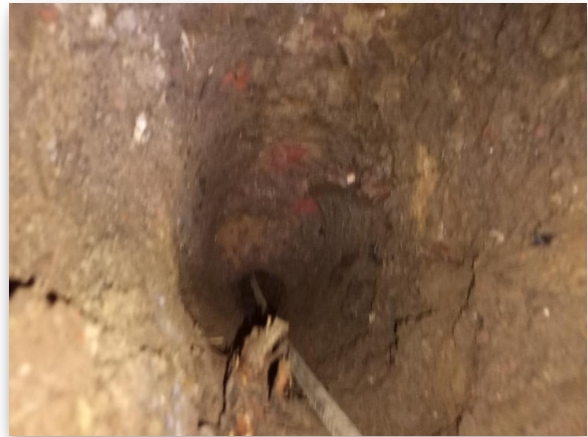
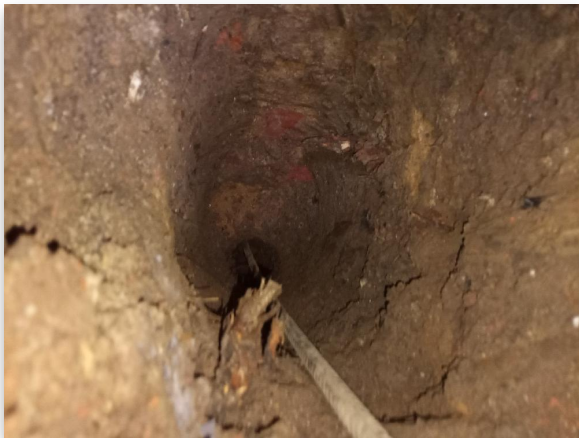
Fig 1.2: Trial Hole 1 Footing

Fig 1.3: Trial Hole 1 Footing

This was excavated to 1.1m and revealed that the brickwork of the original house extends to a depth of 1.1m below ground level including corbelling out two steps. The soil immediately beneath the foundation is dry, very stiff brown sandy and gravelly clay where it changes to sandy clay proven to a depth of 3.0 metres to the base of the borehole.

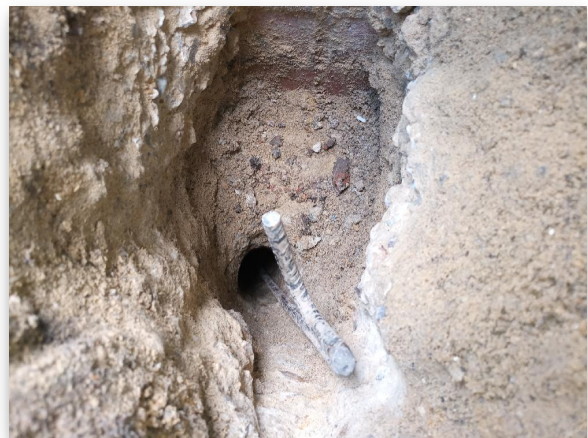
Fig 2.2: Trial Hole 3 Footing

This was excavated to 1.5m and revealed that the brickwork extends to 350mm below ground level where it sits on a concrete trench fill foundation which is 1250mmmm thick with a projection of 120mm. Hence the underside of the foundation is 1.5m below ground level. The soil immediately beneath the foundation is sandy clay proven to a depth of 3.0 metres.

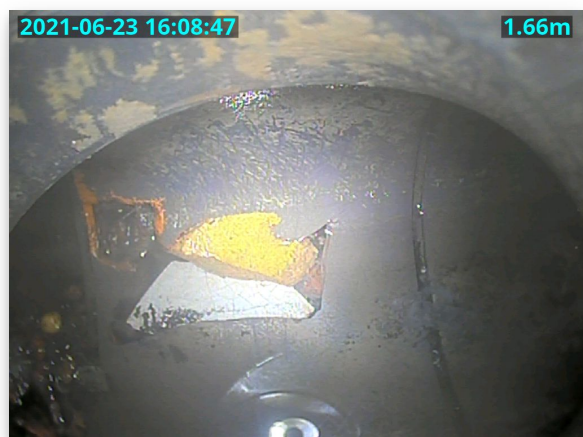
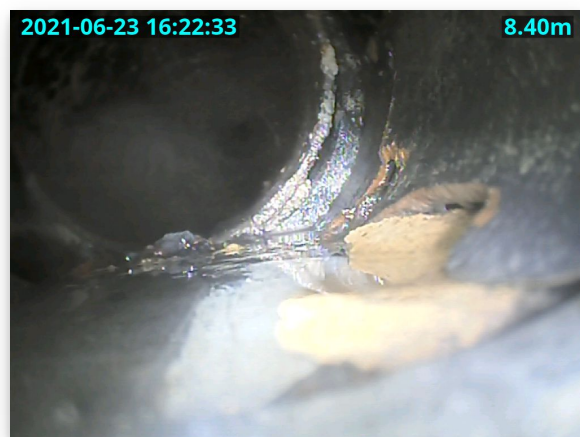
Our CCTV survey revealed a hole in the pipework on the branch connection to SVP2/Line 5, this will be resulting in an escape of water

Fig 3.1: Line 6, hole in pipework

Fig 3.2: Line 6, hole in pipework

**Line 6** - Auger recommend to excavate and replace an isolated 1.0m of 100mm pipework and the branch connection to Line 5 8.4m upstream from MH2 at a depth no greater than 1.0m through block paving.

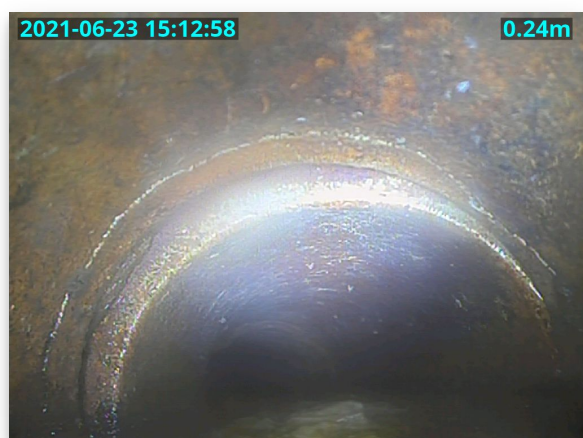
Our CCTV survey revealed joint displacements and a mass build up of waste within this line, due to this we were unable to complete an accurate survey.

Fig 3.3: Line 3, joint displacement

**Line 3** - Auger recommend to extensively jet line clear and determine if line is redundant, dye test internal services

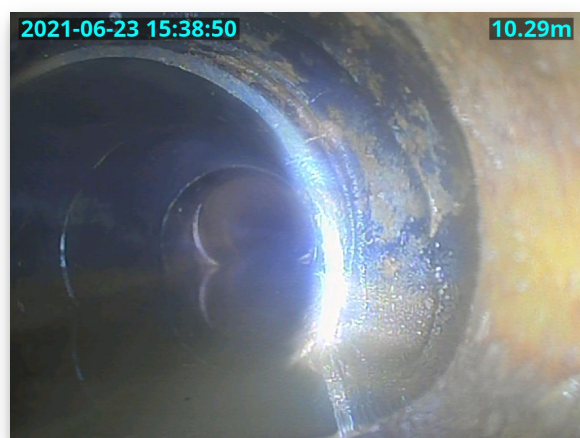
Our CCTV survey revealed joint displacements to a branch connection 10.4m downstream, and cracking 14.0m downstream where a connection running through the manhole has been connection into Line 4 (see fig. 4.1), we then discovered the channelling and benching within the manhole to have failed and caused waste to spill from Line 4 into MH2's channelling. We also discovered displacements from MH2 downstream to Line 7. The aforementioned defects will be resulting in an escape of water.

Fig 3.4: Line 4, joint displacement

**Line 4** - Auger recommend to excavate and replace an isolated 1.0m of 100mm pipework and the branch connection 10.4m downstream from MH1 at a depth no greater than 1.0m through block paving then CCTV up the blind connection and allow for 3.0m of 100mm liner upstream while the excavation is open

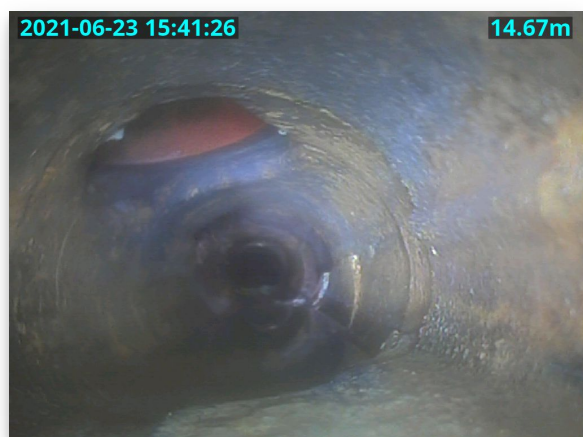
Fig 3.5: Line 4, cracking (Connection from clay pipe in MH2)

Auger recommend to break through the concrete benching within MH2 and remove the clay connection onto Line 6 running across the manhole then install a 100mm patch to cover the cracking upstream, re-bench and re-channel the manhole to make good of the poor arrangement. Cut the clay connection running across the manhole and install a 90 bend so it expels into the channelling, CCTV the line while we have access.

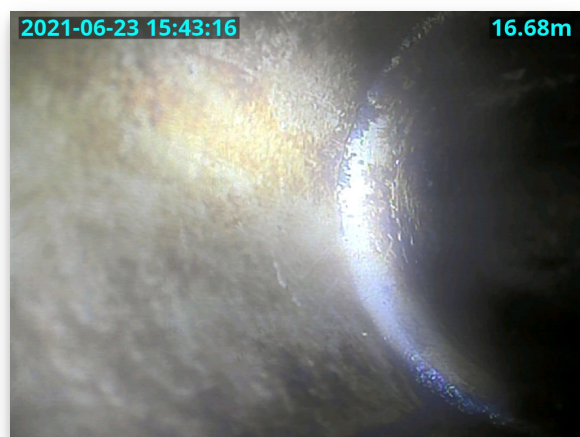
Fig 3.6: Line 4, joint displacement downstream from MH2

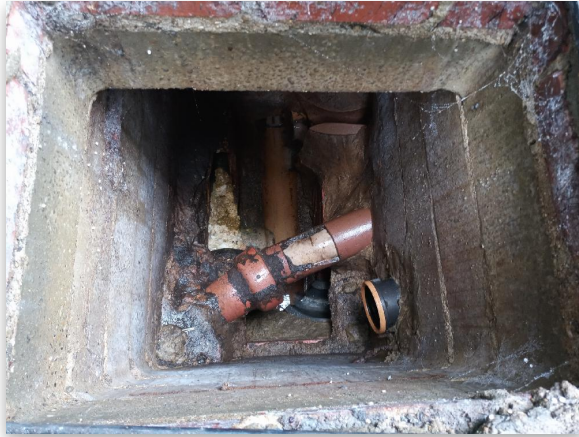
Fig 4.1: MH2

**Please Note:** The appearance of the pipework within MH2 will change to result in the system being repaired and it will have better serviceability, however, the arrangement will still not be ideal due to the initial poor installation.

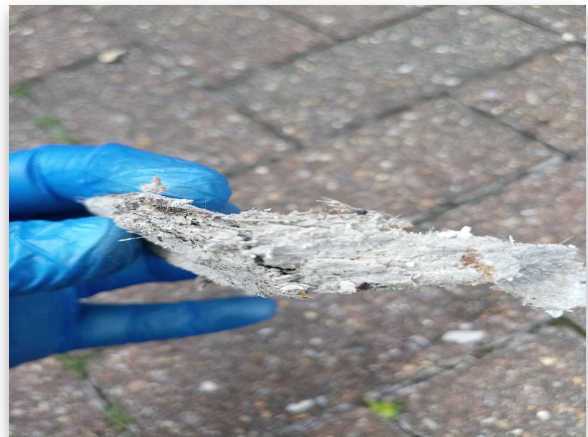
We were unable to carry out TH2 as we discovered asbestos containing material within the trial hole, we therefore terminated the trial hole and attempted it in another location, however, we encountered more asbestos. If the loss adjuster wishes for this trial hole to be undertaken, an asbestos specialist will be required to remove the asbestos found on site and to remove any further asbestos.

Fig 4.4: Potential asbestos containing material

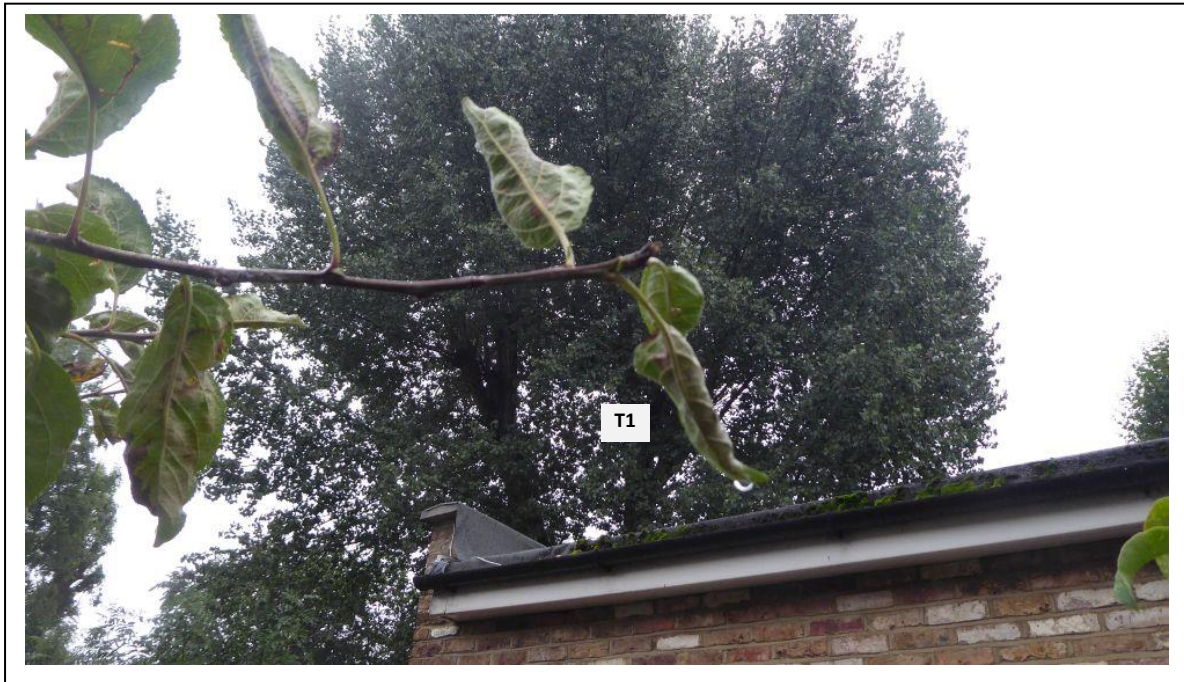
Having considered the information currently available, it is our opinion that T1 Poplar is the principal cause of the current subsidence damage, combined with a localised contributory influence from the nearby larger elements of SG1 and TG1 groups.

View of T1 Poplar

To prevent further movement and damage to the property, the T1 Poplar needs to be removed. If this is rejected due to the TPO protection, then we recommend moving to an underpinning solution, although this will be disruptive and costly. We would hold the current underpinning reserve at £60,000.00 but this may increase during design.

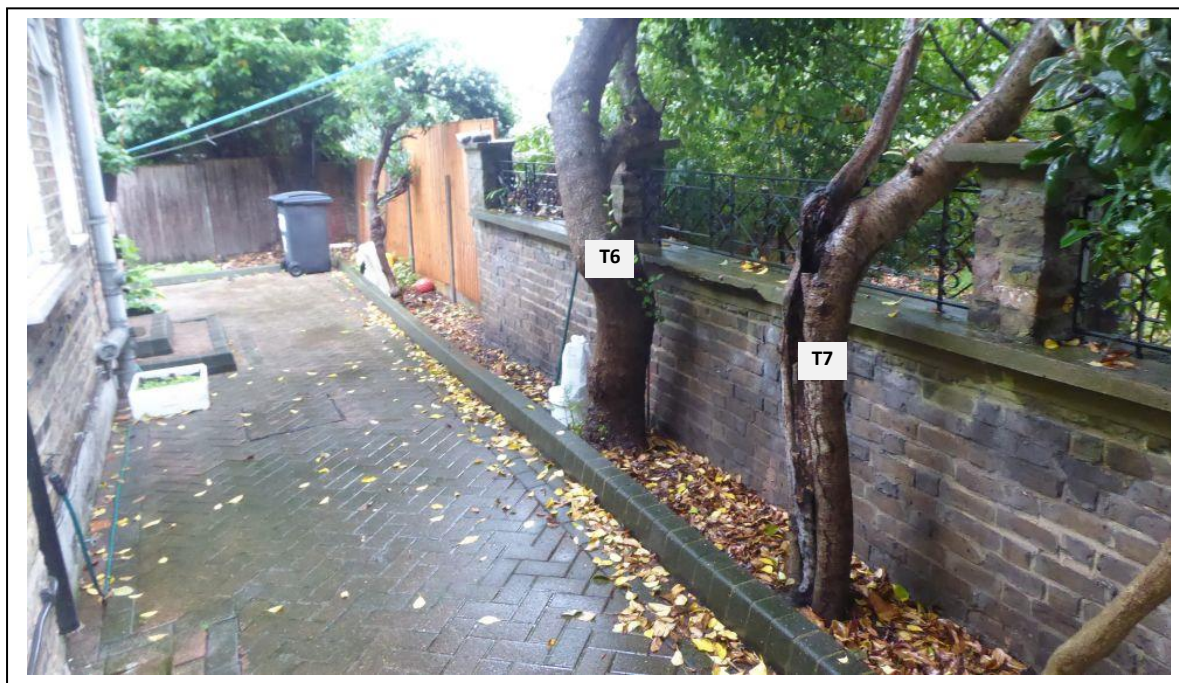
View of TG1 group – stems T6 and T7 to be removed

| Tree No. | Species | Ht (m) | Dia (mm) | Crown Spread (m) | Dist. to building (m) | Age Classification | Ownership |
|---|---|---|---|---|---|---|---|
| Recommendation | | Remove (fell) Magnolia [T6] and Portuguese Laurel [T7] to near ground level and treat stumps to inhibit regrowth.<br>Maintain remainder broadly at no more than current dimensions by periodic [annual] pruning. | | | | | |
