**INITIAL TECHNICAL REPORT**  
Retained

| OUR REFERENCE NO: | 77770003 |
| Ageas | 133 Morley Avenue,<br>London,<br>N22 6NP |

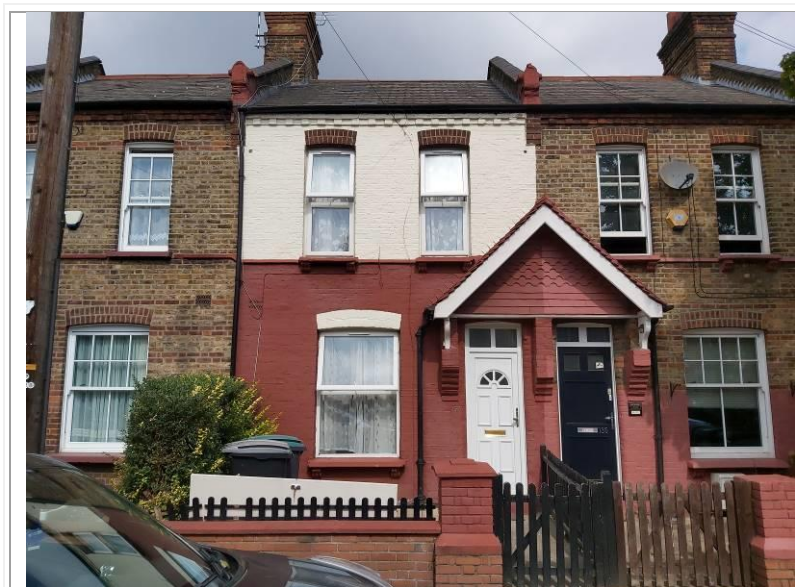
General view of property

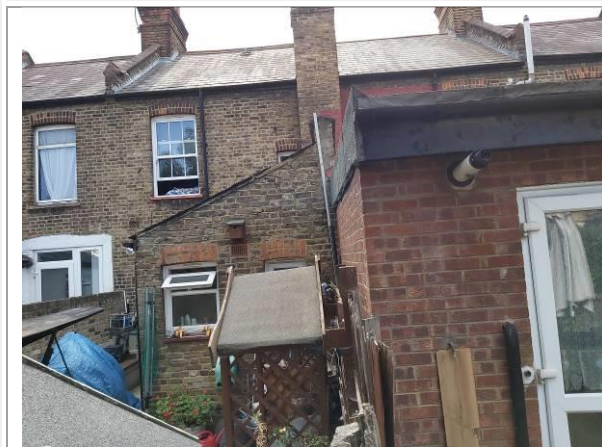
Right flank

It is likely that cracking in the brickwork and brickwork mortar has occurred to the left- and right-hand elevations, however due to access limitation this could not be confirmed or documented.

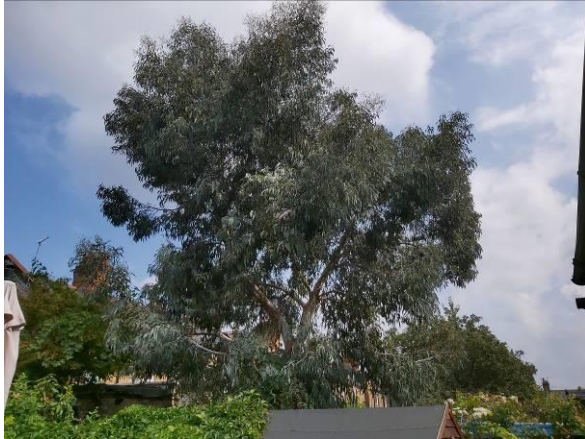
In this situation we believe that the nearby Eucalyptus tree has caused excessive shrinkage to the rear of the rear addition resulting in an uneven movement to the clay under the addition. The result of this is the cracking noted above.

Eucalyptus

- 1 Trial holes / bore holes to the rear right corner the property to confirm the depths of the foundations and condition of the bearing soils beneath the foundations.
- A crack and / or level monitoring exercise for an initial period of 12 months.
- To obtain an arboriculturalist report to obtain advice on the vegetation management works required, and confirm if there are any restrictions in place, regarding the removal of the implicated vegetation.

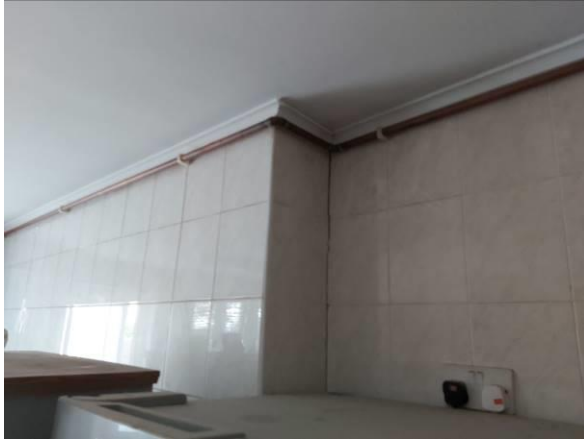
- The right-hand wall at the inside of the return and towards the rear.
- The left-hand wall adjacent to the extractor.
- To the left and right of the window.
- Within the floor tile grout adjacent to the external door
- The external door is binding.

Inside return right hand wall

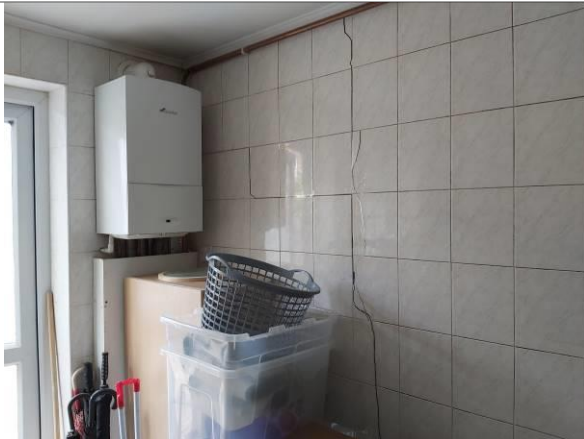
Right hand wall

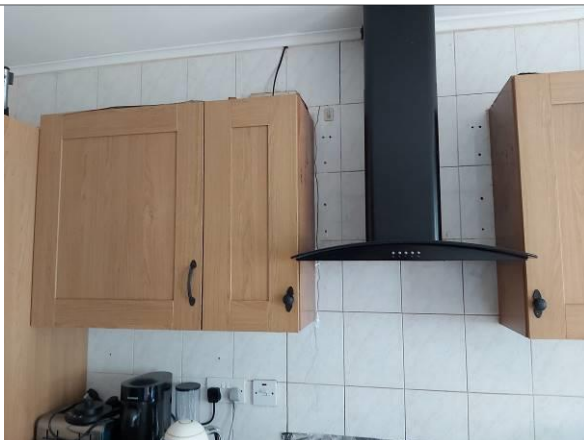
Left hand wall

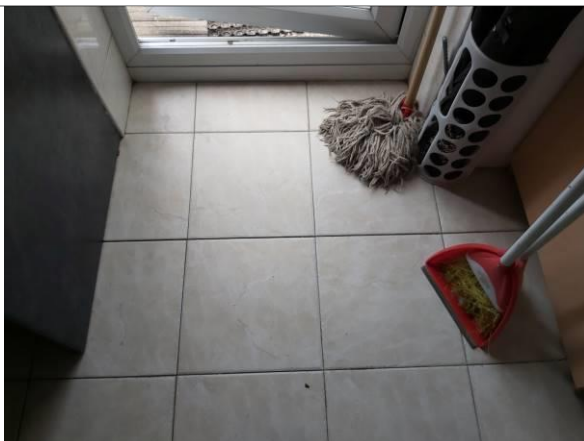
Open tile grout
