# Arboricultural Appraisal Report

## Subsidence Damage Investigation at:

133 Morley Avenue  
London  
N22 6NP

| REPORT DATE: | 12/05/2023 |

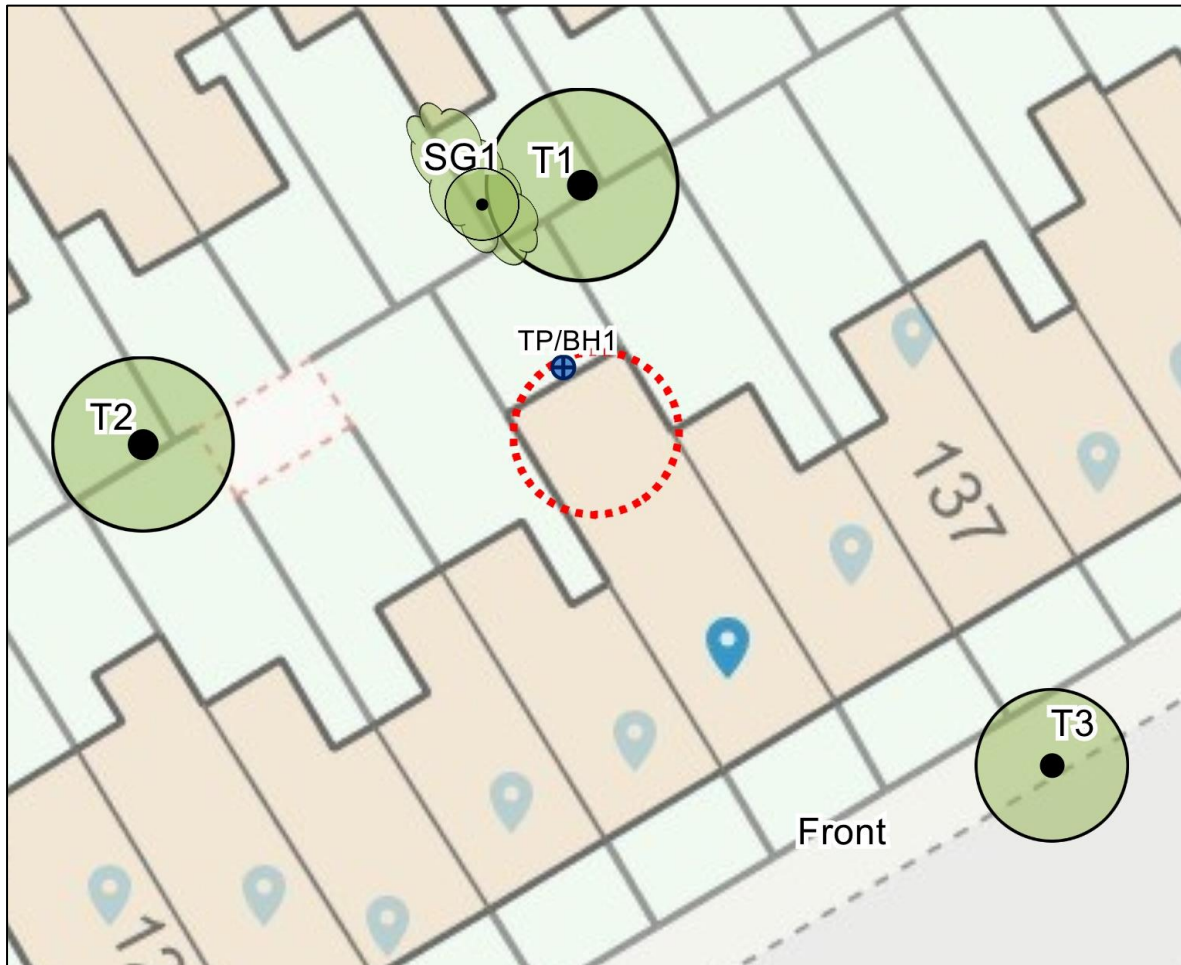
## Site Plan

Approximate areas of damage

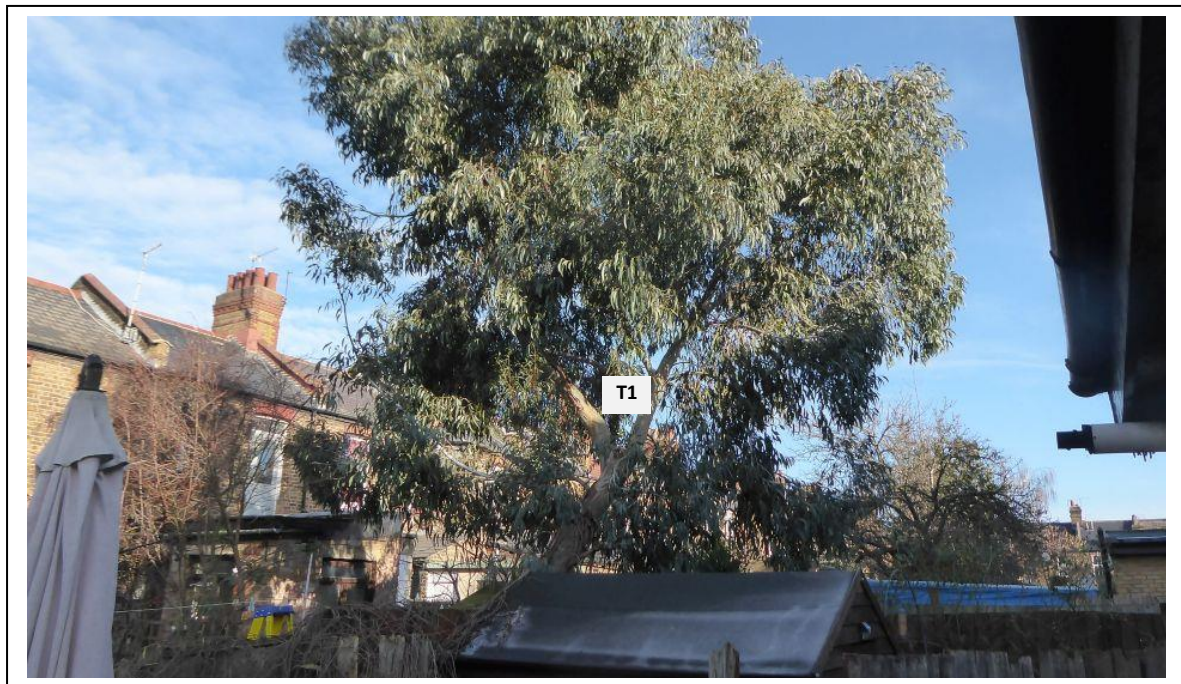
Roots were observed below foundation depth in TP/BH1 and recovered samples have been positively identified (using anatomical analysis) as *Eucalyptus* spp.; the origin of which will be T1 Eucalyptus confirming its influence on the soils below the foundations.

Based on the technical reports currently available, engineering opinion and our own site assessment we conclude the damage is consistent with shrinkage of the clay subsoil related to moisture abstraction by vegetation. It is our opinion that T1 Eucalyptus is the principal cause of the current damage.

| Tree No. | Species | Ht (m) | Dia (mm) | Crown Spread (m) | Dist. to building (m) | Age Classification | Ownership |
|---|---|---|---|---|---|---|---|
| T1 | Eucalyptus | 9.0 * | 330 * | 7.5 | 5.4 | Younger than Property | Third Party<br>152 Moselle Avenue<br>N22 6EX |

View of T1 Eucalyptus

| Tree No. | Species | Ht (m) | Dia (mm) | Crown Spread (m) | Dist. to building (m) | Age Classification | Ownership |
|---|---|---|---|---|---|---|---|
| Recommendation | | Remove (fell) to near ground level and treat stump to inhibit regrowth. | | | | | |

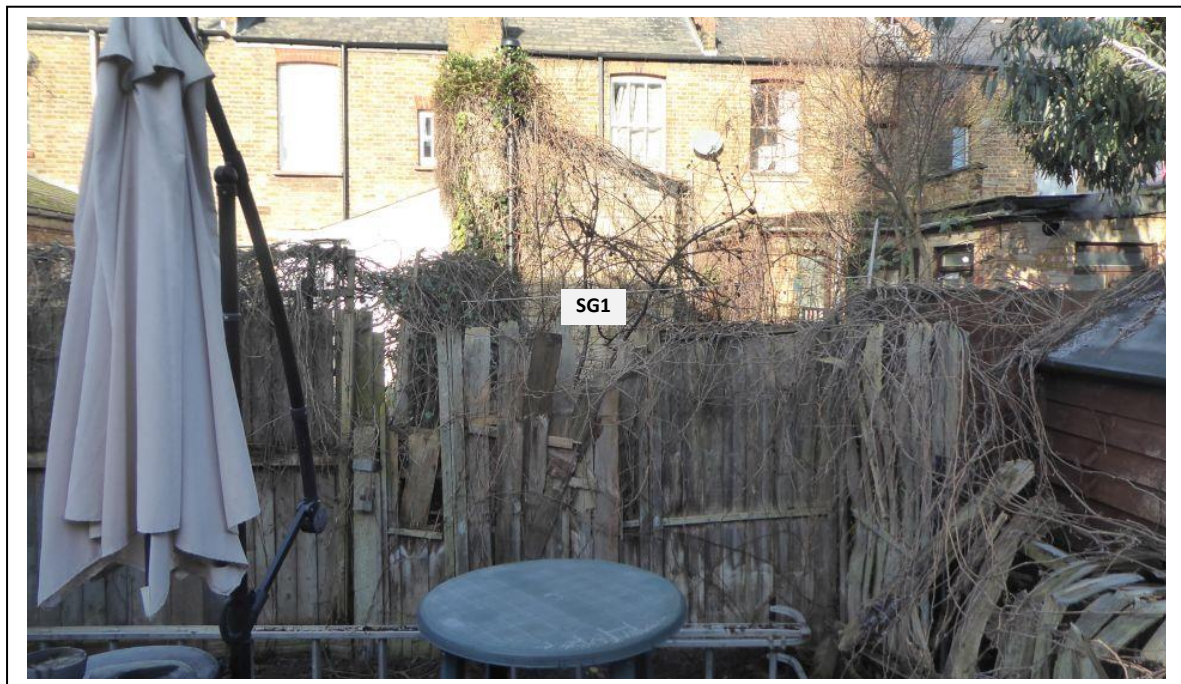
| Tree No. | Species | Ht (m) | Dia (mm) | Crown Spread (m) | Dist. to building (m) | Age Classification | Ownership |
|---|---|---|---|---|---|---|---|
| SG1 | Mixed spp. group of mostly Grape, Cherry, Ivy and Rose | 3.5 | 30 Ms * | 8.0 | 5.0 | Younger than Property | Third Party<br>152 Moselle Avenue<br>N22 6EX |
| Management history | | No significant past management noted.<br>Climbers have extended over subject property garden and causing damage to boundary fences. | | | | | |

View of SG1 group

| Tree No. | Species | Ht (m) | Dia (mm) | Crown Spread (m) | Dist. to building (m) | Age Classification | Ownership |
|---|---|---|---|---|---|---|---|
| Recommendation | | Remove (fell) Cherry and climbers to near ground level and treat stumps to inhibit regrowth. | | | | | |

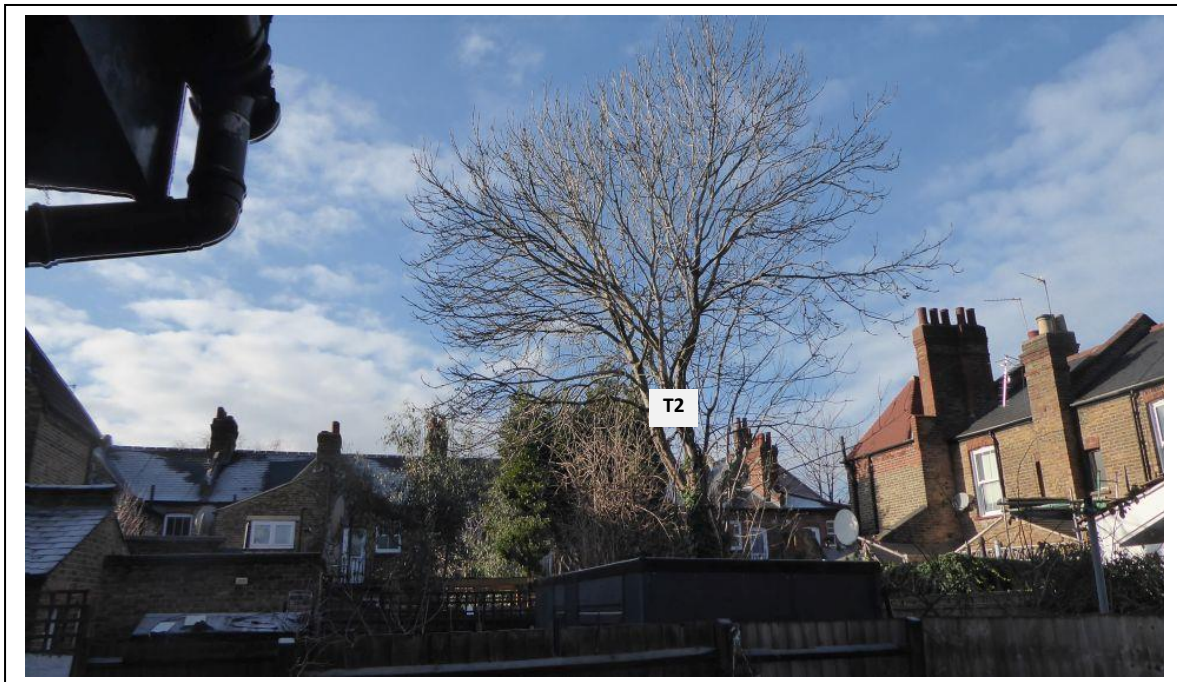
| Tree No. | Species | Ht (m) | Dia (mm) | Crown Spread (m) | Dist. to building (m) | Age Classification | Ownership |
|---|---|---|---|---|---|---|---|
| T2 | Ash | 11.0 | 350 * | 9.5 * | 12.0 | Younger than Property | Third Party<br>144 Moselle Avenue<br>N22 6EX |

View of T2 Ash

| Tree No. | Species | Ht (m) | Dia (mm) | Crown Spread (m) | Dist. to building (m) | Age Classification | Ownership |
|---|---|---|---|---|---|---|---|
| Recommendation | | Remove (fell) to near ground level and treat stump to inhibit regrowth. | | | | | |

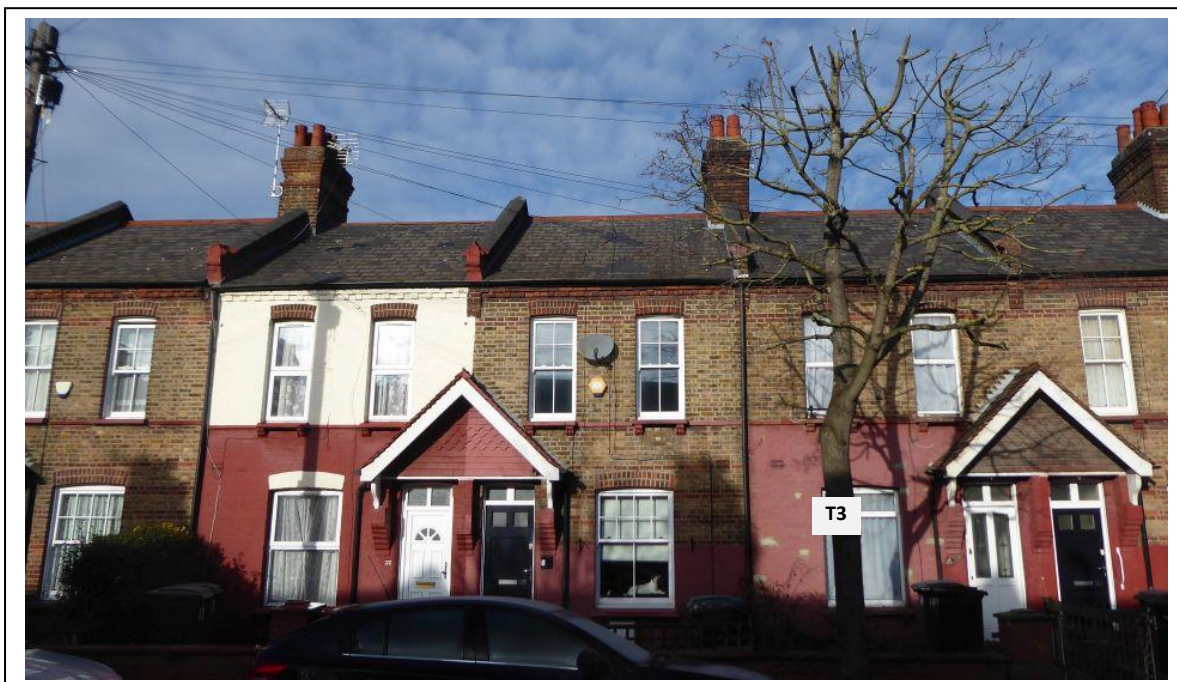
| Tree No. | Species | Ht (m) | Dia (mm) | Crown Spread (m) | Dist. to building (m) | Age Classification | Ownership |
|---|---|---|---|---|---|---|---|
| T3 | Maple | 7.0 | 290 | 5.0 | 6.5 | Younger than Property | No registrations<br>Local Authority assumed |

View of T3 Maple

| Tree No. | Species | Ht (m) | Dia (mm) | Crown Spread (m) | Dist. to building (m) | Age Classification | Ownership |
|---|---|---|---|---|---|---|---|
| Recommendation | | No works required. | | | | | |
