# Arboricultural Consultancy for Lloyds Bank

| Insured | Mr and Mrs Darryl and Jacqueline Burchell | Address | 47 Western Park, London, N8 9SY | | |
| Client | Subsidence Management Services | Contact | Ian Domigan | Claim No. | IFS-LBG-SUB-22-0105179 |

The insured structure is a 3 storey end-terrace house. It has been extended with a single-storey extension to the rear. The property occupies a level site with no adverse topographical features.

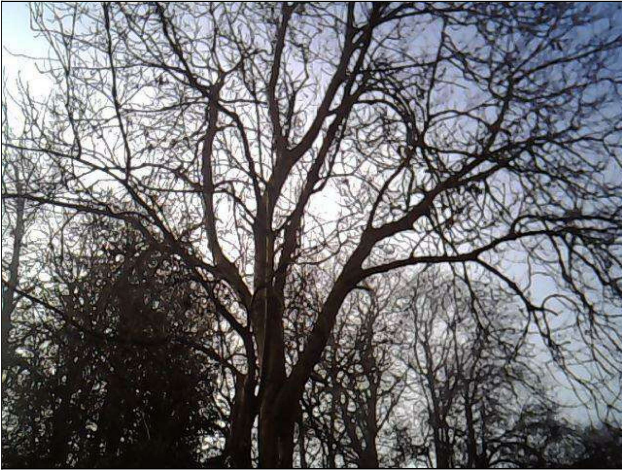
T1 - Ash

| Tree No. | Species | Age Cat | Approx. Height (m) | Distance to Building (m) * | Ownership | Action | Requirement |
|---|---|---|---|---|---|---|---|
| T1 | Ash | 1 | 15 | 9 | C - Insured | Action to avoid future risk | Crown reduce overall canopy by 30% (minimum) to achieve a crown volume reduction in line with BRE IP7/06. Maintain at reduced dimensions by re-pruning back to points of previous reduction on a 3 year (max) cycle. |

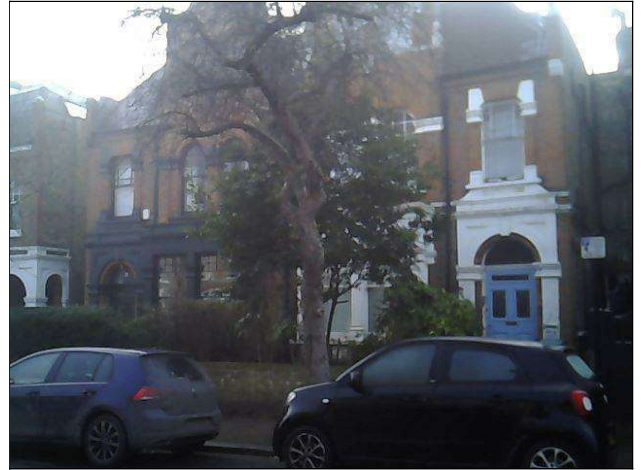
T4 - Apple (Crab)

| Tree No. | Species | Age Cat | Approx. Height (m) | Distance to Building (m) * | Ownership | Action | Requirement |
|---|---|---|---|---|---|---|---|
| T4 | Apple (Crab) | 1 | 9.3 | 10 | B - Local Authority | Action to avoid future risk | Maintain at broadly current dimensions by way of regular pruning. |

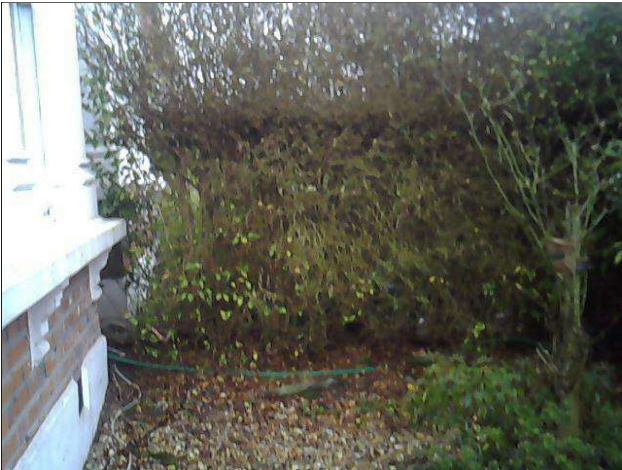
With due regards to species profile, size and proximity, H1 (Privet), T2 (Lime) and S1 (Privet) are considered the dominant features proximate to the focal area of movement and accordingly, where vegetation is confirmed as being causal, we have identified them as the primary cause of the current subsidence damage.

H1 - Privet

| Tree No. | Species | Age Cat | Approx. Height (m) | Distance to Building (m) * | Ownership | Action | Requirement |
|---|---|---|---|---|---|---|---|
| H1 | Privet | 1 | 2.5 | 0.6 | C - Insured | Remove | Remove close to ground level; do not treat stumps due to translocation risk. Where such a risk exists, we advise that any emergent regrowth is removed annually. |

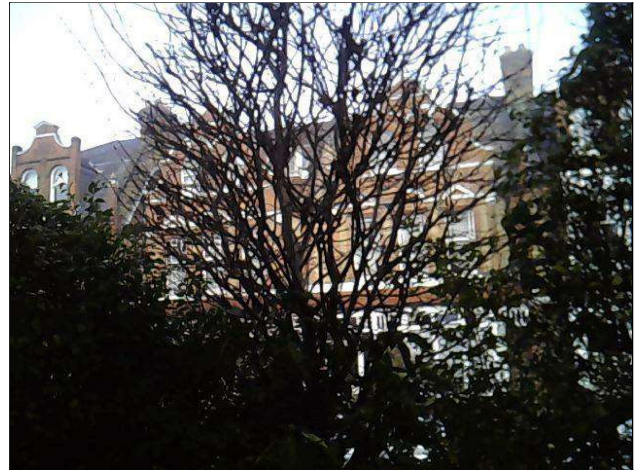
T2 - Lime

| Tree No. | Species | Age Cat | Approx. Height (m) | Distance to Building (m) * | Ownership | Action | Requirement |
|---|---|---|---|---|---|---|---|
| T2 | Lime | 1 | 3.4 | 3.6 | C - Insured | Remove | Remove close to ground level and treat stump to inhibit regrowth. |

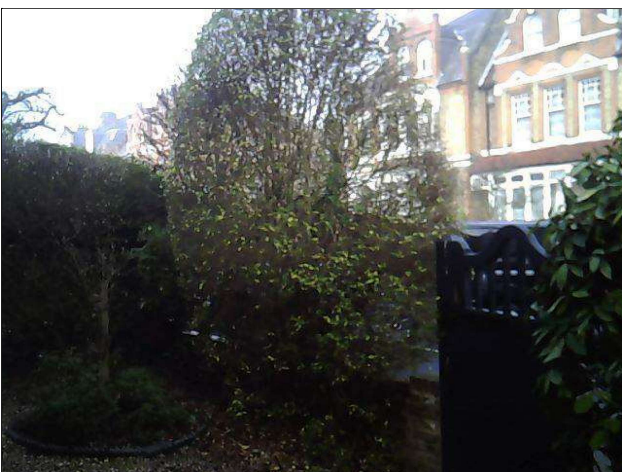
S1 - Privet

| Tree No. | Species | Age Cat | Approx. Height (m) | Distance to Building (m) * | Ownership | Action | Requirement |
|---|---|---|---|---|---|---|---|
| S1 | Privet | 1 | 3.4 | 3.2 | C - Insured | Remove | Remove close to ground level; do not treat stump due to translocation risk. Where such a risk exists, we advise that any emergent regrowth is removed annually. |

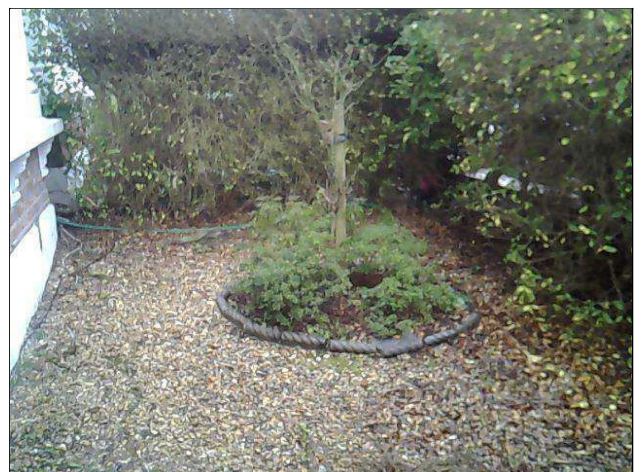
SG1 - Rose

| Tree No. | Species | Age Cat | Approx. Height (m) | Distance to Building (m) * | Ownership | Action | Requirement |
|---|---|---|---|---|---|---|---|
| SG1 | Rose | 1 | 1.5 | 2.1 | C - Insured | No action | No works. |

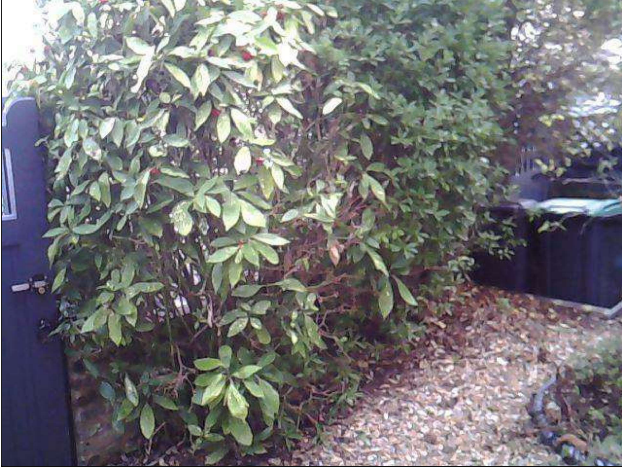
H2 - Mixed species hedge

| Tree No. | Species | Age Cat | Approx. Height (m) | Distance to Building (m) * | Ownership | Action | Requirement |
|---|---|---|---|---|---|---|---|
| H2 | Mixed species hedge | 1 | 2.5 | 4.2 | C - Insured | Action to avoid future risk | Maintain at broadly current dimensions by way of regular pruning.<br>Aucuba and Privet |

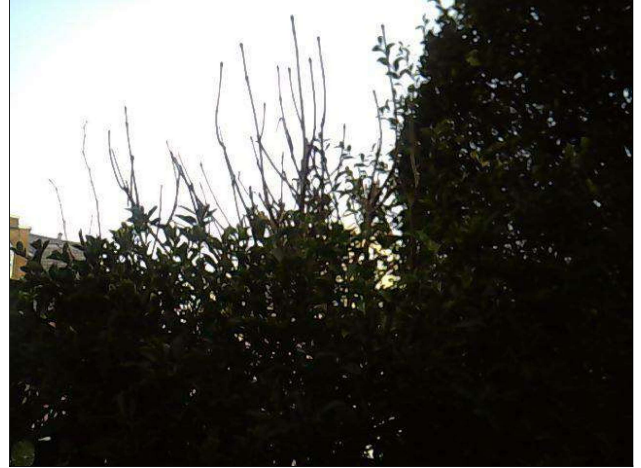
T3 - Horse Chestnut

| Tree No. | Species | Age Cat | Approx. Height (m) | Distance to Building (m) * | Ownership | Action | Requirement |
|---|---|---|---|---|---|---|---|
| T3 | Horse Chestnut | 1 | 2.8 | 4.2 | C - Insured | Action to avoid future risk | Maintain at broadly current dimensions by way of regular pruning. |

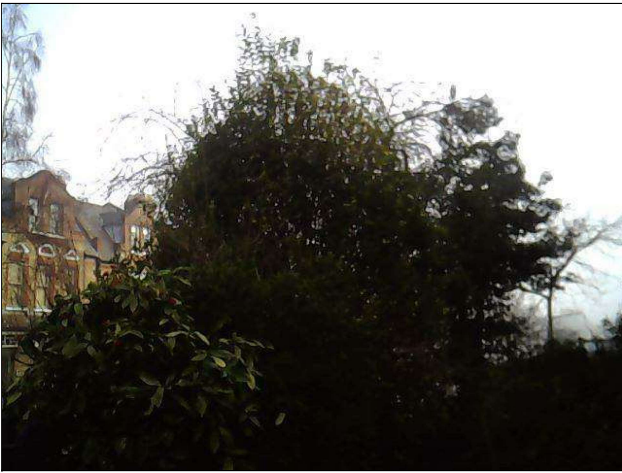
S2 - Privet

| Tree No. | Species | Age Cat | Approx. Height (m) | Distance to Building (m) * | Ownership | Action | Requirement |
|---|---|---|---|---|---|---|---|
| S2 | Privet | 1 | 3.6 | 4.1 | C - Insured | Action to avoid future risk | Maintain at broadly current dimensions by way of regular pruning. |

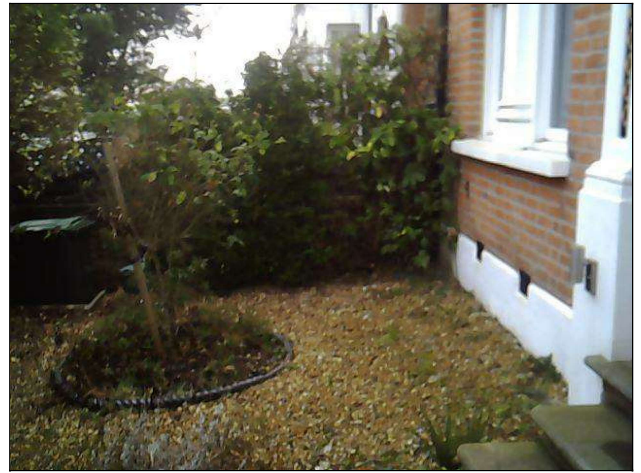
H3 - Mixed species hedge

| Tree No. | Species | Age Cat | Approx. Height (m) | Distance to Building (m) * | Ownership | Action | Requirement |
|---|---|---|---|---|---|---|---|
| H3 | Mixed species hedge | 1 | 2.5 | 0.4 | C - Insured | Action to avoid future risk | Do not allow to exceed current dimensions by way of regular pruning.<br>Aucuba, Sycamore and Euonymus |

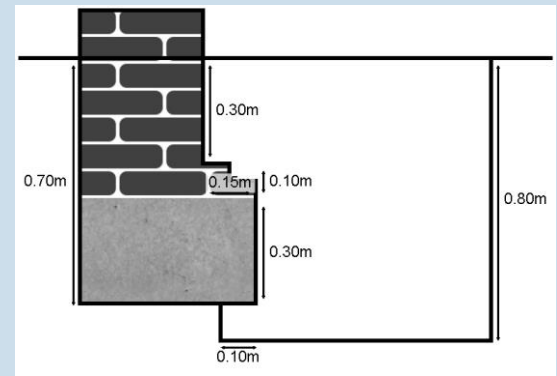
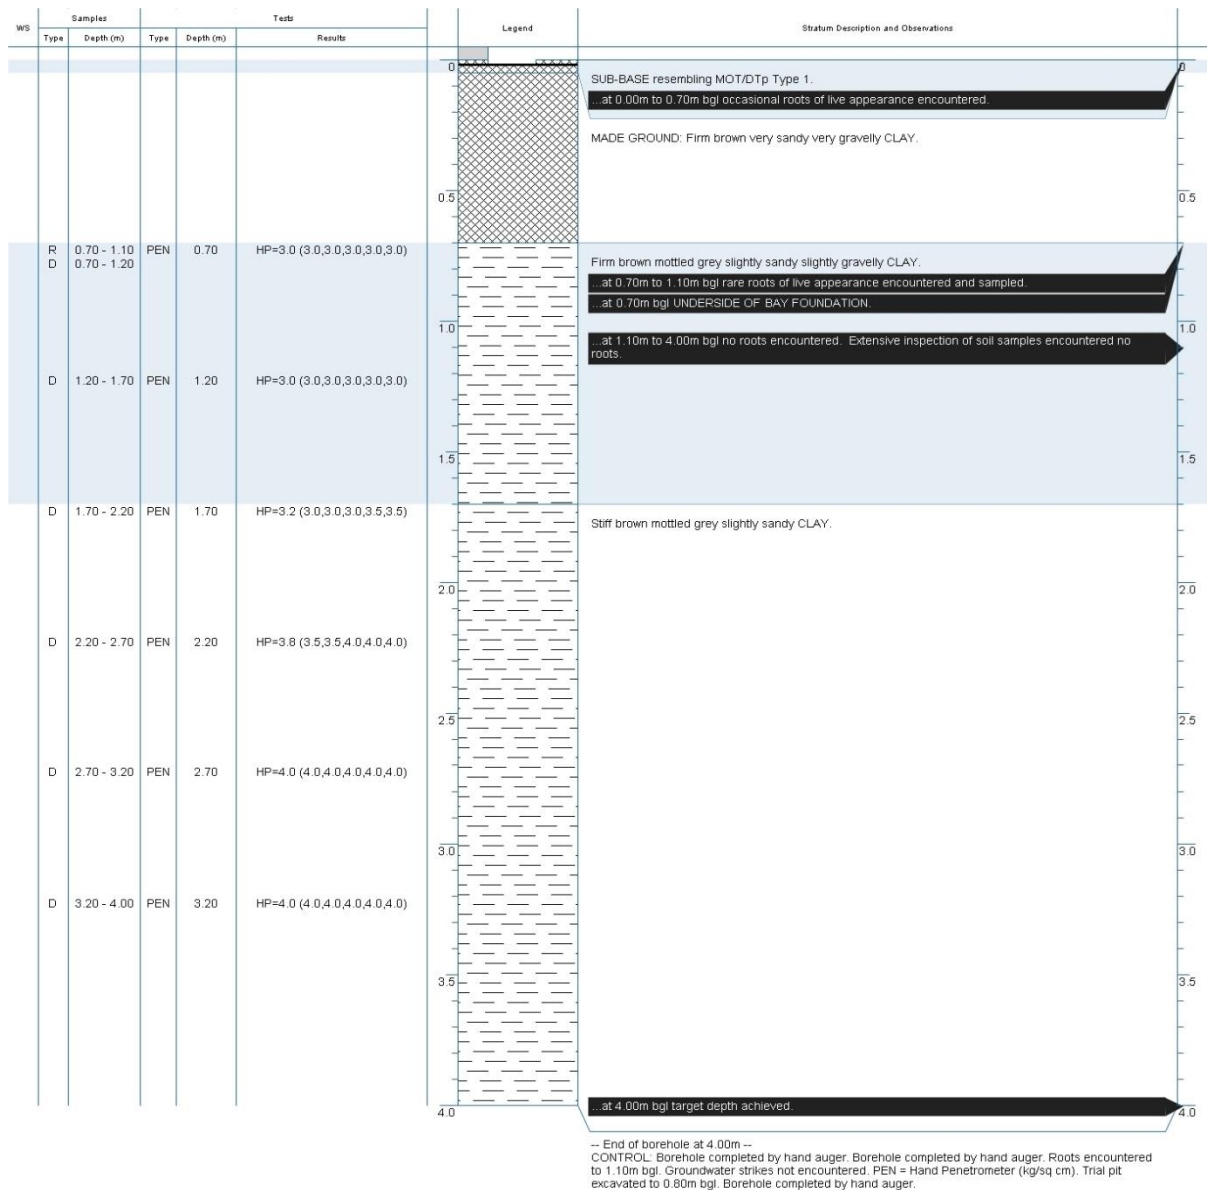
## TP/BH1 Foundation Detail and Borehole Log

Bay foundation comprised of brick wall to 300mm bgl, bearing on stepped brickwork to 400mm bgl with a total projection of 150mm from the elevation. In turn, bearing on concrete to 700mm bgl with a total projection of 150mm from the elevation. Underside of foundation (USF) was exposed to 100mm back from the face of the foundation and probed 200mm back from the face of the foundation.

At 0.70m bgl UNDERSIDE OF BAY FOUNDATION in TP/BH1.

At 0.00m to 0.70m bgl occasional roots of live appearance encountered in TP/BH1.

At 0.70m to 1.10m bgl rare roots of live appearance encountered and sampled in TP/BH1.

At 1.10m to 4.00m bgl no roots encountered. Extensive inspection of soil samples encountered no roots in TP/BH1.
