# ARBORICULTURAL ASSESSMENT REPORT

Holy Trinity Vicarage, Granville Road, London, N4 4EL

**PRI Ref:** 236626

**Survey Date:** 22/07/2022

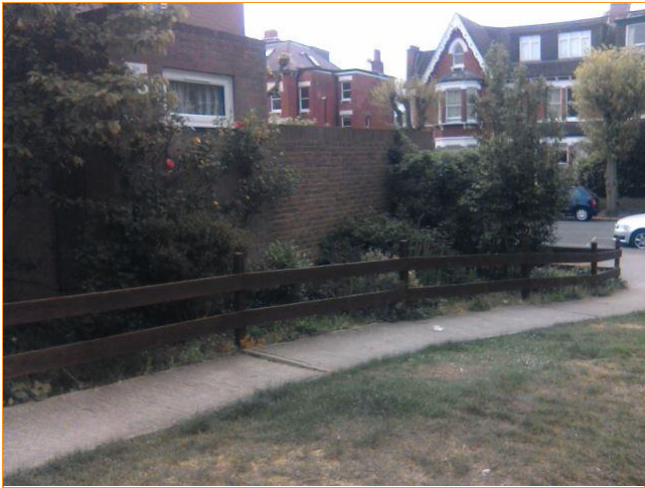
SG1 - Mixed species shrubs (April 2020)

| Tree No | Common Name | Age Class | Condition | Height (m) | Crown Spread (m) | Stem diam. (mm) | Dist to bldg. (m) | Roots Implicated | Pruning history | Recommendation | Tree work constraints | Notes | Owner address | Owner |
|---|---|---|---|---|---|---|---|---|---|---|---|---|---|---|
| SG1 | Mixed species shrubs | Early Mature | Good | 1.2 | 1.8 | 10 | 0.1 | Y | Subject to past management. Group reduced but in need of removal and treatment. | Fell and treat stumps of group. | | Mixed shrubs including Rose, Cotoneaster, Flowering Currant, Fuchsia and Juneberry. Rose roots found, other shrubs implicated due to size and location. Group is 8m long. | Holy Trinity Vicarage<br>Granville Road<br>London<br>N4 4EL | PH |

| Tree No: | Species | Works Required |
|---|---|---|
| SG1 | Mixed species shrubs | Fell and treat stumps of group. |

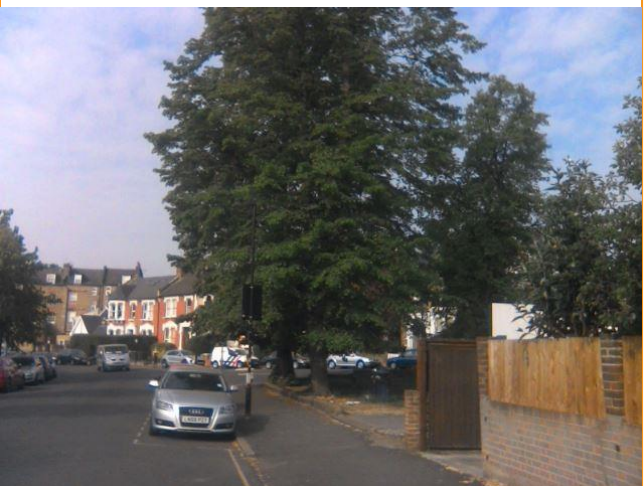
T1 - Lime (April 2020)

| Tree No | Common Name | Age Class | Condition | Height (m) | Crown Spread (m) | Stem diam. (mm) | Dist to bldg. (m) | Roots Implicated | Pruning history | Recommendation | Tree work constraints | Notes | Owner address | Owner |
|---|---|---|---|---|---|---|---|---|---|---|---|---|---|---|
| T1 | Lime | Mature | Fair | 7 | 3.20 | 565 | 12 | Y | Pollarded with approximately 1 years regrowth. | Fell and treat stump. | Pre cone/signage/ barriers action required - footpaths/public access. Adjacent to highway - traffic management required. | | Holy Trinity Vicarage<br>Granville Road<br>London<br>N4 4EL | PH |

| Tree No: | Species | Works Required |
|---|---|---|
| T1 | Lime | Fell and treat stump. |

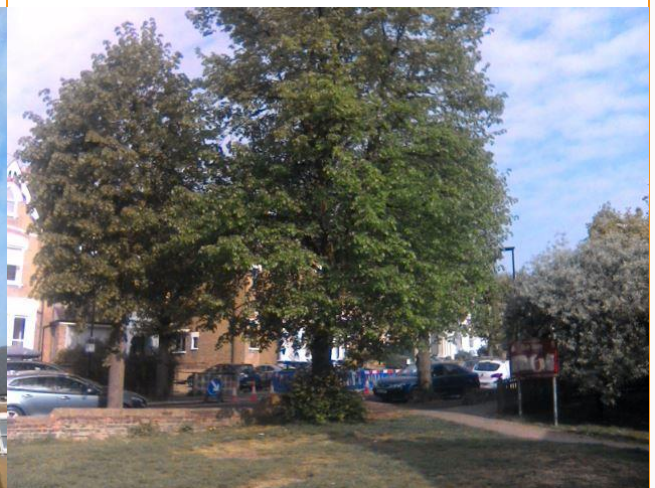
T4 – Lime (April 2020)

| Tree No | Common Name | Age Class | Condition | Height (m) | Crown Spread (m) | Stem diam. (mm) | Dist to bldg. (m) | Roots Implicated | Pruning history | Recommendation | Tree work constraints | Notes | Owner address | Owner |
|---|---|---|---|---|---|---|---|---|---|---|---|---|---|---|
| T4 | Lime | Mature | Fair | 13.5 | 8.5 | 480 | 13.2 | Y | Subject to past management. | Fell and treat stump. | Adjacent to highway - traffic management required. Pre cone/signage/barriers action required - footpaths/public access. | | Holy Trinity Vicarage<br>Granville Road<br>London<br>N4 4EL | PH |

| Tree No: | Species | Works Required |
|---|---|---|
| T4 | Lime | Fell and treat stump. |

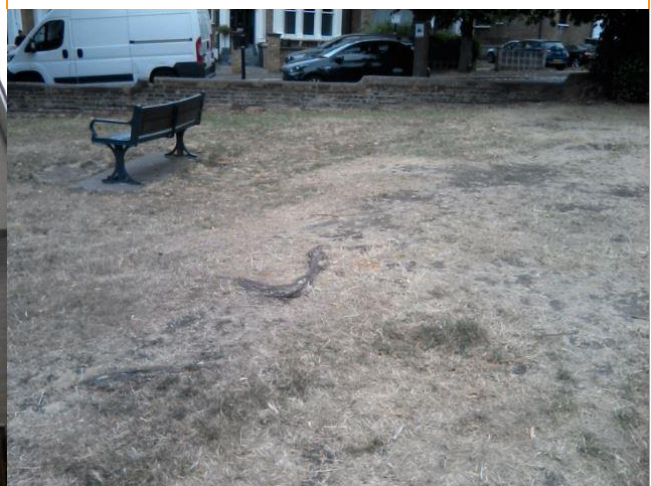
Large roots observed in grass area RHS of property  
believed to be from a previously felled tree. (July 2022)

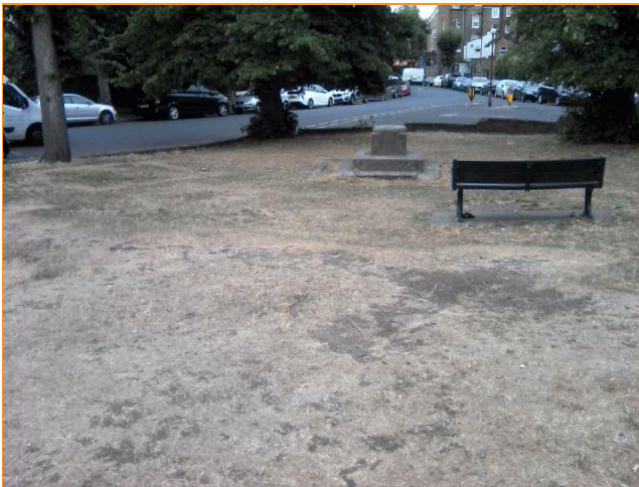
Roots continued (July 2022)

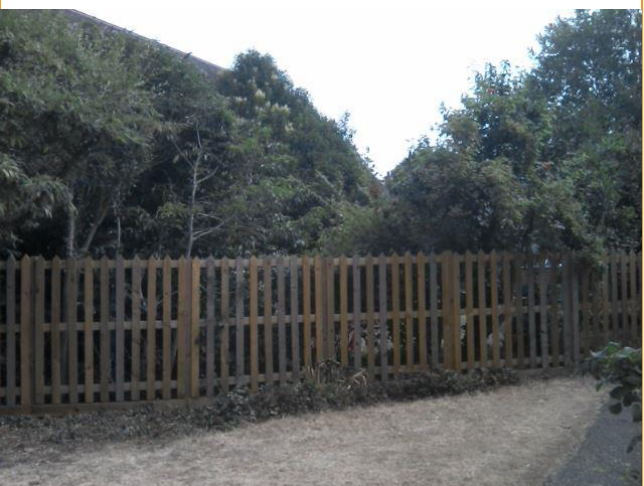
SG3 - Mixed species group (July 2022)

| Tree No | Common Name | Age Class | Condition | Height (m) | Crown Spread (m) | Stem diam. (mm) | Dist to bldg. (m) | Roots Implicated | Pruning history | Recommendation | Tree work constraints | Notes | Owner address | Owner |
|---|---|---|---|---|---|---|---|---|---|---|---|---|---|---|
| SG3 | Mixed species group | Mature | Fair | 4 | 2.50 | 80 | 5.6 | Y | Subject to past management. | Remove section of shrub group and grind stumps to allow a minimum clearance of 7m from the front of the property. No work to remaining shrubs in group. (Total 4.5m in length to remove). | Access through side/rear gate. | Group consists of Lilac, Rose, Viburnum and Laurel. | Holy Trinity Vicarage<br>Granville Road<br>London<br>N4 4EL | PH |

| Tree No: | Species | Works Required |
|---|---|---|
| SG3 | Mixed species group | Remove section of shrub group and grind stumps to allow a minimum clearance of 7m from the front of the property. No work to remaining shrubs in group. (Total 4.5m in length to remove). |

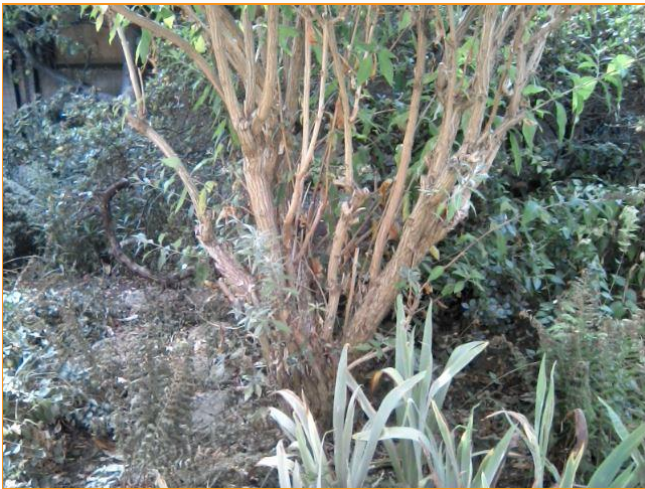
S4 – Buddleia (July 2022)

| Tree No | Common Name | Age Class | Condition | Height (m) | Crown Spread (m) | Stem diam. (mm) | Dist to bldg. (m) | Roots Implicated | Pruning history | Recommendation | Tree work constraints | Notes | Owner address | Owner |
|---|---|---|---|---|---|---|---|---|---|---|---|---|---|---|
| S4 | Buddleia | Mature | Good | 3 | 2.9 | 50 | 2.7 | N | Subject to past management. | Fell and treat stump with eco plugs (broadleaved). | Access through side/rear gate. | | Holy Trinity Vicarage<br>Granville Road<br>London<br>N4 4EL | PH |

| Tree No: | Species | Works Required |
|---|---|---|
| S4 | Buddleia | Fell and treat stump with eco plugs (broadleaved). |

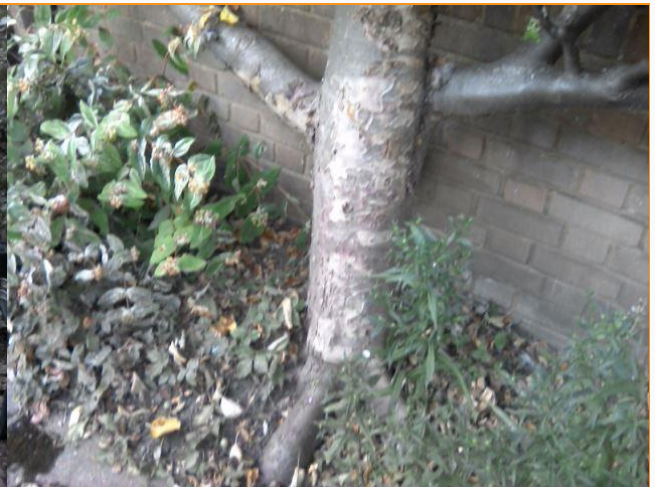
T12 – Apple (July 2022)

| Tree No | Common Name | Age Class | Condition | Height (m) | Crown Spread (m) | Stem diam. (mm) | Dist to bldg. (m) | Roots Implicated | Pruning history | Recommendation | Tree work constraints | Notes | Owner address | Owner |
|---|---|---|---|---|---|---|---|---|---|---|---|---|---|---|
| T12 | Apple | Mature | Good | 4.5 | 4.35 | 230 | 6.4 | Y | Subject to past management. | Fell and treat stump with eco plugs (broadleaved). | Access through side/rear gate. | Previously part of TG2. | Holy Trinity Vicarage<br>Granville Road<br>London<br>N4 4EL | PH |

| Tree No: | Species | Works Required |
|---|---|---|
| T12 | Apple | Fell and treat stump with eco plugs (broadleaved). |

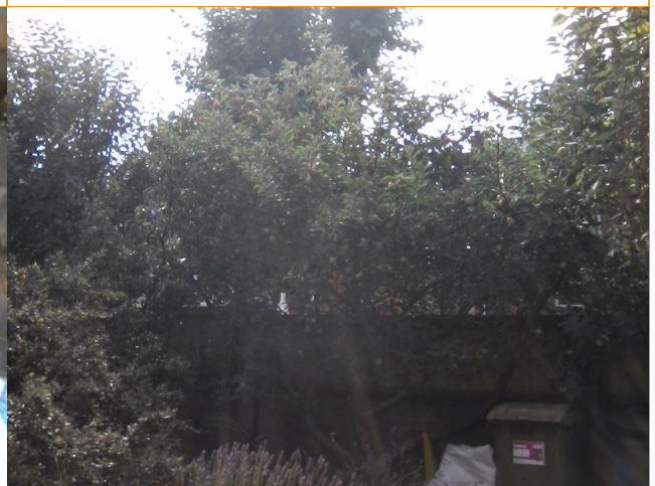
T14 - Apple (July 2022)

| Tree No | Common Name | Age Class | Condition | Height (m) | Crown Spread (m) | Stem diam. (mm) | Dist to bldg. (m) | Roots Implicated | Pruning history | Recommendation | Tree work constraints | Notes | Owner address | Owner |
|---|---|---|---|---|---|---|---|---|---|---|---|---|---|---|
| T14 | Apple | Mature | Fair | 3.5 | 3.4 | 100 | 6.5 | Y | Subject to past management. | Fell and treat stump with eco plugs (broadleaved). | Access through side/rear gate. | Previously part of TG2. | Holy Trinity Vicarage<br>Granville Road<br>London<br>N4 4EL | PH |

| Tree No: | Species | Works Required |
|---|---|---|
| T14 | Apple | Fell and treat stump with eco plugs (broadleaved). |

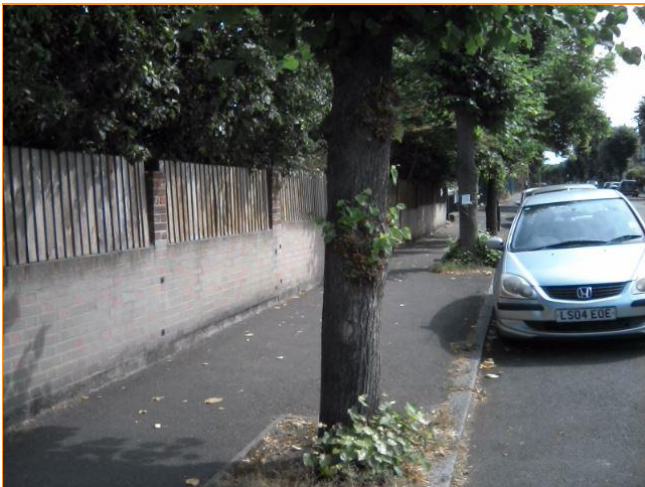
T15 – Lime (July 2022)

| Tree No | Common Name | Age Class | Condition | Height (m) | Crown Spread (m) | Stem diam. (mm) | Dist to bldg. (m) | Roots Implicated | Pruning history | Recommendation | Tree work constraints | Notes | Owner address | Owner |
|---|---|---|---|---|---|---|---|---|---|---|---|---|---|---|
| T15 | Lime | Mature | Fair | 7* | 3.35 | 385 | 8.5* | Y | Pollarded with approximately 1 years regrowth. | Fell and treat stump with eco plugs (broadleaved). | Adjacent to highway - traffic management required. Pre cone/signage/barriers action required - footpaths/public access. | | London Borough of Haringey Council | LA |

| Tree No: | Species | Works Required |
|---|---|---|
| T15 | Lime | Fell and treat stump with eco plugs (broadleaved). |
