# GEOSHIELD Verification Report

Phase 3:Clarendon Road, GR DPC installation.

AREA SURVEYED: Threshold Detail - Block D2

DATE: 03/07/2023

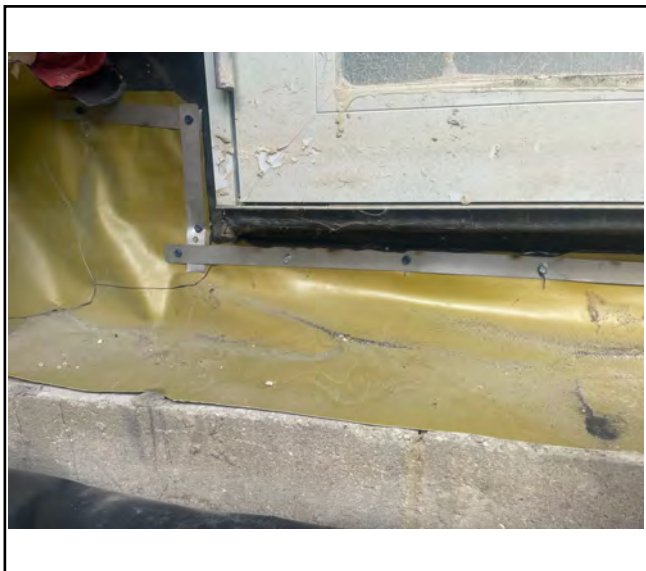
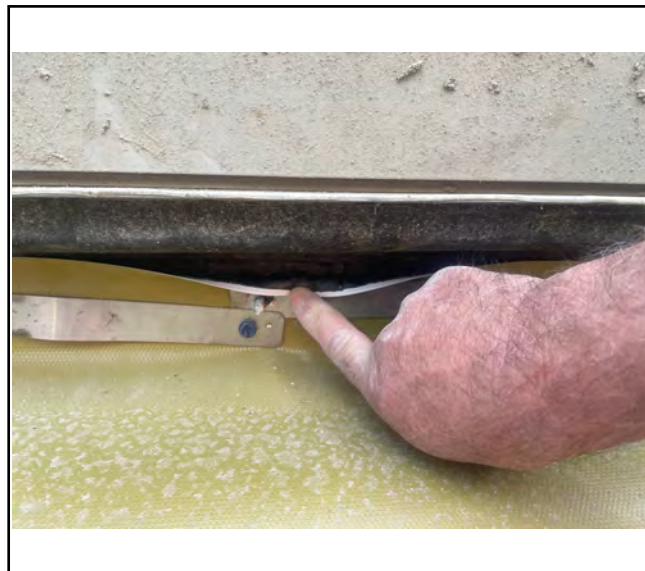
LOCATION/GRID LINE: Threshold Detail - Block D2

The threshold has been sealed on the west elevation of block D2. Visqueen Ultimate

HC Blok been installed to the threshold area and adhered to the previously installed

Self Adhesive Membrane. Double sided butyl tape has been applied underneath the

DPC, a termination strap has then been mechanically fixed through the Ultimate HC Blok and the double sided butyl tape applied to complete the seal. The first photograph above displays an overview of the sealed threshold. The second photograph highlights the double sided butyl tape beneath the termination strap.

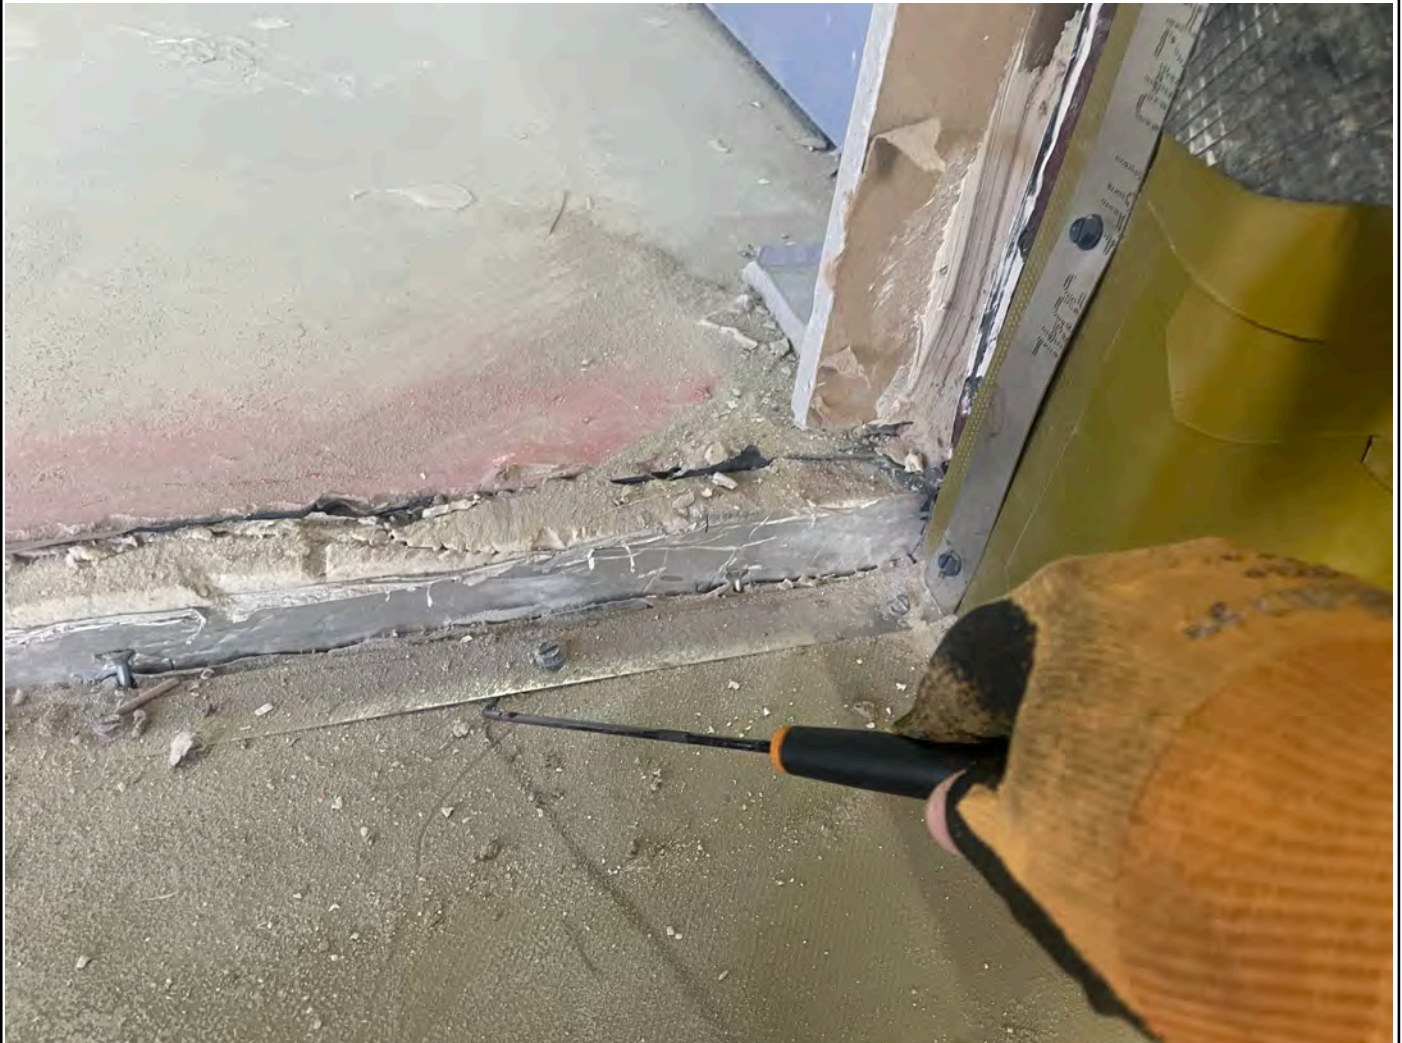
The photograph above displays a mechanical point stress test, also known as a pick and probe test, being conducted on the sealed threshold. A visual inspection and thorough pick and probe tests were carried out on all thresholds in the referenced area, no faults were identified. Tested and verified in accordance with CIRIA 735.

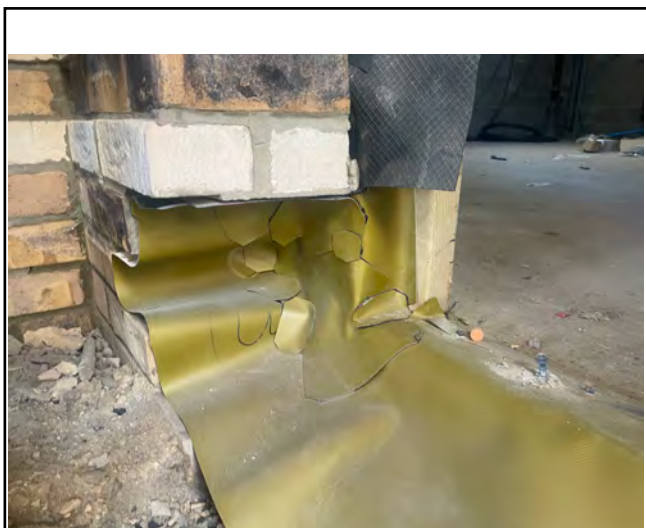
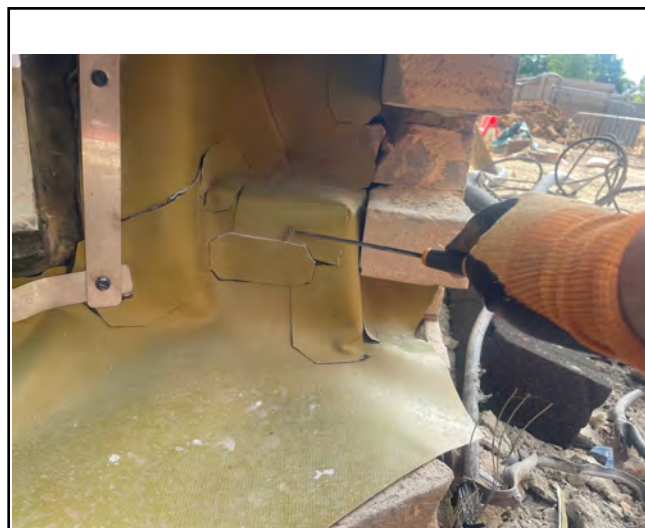
LOCATION/GRID LINE: Threshold Detail - Block D2

The Visqueen Ultimate HC Blok has been taken across the threshold, up the cavity and sealed to the cavity tray. The installation has been sealed using double sided butyl tape and termination straps mechanically fixed. The first photograph below evidences the

DPC installed to the cavity tray. The second photograph displays a mechanical point stress test being carried out on the corner returns which has been sufficiently sealed by the installers from Landmark Brickwork.

Tested and verified in accordance with CIRIA 735.

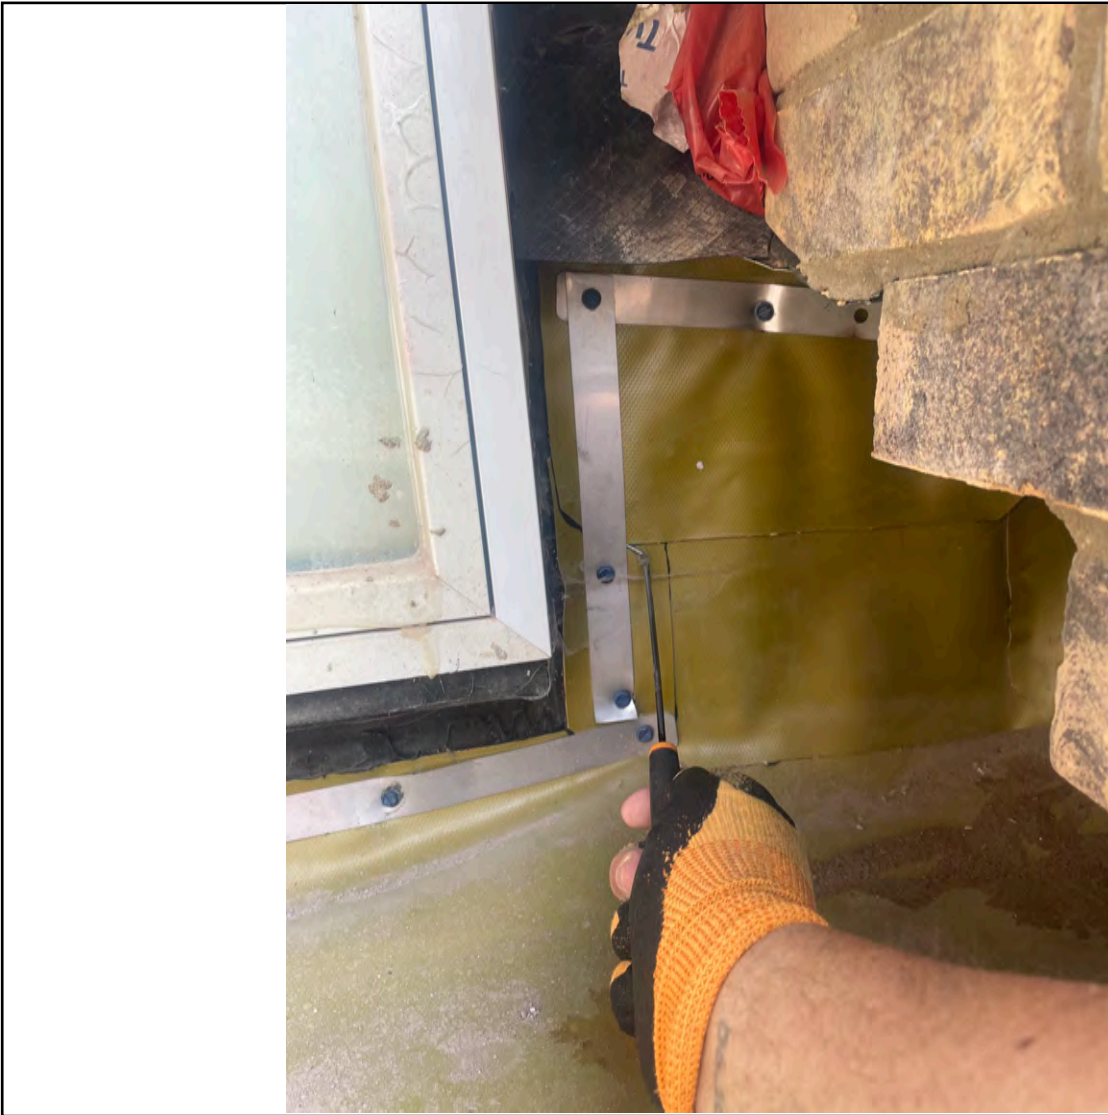
The photograph above displays a mechanical point stress test being conducted upon the termination strap that has been installed up the cavity wall. The threshold detail has been successfully sealed to ensure a gas resistant seal is achieved throughout the installation. Tested and verified in accordance with CIRIA 735.

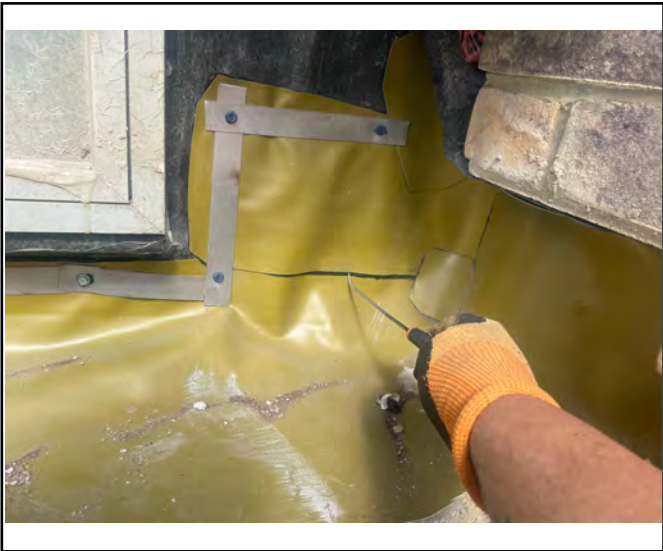
A pick and probe test

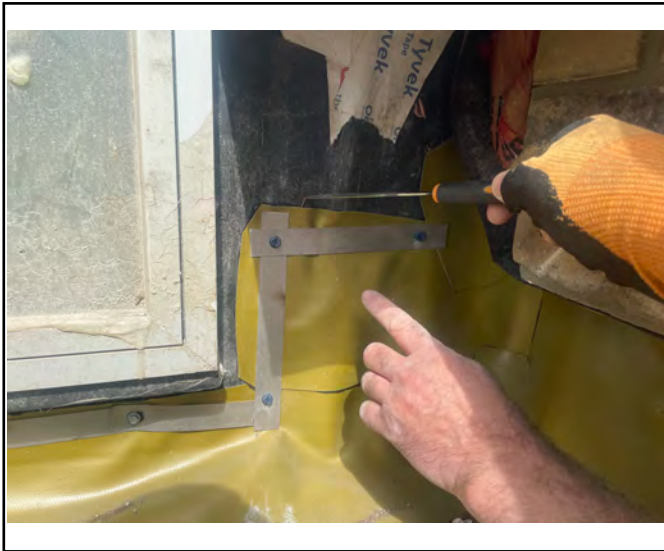
A pick and probe test

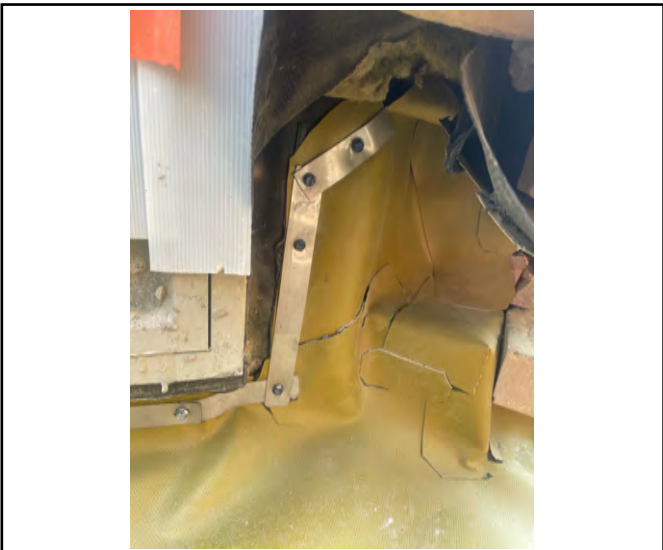
The sealed membrane into the

cavity tray

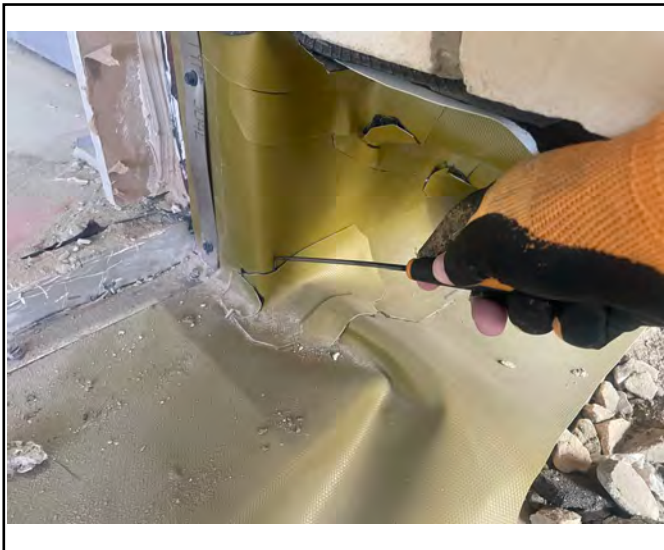
A pick and probe test
