# ARBORICULTURAL ASSESSMENT REPORT

49 Weston Park, London, N8 9SY

**Client:** Sedgwick International UK  
**Insurer:** Allianz Insurance Plc

**Survey Date:** 18/04/2023

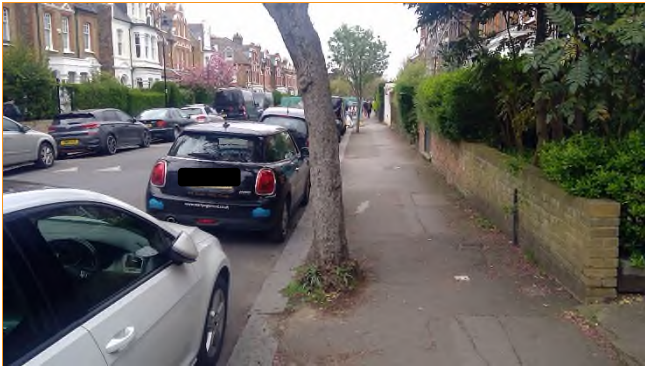
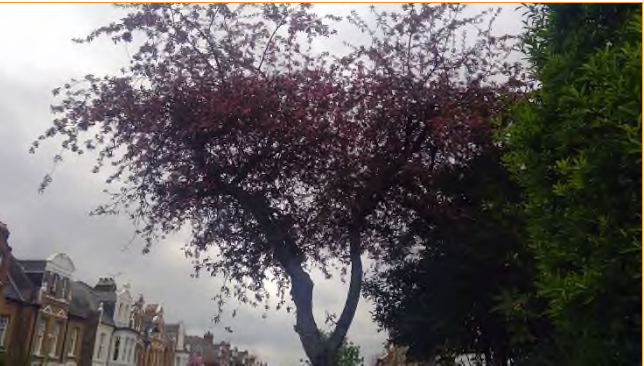
T1 - Plum (Cherry)

In relation to s96(6) of the Highway's Act 1980, we understand that highway tree T1 is under the ownership and control of London Borough of Haringey Council.

| Tree No | Common Name | Age Class | Condition | Height (m) | Crown Spread (m) | Stem diam. (mm) | Dist to bldg. (m) | Roots Implicated | Pruning history | Recommendation | Tree work constraints | Notes | Owner address | Owner |
|---|---|---|---|---|---|---|---|---|---|---|---|---|---|---|
| T1 | Plum (Cherry) | Mature | Good | 7 | 5.0 | 280 | 6 | N | Subject to past management. | Fell and treat stump with eco plugs (broadleaved). | | | London<br>Borough of Haringey<br>Council | LA |

| Tree No: | Species | Works Required | CA | TPO | Ownership |
|---|---|---|---|---|---|
| T1 | Plum (Cherry) | Fell and treat stump with eco plugs (broadleaved) | Yes | No | LA |

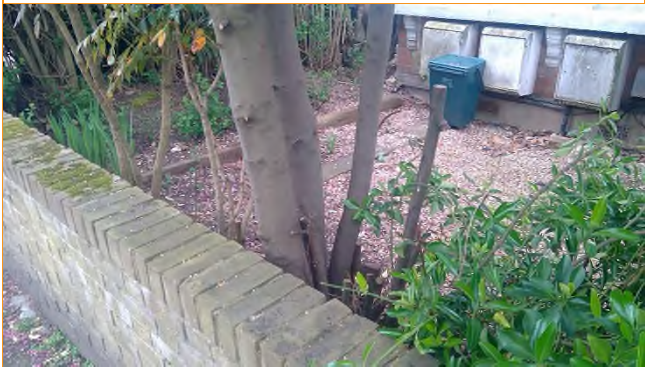
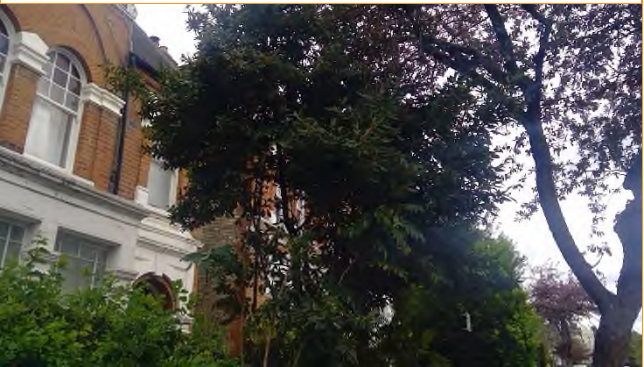
S1 - Laurel (Bay)

| Tree No | Common Name | Age Class | Condition | Height (m) | Crown Spread (m) | Stem diam. (mm) | Dist to bldg. (m) | Roots Implicated | Pruning history | Recommendation | Tree work constraints | Notes | Owner address | Owner |
|---|---|---|---|---|---|---|---|---|---|---|---|---|---|---|
| S1 | Laurel (Bay) | Mature | Good | 6 | 3.0 | 80 | 3.2 | N | Subject to past management. | Fell and treat stump with eco plugs (broadleaved). | Pre cone/signage/ barriers action required - footpaths/public access. | | 49 Weston Park<br>London<br>N8 9SY | PH |

| Tree No: | Species | Works Required | CA | TPO | Ownership |
|---|---|---|---|---|---|
| S1 | Laurel (Bay) | Fell and treat stump with eco plugs (broadleaved) | Yes | No | PH |

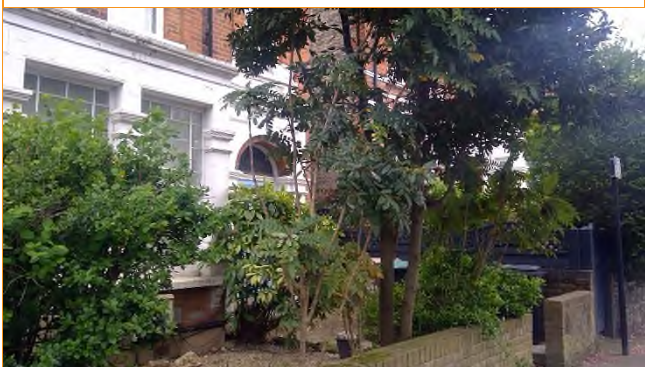
S2 - Mahonia

| Tree No | Common Name | Age Class | Condition | Height (m) | Crown Spread (m) | Stem diam. (mm) | Dist to bldg. (m) | Roots Implicated | Pruning history | Recommendation | Tree work constraints | Notes | Owner address | Owner |
|---|---|---|---|---|---|---|---|---|---|---|---|---|---|---|
| S2 | Mahonia | Semi-Mature | Good | 3 | 1.0 | 20 | 3.3 | N | No significant past tree works. | No work required. | | | 49 Weston Park<br>London<br>N8 9SY | PH |

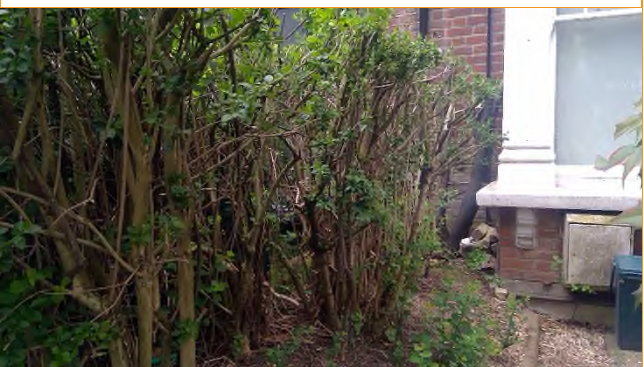
H1 - Privet

| Tree No | Common Name | Age Class | Condition | Height (m) | Crown Spread (m) | Stem diam. (mm) | Dist to bldg. (m) | Roots Implicated | Pruning history | Recommendation | Tree work constraints | Notes | Owner address | Owner |
|---|---|---|---|---|---|---|---|---|---|---|---|---|---|---|
| H1 | Privet | Mature | Good | 1.5 | 1.0 | 20 | 1 | N | Subject to past management. | No work required. | | | 49 Weston Park<br>London<br>N8 9SY | PH |

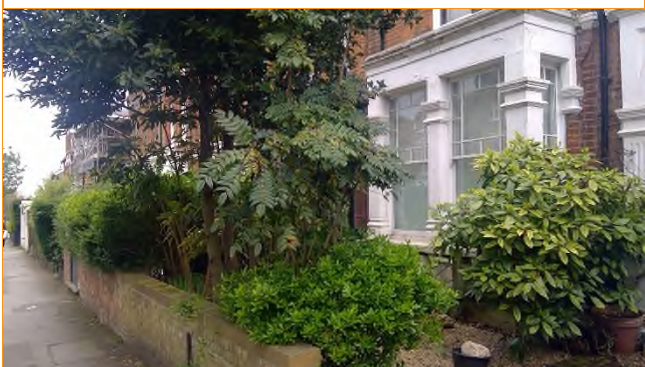
S3 - Mixed species shrubs

| Tree No | Common Name | Age Class | Condition | Height (m) | Crown Spread (m) | Stem diam. (mm) | Dist to bldg. (m) | Roots Implicated | Pruning history | Recommendation | Tree work constraints | Notes | Owner address | Owner |
|---|---|---|---|---|---|---|---|---|---|---|---|---|---|---|
| S3 | Mixed species shrubs | Mature | Good | 3 | 1.0 | 20 | 3.3 | N | No significant past tree works. | No work required. | | Includes Mahonia and Euonymous | 49 Weston Park<br>London<br>N8 9SY | PH |

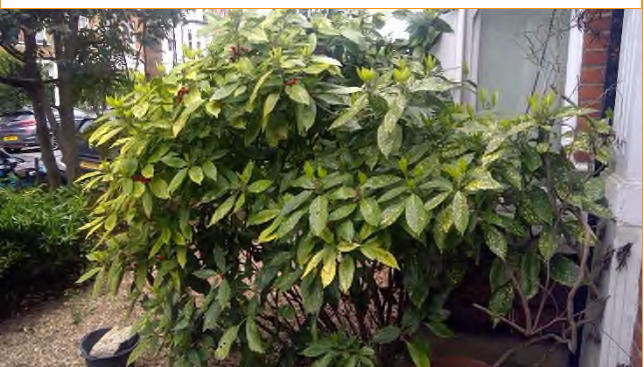
S4 - Laurel

| Tree No | Common Name | Age Class | Condition | Height (m) | Crown Spread (m) | Stem diam. (mm) | Dist to bldg. (m) | Roots Implicated | Pruning history | Recommendation | Tree work constraints | Notes | Owner address | Owner |
|---|---|---|---|---|---|---|---|---|---|---|---|---|---|---|
| S4 | Laurel (speckled) | Mature | Good | 2 | 1.50 | 40 | 0.6 | N | Subject to past management. | Fell and treat stump with eco plugs (broadleaved). | | | 49 Weston Park<br>London<br>N8 9SY | PH |

| Tree No: | Species | Works Required | CA | TPO | Ownership |
|---|---|---|---|---|---|
| S4 | Laurel (speckled) | Fell and treat stump with eco plugs (broadleaved) | No | No | PH |

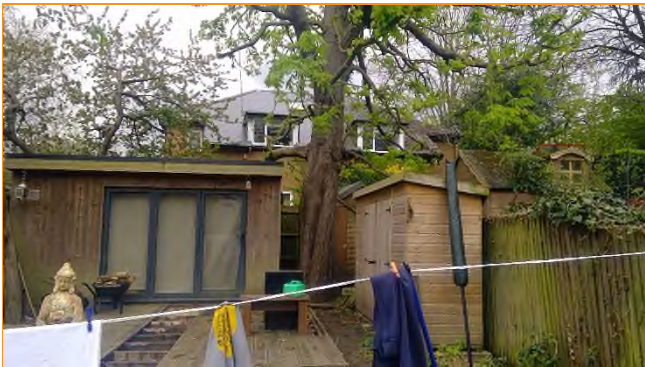
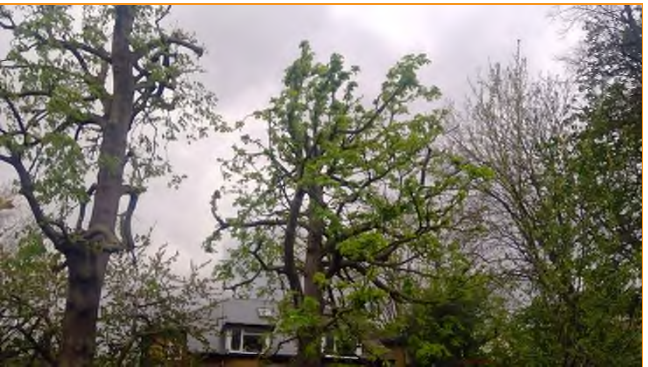
T2 - Horse Chestnut

| Tree No | Common Name | Age Class | Condition | Height (m) | Crown Spread (m) | Stem diam. (mm) | Dist to bldg. (m) | Roots Implicated | Pruning history | Recommendation | Tree work constraints | Notes | Owner address | Owner |
|---|---|---|---|---|---|---|---|---|---|---|---|---|---|---|
| T2 | Horse Chestnut | Mature | Fair | 14 | 9.0 | 690 | 22.3 | N | Subject to recent management. | No work required. | | | 49 Weston Park<br>London<br>N8 9SY | PH |

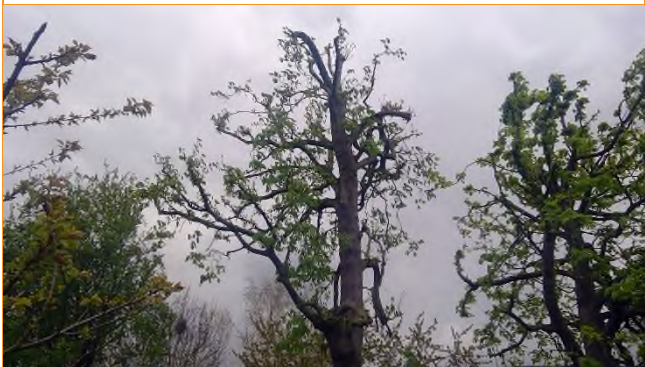
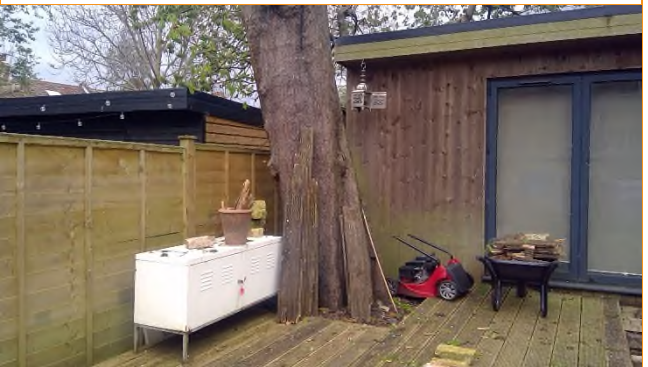
T3 - Horse Chestnut

| Tree No | Common Name | Age Class | Condition | Height (m) | Crown Spread (m) | Stem diam. (mm) | Dist to bldg. (m) | Roots Implicated | Pruning history | Recommendation | Tree work constraints | Notes | Owner address | Owner |
|---|---|---|---|---|---|---|---|---|---|---|---|---|---|---|
| T3 | Horse Chestnut | Mature | Fair | 14 | 7.0 | 690 | 20.6 | N | Subject to recent management. | No work required. | | | 49 Weston Park<br>London<br>N8 9SY | PH |

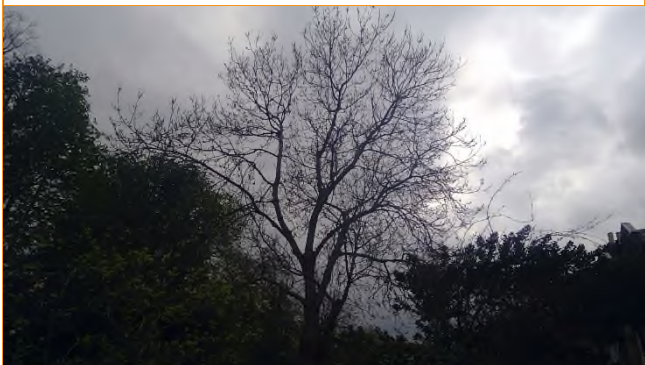
T4 - Ash (Common)

| Tree No | Common Name | Age Class | Condition | Height (m) | Crown Spread (m) | Stem diam. (mm) | Dist to bldg. (m) | Roots Implicated | Pruning history | Recommendation | Tree work constraints | Notes | Owner address | Owner |
|---|---|---|---|---|---|---|---|---|---|---|---|---|---|---|
| T4 | Ash (Common) | Mature | Fair | 14 | 9.0 | 550* | 15.7 | N | Subject to past management. | No work required. | | | 47 Weston Park<br>London<br>N8 9SY | P3P |

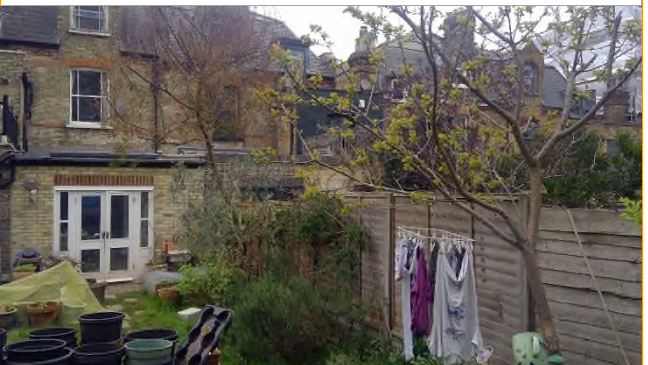
TG1 - Mixed species group

| Tree No | Common Name | Age Class | Condition | Height (m) | Crown Spread (m) | Stem diam. (mm) | Dist to bldg. (m) | Roots Implicated | Pruning history | Recommendation | Tree work constraints | Notes | Owner address | Owner |
|---|---|---|---|---|---|---|---|---|---|---|---|---|---|---|
| TG1 | Mixed species group | Mature | Good | 4 | 2 | 100 | 4 | N | Subject to past management. | No work required. | | Includes Silver wattle, Olive, Plum and Bay laurel | 49 Weston Park<br>London<br>N8 9SY | PH |

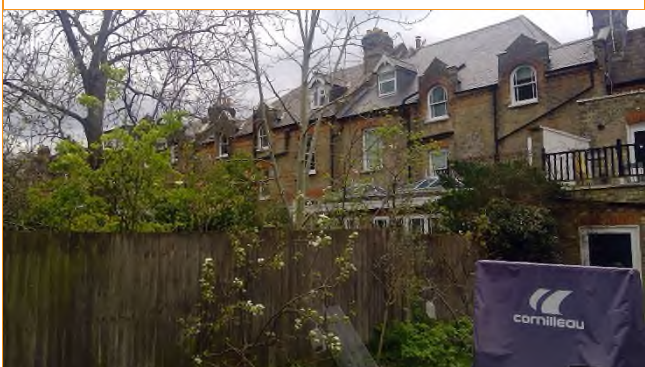
TG2 - Mixed species group

| Tree No | Common Name | Age Class | Condition | Height (m) | Crown Spread (m) | Stem diam. (mm) | Dist to bldg. (m) | Roots Implicated | Pruning history | Recommendation | Tree work constraints | Notes | Owner address | Owner |
|---|---|---|---|---|---|---|---|---|---|---|---|---|---|---|
| TG2 | Mixed species group | Semi-Mature | Good | 4 | 2 | 100 | 3 | N | Subject to past management. | No work required. | | Included Ceonothus, Ash, Plum, Apple and Magnolia | 47 Weston Park<br>London<br>N8 9SY | P3P |

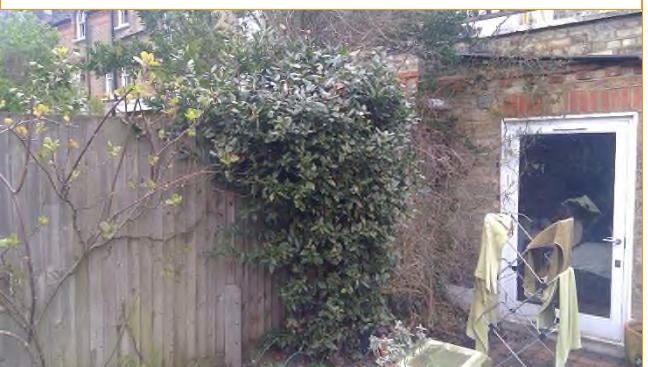
S5 - Laurel (Bay)

| Tree No | Common Name | Age Class | Condition | Height (m) | Crown Spread (m) | Stem diam. (mm) | Dist to bldg. (m) | Roots Implicated | Pruning history | Recommendation | Tree work constraints | Notes | Owner address | Owner |
|---|---|---|---|---|---|---|---|---|---|---|---|---|---|---|
| S5 | Laurel (Bay) | Mature | Good | 2 | 0.50 | 30 | 2.7 | N | Subject to past management. | No work required. | | | 49 Weston Park<br>London<br>N8 9SY | PH |

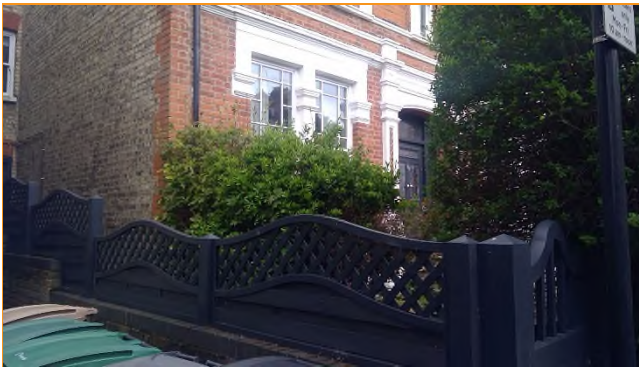
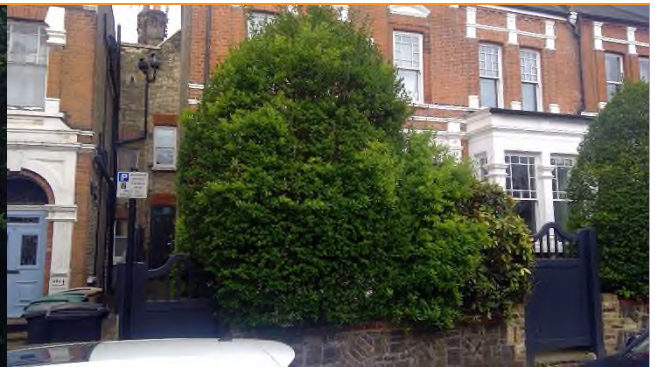
SG1 - Mixed species shrubs

| Tree No | Common Name | Age Class | Condition | Height (m) | Crown Spread (m) | Stem diam. (mm) | Dist to bldg. (m) | Roots Implicated | Pruning history | Recommendation | Tree work constraints | Notes | Owner address | Owner |
|---|---|---|---|---|---|---|---|---|---|---|---|---|---|---|
| SG1 | Mixed species shrubs | Mature | Good | 4 | 2 | 50 | 4 | N | Subject to past management. | No work required. | | Includes Euonymus, Privet and Laurel | 47 Weston Park<br>London<br>N8 9SY | P3P |
