# **Phase 1 Land Contamination Risk Assessment**

## **Proposed Conversion of Bowling Green and Clubhouse to single residential unit**

**Glencairn Bowls Club,  
Blake Road, Southgate, London  
N11 2AF**

3067D P1V2 Lousada PLC

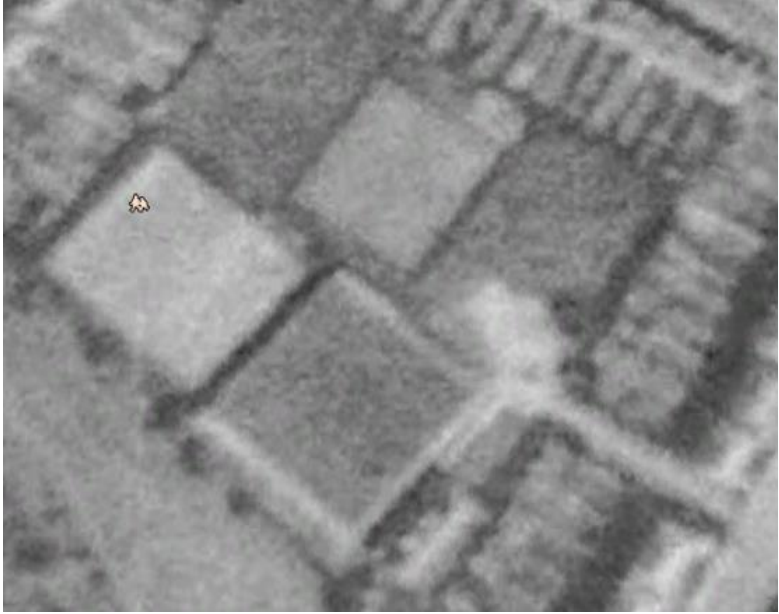
| Date | Description |
|---|---|
| December 1945 | Imagery is indistinct. However, the site is shown as occupied by the clubhouse and bowling green as seen in the present-day. The site surroundings roughly resemble the present day with open green space (possibly a golf course as in the present-day) to the west and some industry beyond housing to the north. There may be an additional 2 No. greens located immediately north and north west of site (see image below) |

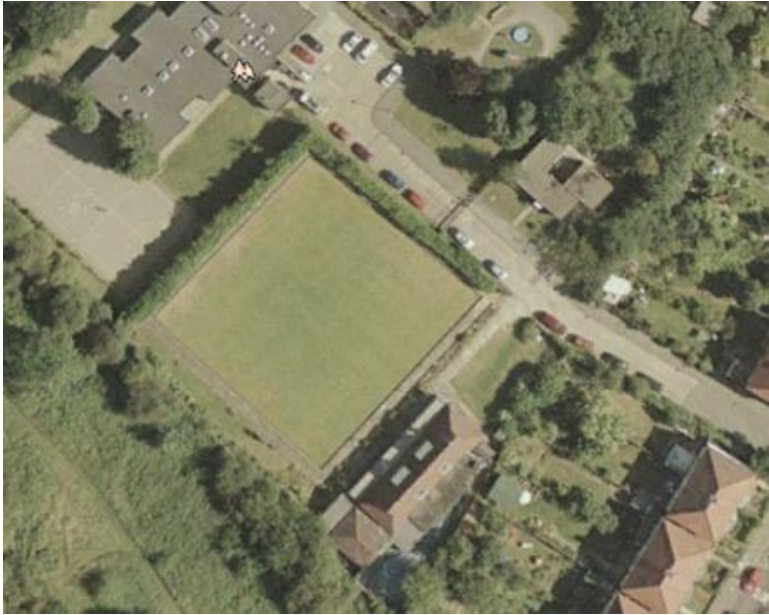
| Date | Description |
|---|---|
| September 1999 | Site is now clearly shown as occupied by the clubhouse and bowling green. The school directly north has been constructed at this time. The industrial area to the north has seen some extension (see image below). |

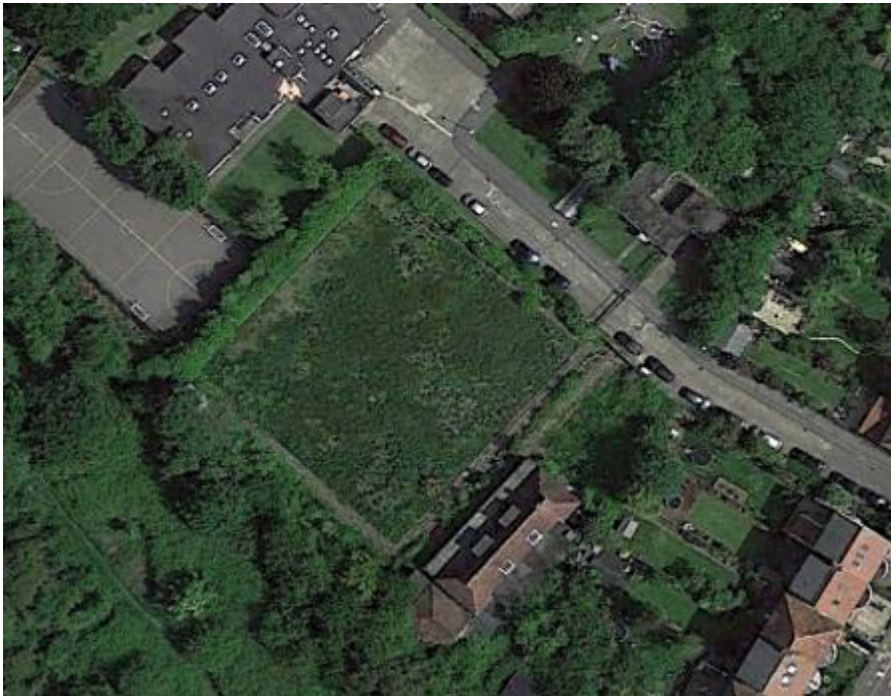
| Date | Description |
|---|---|
| July 2013 | The site now appears disused as the state of the bowling green has declined into a rougher vegetated state. Fencing can be seen boarding up the site access and no cars are parked on site. The building in the far west of site has been overgrown slightly (see image below). |

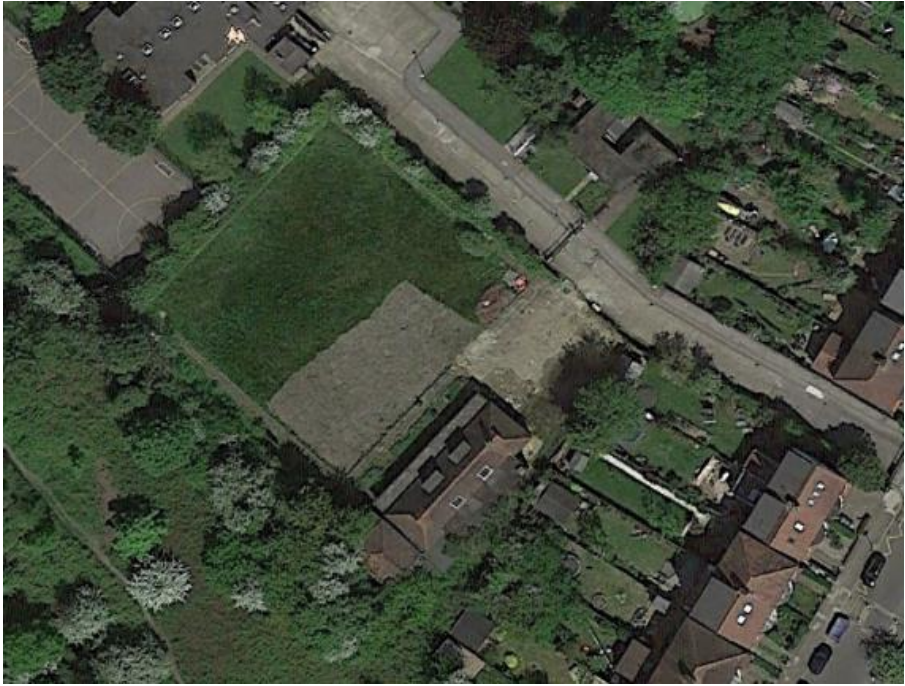
| Date | Description |
|---|---|
| May 2018 | The eastern area of site appears to have been scraped of vegetation and had some paving and material removed. A spoil pile can be seen adjacent to the site access and on the green itself and the green has seen some material removed. This leaves approximately a third of the green appearing bare of vegetation (see image below). |

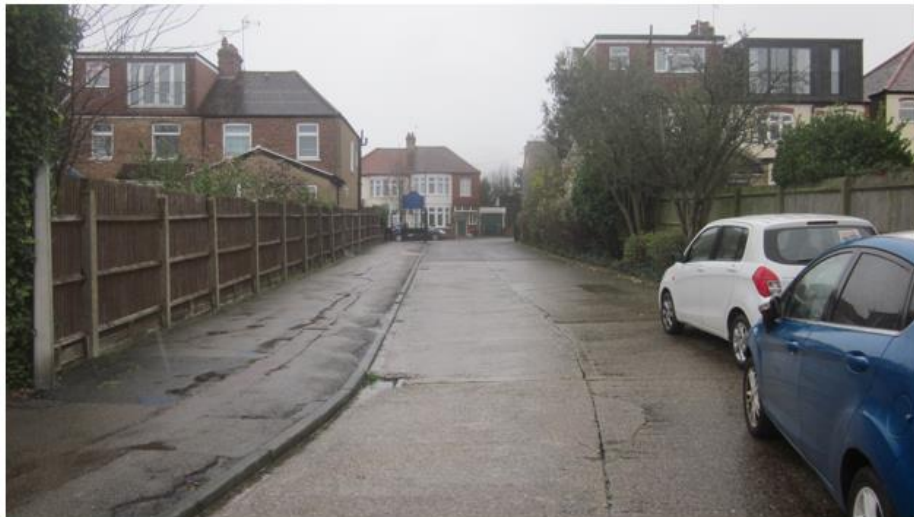
Photo No.1: Site access track off Blake Road, facing SE

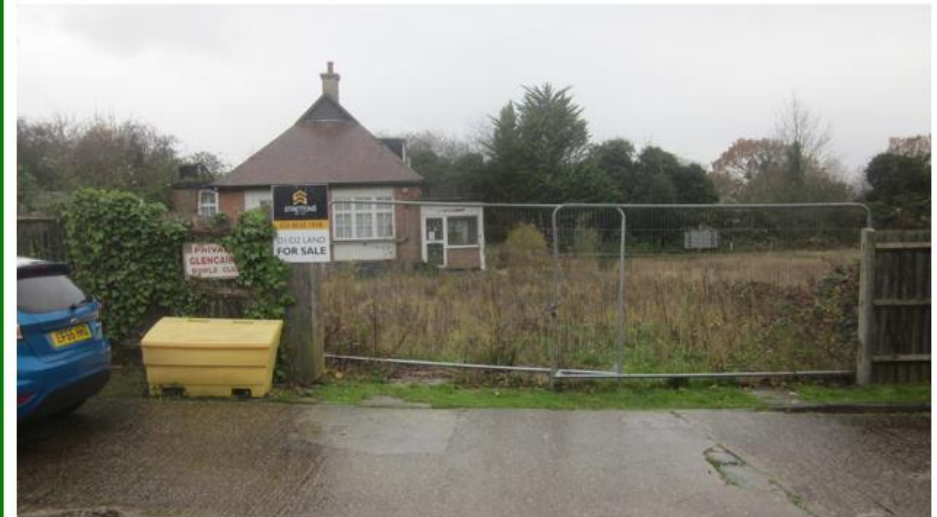
Photo No.2: Site access off track, facing SW

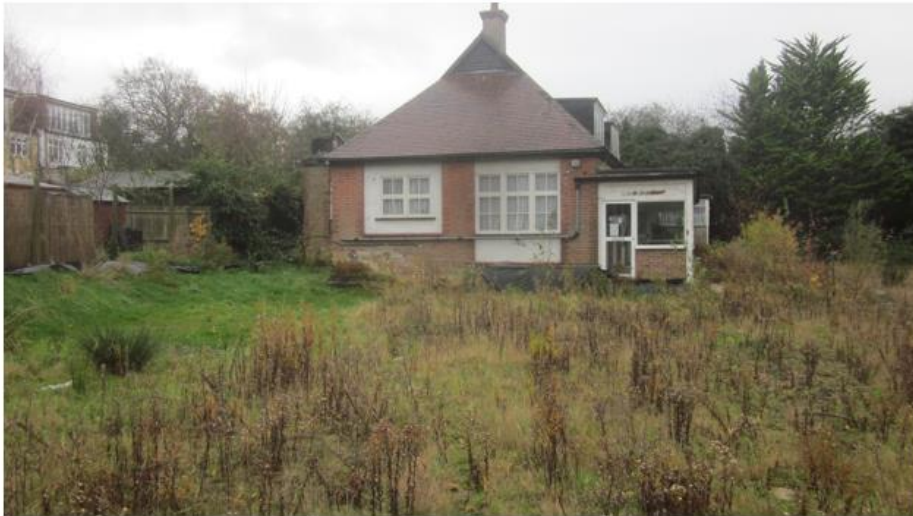
**Photo No.3: Bowling clubhouse from site access, facing SW**

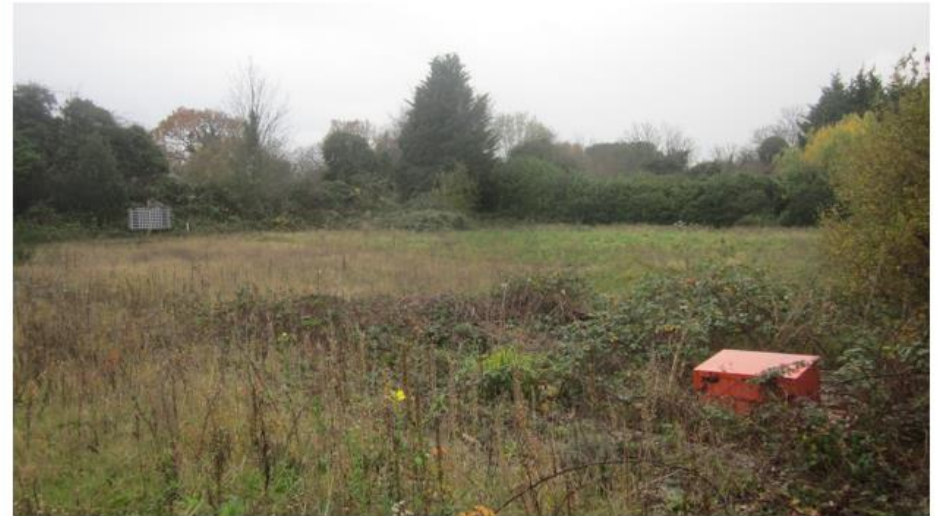
**Photo No.4: Site and bowling green area from eastern corner of site, facing west toward western corner**

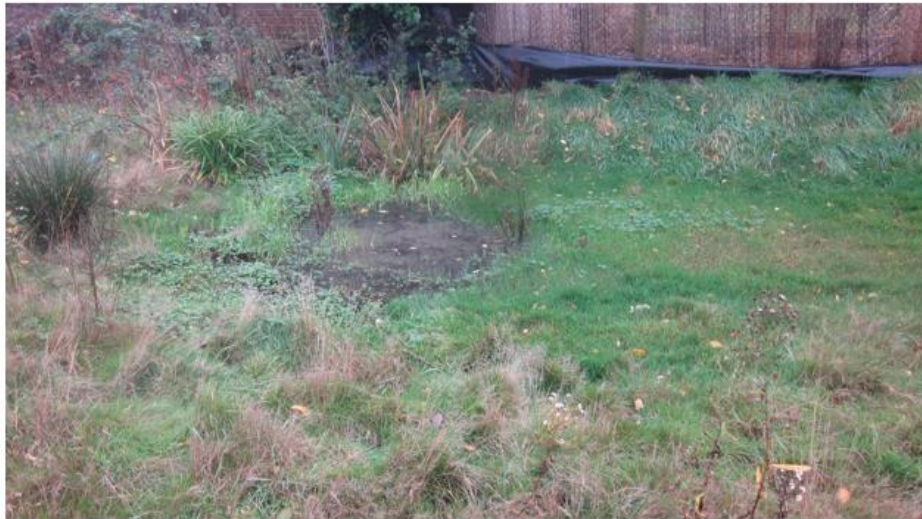
**Photo No.5: Boggy area noted immediately south of access**

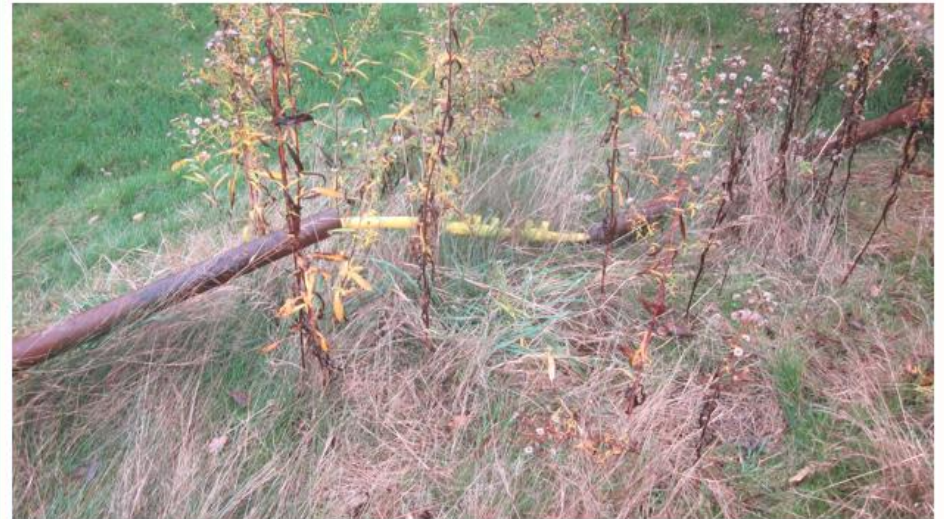
**Photo No.6: Gas main seen entering building from site access**

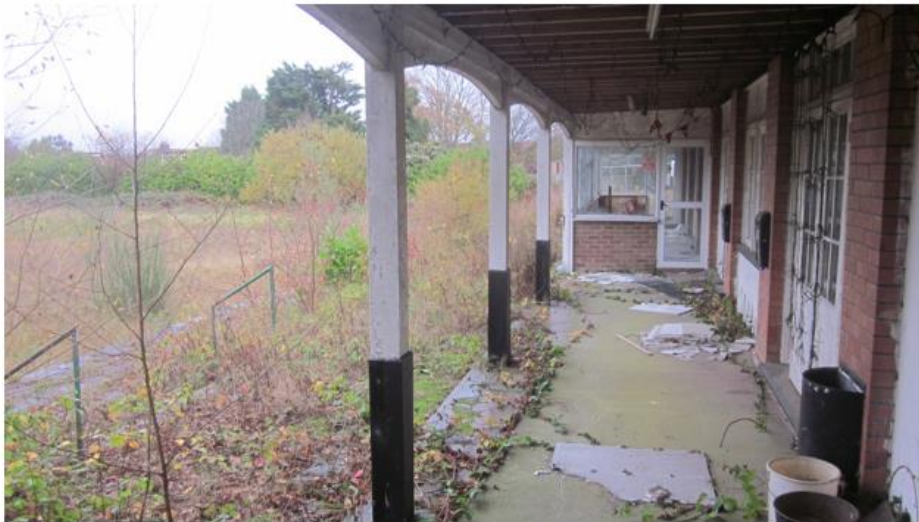
**Photo No.7: Clubhouse pavilion, facing NE**

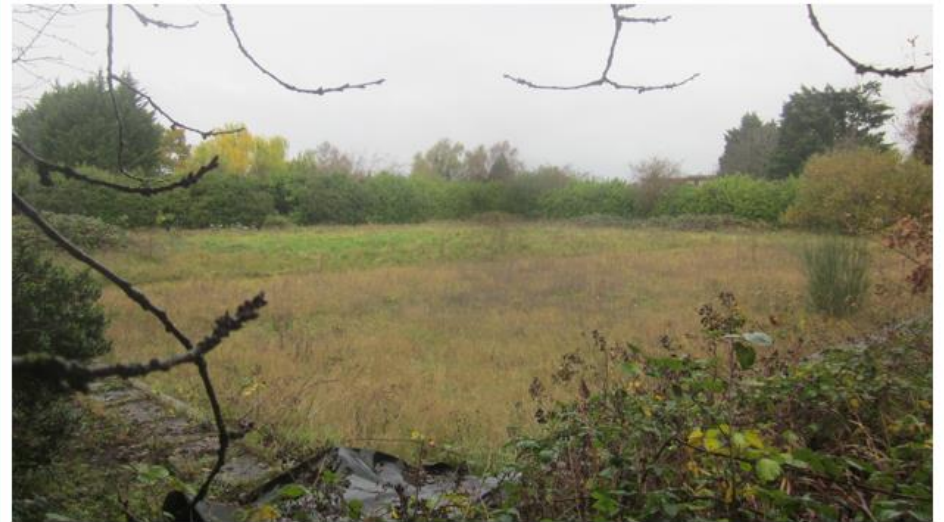
**Photo No.8: Site from southern corner and clubhouse, facing north toward northern corner across bowling green**

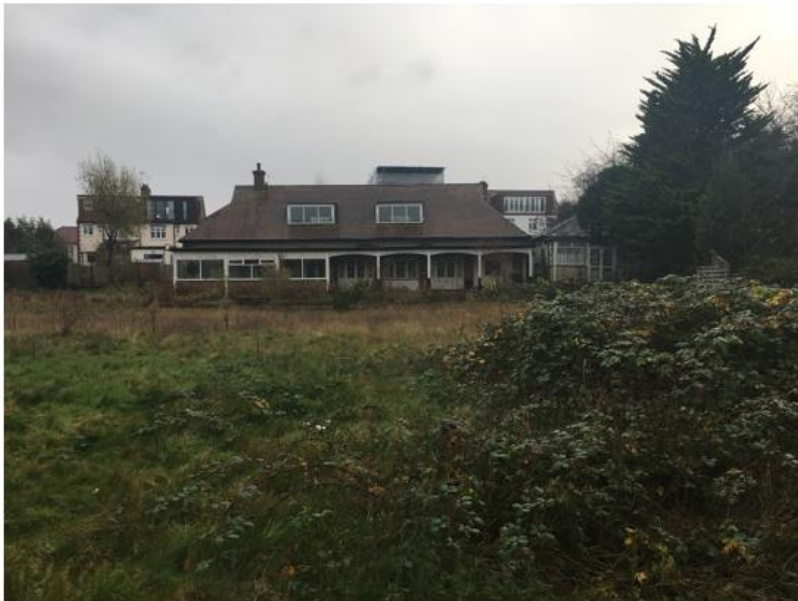
**Photo No.9: Clubhouse from NW boundary, facing SE**

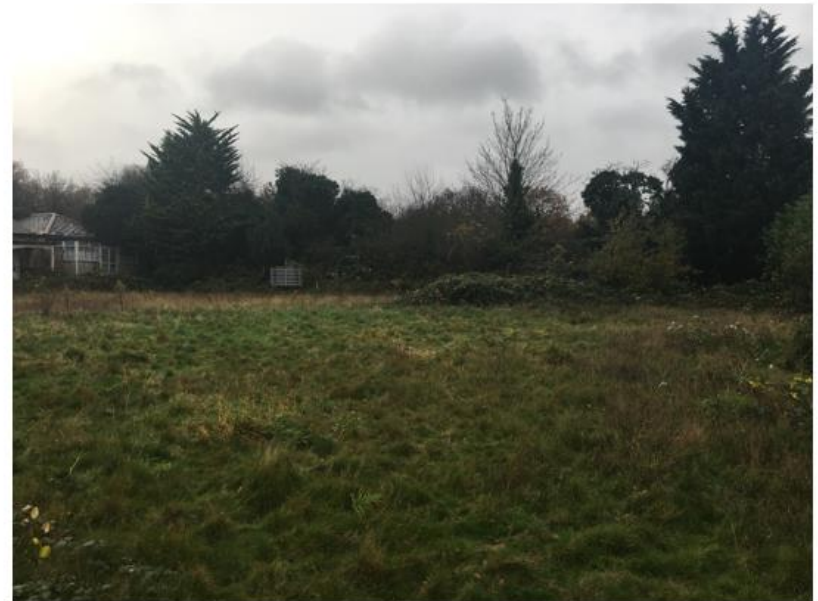
**Photo No.10: Bowling green from northern corner of site,  
facing south west toward western corner of site**
