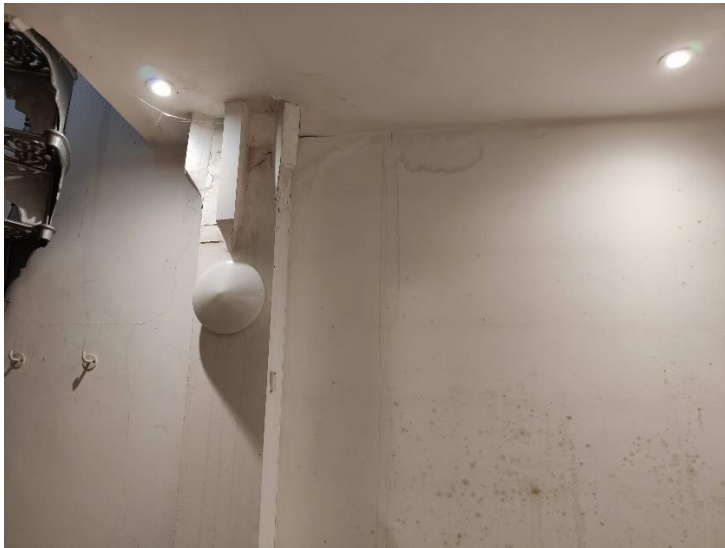
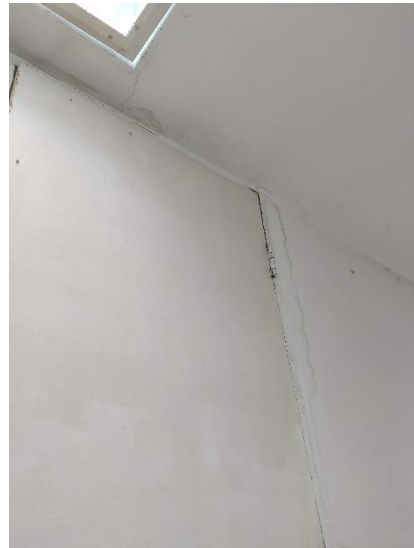
Internal damp and leaks to the external wall and ceiling

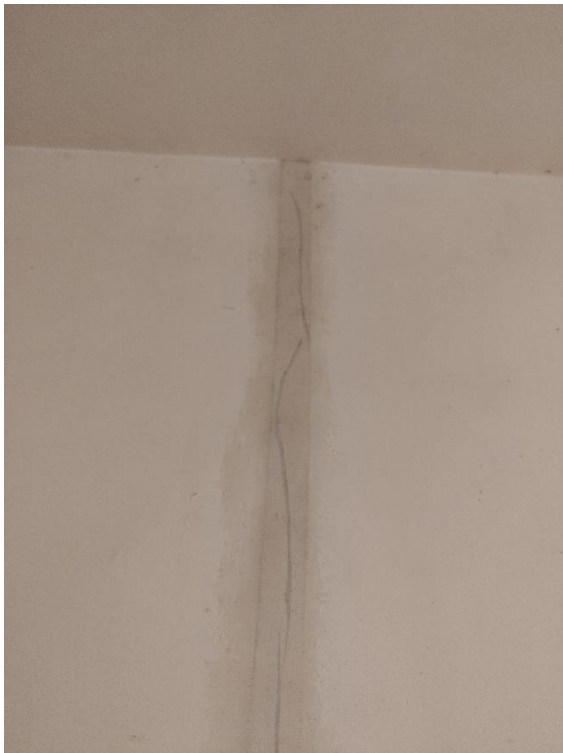
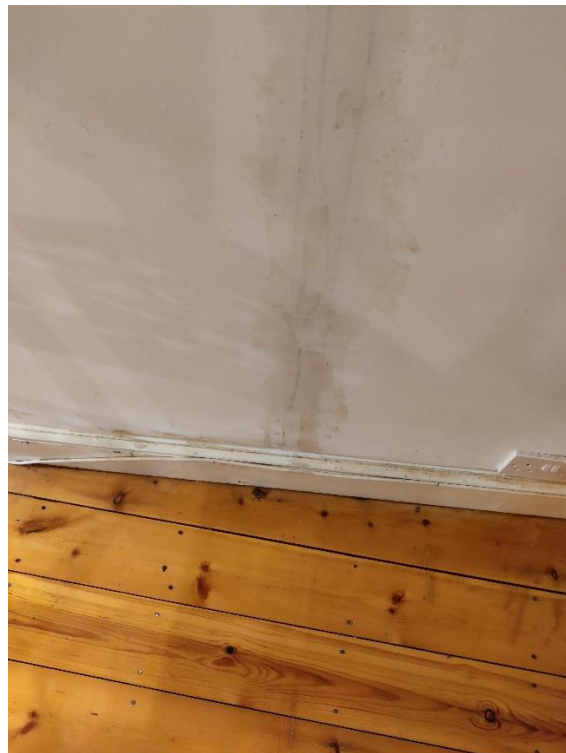
Structural cracks of more than 1cm width to side extension that have been taped over

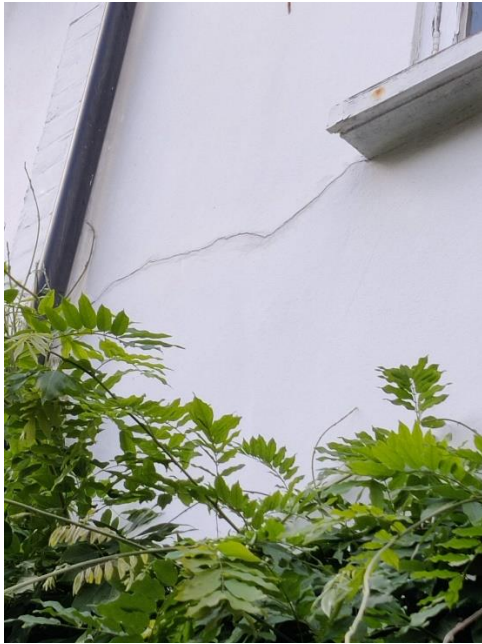
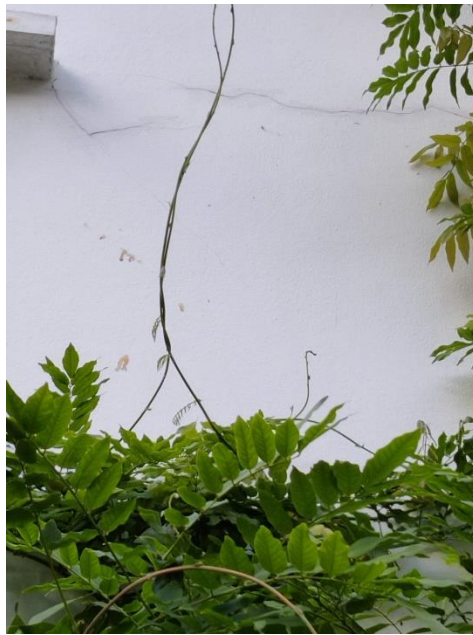
External cracks to render walls

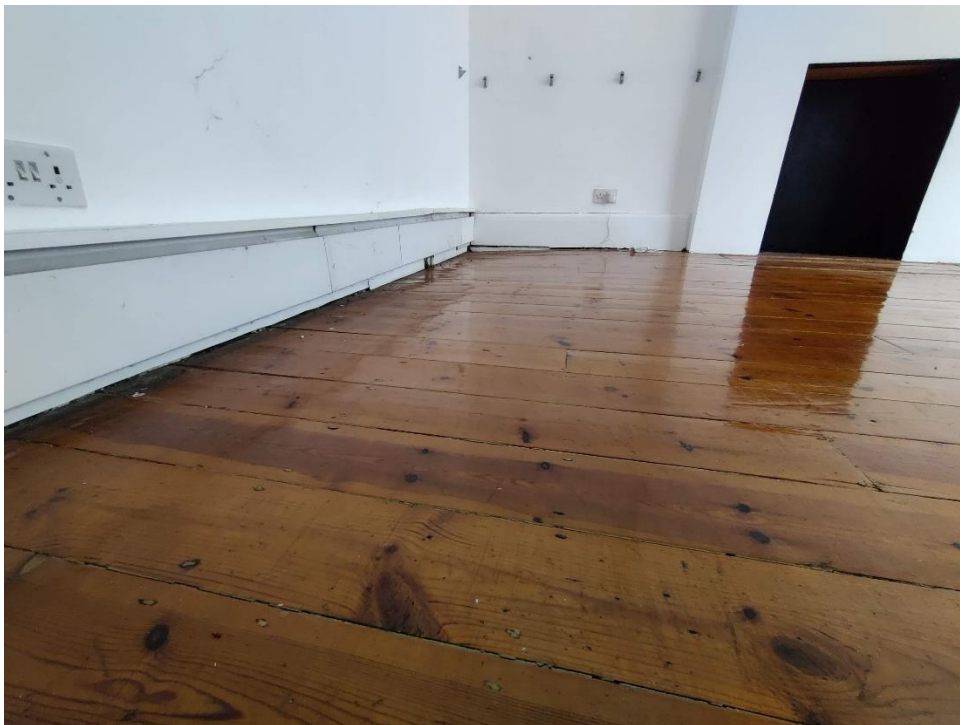
Uneven internal floors of 50 - 75mm differential across rooms

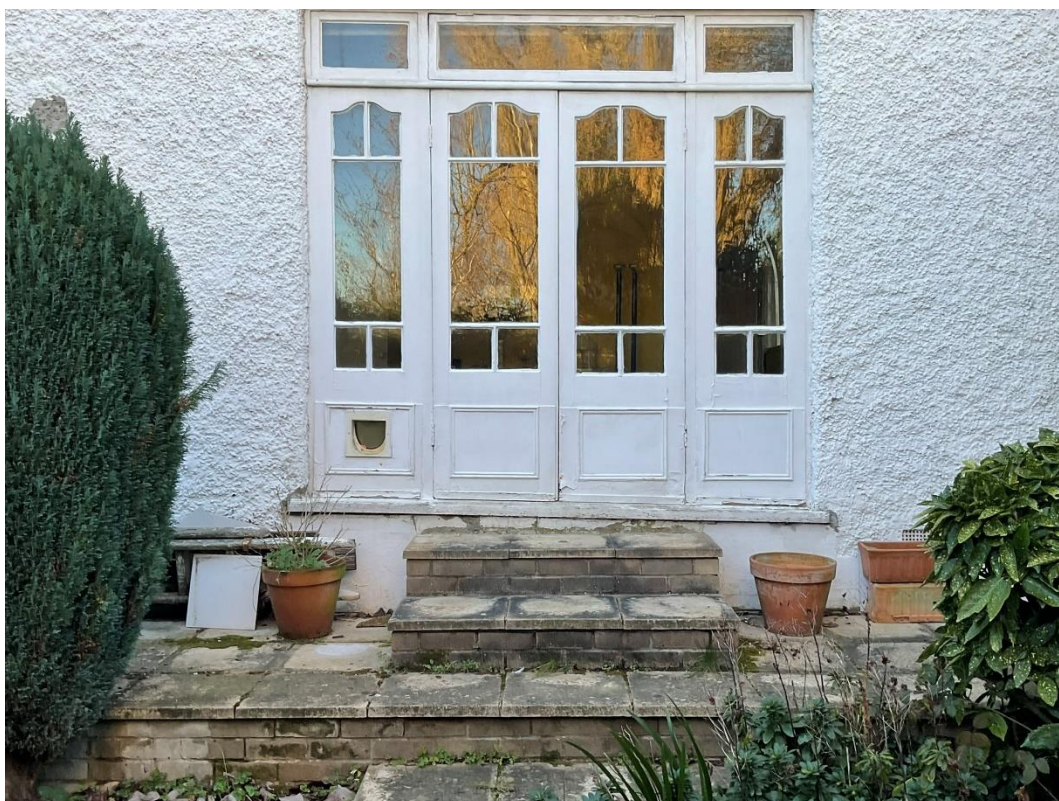
Evidence of structural subsidence, above right corner of patio door which is 70mm lower

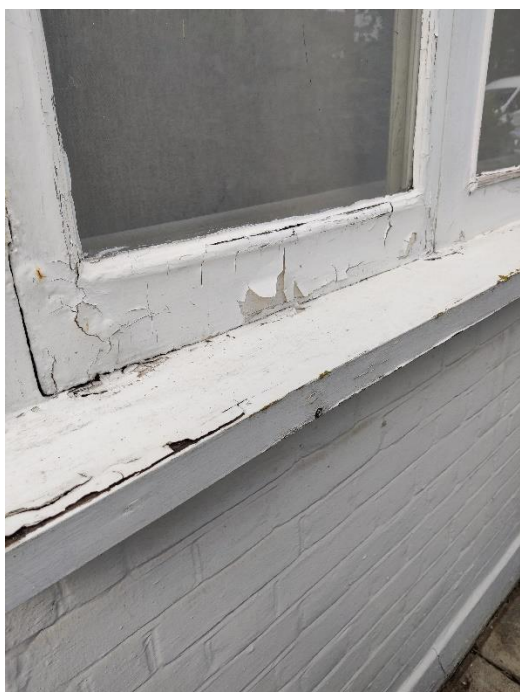
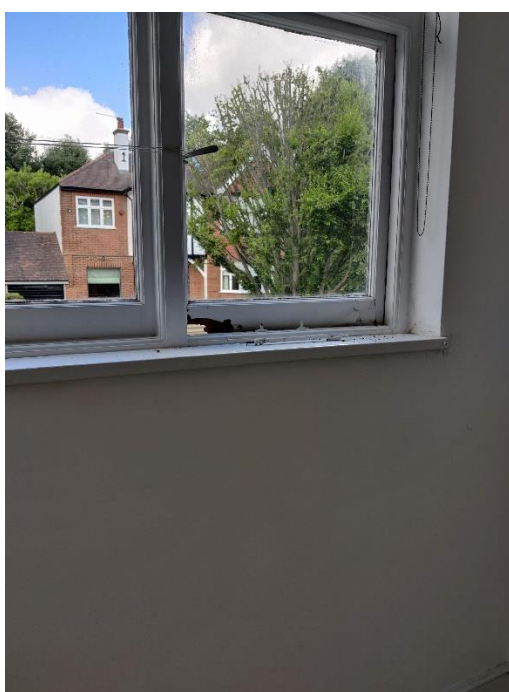
Poor condition of timber windows including rot

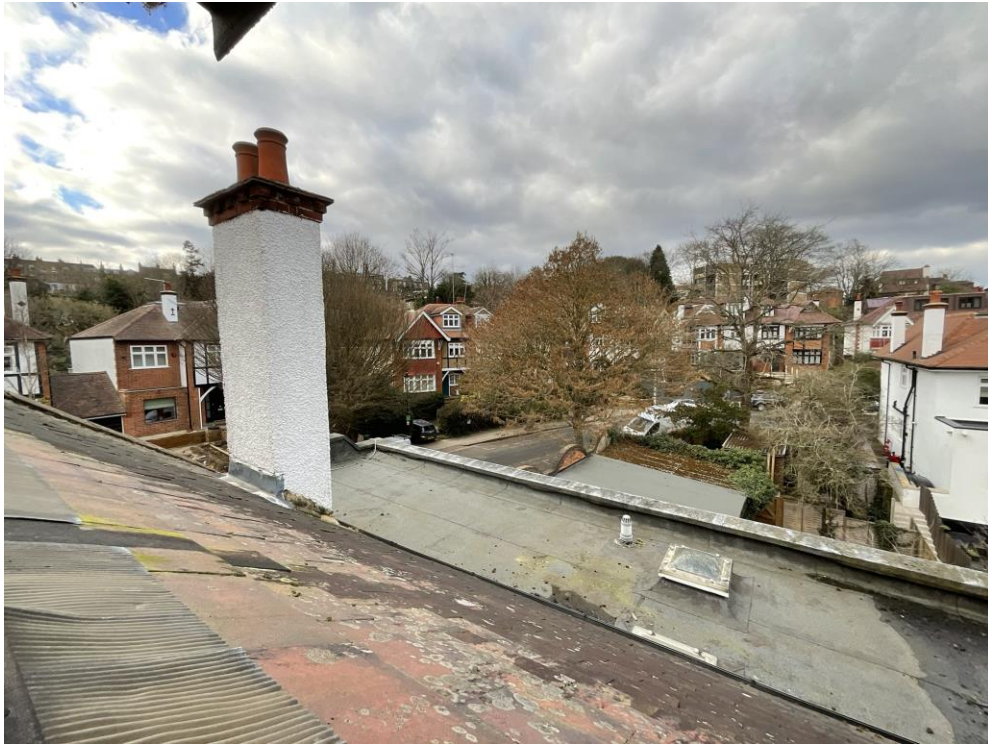
Poor condition of the existing roof
