**From:** Christopher Davies <Christopher.Davies@crawco.co.uk>  
**Sent:** 19 July 2023 15:47  
**To:** Subsidence <subsidence@crawco.co.uk>  
**Cc:** MWA Arboriculture Office <Office@mwaarboriculture.co.uk>  
**Subject:** SU2206135 - RE: S211 - HGY/2023/1685 - 154 Morley Avenue N22 - SU2206135

SU2206135 LA want additional info S211 Cypress tree

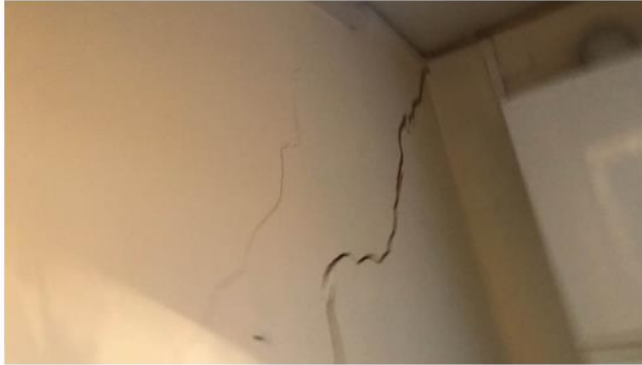
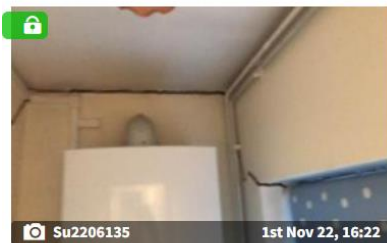
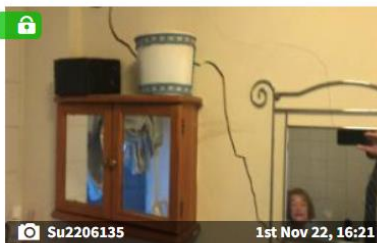
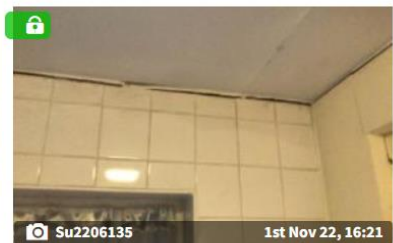
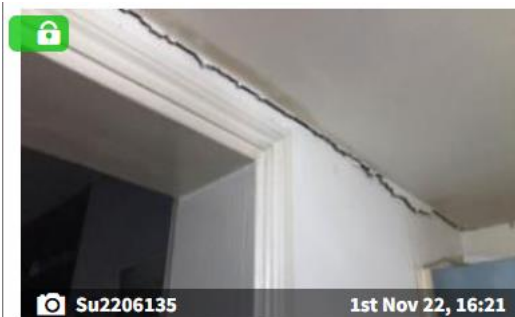
In structural terms the damage falls into Category 4 of Table 1, Building Research Establishment<sup>[1]</sup> Digest 251, which describes it as “severe”.

The damage was first noticed during August 2022, at a time of year when soil moisture deficits due to tree root activity would be reaching their peak. Due to the timing of the damage, the presence of Cypress roots and the abnormally dry condition of the soil in January, with no other likely causes, it is clear that, on the balance of probabilities, that the Cypress trees are the substantive and effective cause of the damage. Where the cause is clear, level monitoring is not instructed as a matter of course.

Photos of the damage not included within reports:
