## **TECHNICAL REPORT ON A SUBSIDENCE CLAIM**

**Crawford Reference: SU2206135**

**Sanctuary Housing Association  
154 Morley Avenue  
London  
N22 6NT**

**SUBSIDENCE CLAIM**

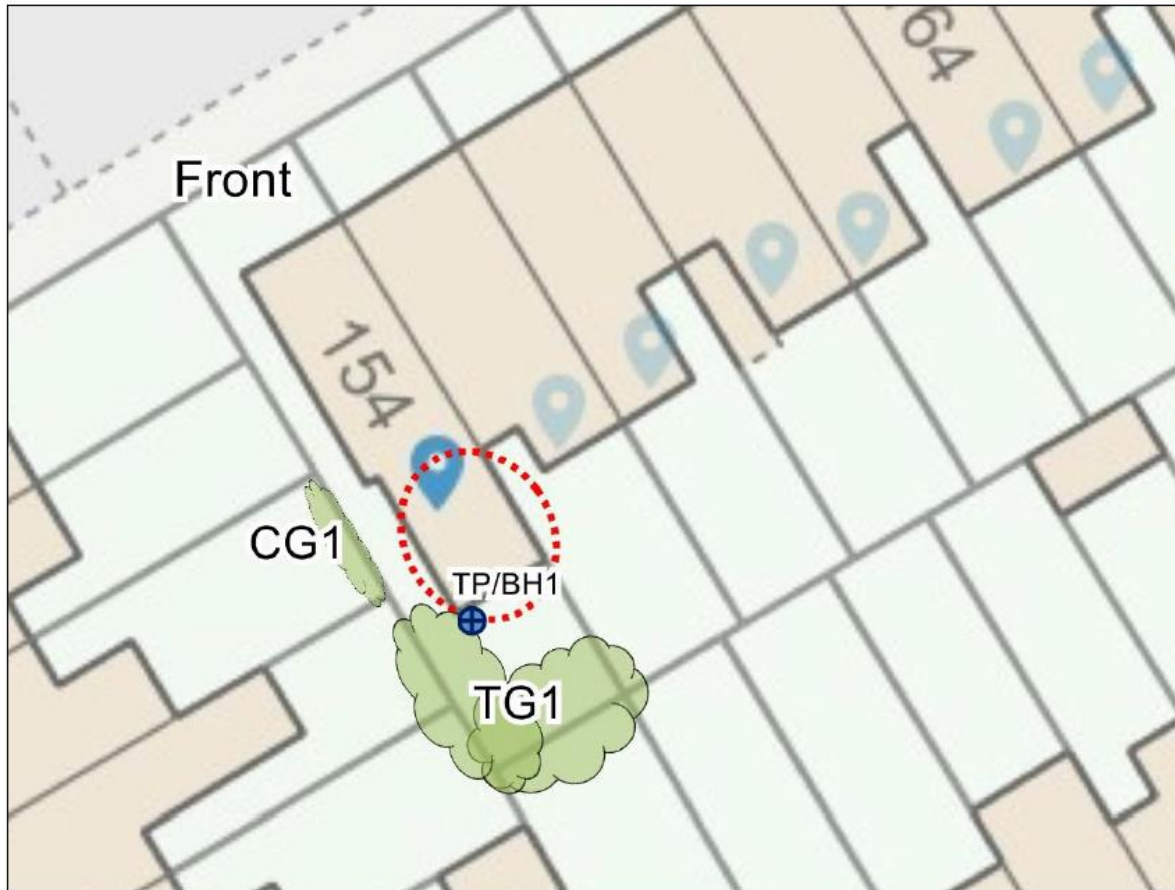
### Site Plan

Approximate areas of damage

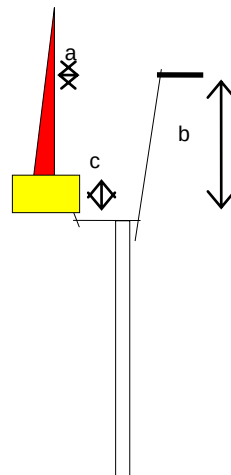
Foundation Details

| No. | Borehole Depth | Footing (a) | Underside (b) | Thickness (c) |
| TH1 | 3.00 m. | 180 mm. | 700 mm. | 400 mm. |

- The foundations are at a depth of 800 mm which is below the level that normal seasonal movement would be expected to occur.
- Atterberg limit testing indicates that the soil has a high plasticity and hence will shrink and swell with changes in moisture content.
- Roots were found to the underside of the foundation. Starch was present which indicates that the roots were alive at the time of retrieval.
- An expert Arboricultural report has confirmed that nearby vegetation is the cause of the subsidence related damage to the property and identified tree management works required to stabilise the property.
