**Haringey Civic Centre – Masonry Façade Condition Survey**

# Haringey Civic Centre

## Masonry Façade Survey February 2023

REF 23018-PAYE-RPT-002

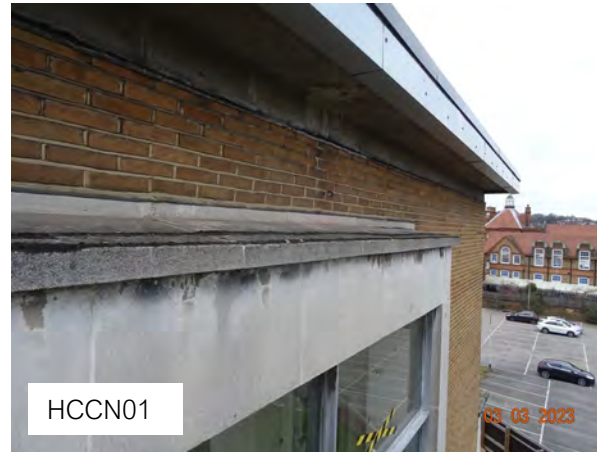
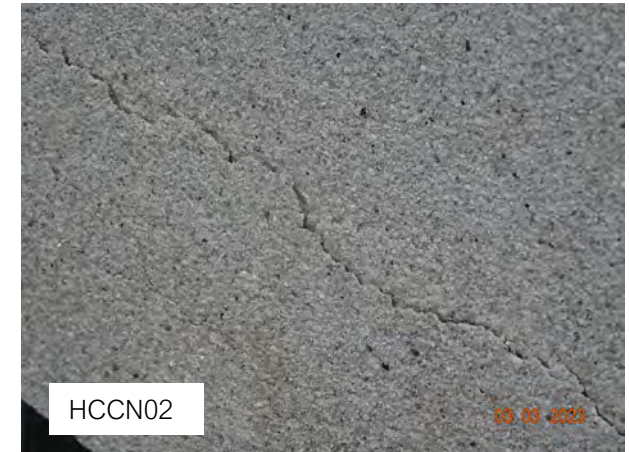
PHOTOS: HCCN01-02

A 1mtr section of the leading edge to the pre-cast window head over the door entrance is fractured. The facing mortar has de-bonded potentially allowing moisture to come into contact with embedded reinforcement.

RISK: RED

**HCCN01-02** Failing pre-cast window head. Continuous horizontal fracture.

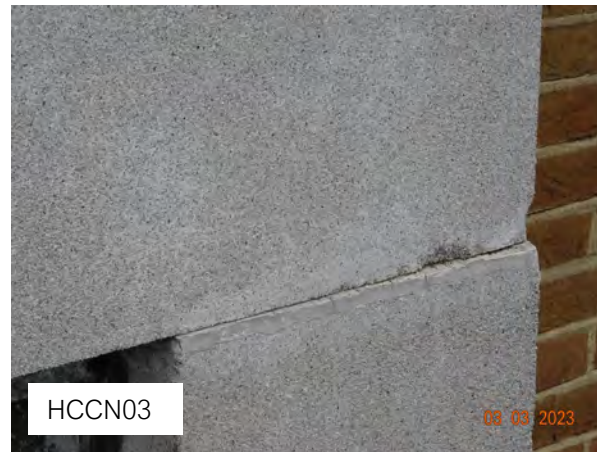
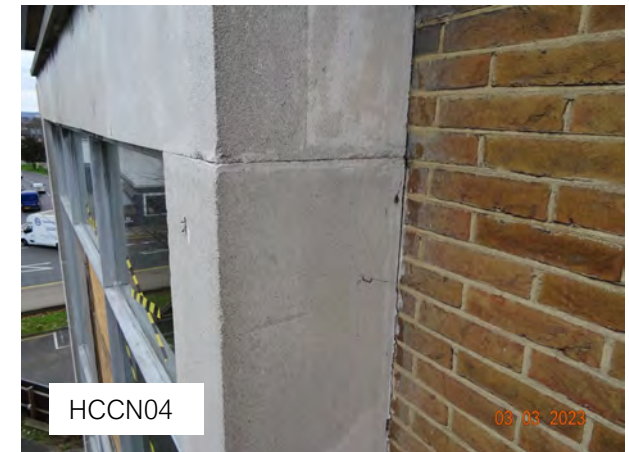
PHOTOS: HCCN03-04

Displacement of cast head. Apparent movement of masonry, possible de-bonding from backing structure. Recommend further structural engineer consultation.

RISK: AMBER/RED

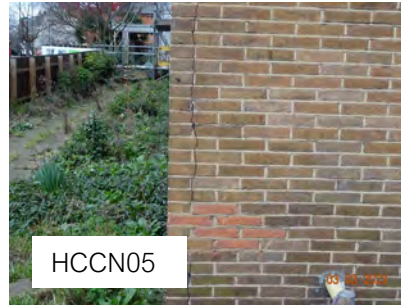
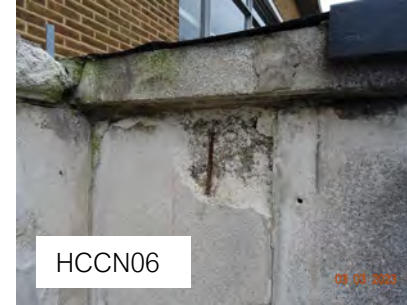
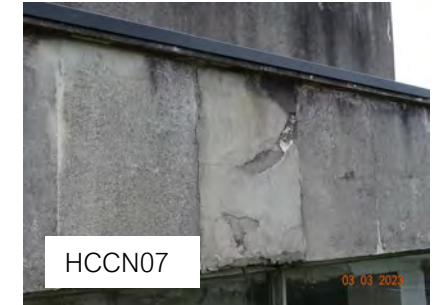
PHOTO: HCCN05

Continuous vertical fracture through brickwork. Evidence of previous brick repairs being carried out. Recommend further structural engineer consultation to help verify cause and any inherent on-going defect.

RISK:AMBER/RED

**HCCN05** Continuous vertical fracture through brickwork. Evidence of previous brick repairs being carried out.

| Item | Photo ref: | Schedule of works | Qty | Unit | Rate | £ |
|---|---|---|---|---|---|---|
| 1.6 | HCCN05,HCC E01,HCC W17-20 | RED. Cut out fractured facing brickwork. Supply and fix new bricks. Repairs to backing structure, foundations by others | | item | | 33,200.00 |

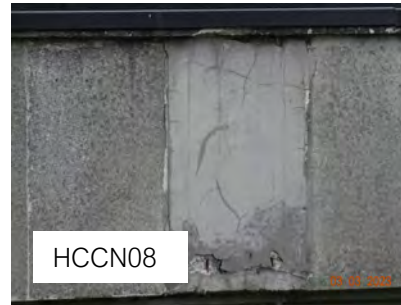
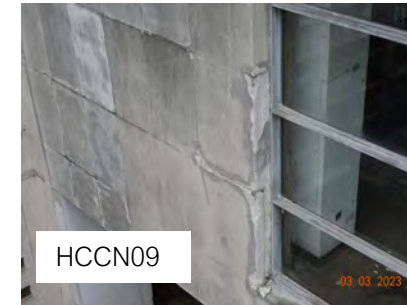
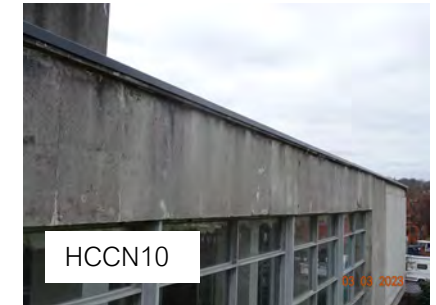
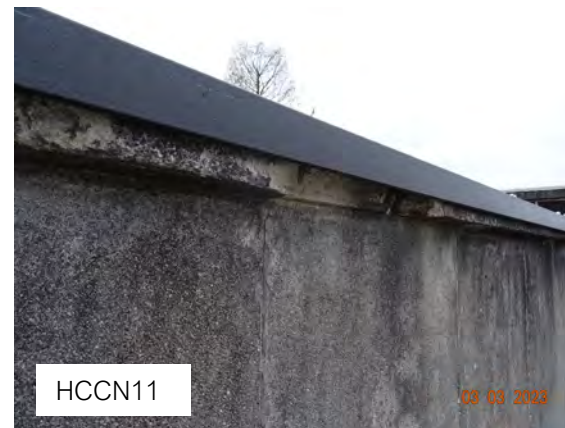
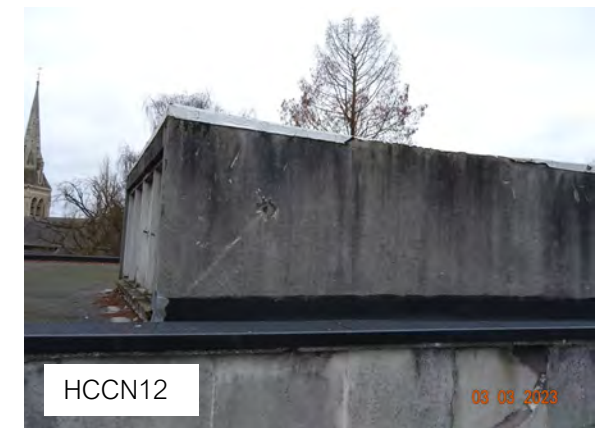
PHOTOS: HCCN06-12

On-going deterioration and failure of pre-cast cladding panels.

Poor, low quality historic repairs have failed, continued corrosion of embedded reinforcement causing damage to masonry.

RISK: RED

**HCCN06-12** Failed previous mortar repairs. Failure of mortar skim coat. Pre-cast cladding in an on-going deteriorating condition.

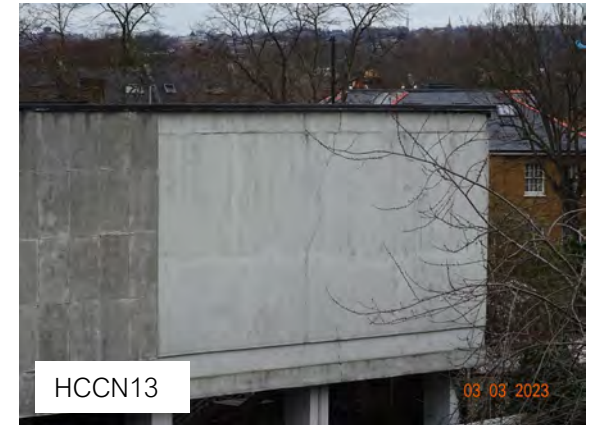
PHOTO: HCCN13

Continuous vertical fracture through render. Recommend further structural engineer consultation to help verify cause and any inherent on-going defect.

RISK: AMBER/RED

**HCCN13** Fractured, damaged render. Recommend a tap test survey and further investigation into cause of fracturing. Undertake appropriate repairs.

| Item | Photo ref: | Schedule of works | Qty | Unit | Rate | £ |
|---|---|---|---|---|---|---|
| 1.8 | HCCN13,HCCW04a | AMBER/RED. Cut back loose, de-bonded render and re-render maximum 30mm thick using a compatible mortar | | item | | 11,210.00 |

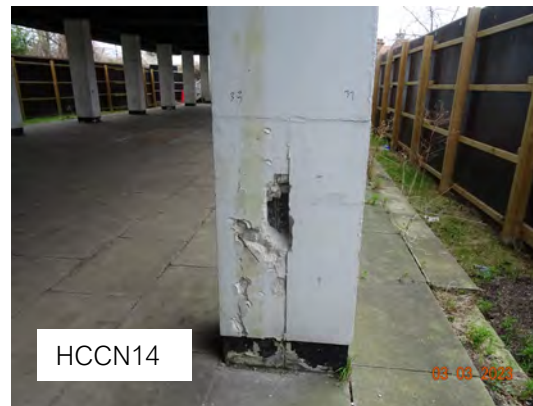
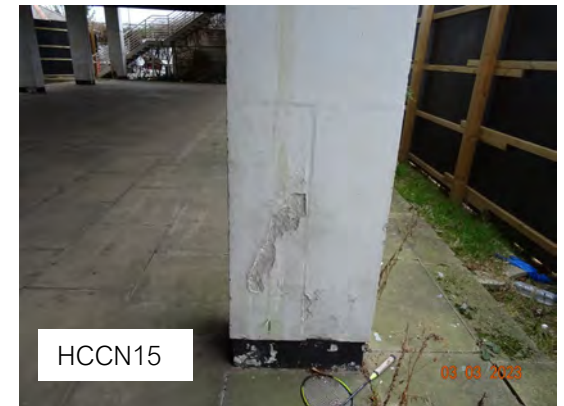
PHOTOS: HCCN06-12

On-going deterioration and failure of pre-cast cladding panels to colonnade.

Continued corrosion of embedded reinforcement causing damage to masonry.

RISK: RED

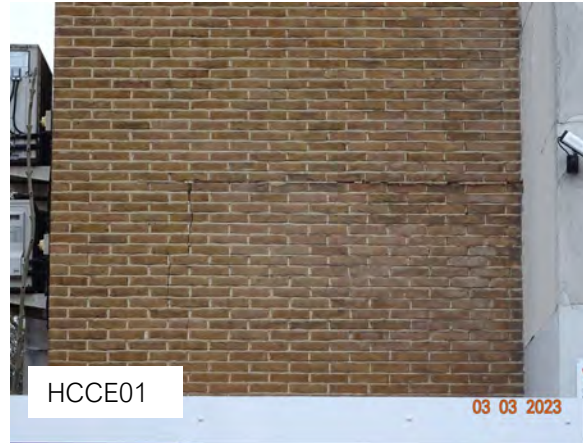
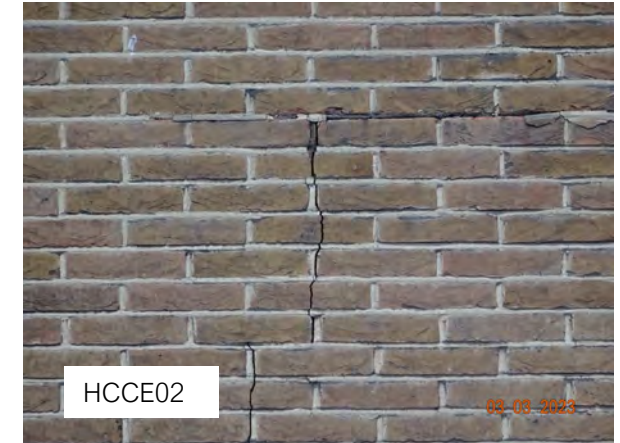
PHOTOS: HCCE01-02

Progressive fracturing of facing brickwork caused by corrosion of embedded metal work. Recommend further structural engineer consultation and intrusive investigation.

RISK: RED

**HCCE01-02** Continuous horizontal and vertical fracture through brickwork. Visible corroded steel support angle

Recommend further structural engineer consultation to help verify cause, any inherent on-going defect and develop repair strategy.

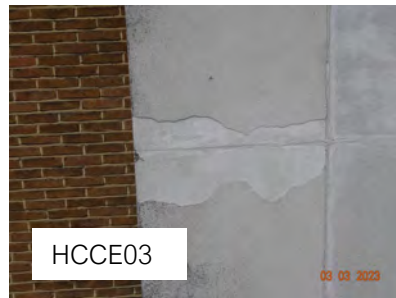
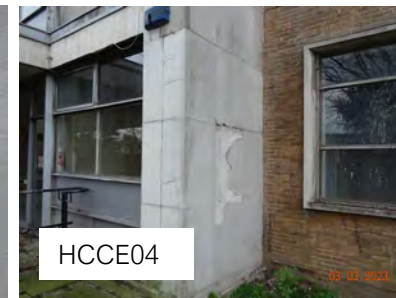
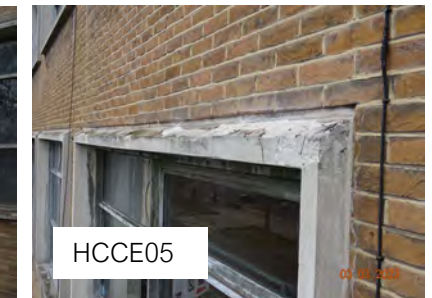
PHOTOS: HCCE03-05

Failure, de-bonding of mortar skim coat. Skim coat applied over the majority of the pre-cast cladding including cast window surrounds.

RISK: RED

**HCCE03, 12** Failure of mortar skim coat and applied coating. Pre-cast cladding in an on-going deteriorating condition.

**HCCE04** Failure of mortar skim coat. Pre-cast cladding in an on-going deteriorating condition.

| Item | Photo ref: | Schedule of works | Qty | Unit | Rate | £ |
|---|---|---|---|---|---|---|
| 1.0 | HCCE03,04,HCC S01,03 | RED. Supply and fix new pre-cast Portland ashlar restrained with stainless steel fixings drilled into existing backing structure. | 210 | m2 | 830.00 | 174,300.00 |

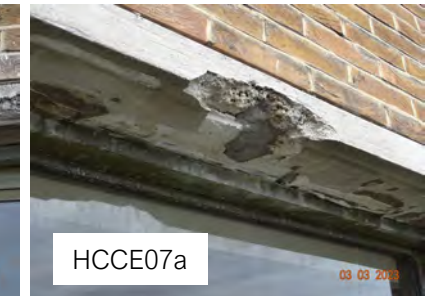
PHOTOS: HCCE06-07a

Corrosion of embedded reinforcement affecting cast window heads. Cast concrete is poor, low quality. Inconsistent compaction, ungraded mortar allowing for unrestricted migration of moisture.

RISK: RED

**HCCE06-7a** Failure of mortar skim coat over window surrounds. Corroded reinforcement causing damage and loss of masonry.

Pre-cast windows in an on-going deteriorating condition.

| Item | Photo ref: | Schedule of works | Qty | Unit | Rate | £ |
|---|---|---|---|---|---|---|
| 1.5 | HCCE05-07a | RED. Cut back loose, friable cast masonry to window surrounds. Drill in stainless steel reinforcement as required. Reform profiles using a compatible mortar. | | item | | 21,100.00 |

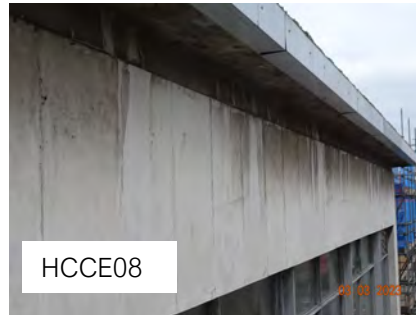
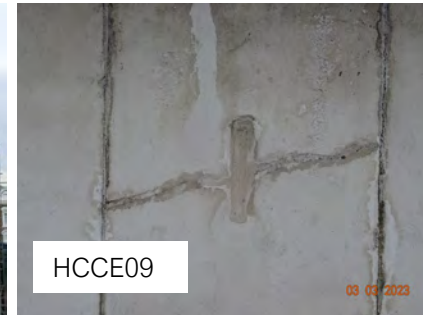
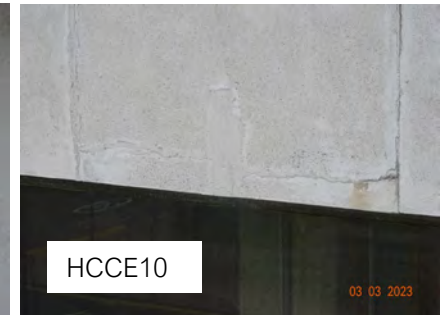
PHOTOS: HCCE08-10

Previously repaired continuous horizontal fractures visible across the fascia course. Further hairline fracturing observed during the survey indicating an on-going inherent defect affecting the stability of the cladding.

**RISK: RED**

**HCCE08-10** Previously repaired continuous horizontal fractures visible across the fascia course.

Further hairline fracturing observed during the survey indicating an on-going inherent defect affecting the stability of the cladding.

Recommend further structural engineer consultation and intrusive investigation of the fractures, repairs, movement, restraint fixings and backing structure.

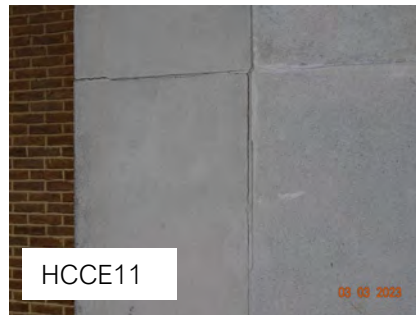
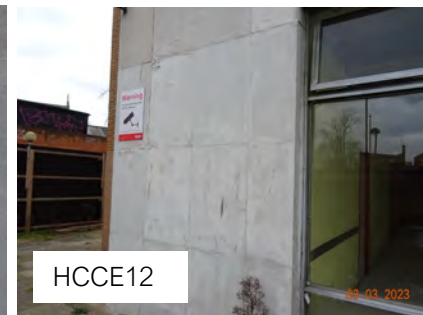
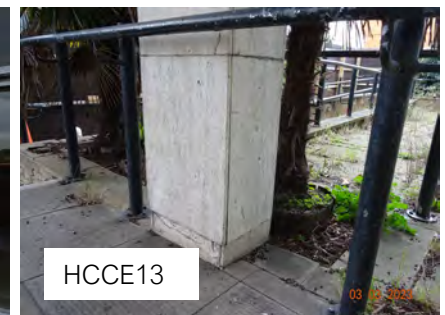
PHOTOS: HCCE11-13

Signs of possible movement to cladding panels. Verify condition and suitability of restraint and support fixings.

Applied coating is failing, pre-cast substrate is in a deteriorating condition.

Signs of movement to travertine cladding, fractured plinth. Recommend removal to verify condition and suitability of fixings.

**RISK: AMBER/RED**

**HCCE13** Signs of movement to travertine cladding, fractured plinth. Recommend removal to verify condition and suitability of fixings.

| Item | Photo ref: | Schedule of works | Qty | Unit | Rate | £ |
|---|---|---|---|---|---|---|
| 1.7 | HCCE13 | AMBER/RED. Remove, salvage and re-fix loose, displaced travertine marble cladding | | item | | 3,000.00 |

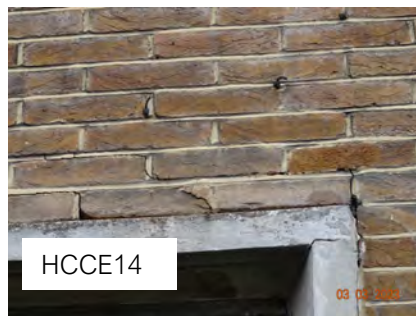
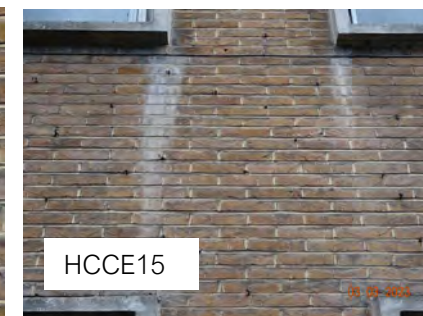
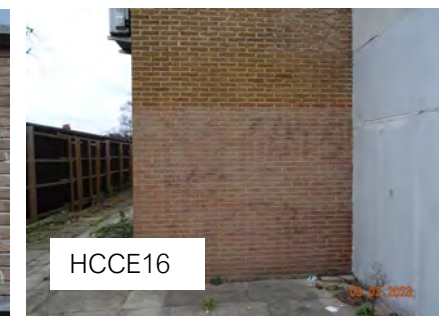
PHOTOS: HCCE14-16

Fractures and minor displacement affecting brickwork.

Numerous redundant metal fixings embedded into brick joints.

Abrasively cleaned brickwork is damaged with visible loss of fire skin. Damaged brickwork may be prone to deteriorate over time due to loss of protective fire skin.

**RISK: AMBER/RED**

**HCCE16** Abrasively cleaned brickwork is damaged with visible loss of fire skin. Damaged brickwork may be prone to deteriorate over time due to loss of protective fire skin.

**HCCE14** Continuous fracture through brickwork.

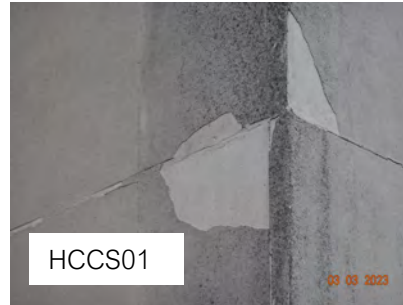
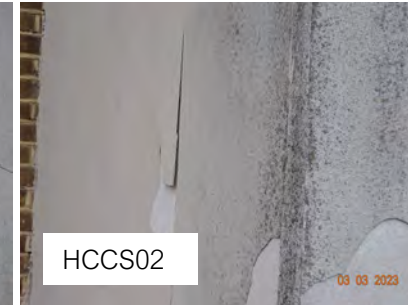
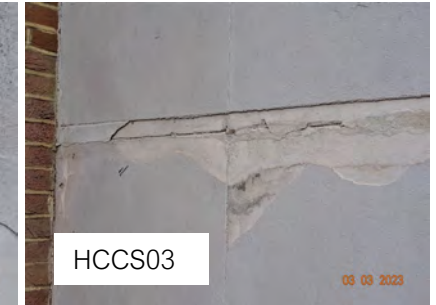
PHOTOS: HCCS01-03a

Failure, de-bonding of mortar skim coat. Skim coat applied over the majority of the pre-cast cladding. Signs of possible movement to cladding panels. Verify condition and suitability of restraint and support fixings.

**RISK: RED**

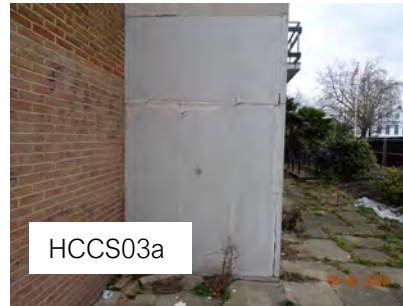
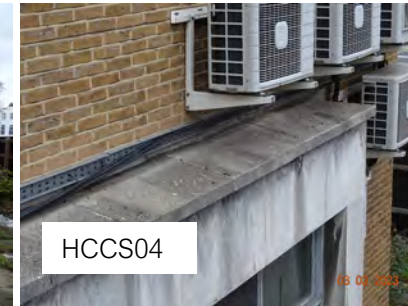
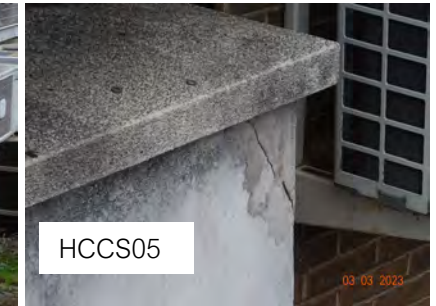
PHOTOS: HCCS04-05 RISK:

Cast copings appear to be in reasonable condition. Isolated fracture through fascia. Failed previous repair. Recommend removal and repair of fractured unit.

**AMBER/RED**

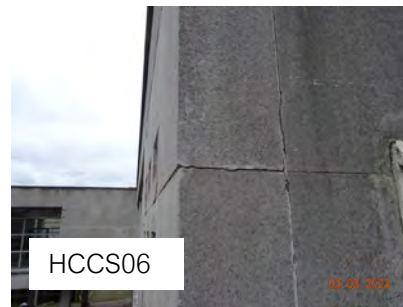
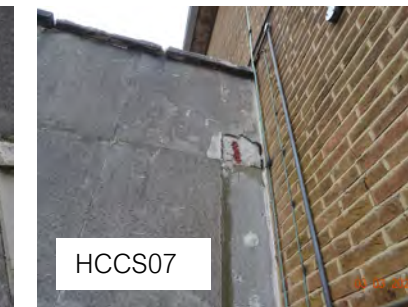
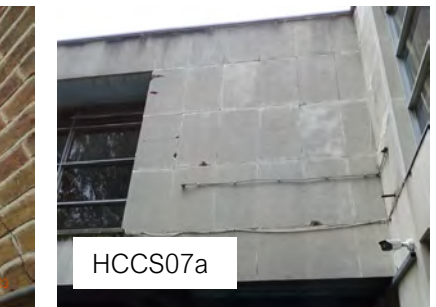
PHOTOS: HCCS06-07a

Visible displacement of masonry. Joints are open and cladding has moved of the building line. Affected pre-cast is within the location of significant brick fracturing and subsidence.

Incomplete previous repairs, exposed reinforcement, failing skim coat.

**RISK: RED**

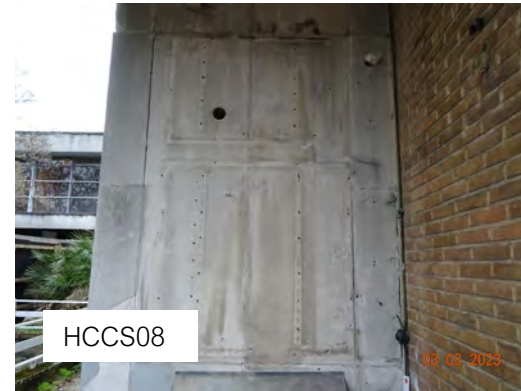
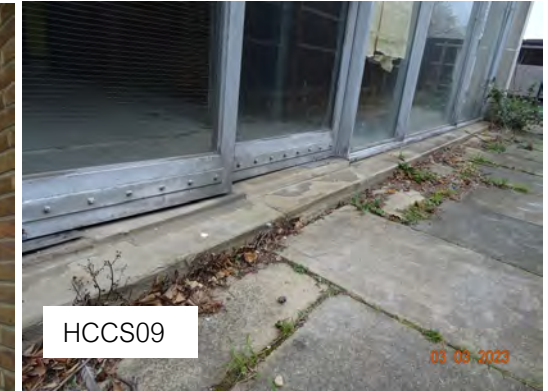
PHOTOS: HCCS08, 09

Numerous redundant fixing holes drilled through pre-cast cladding.  
Eroded, deteriorating York stone threshold.

RISK: GREEN/AMBER

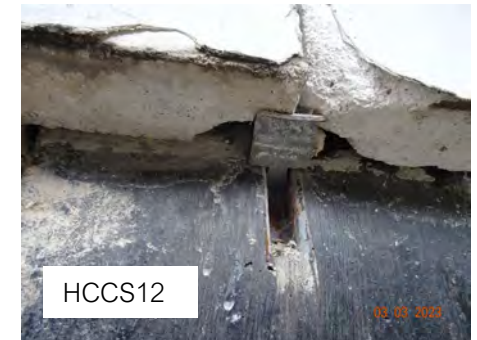
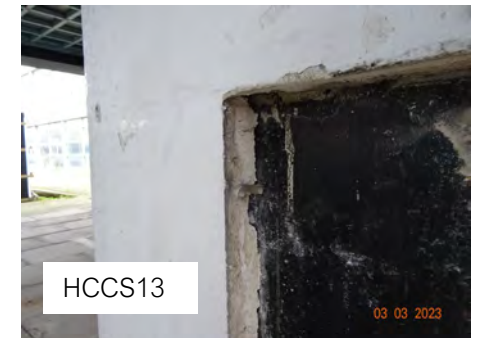
PHOTOS: HCCS10-13

Significant damaged caused to column cladding. No attempt made to remove cladding carefully for salvage and re-use.

Exposed fixings. Structural engineer to inspect and verify suitability to provide on-going long-term restraint and support.

RISK: RED

| Item | Photo ref: | Schedule of works | Qty | Unit | Rate | £ |
|---|---|---|---|---|---|---|
| 1.3 | HCCN14-15,HCC S10-13 | RED. Supply and fix new pre-cast column cladding restrained with stainless steel fixings drilled into existing backing structure. | 10 | m2 | 830.00 | 8,300.00 |

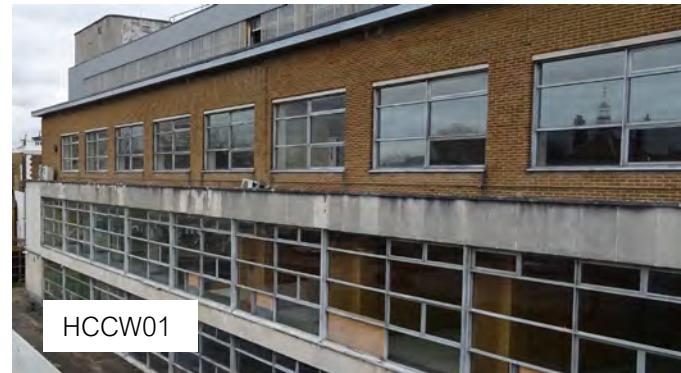
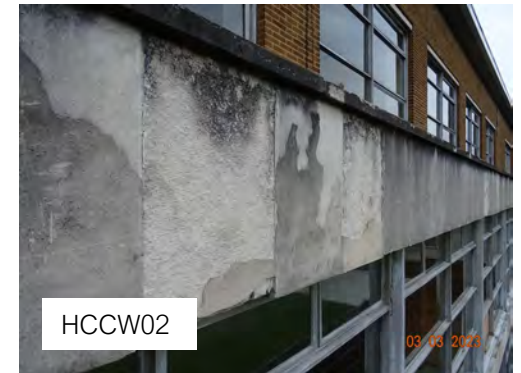
PHOTOS: HCCW01-04

On-going deterioration and failure of pre-cast cladding panels at 2<sup>nd</sup> and 1<sup>st</sup> floor level.

Poor, low quality historic repairs have failed, continued corrosion of embedded reinforcement causing damage to masonry

**RISK: RED**

**HCCW01-04** Failure of mortar skim coat. On-going deterioration of cladding panels.

| Item | Photo ref: | Schedule of works | Qty | Unit | Rate | £ |
|---|---|---|---|---|---|---|
| 1.1 | HCCN07,09,HCC E08,HCCW01-04 | RED. Supply and fix new pre-cast Portland L shaped units restrained with stainless steel fixings drilled into existing backing structure. | 344 | Nr | 492.00 | 169,248.00 |

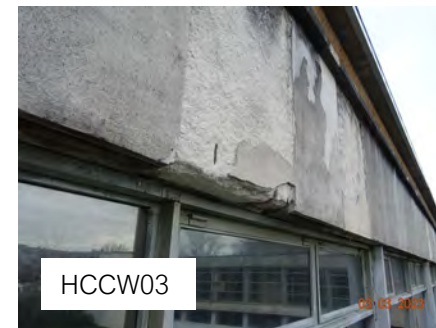
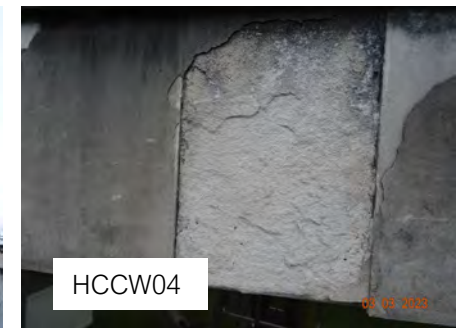
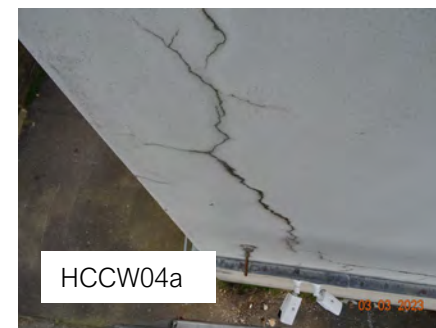
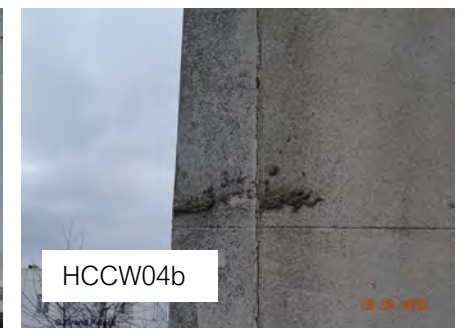
PHOTOS: HCCW04a, 04b

Fractured, damaged render. Recommend further investigation into cause of fracturing. Undertake appropriate repairs.

Signs of possible movement to cladding panels. Verify condition and suitability of restraint and support fixings.

**RISK: AMBER/RED**

**HCCW04a, 04b** Fractured, damaged render. Recommend further investigation into cause of fracturing. Undertake appropriate repairs.

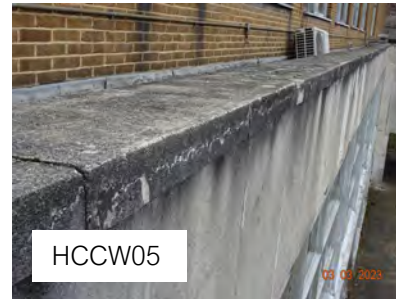
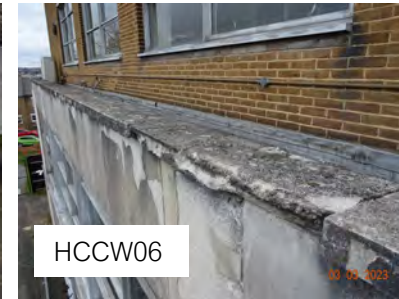
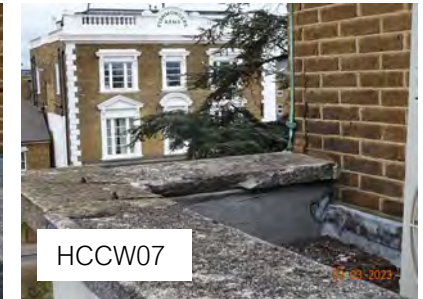
PHOTOS: HCCW06-08

Progressive failure of pre-cast copings. Continuous horizontal fracture along the leading edge.

Masonry has failed, detached and broken away. Lack of protection to adjacent cladding panels may be contributing to failure of masonry.

**RISK: RED**

**HCCW05-07** Progressive failure of pre-cast copings. Continuous horizontal fracture to leading edge.

| Item | Photo ref: | Schedule of works | Qty | Unit | Rate | £ |
|---|---|---|---|---|---|---|
| 1.2 | HCCN11,HCCW05-07 | RED. Supply and fix new pre-cast Portland copings | 200 | m | 240.00 | 48,000.00 |

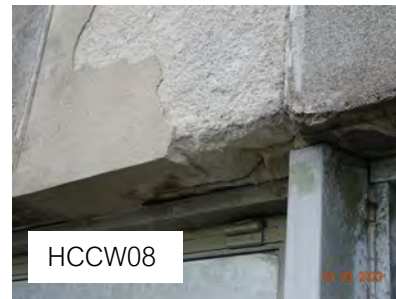
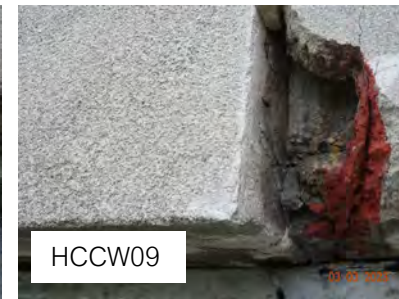
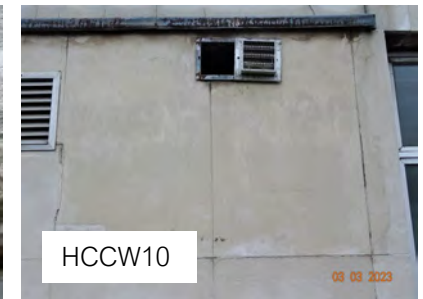
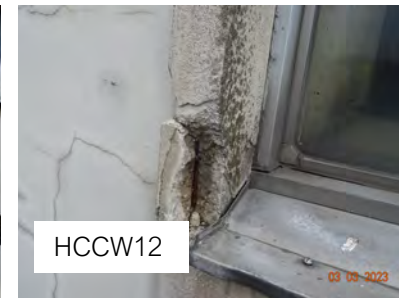
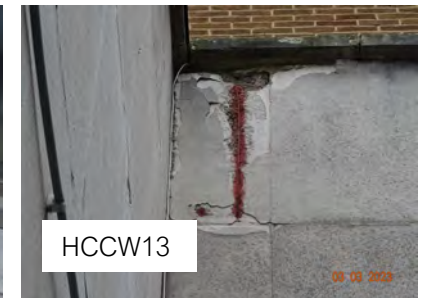
PHOTOS: HCCW08-13

Incomplete repairs. Damage to cladding panel exposes the make up of the unit, poor-quality mortars and mix ratios and insufficient cover to the reinforcement.

Failing previous mortar repairs. Damaged window jamb caused by corroded reinforcement.

**RISK: RED**

**HCCW08,10-11** Failed previous mortar repairs.

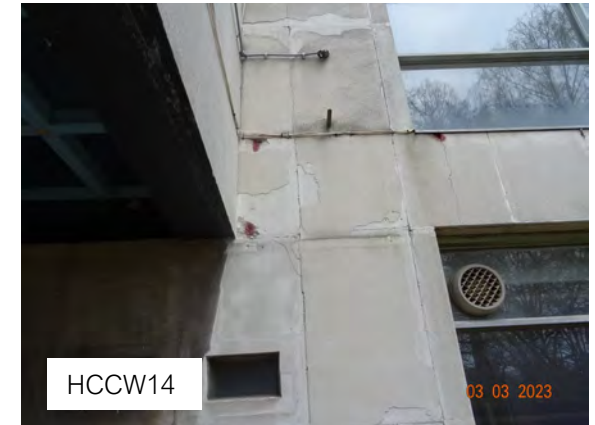
PHOTOS: HCCW14

Failure of skim coat, previous mortar repairs. Incomplete previous repairs, exposed reinforcement.

RISK: RED

**HCCW14** Failure of mortar skim coat. On-going deterioration, fracturing of cladding panels.

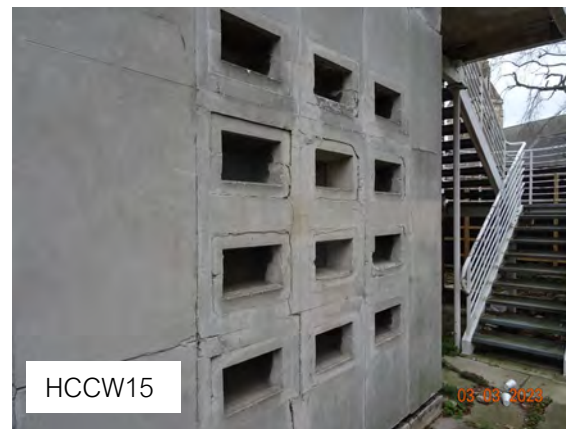
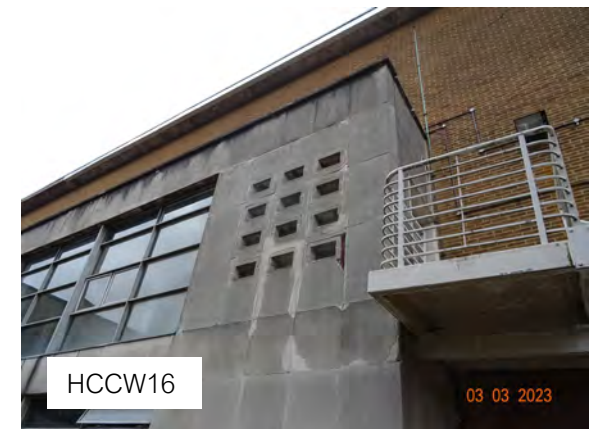
PHOTOS: HCCW15-16

Notable failure of pre-cast around punched windows. Exposed corroding reinforcement, failing previous mortar repairs.

RISK: RED

**HCCW15-16** Notable failure of pre-cast punched windows. Failing previous mortar repairs, corroding reinforcement. Displacement of masonry.

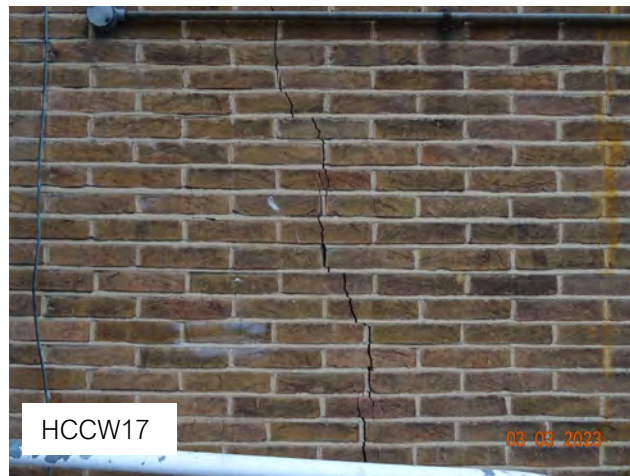
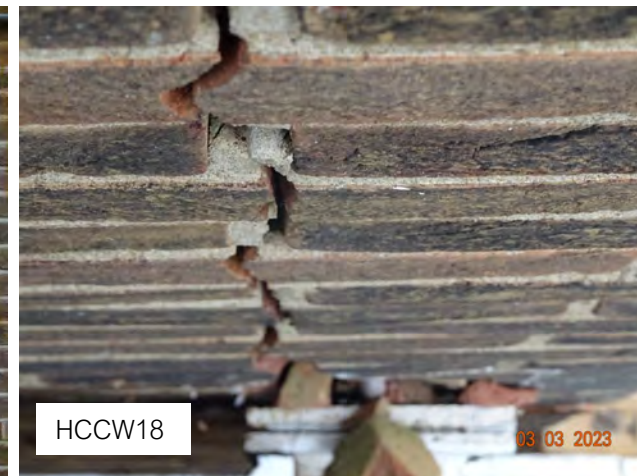
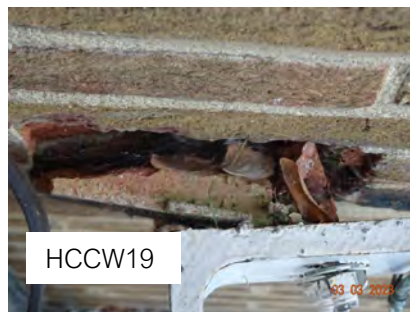
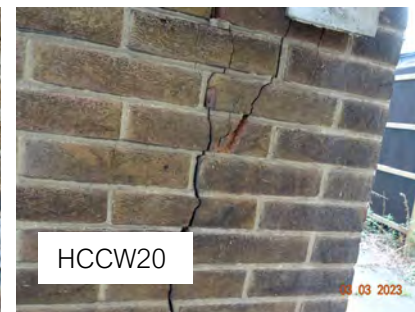
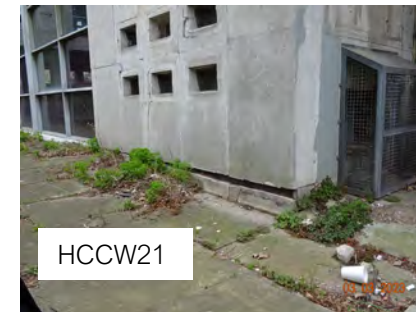
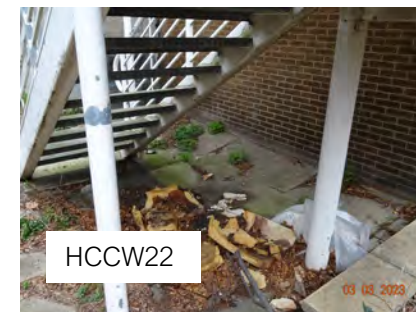
PHOTOS: HCCW17-22

Significant fracturing through brickwork and visible subsidence that has caused the façade to drop.

Restraint fixings securing the fire escape have failed and pulled out of the brickwork.

The fire escape is out of level. Recommend closure of the staircase subject to a detailed assessment of its stability.

RISK: RED

**HCCW17-22** Significant fracturing through brickwork and visible subsidence that has caused the façade to drop.

Restraint fixings securing the fire escape have failed and pulled out of the brickwork. The fire escape is out of level. Recommend closure of the staircase subject to a detailed assessment of its stability.

Recommend further structural engineer consultation and intrusive investigations to help determine the cause and develop an appropriate repair strategy.
