# Arboricultural Appraisal Report

## Subsidence Damage Investigation at:

14 Park Avenue  
London  
N22 7EX

| REPORT DATE: | 21/07/2023 |

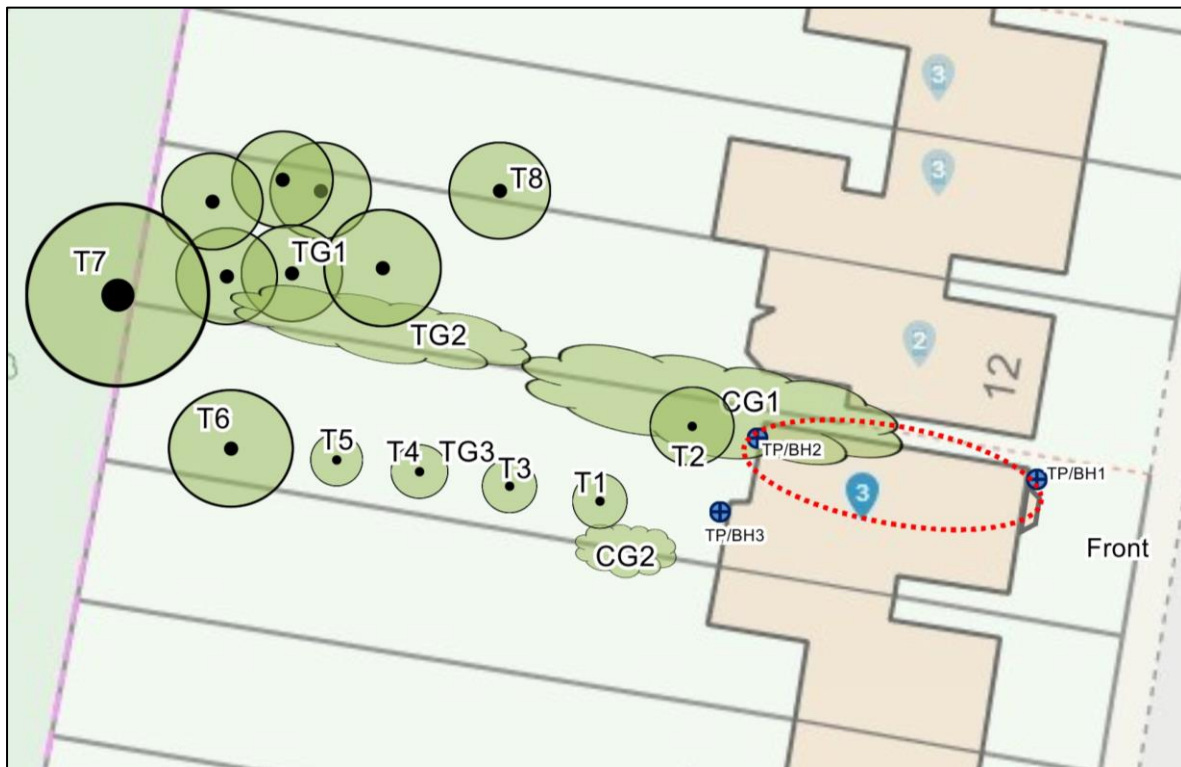
## Site Plan

Approximate areas of damage

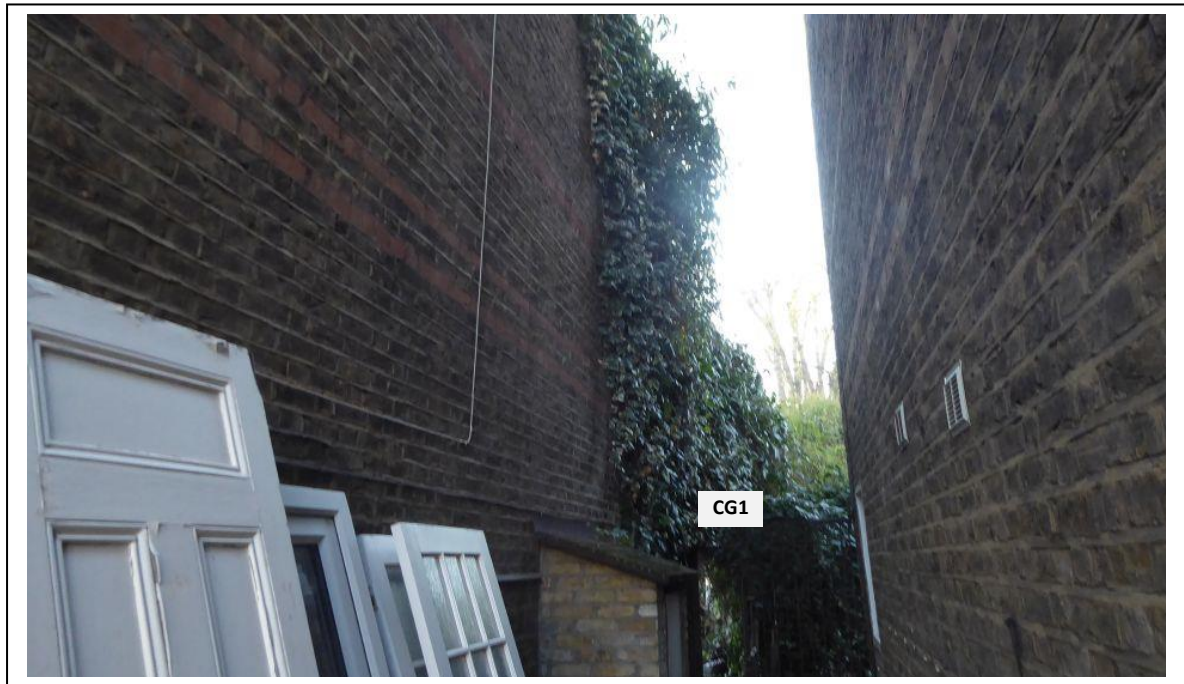
At present the most significant of the retrieved root samples are those relating to the Clematis and Magnolia elements. These will originate from the Clematis of the CG1 and the Magnolia T2 and the climber group which swamps the rear right hand corner of the building and surrounding areas. The Populus spp. roots will emanate from the T7 Poplar, but at present are not considered significant while the climbers and more proximal vegetation remains in situ. The Cupressaceae spp. roots at TP/BH1 at the property frontage are not considered relevant.

| Tree No. | Species | Ht (m) | Dia (mm) | Crown Spread (m) | Dist. to building (m) | Age Classification | Ownership |
|---|---|---|---|---|---|---|---|
| CG1 | Group of mixed spp. climbers including Ivy, Passionflower and Clematis | 15.0 | 60 * | 15.0 * | 1.0 * | Younger than Property | Joint Policy Holder & 12 Park Avenue N22 7EX |
| Management history | | No significant past management noted.<br>Extensive growth over boundary fence and colonisation of rear right-hand corner of building | | | | | |

View from right-hand flank of CG1 group

If an arboricultural solution is to be implemented to mitigate the influence of the implicated trees/vegetation we recommend that the climbers of CG1 and T2 Magnolia are removed in the first instance.

Removals of the CG1 group should include removal of any and all understorey trees/shrubs which have been swamped by the growth and are no longer visible. Removals of the CG1 should also include related elements which have grown outside of the property boundary and progressed into the adjacent third party garden.

| Tree No. | Species | Ht (m) | Dia (mm) | Crown Spread (m) | Dist. to building (m) | Age Classification | Ownership |
|---|---|---|---|---|---|---|---|
| Recommendation | | Remove (fell) all within 6.0m of the building to near ground level and treat stumps to inhibit regrowth.<br>Removal should include any/all understorey trees and shrubs and any elements that have crossed the boundary into adjacent third party garden. | | | | | |

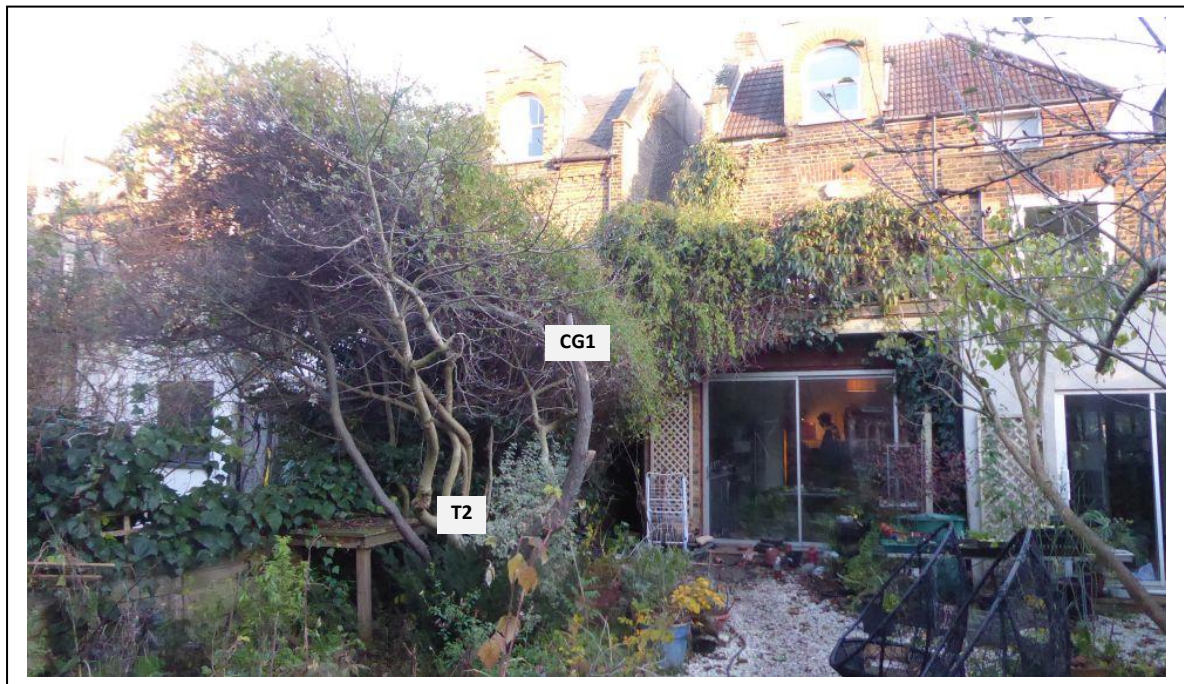
| Tree No. | Species | Ht (m) | Dia (mm) | Crown Spread (m) | Dist. to building (m) | Age Classification | Ownership |
|---|---|---|---|---|---|---|---|
| T2 | Magnolia | 5.0 | 150 Ms * | 5.5 | 4.8 | Younger than Property | Policy Holder |

View from rear of CG1 group and T2 Magnolia

| Tree No. | Species | Ht (m) | Dia (mm) | Crown Spread (m) | Dist. to building (m) | Age Classification | Ownership |
|---|---|---|---|---|---|---|---|
| Recommendation | | Remove (fell) to near ground level and treat stump to inhibit regrowth. | | | | | |

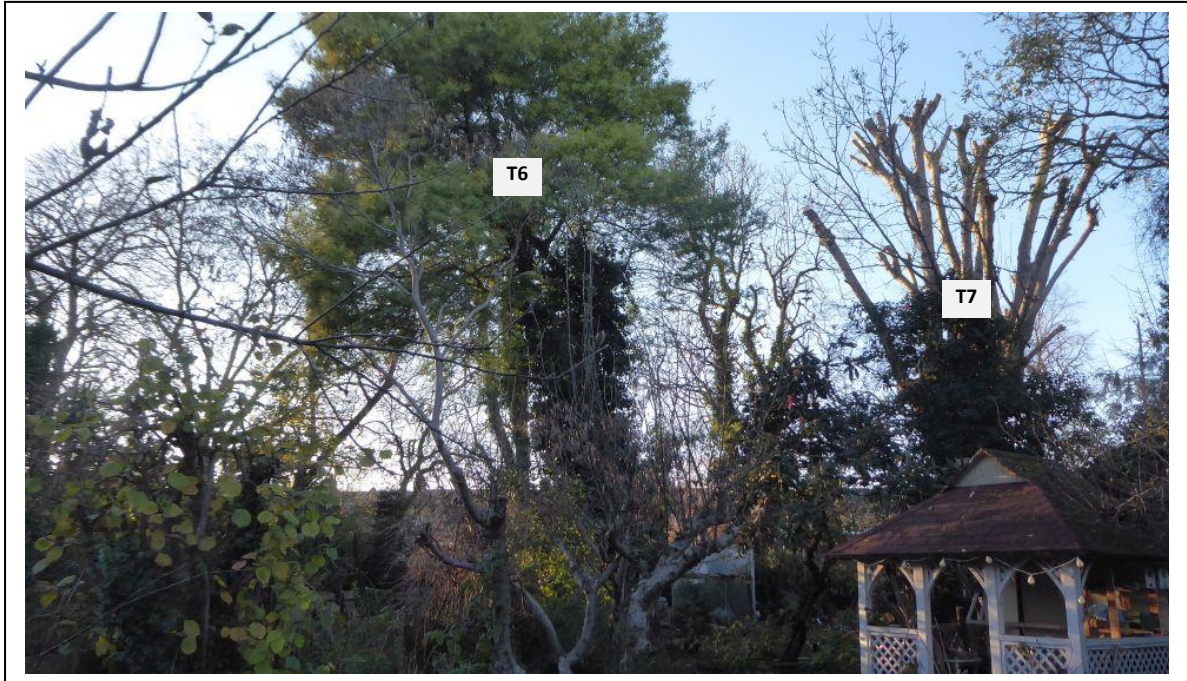
| Tree No. | Species | Ht (m) | Dia (mm) | Crown Spread (m) | Dist. to building (m) | Age Classification | Ownership |
|---|---|---|---|---|---|---|---|
| T6 | Mimosa | 13.5 | 400 * | 9.5 | 24.5 | Younger than Property | Policy Holder |
| T7 | Poplar | 16.5 | 1300 | 16.0 | 33.0 | Younger than Property | Local Authority |
| Management history | | Subject to past management/pruning - previously pollarded at approx. 8.0m. | | | | | |

View of T6 Mimosa and T7 Poplar

| Tree No. | Species | Ht (m) | Dia (mm) | Crown Spread (m) | Dist. to building (m) | Age Classification | Ownership |
|---|---|---|---|---|---|---|---|
| Recommendation | | No works required at present (subject to review if movement persists). | | | | | |

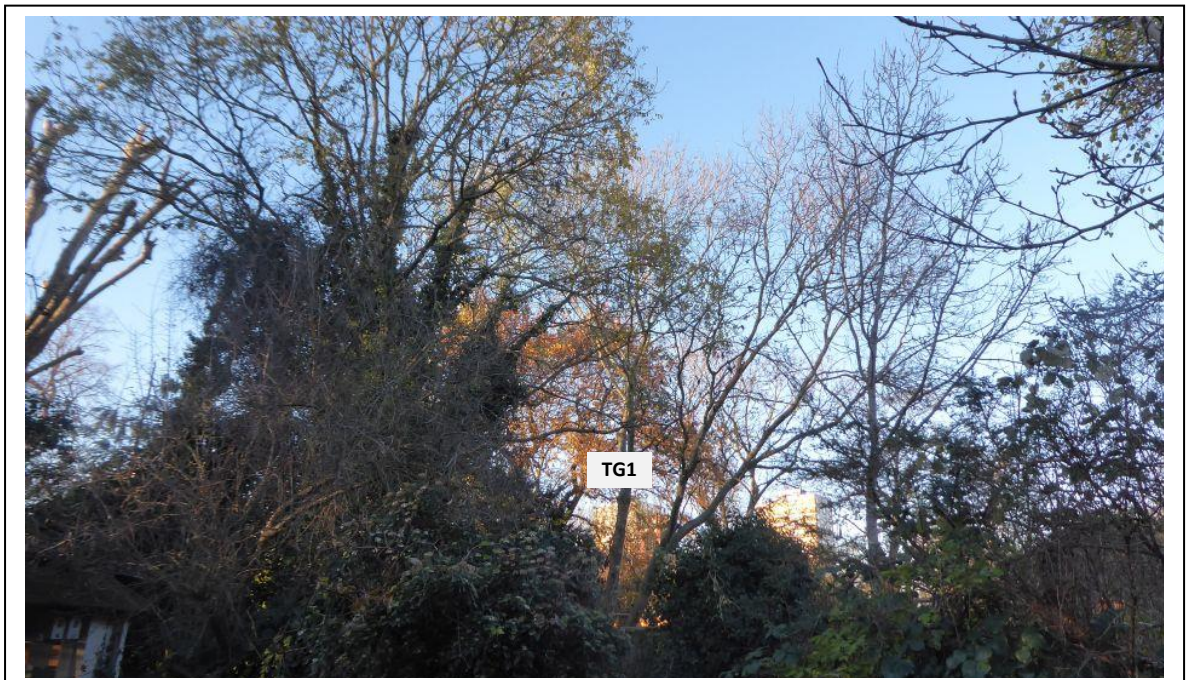
| Tree No. | Species | Ht (m) | Dia (mm) | Crown Spread (m) | Dist. to building (m) | Age Classification | Ownership |
|---|---|---|---|---|---|---|---|
| TG1 | Ash group | 16.0 | 450 * | 14.5 | 19.7 | Younger than Property | Third Party<br>12 Park Avenue<br>N22 7EX |

View of TG1 Ash group

| Tree No. | Species | Ht (m) | Dia (mm) | Crown Spread (m) | Dist. to building (m) | Age Classification | Ownership |
|---|---|---|---|---|---|---|---|
| Recommendation | | No works required at present (subject to review if movement persists). | | | | | |
