## SITE INVESTIGATION FACTUAL REPORT

Report No: SI-559746  
Client: Crawford Claims Management  
Site: 14 Park Avenue, London  
Client Ref: SU2205934  
Date of Visit: 19/06/2023

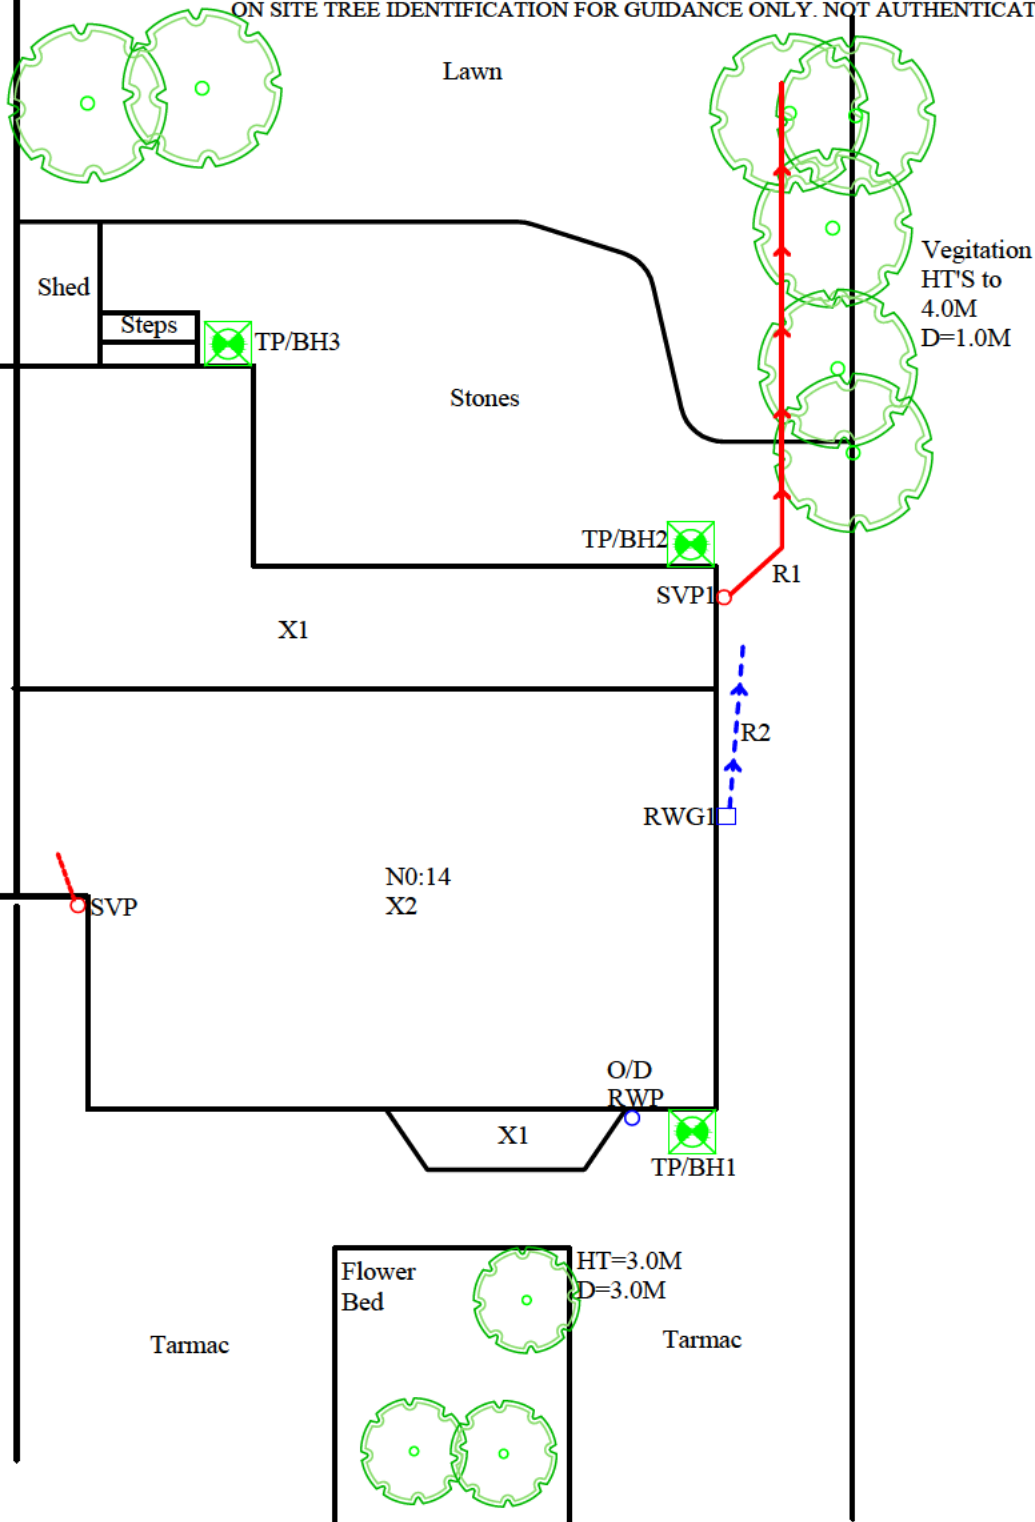
# Investigation Layout Plan

ON SITE TREE IDENTIFICATION FOR GUIDANCE ONLY. NOT AUTHENTICATED

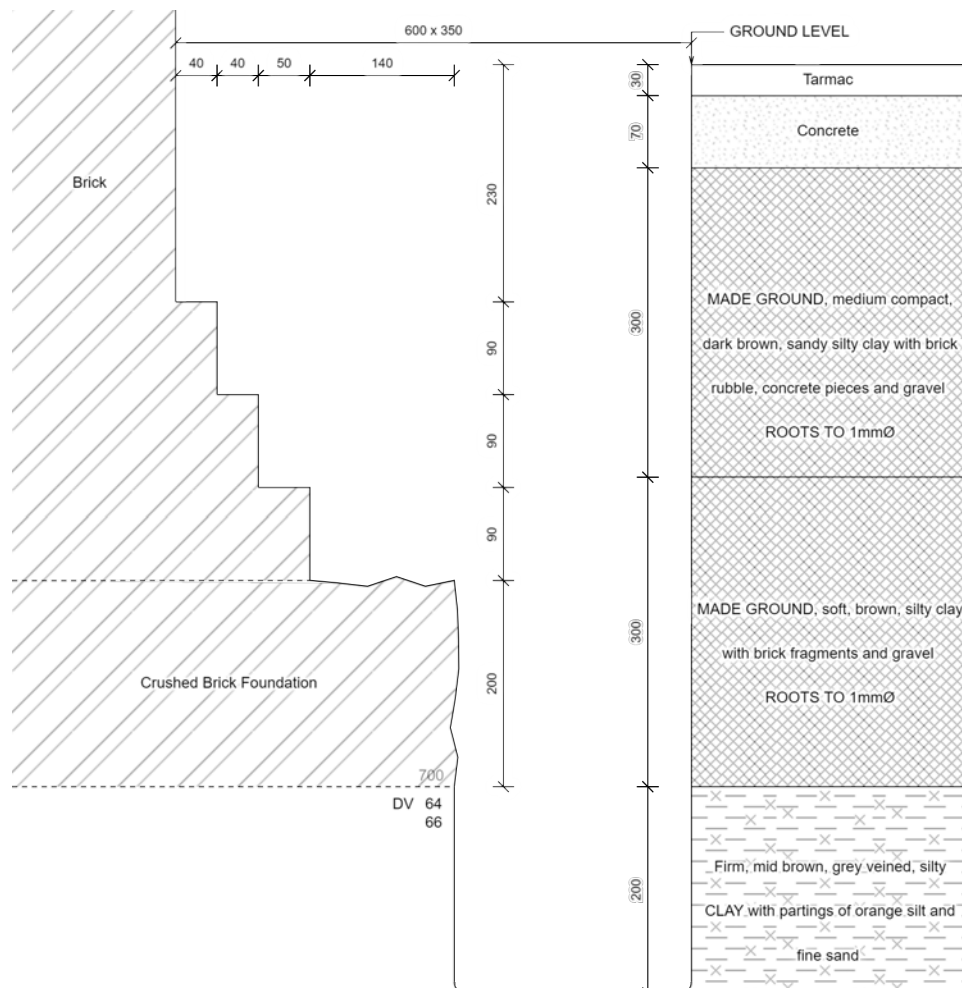
TRIAL PIT REF: TP1 DATE: 19/06/2023

For Strata below 900mm see Bore Hole log

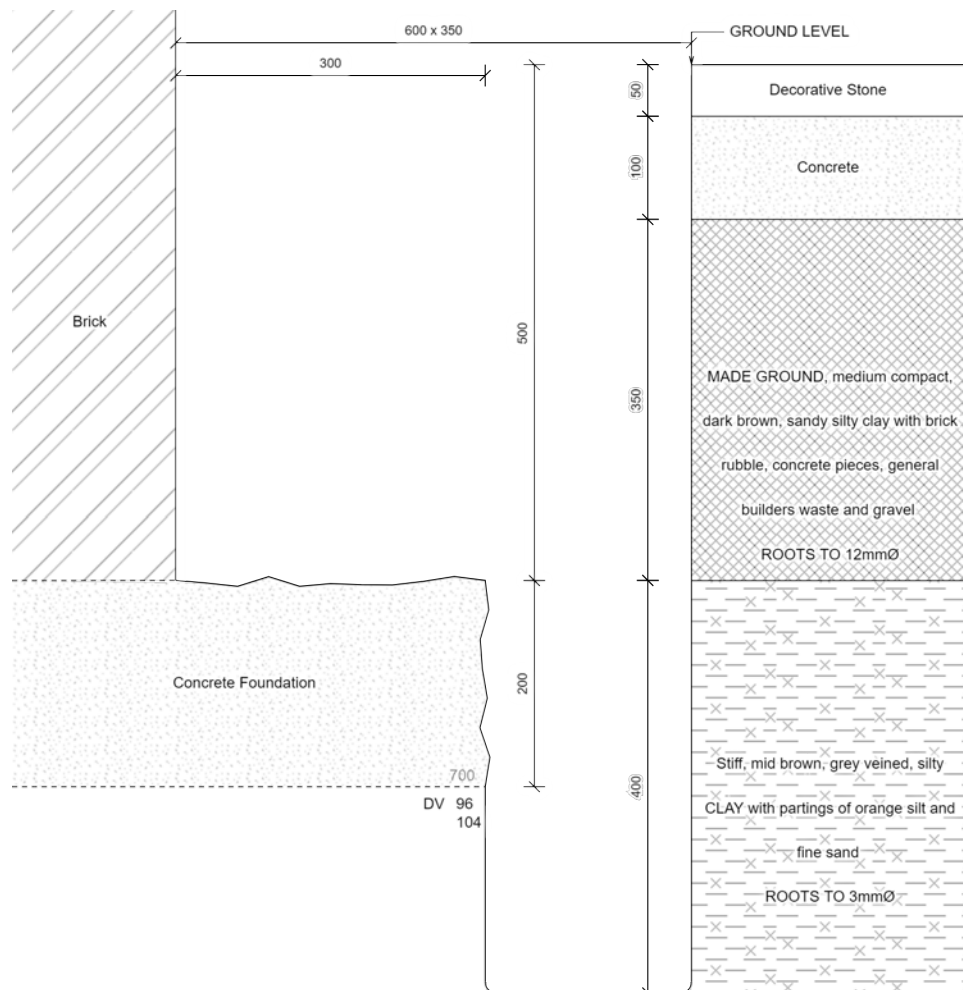
TRIAL PIT REF: TP2 DATE: 19/06/2023

For Strata below 900mm see Bore Hole log

Curved steel pin driven under concrete 200mm at 700mm below ground level.

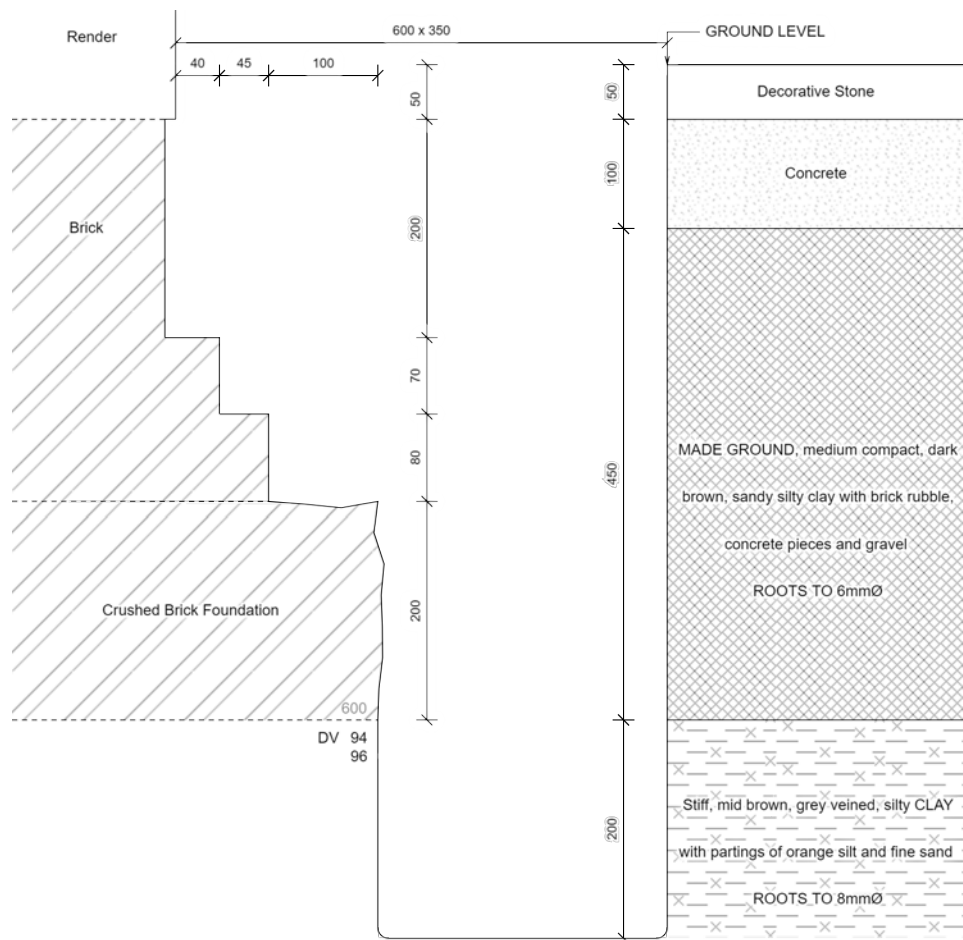
TRIAL PIT REF: TP3 DATE: 19/06/2023

For Strata below 800mm see Bore Hole log

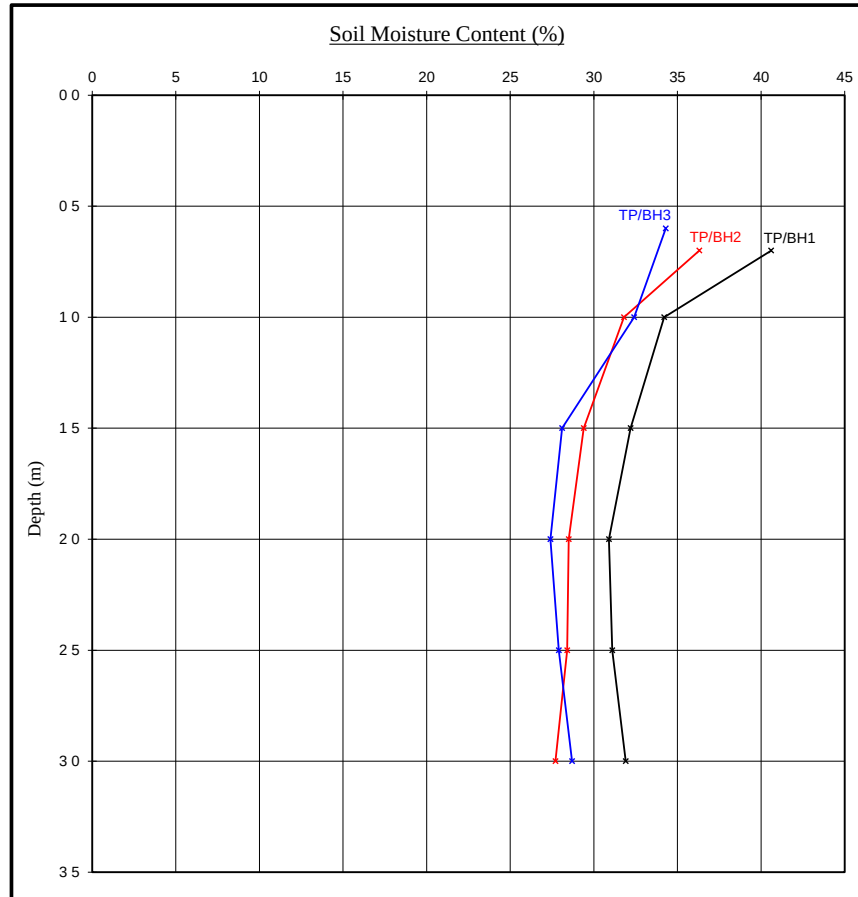
## Moisture Content Profiles

- 1 If plotted, 0.4 LL and PL+2 (after Driscoll, 1983) should only be applied to London Clay (and similarly overconsolidated clay) at shallow depths
- 2 Unless specifically noted the profiles have not been related to a site datum

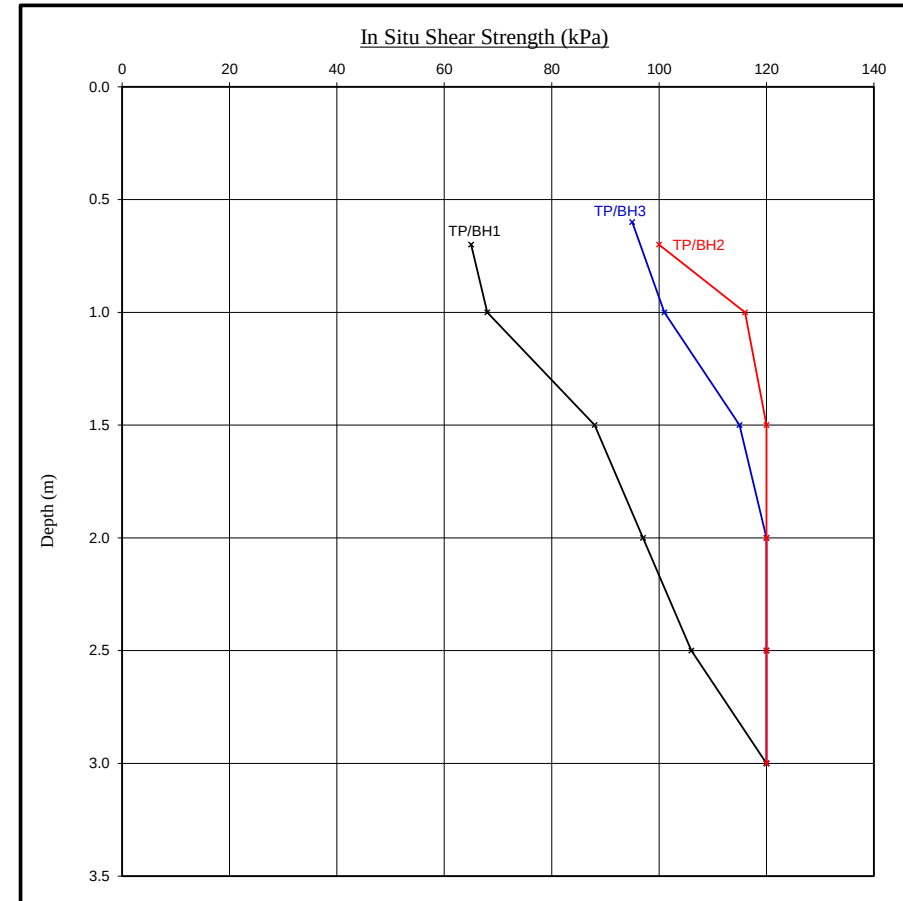
## Shear Strength Profiles

- 1 Unless otherwise stated, values of Shear Strength were determined in situ by CTS using a Pilcon Hand Vane the calibration of which is limited to a maximum reading of 130 kPa
- 2 Unless specifically noted the profiles have not been related to a site datum
