Civic Centre

Repair and restoration of the civic centre

Curtain Walling and Windows

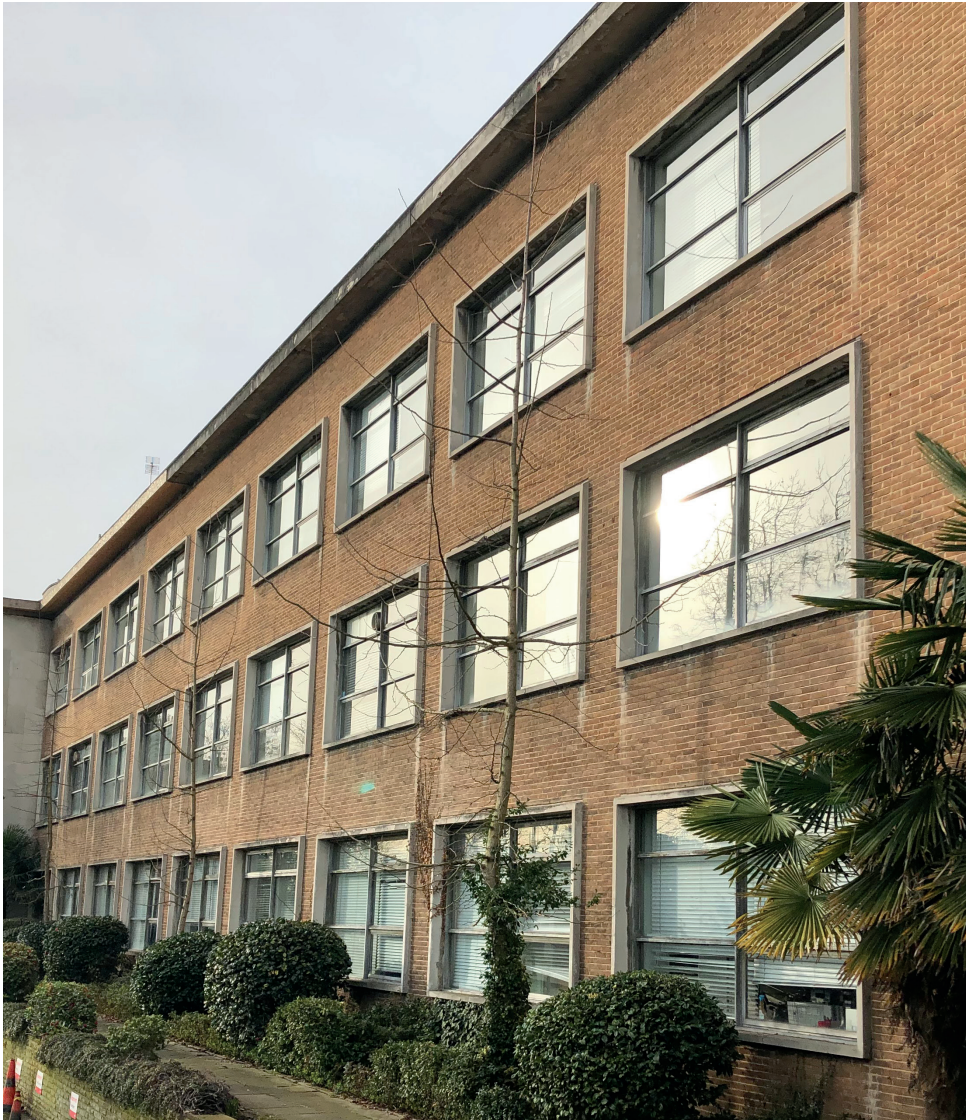
Aluminium Punch Windows - GF-L02

Ground floor to Second Floor  
East (Front) & West (Courtyard) elevations

- Aluminium stick system
- Generally Single glazed
- Inconsistent positioning of top-hung opening lights,
- Internally solar control film in places - in some locations this is degrading/peeling
- Sealant/beading has degraded and contains asbestos

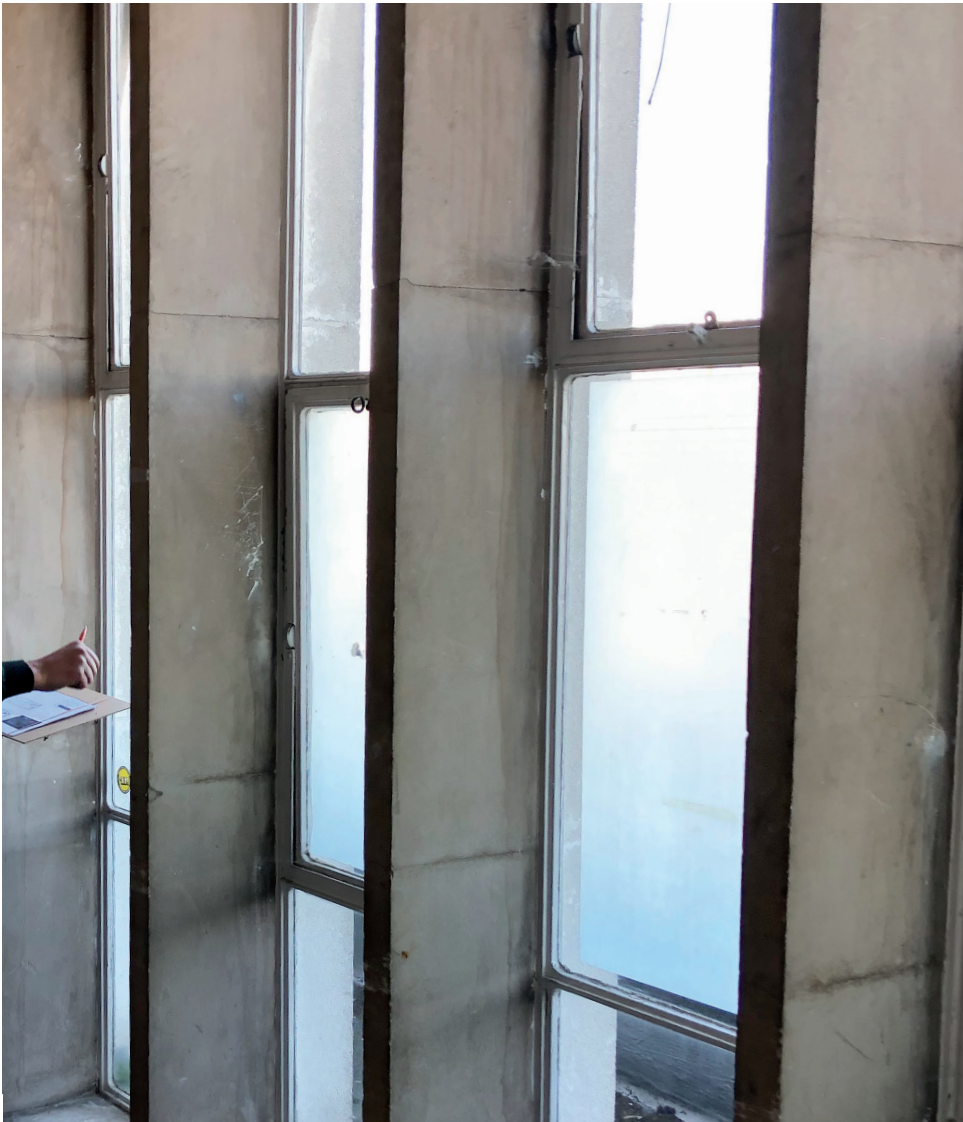
Steel Windows

Third Floor (Attic)  
All elevations

- Steel window system
- Precast concrete surrounds in need of urgent repair (Repaired in places previously unsympathetically), not thermally broken and signs of water ingress.
- Generally Single glazed
- Inconsistent positioning of top-hung opening lights,
- Internally solar control film in places - in some locations this is degrading/peeling
- Sealant/beading has degraded
- Paint added to frames has degraded
