Existing Building

Key Internal Spaces - Council Chamber

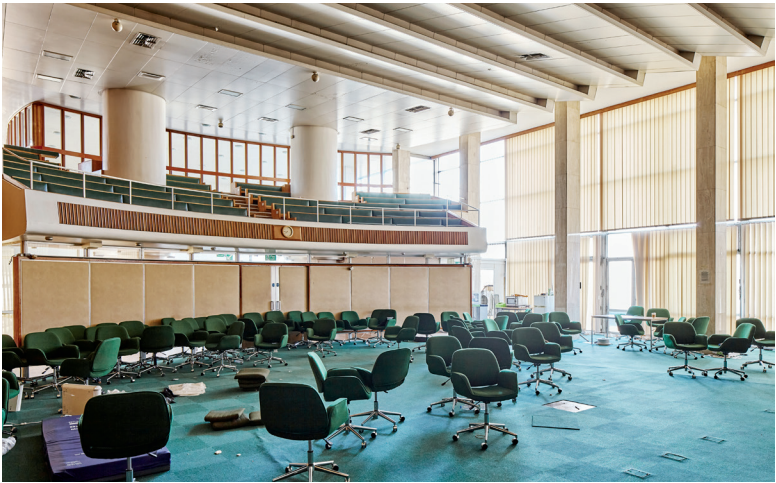
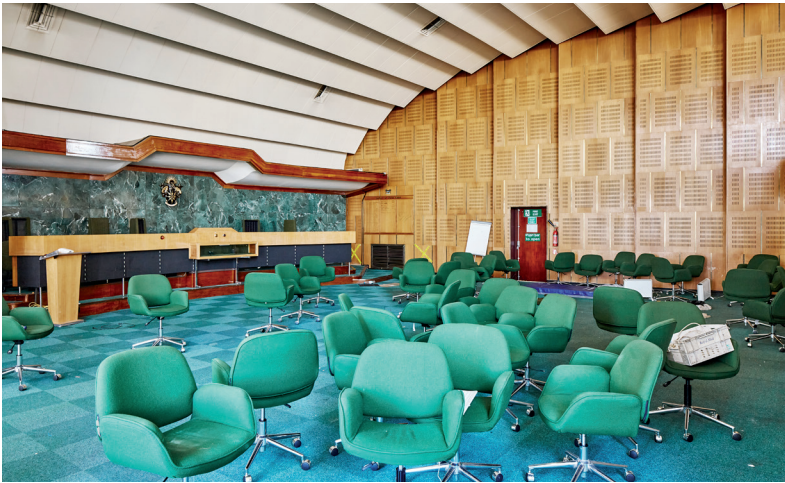
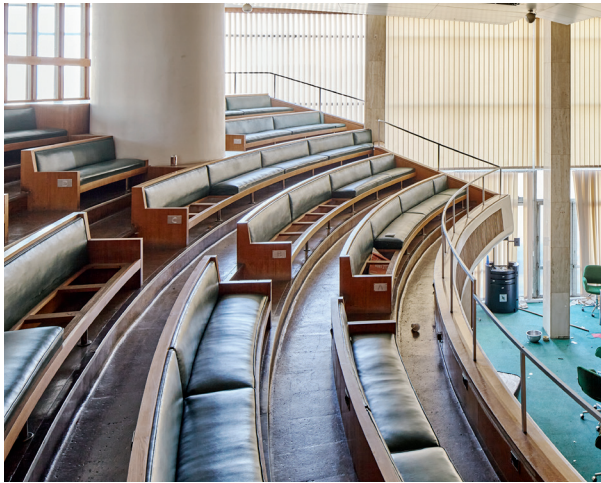
Middle  
Pre-Enabling Works

- Asbestos ceiling
- Timber panelling with brass inlays - brass tarnished
- Non-Original carpet
- Vertical Blinds
- Original brass clock removed

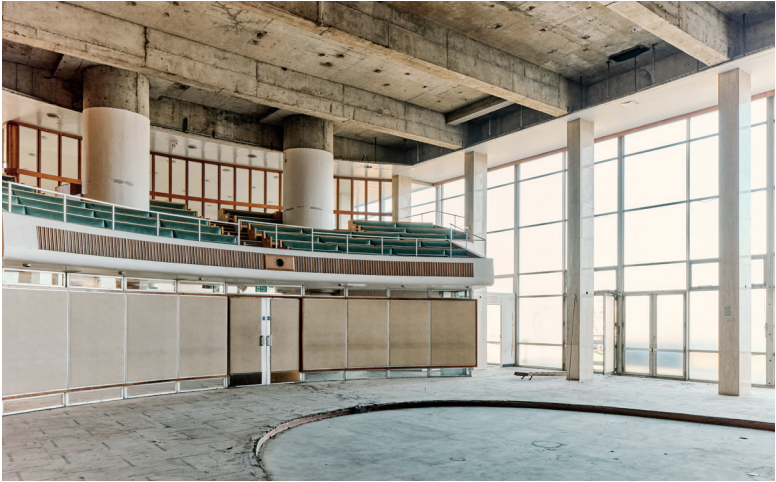
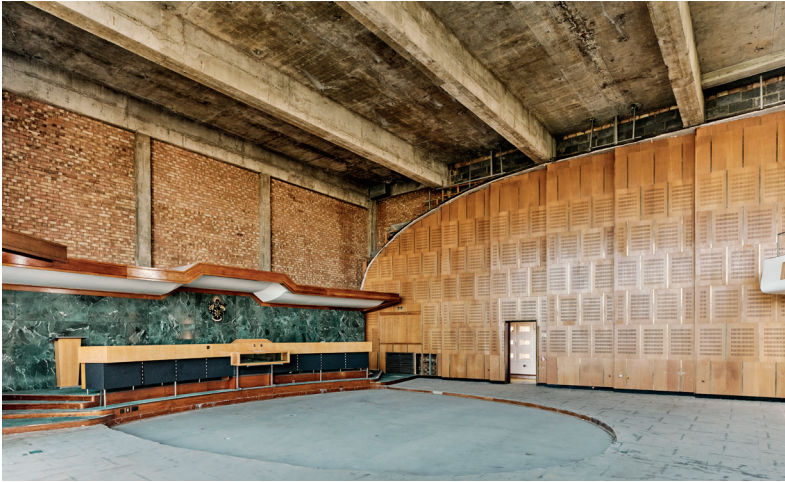
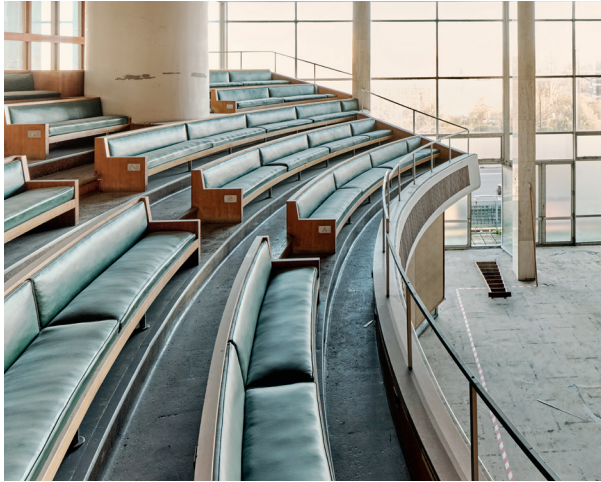
Bottom  
Post-Enabling Works

- Asbestos ceiling removed
- Carpet Removed & Blinds Removed (Curtain track retained)
