Existing Building

External Fabric Condition

## Haringey Civic Centre

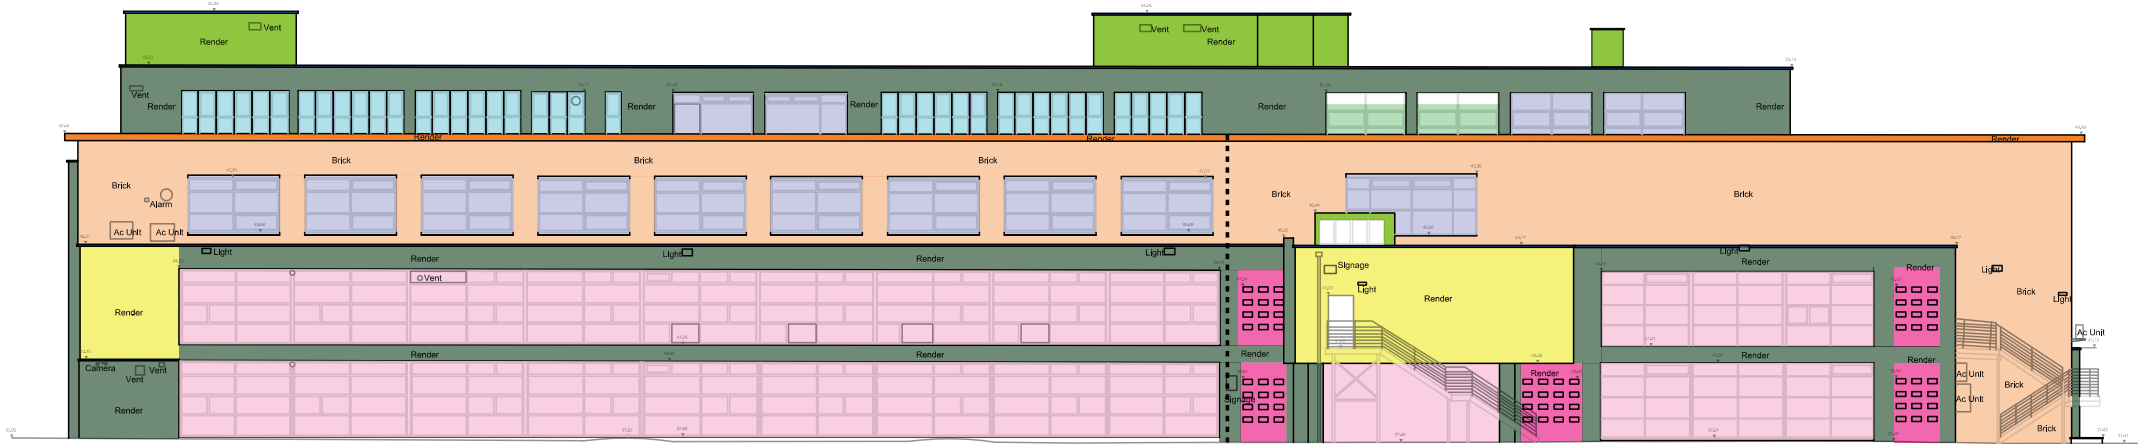
**Concrete Capping and Roof**

The reinforced concrete cornice at level 3 is in need of urgent concrete treatment including removal of stone cladding, removal of detached and loose portions of concrete, making good of the exposed reinforcement with anti corrosion treatment, refacing with thixotropic mortar products.
