| PROJECT | S-2310 | HARINGEY CIVIC CENTRE |

| ELEVATION | EAST |
| FLOOR | 3RD FLOOR |
| WIN NO | W3-01 |

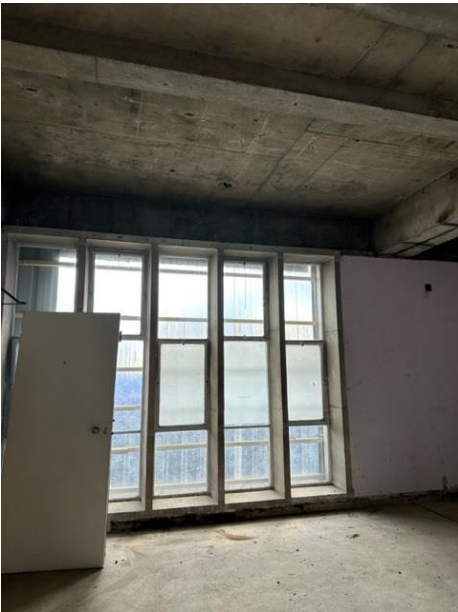
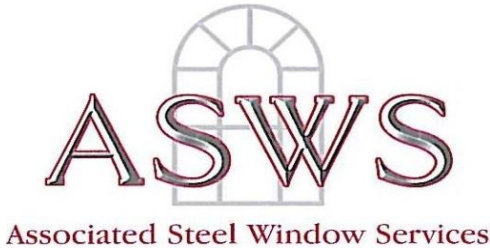
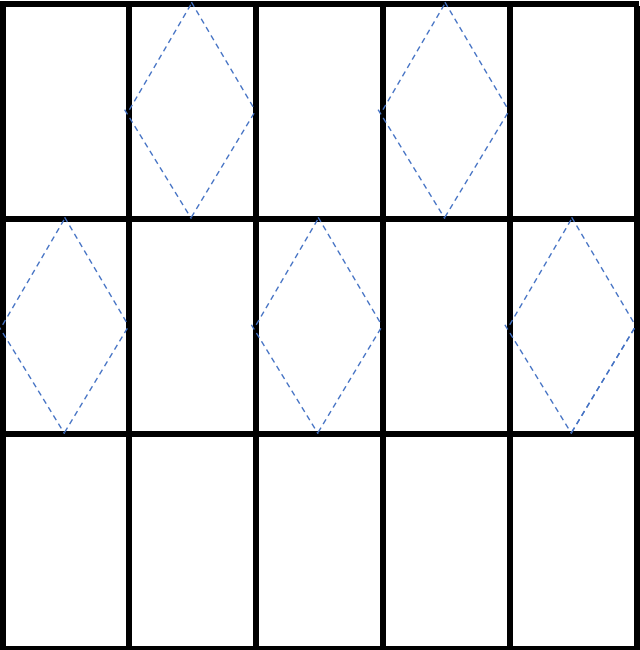
| MATERIAL | |
|---|---|
| FAIR | <input checked="" type="checkbox"/> |

| NOTES |
|---|
| Divided by concrete mullions |
| Galvanised |

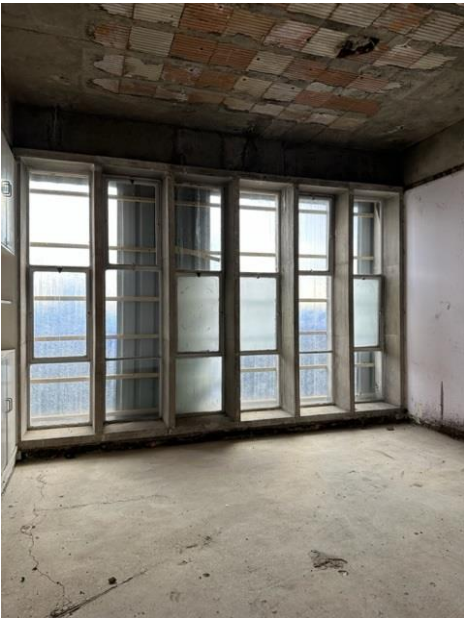
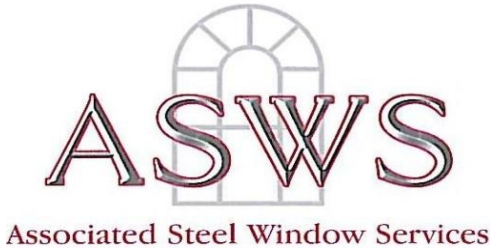
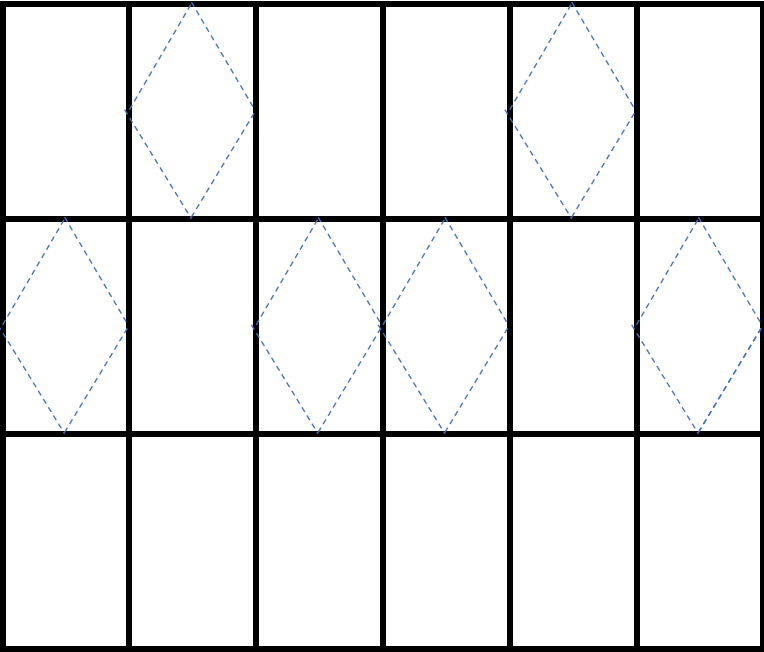
| WIN NO | W3-02 |

| FAIR | <input checked="" type="checkbox"/> |

| Divided by concrete mullions |
| Galvanised |

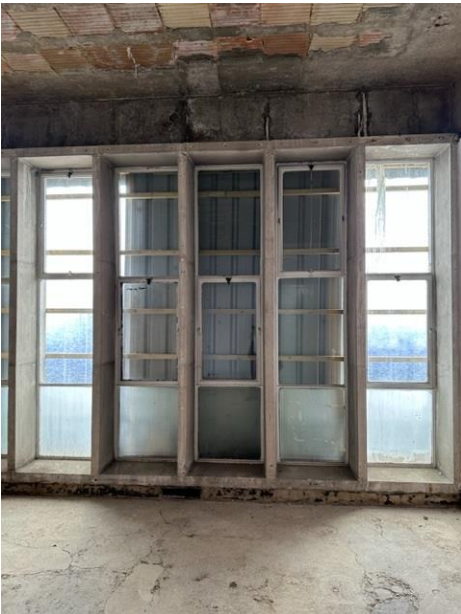
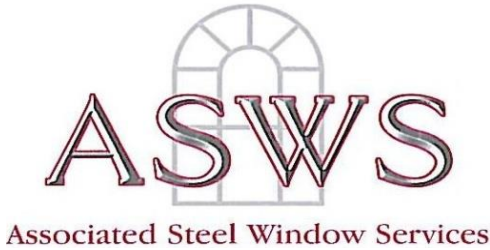
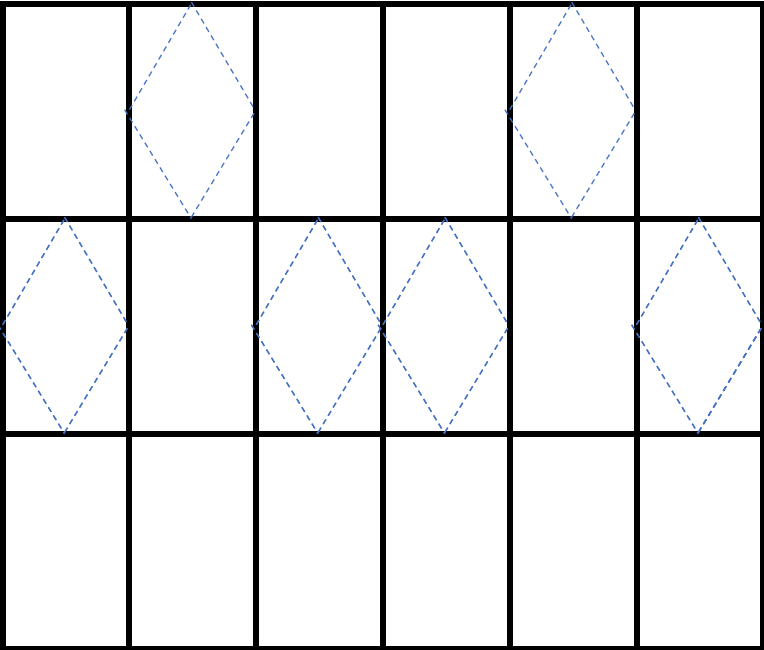
| WIN NO | W3-03 |

| FAIR | <input checked="" type="checkbox"/> |

| Divided by concrete mullions |
| Galvanised |

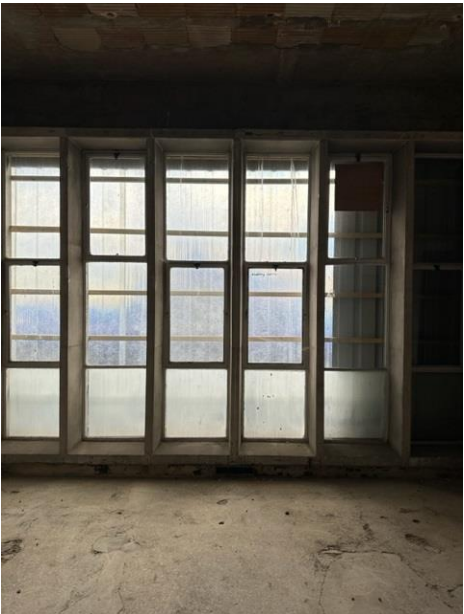
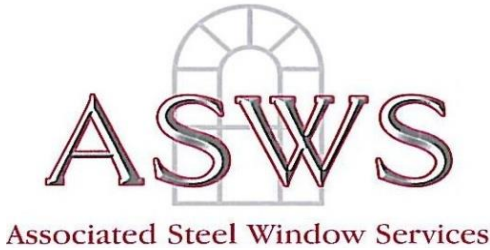
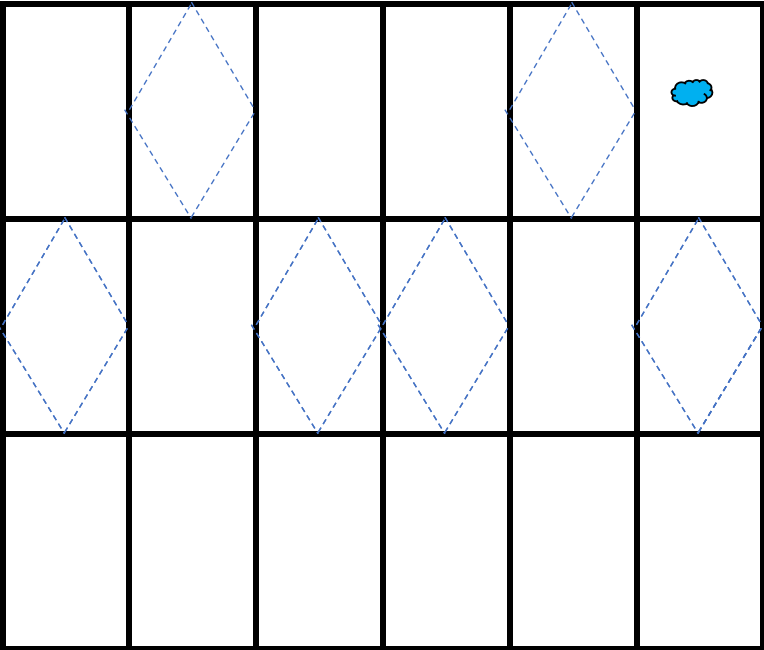
| WIN NO | W3-04 |

| MATERIAL | |
|---|---|
| FAIR | <input checked="" type="checkbox"/> |

| NOTES |
|---|
| Divided by concrete mullions |
| Galvanised |

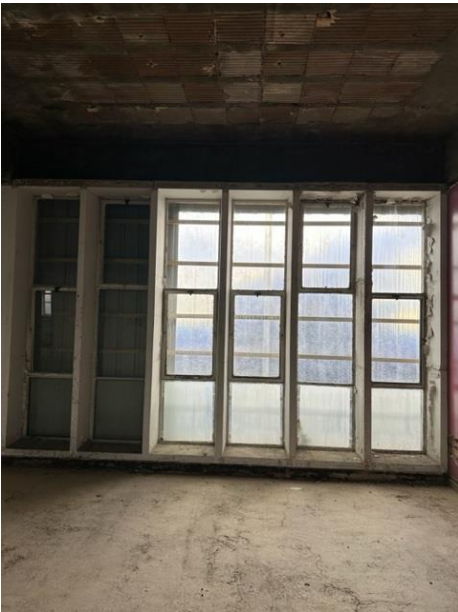
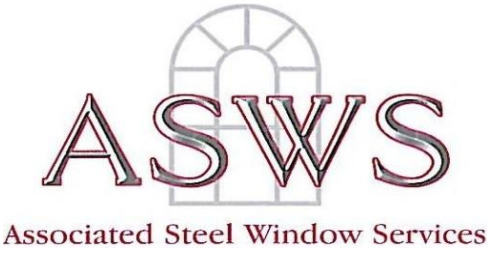
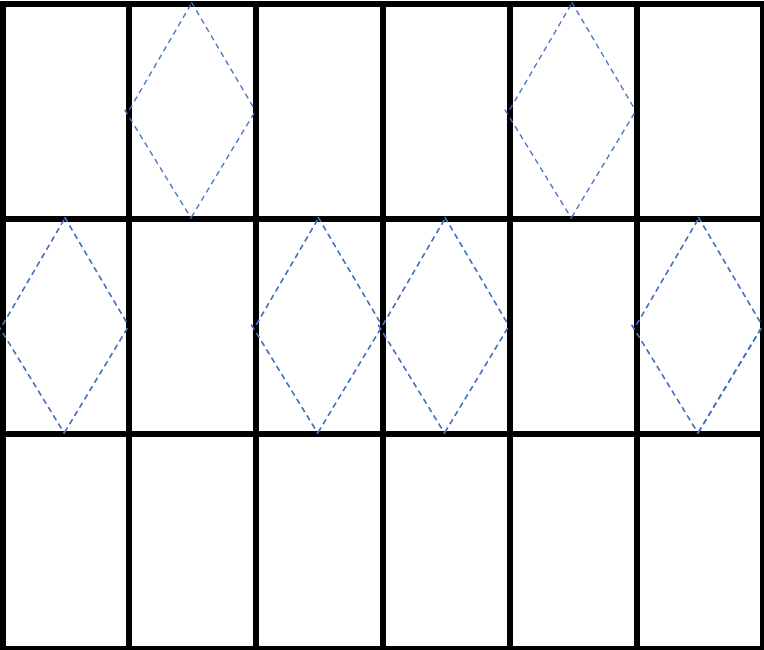
| WIN NO | W3-05 |

| MATERIAL | |
|---|---|
| FAIR | <input checked="" type="checkbox"/> |

| NOTES |
|---|
| Divided by concrete mullions |
| Galvanised |

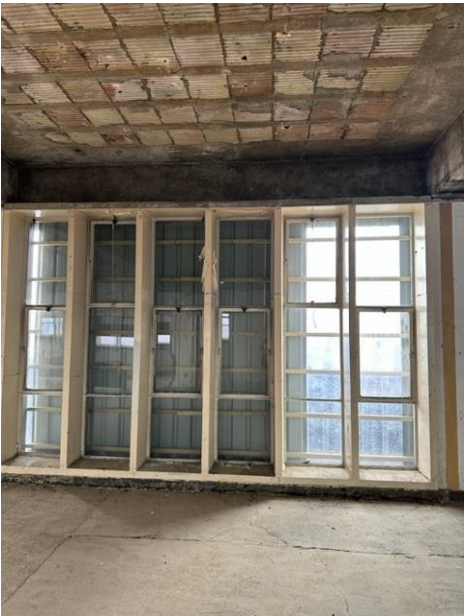
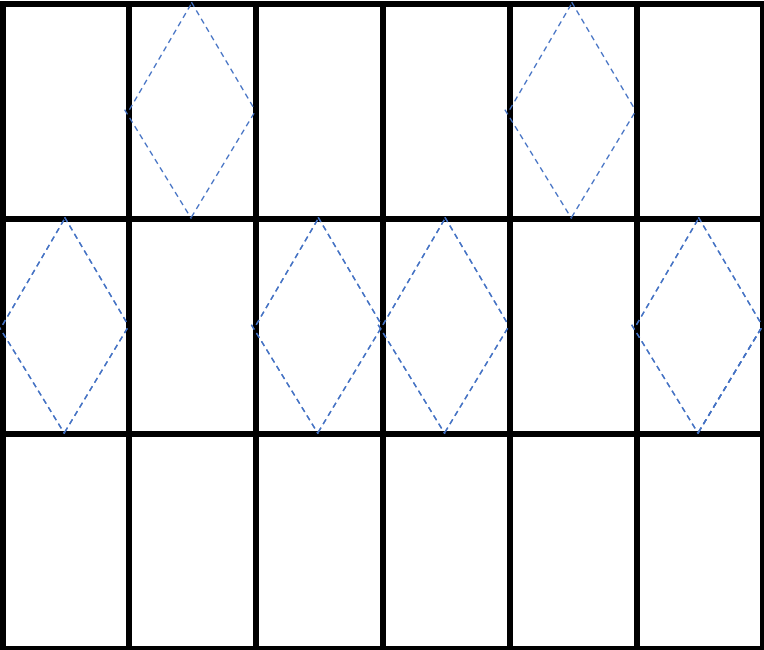
| WIN NO | W3-06 |

| MATERIAL | |
|---|---|
| FAIR | <input checked="" type="checkbox"/> |

| NOTES |
|---|
| Divided by concrete mullions |
| Galvanised |

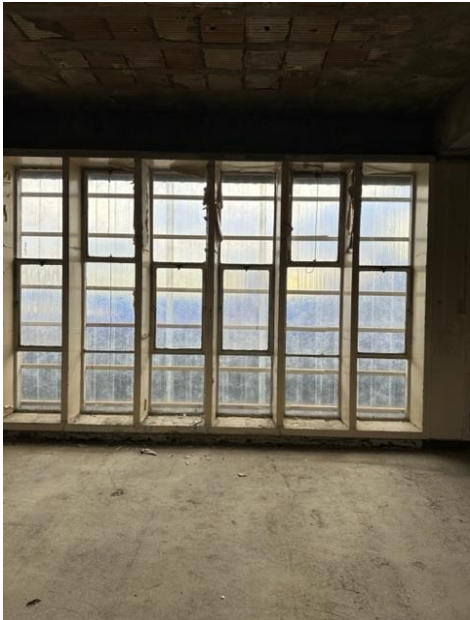
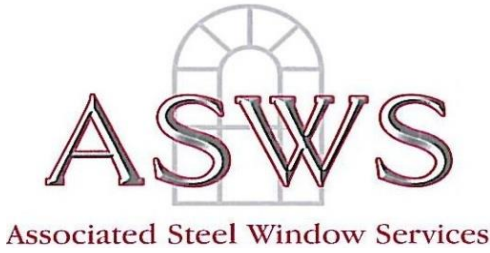
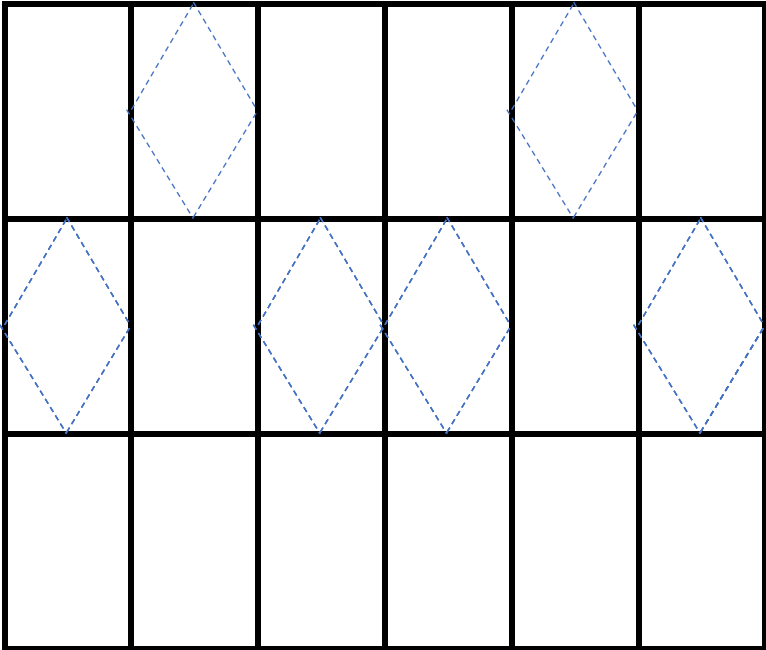
| WIN NO | W3-07 |

| MATERIAL | |
|---|---|
| FAIR | <input checked="" type="checkbox"/> |

| NOTES |
|---|
| Divided by concrete mullions |
| Galvanised |

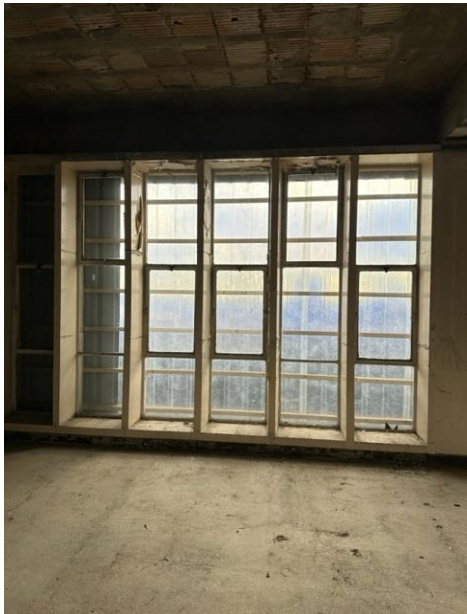
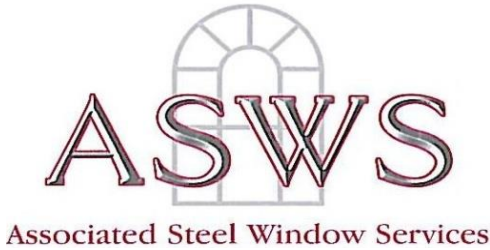
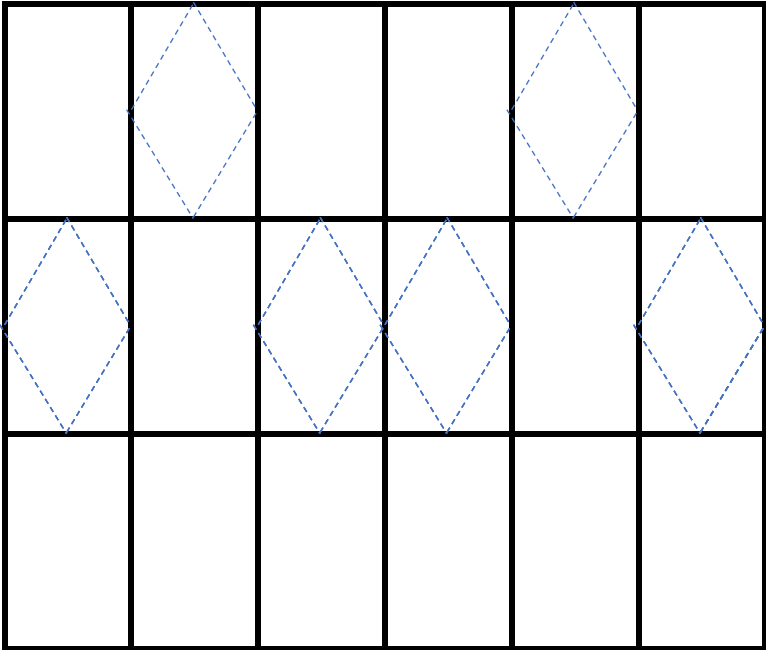
| WIN NO | W3-08 |

| FAIR | <input checked="" type="checkbox"/> |

| Divided by concrete mullions |
| Galvanised |

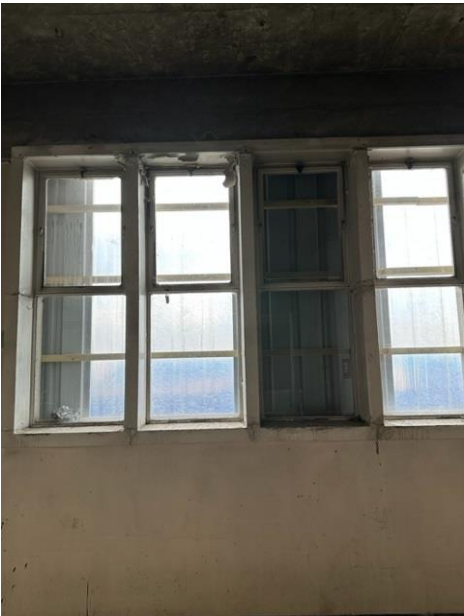
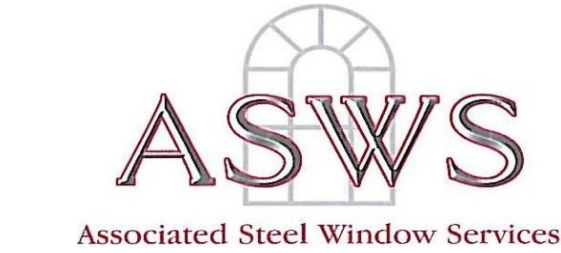
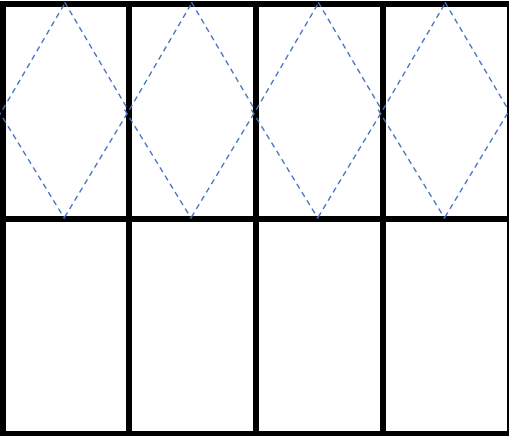
| WIN NO | W3-09 |

| MATERIAL | |
|---|---|
| FAIR | <input checked="" type="checkbox"/> |

| NOTES |
|---|
| Divided by concrete mullions |
| Galvanised |

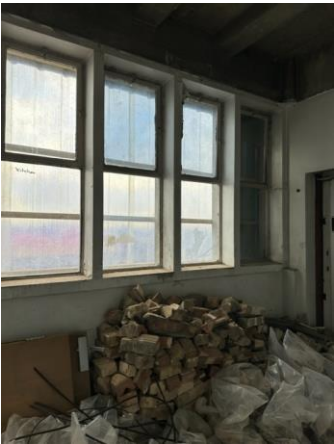
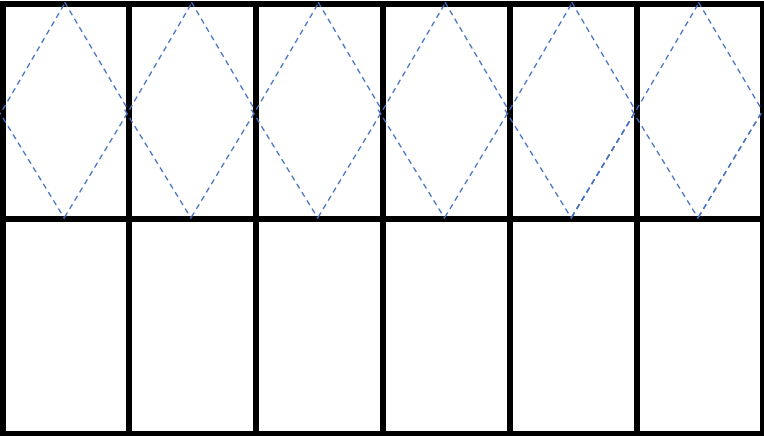
| WIN NO | W3-10 |

| MATERIAL | |
|---|---|
| FAIR | <input checked="" type="checkbox"/> |

| NOTES |
|---|
| Divided by concrete mullions |
| Galvanised |

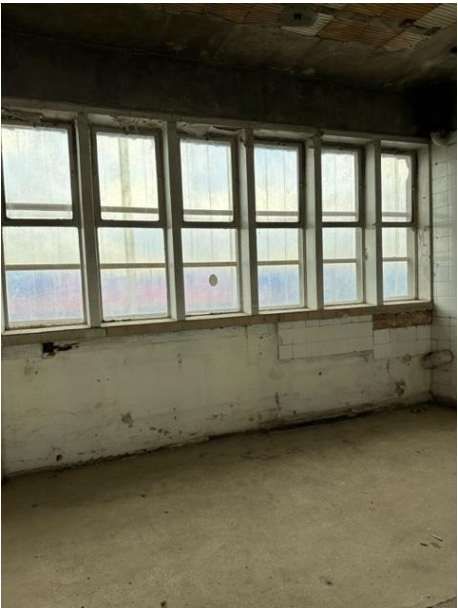
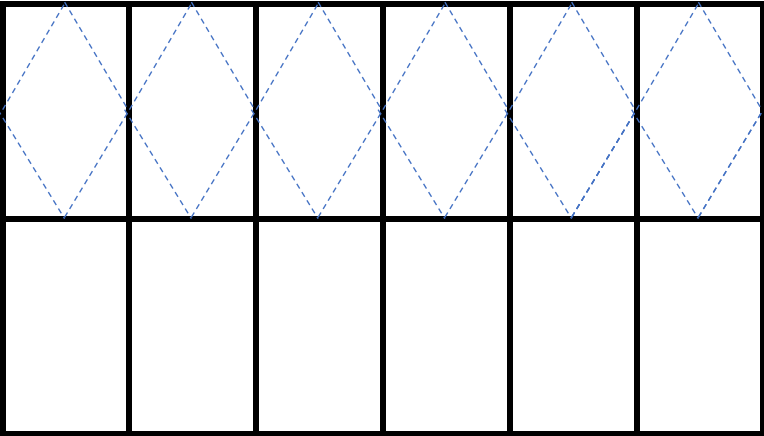
| WIN NO | W3-11 |

| MATERIAL | |
|---|---|
| FAIR | <input checked="" type="checkbox"/> |

| NOTES |
|---|
| Divided by concrete mullions |
| Galvanised |

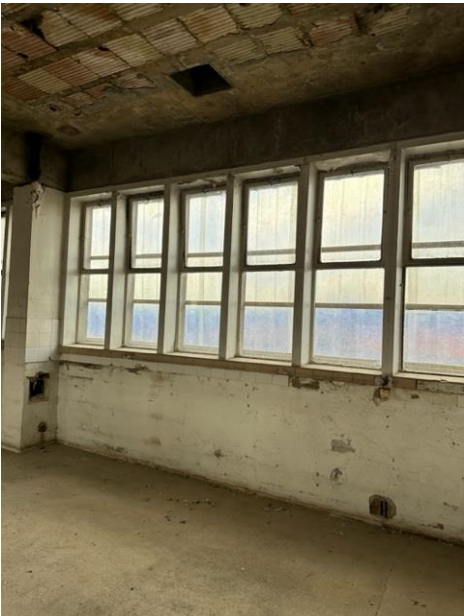
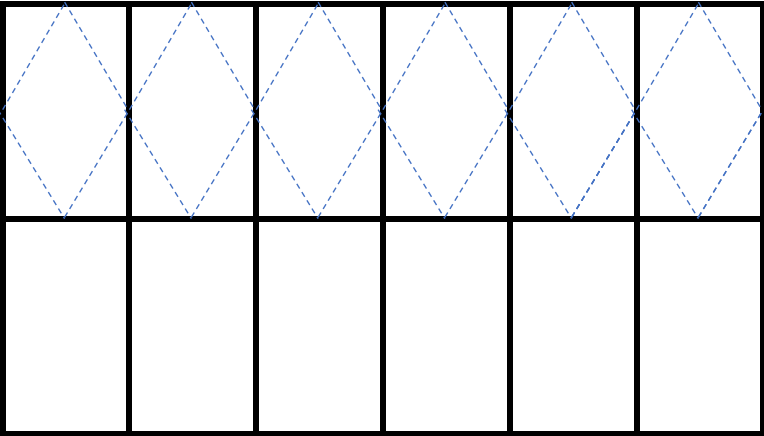
| WIN NO | W3-12 |

| MATERIAL | |
|---|---|
| FAIR | <input checked="" type="checkbox"/> |

| NOTES |
|---|
| Divided by concrete mullions |
| Galvanised |
