# HARINGEY CIVIC CENTRE

# WINDOW CONDITION SURVEY

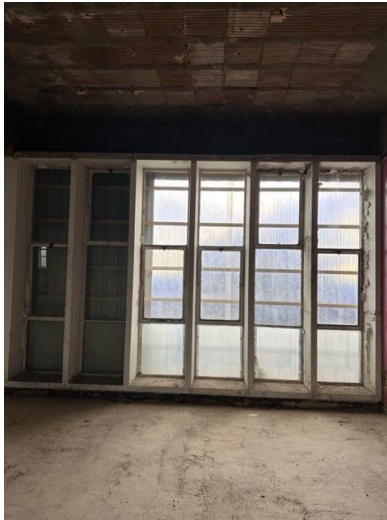
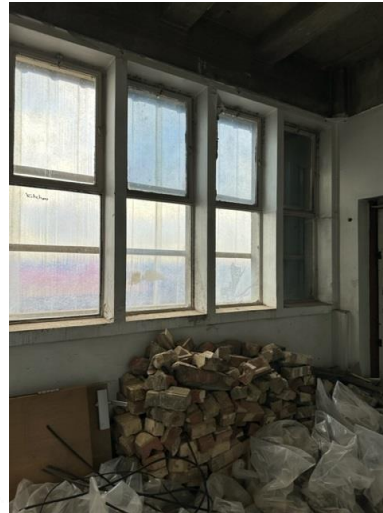
### **Type A – Steel Windows – 3<sup>rd</sup> Floor**

The windows are generally in fair condition but would require a meaningful refurbishment to extend their lifespan.

As the windows are steel, the scope for refurbishment is greater than aluminium. All windows seen could be refurbished, they may require removal in order to affect this. This would involve deglazing and removal all paint in a controlled environment.

We have not been able to confirm the presence of safety glass which would be required for the lower panes.

Some of the panes are filmed.

The ironmongery is largely intact but is showing signs of age.

The existing coatings are in poor condition. It is likely that the galvanised surfaces were not treated with a neutraliser prior to hand painting which has resulted in poor adhesion.

Although we were unable to access the external elevation, it is likely that the perimeter seals would require raking out and reapplying with a suitable silicone sealant

If a full and meaningful restoration is to be considered our suggestion would be that the windows are carefully removed from the openings, individually tagged and a heritage asset register created, and an extensive and sympathetic restoration is undertaken off site. This will not only extend the lifespan of the windows but also improve their operation.

This refurbishment could be undertaken in situ however there is clear evidence of structural issues with the concrete fins so removal may be a better option. If the presence of lead-based pigments is confirmed this will impact upon the method of decoration which can be undertaken in-situ in a safe manner so removal may be preferred.

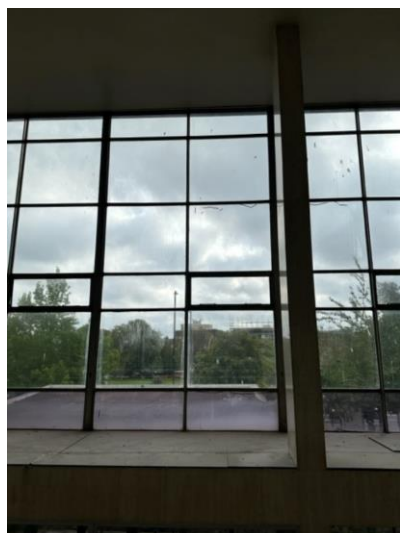
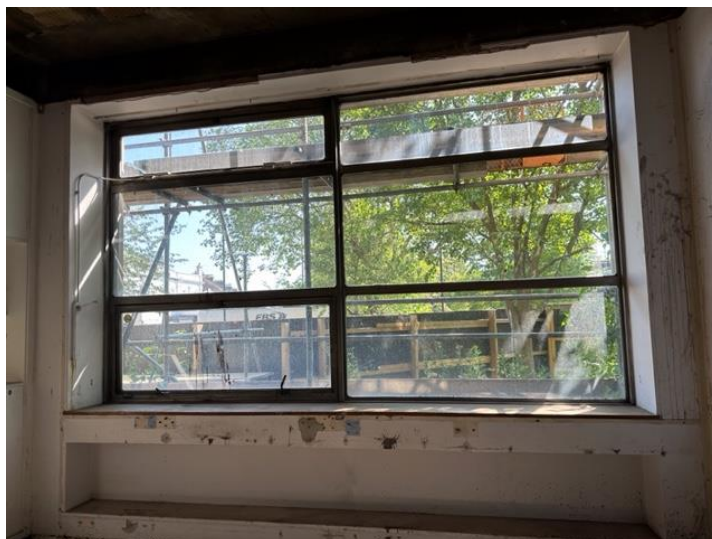
**Type 2: Aluminum Fixed and Opening Casement Screen Fenestration – 3<sup>rd</sup>, 2<sup>nd</sup>, 1<sup>st</sup> and Ground Floors**

Universally the windows are in very poor condition.

There is evidence of;

- splitting of the transoms and mullions
- evidence of water penetration at the mullions
- failure of the opening lights

Many panes have been reglazed over the years. Having spoken to the maintenance man on site many of these panes have failed due to unexplained breakage; which could indicate thermal stress.

The bedding compound has failed and is degraded and we would suggest this is tested for asbestos if it hasn't already been done.

Much of the original ironmongery is in poor condition where it exists.

There is evidence that the hinge mechanism has failed.

The surfaces of all areas are in poor condition. Where spraying has previously occurred, this is flaking away and has failed.

Although refurbishment of aluminium windows of this type can be undertaken it is our opinion that these windows are beyond meaningful and effective refurbishment for the following reasons;

It is for these reasons that we would recommend a sympathetic and faithful replacement which would provide a structurally sound and thermally efficient system. Many systems currently available could mimic the existing aesthetic whilst vastly improving performance and functionality.
