# HARINGEY CIVIC CENTRE

# WINDOW CONDITION SURVEY

## Appendix

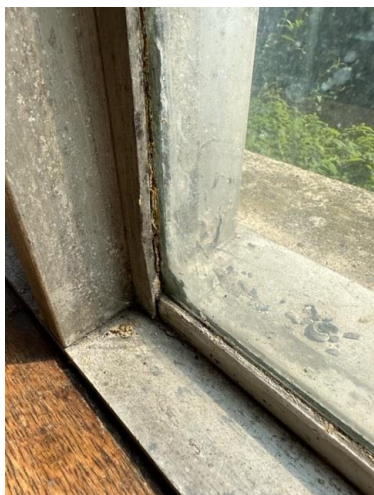
*fig 1 Bedding compound in poor condition*

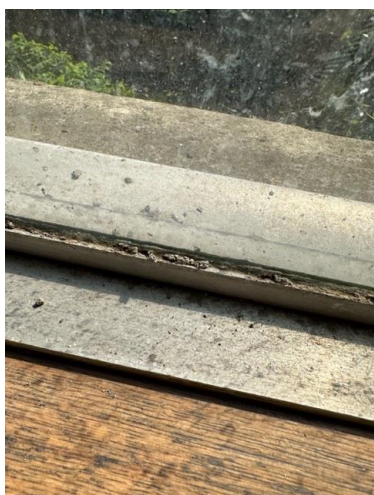
*fig 2 Bedding compound in poor condition*

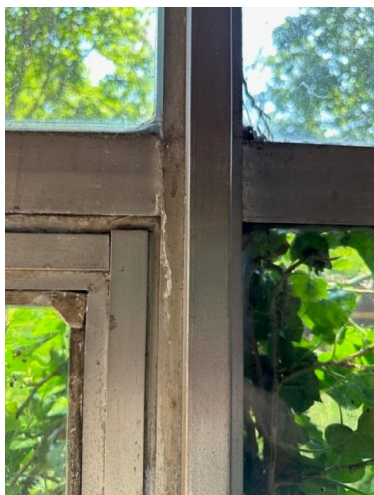
*fig 3 Failure at mullion and transom junction*

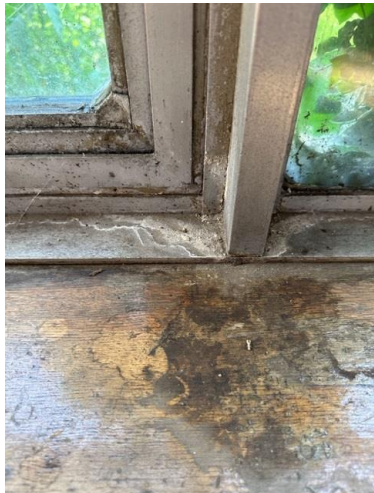
*fig 4 Evidence of water penetration*

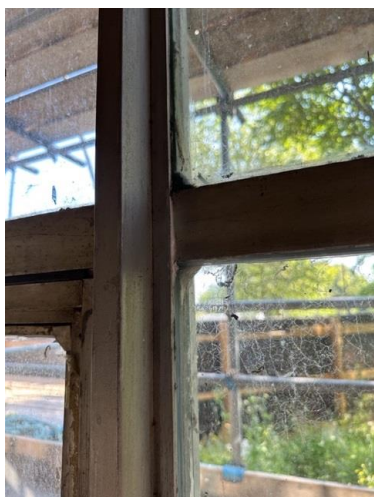
*fig 5 Separating at transom glazing bar*

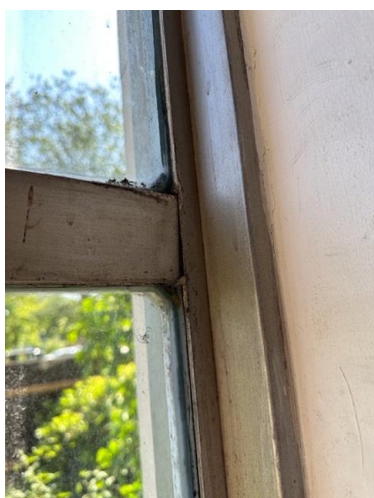
*fig 6 Separating at transom glazing bar*

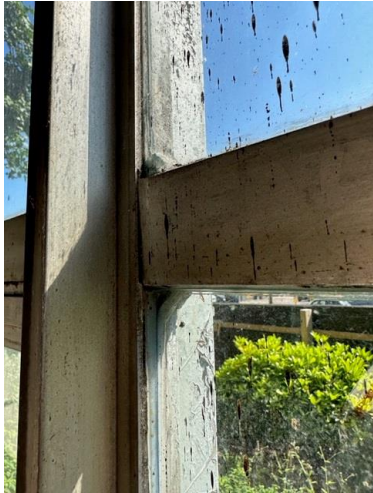
*fig 7 Separating at transom glazing bar*

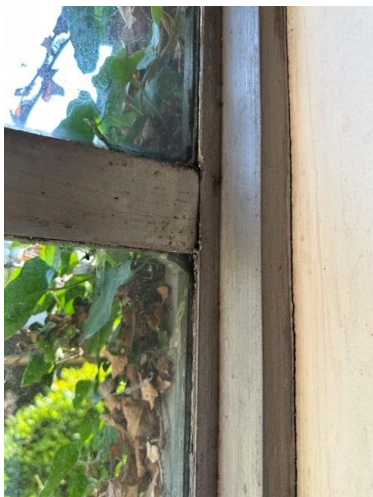
*fig 8 Separating at transom glazing bar*

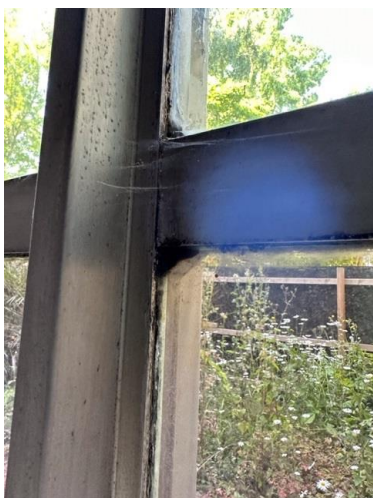
*fig 9 Separating at transom glazing bar*

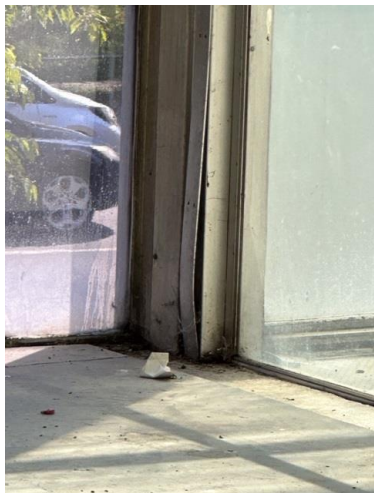
*fig 10 Splitting of corner post mullion*

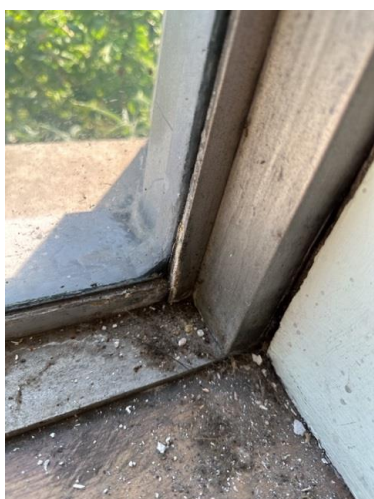
*fig 11 Distortion of frame*

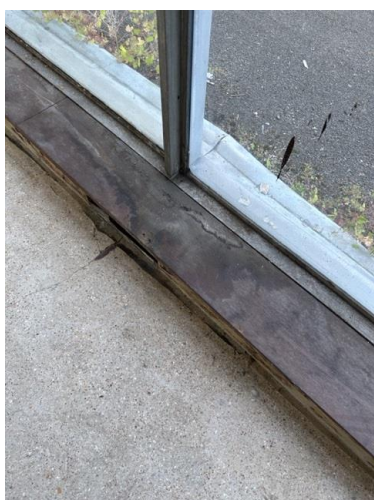
*fig 12 Evidence of water penetration*

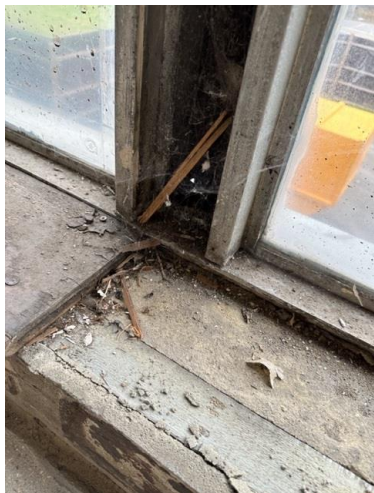
*fig 13 Daylight seen through mullion*

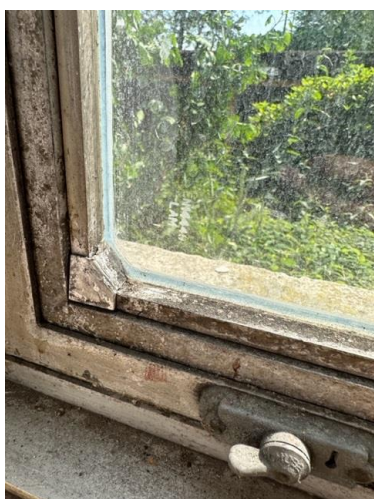
*fig 14 Condition of internal surface finishes and pitting*

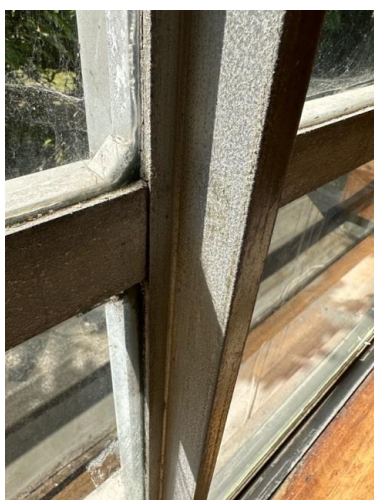
*fig 15 General condition of internal surfaces*

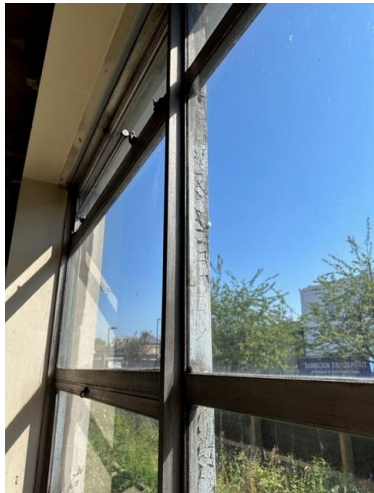
*fig 16 Poor condition of external surfaces*

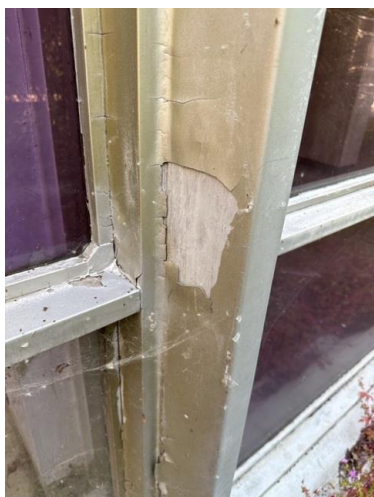
*fig 17 Failure of previous spray application externally*

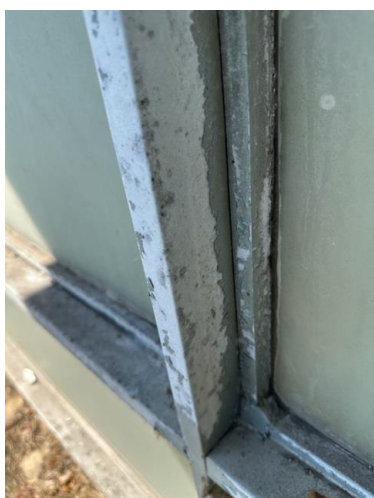
*fig 18 Generally poor condition of external surfaces*
