| PROJECT | S-2310 | HARINGEY CIVIC CENTRE |

| ELEVATION | EAST |
| FLOOR | GROUND FLOOR |

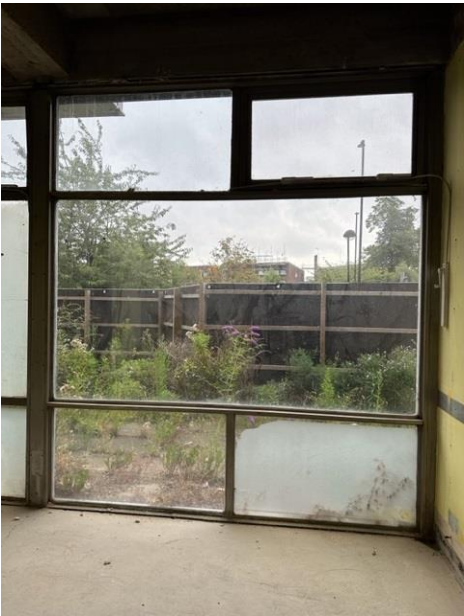
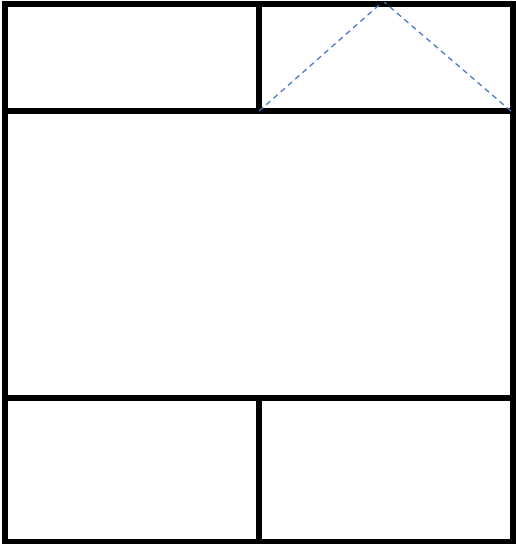
| WIN NO | WG-01 |

| All surfaces showing signs of deterioration |
| Sections separating |

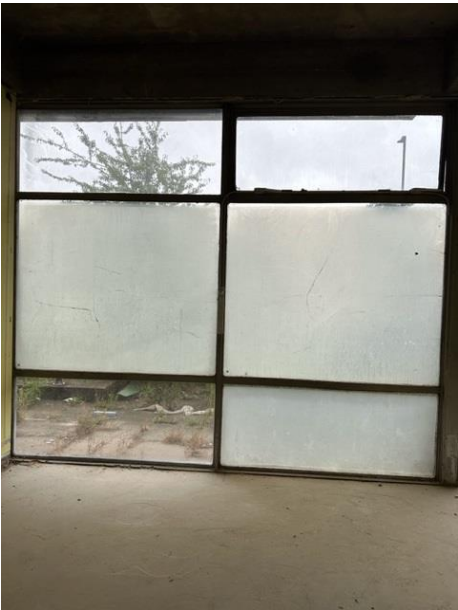
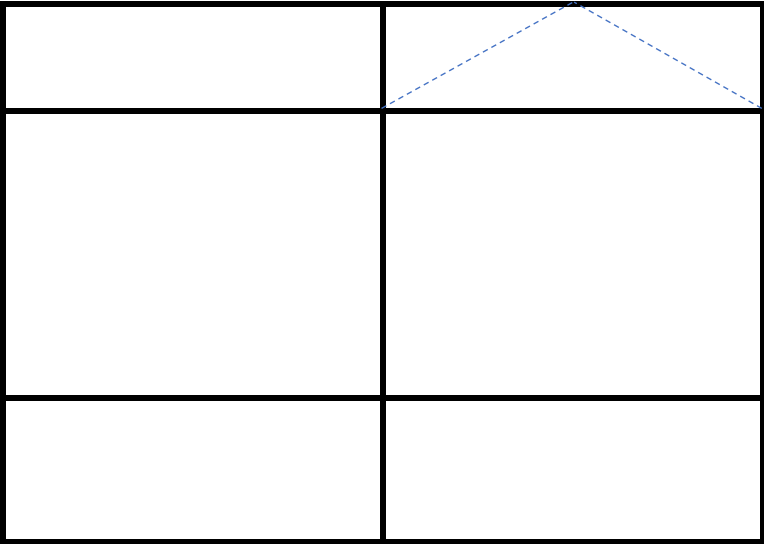
| WIN NO | WG-02 |

| All surfaces showing signs of deterioration |
| Sections separating |

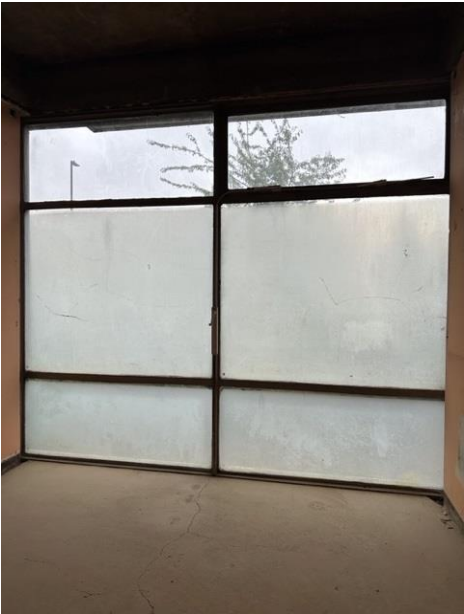
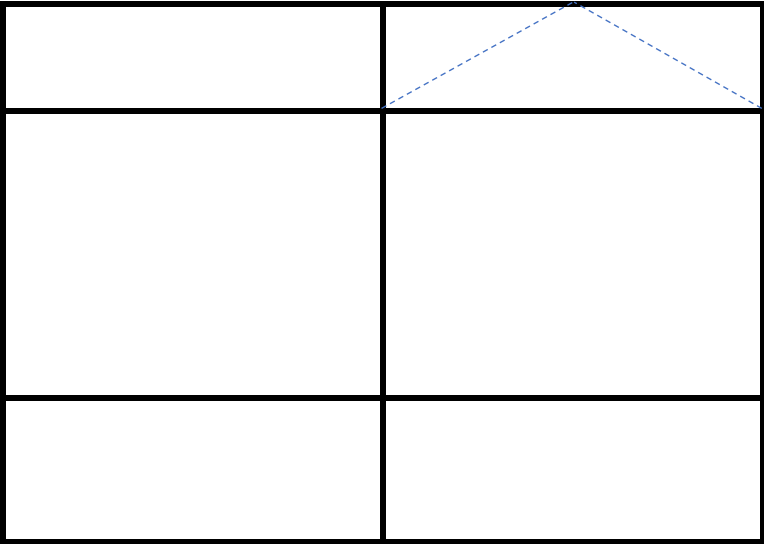
| WIN NO | WG-03 |

| All surfaces showing signs of deterioration |
| Sections separating |

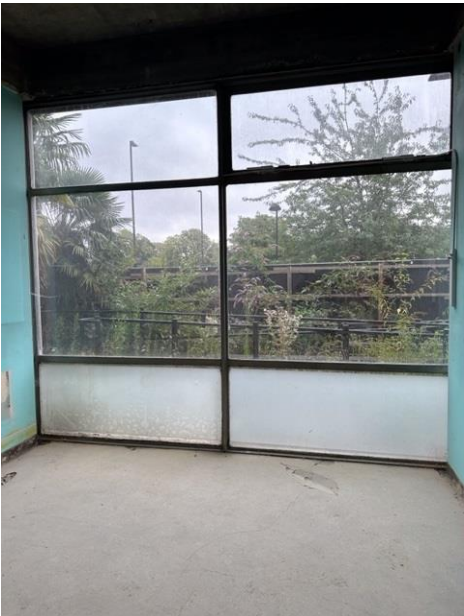
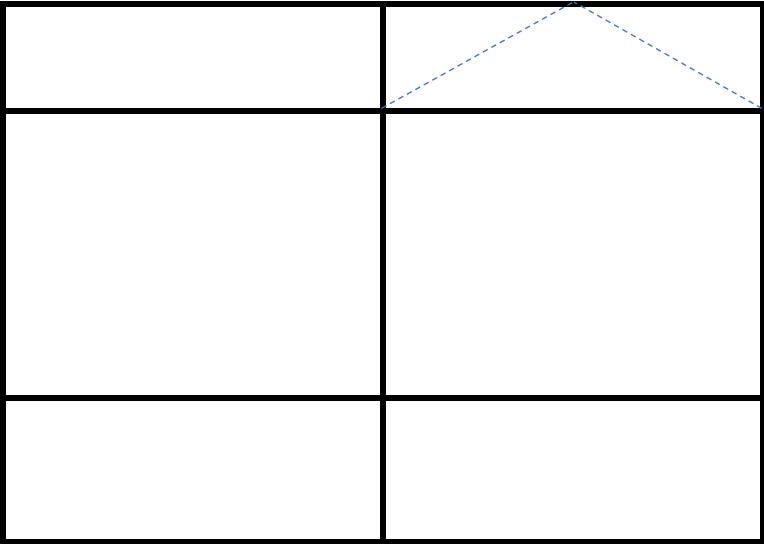
| WIN NO | WG-04 |

| All surfaces showing signs of deterioration |
| Sections separating |

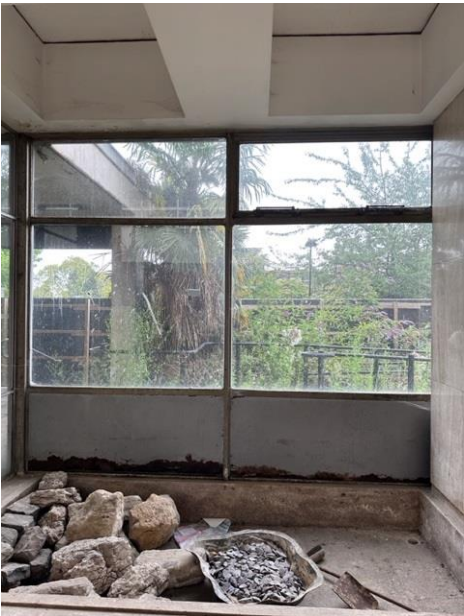
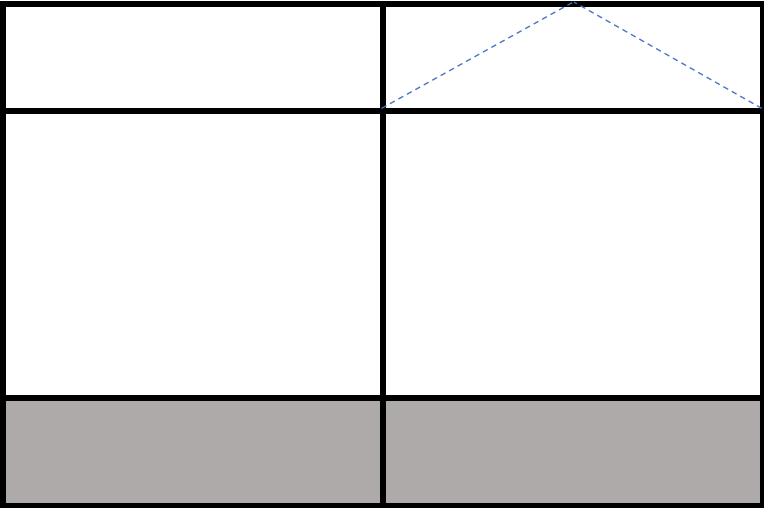
| WIN NO | WG-05 |

| All surfaces showing signs of deterioration |
| Sections separating |
| Steel plate panels at bottom badly corroded |

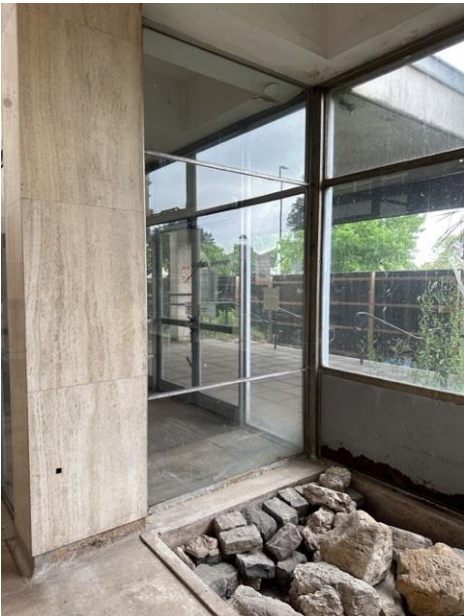
| WIN NO | WG-06 |

| All surfaces showing signs of deterioration |
| Sections separating |

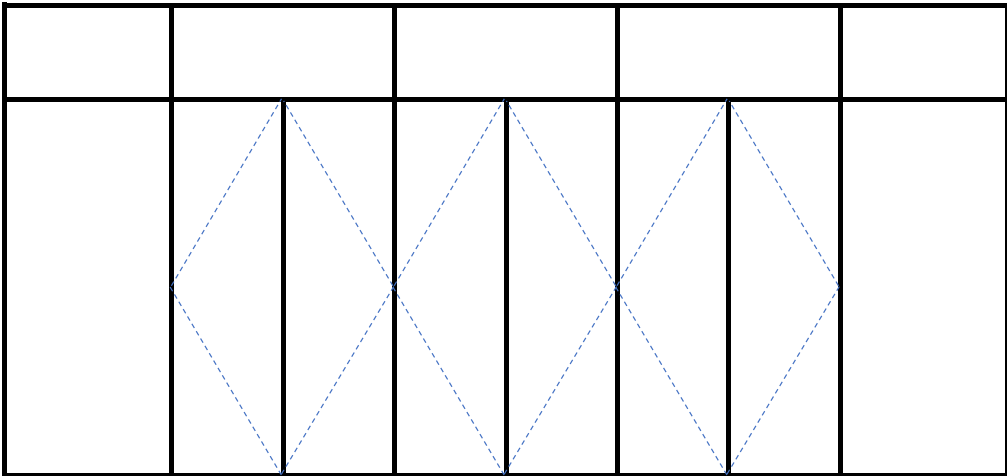
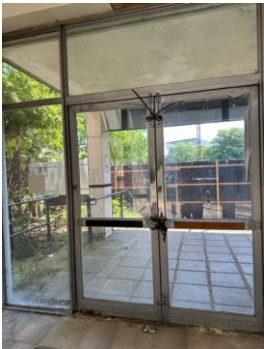
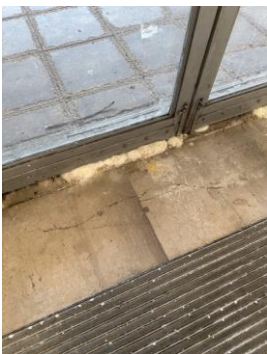
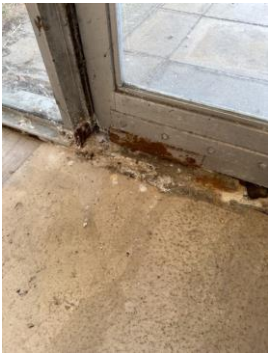
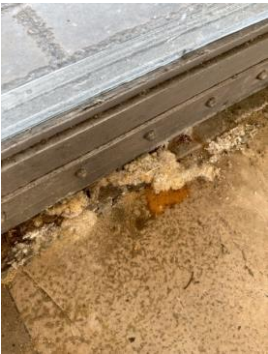
| WIN NO | DG-07 External |

| NOTES |
|---|
| All surfaces showing signs of deterioration |
| Sections separating |
| Doors in poor condition, closer and plates corroded |

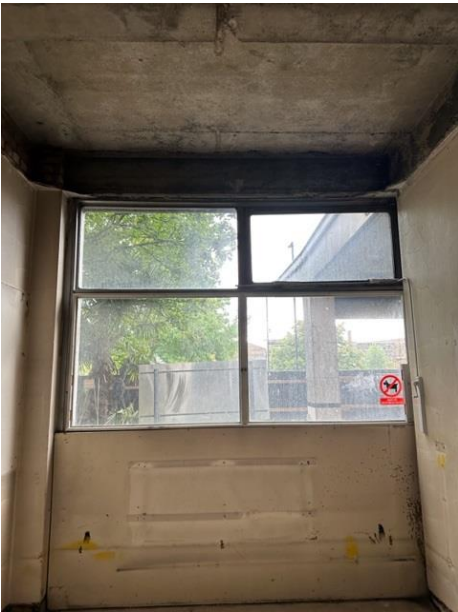
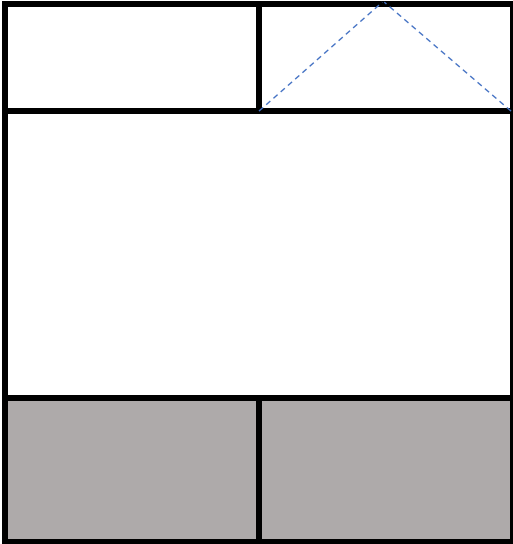
| WIN NO | WG-08 |

| All surfaces showing signs of deterioration |

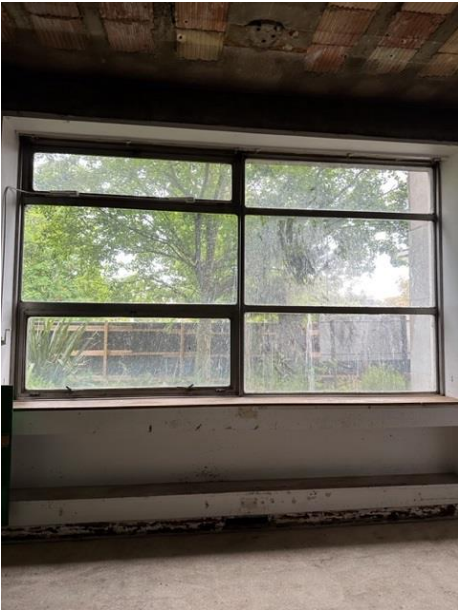
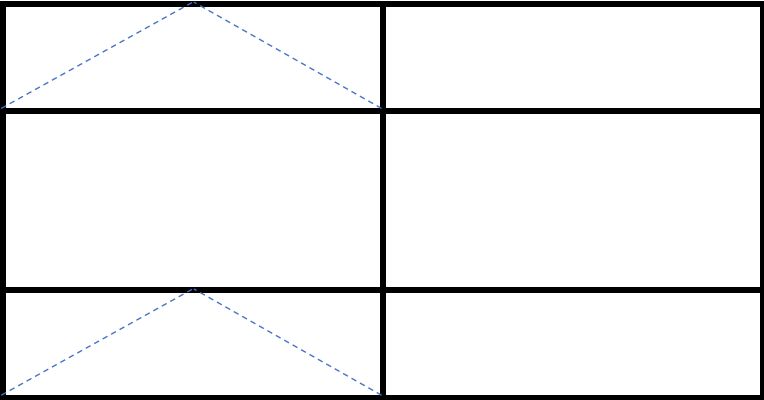
| All surfaces showing signs of deterioration |

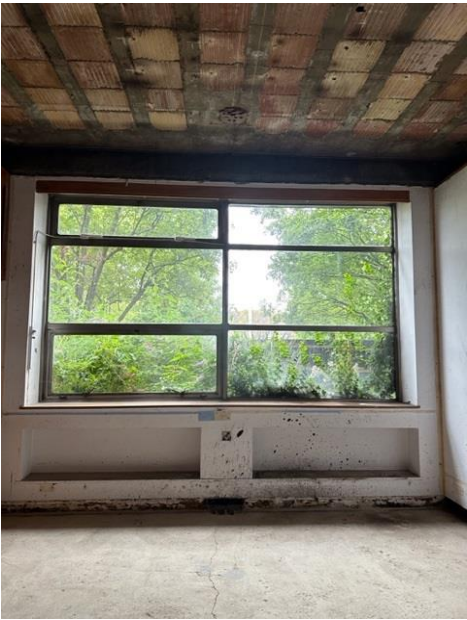
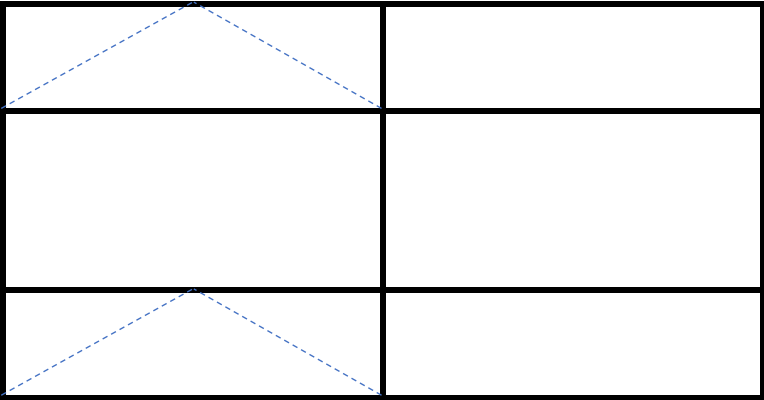
| All surfaces showing signs of deterioration |

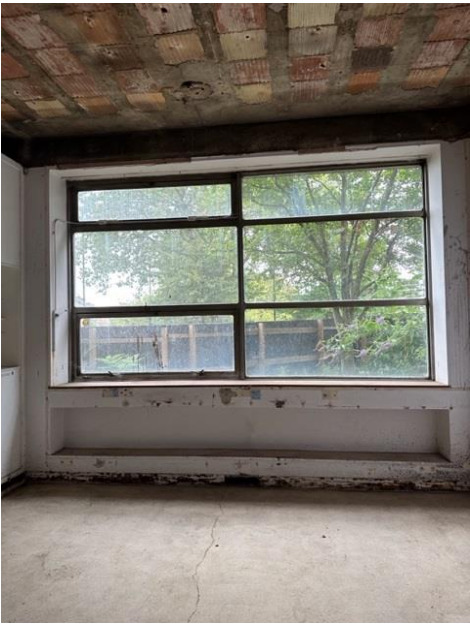
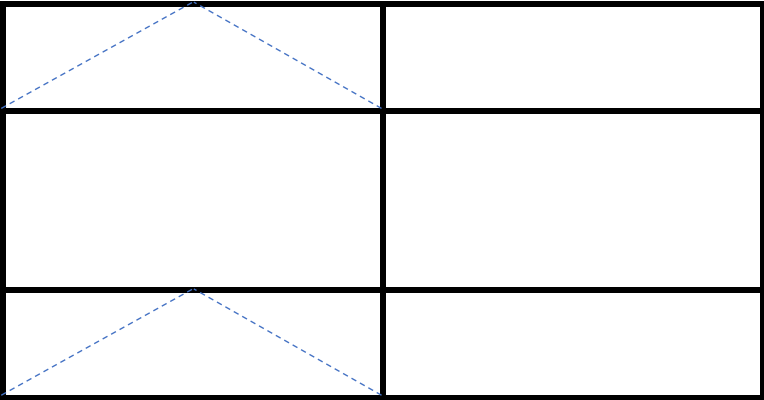
| All surfaces showing signs of deterioration |

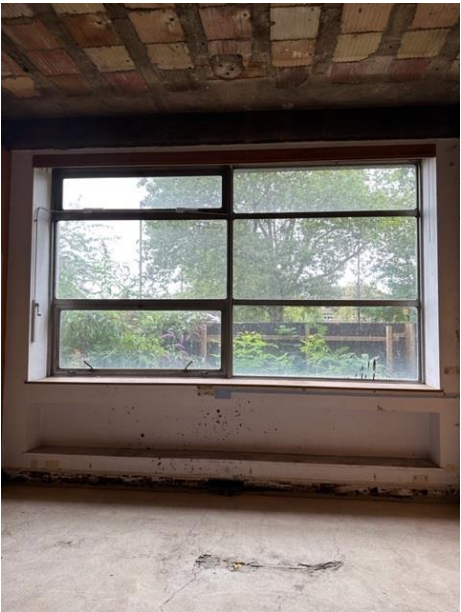
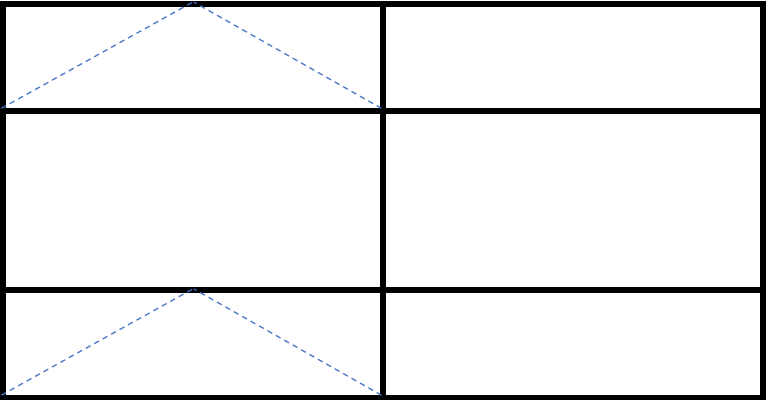
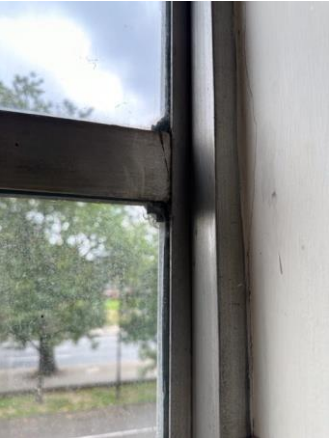
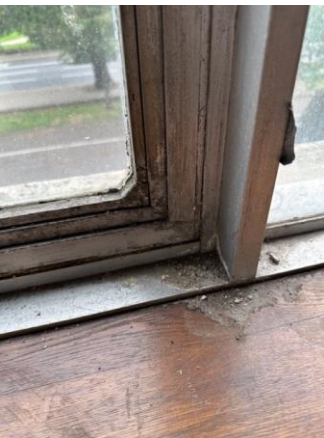
| All surfaces showing signs of deterioration |

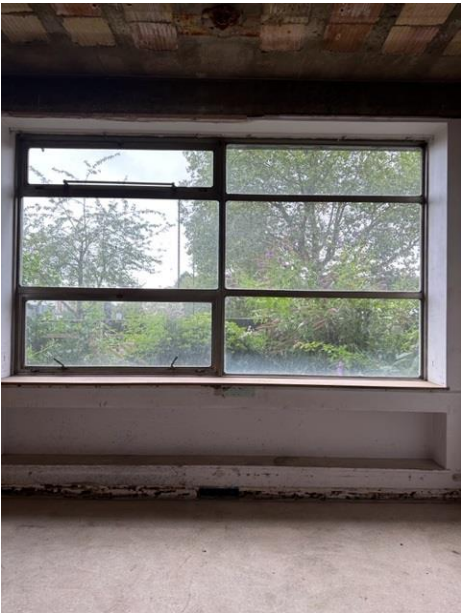
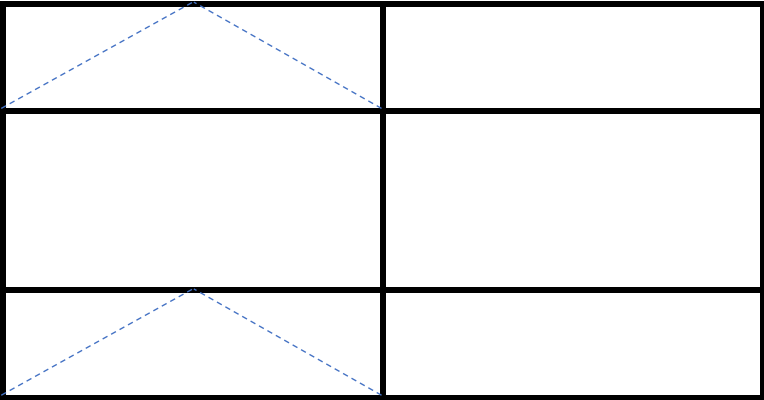
| All surfaces showing signs of deterioration |

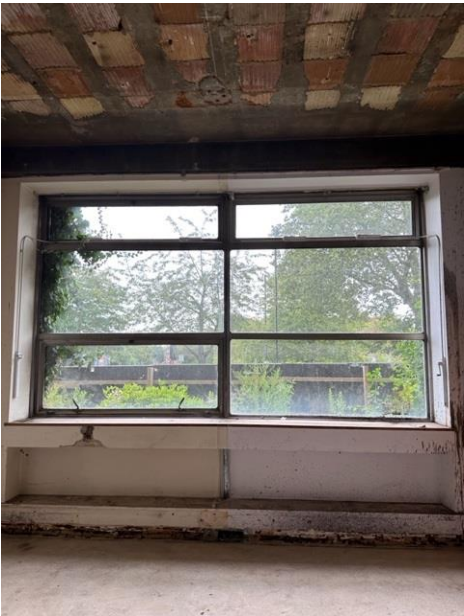
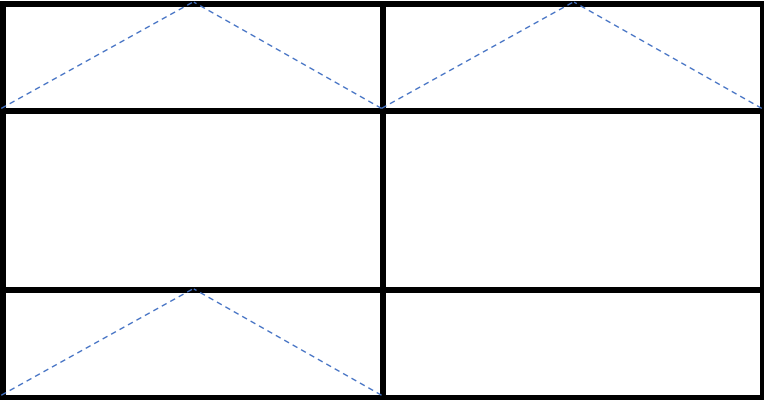
| All surfaces showing signs of deterioration |

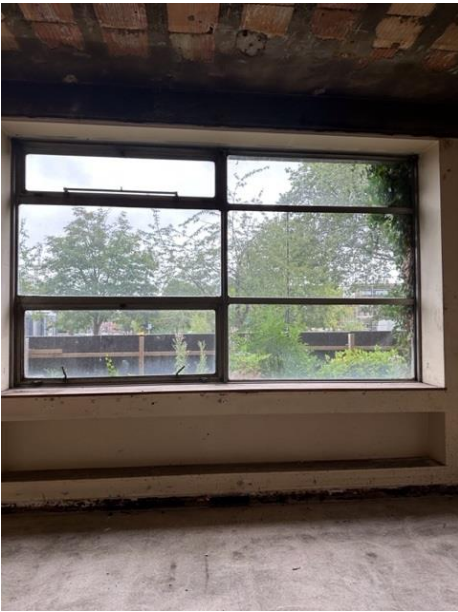
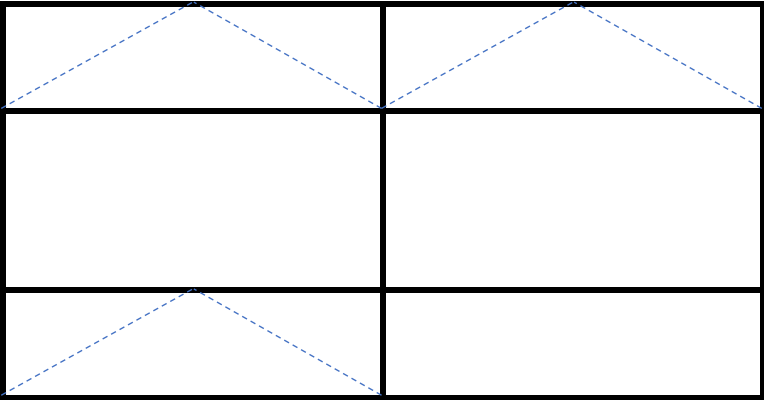
| All surfaces showing signs of deterioration |

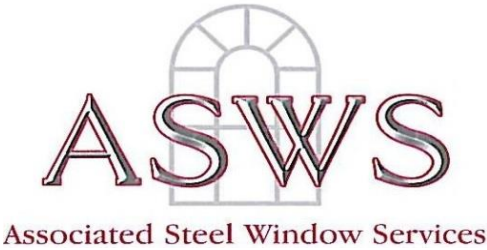
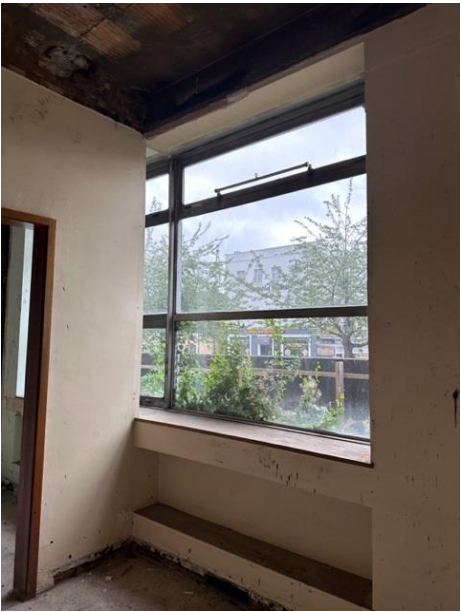
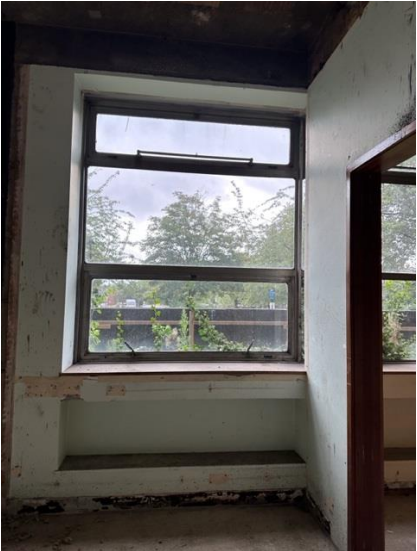
| NOTES |
|---|
| All surfaces showing signs of deterioration |

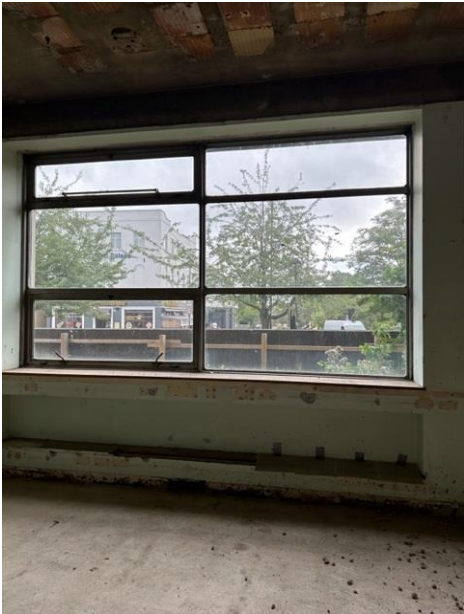
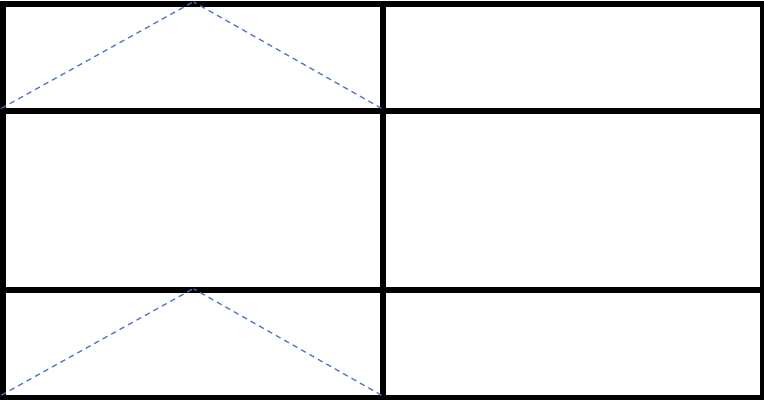
| All surfaces showing signs of deterioration |

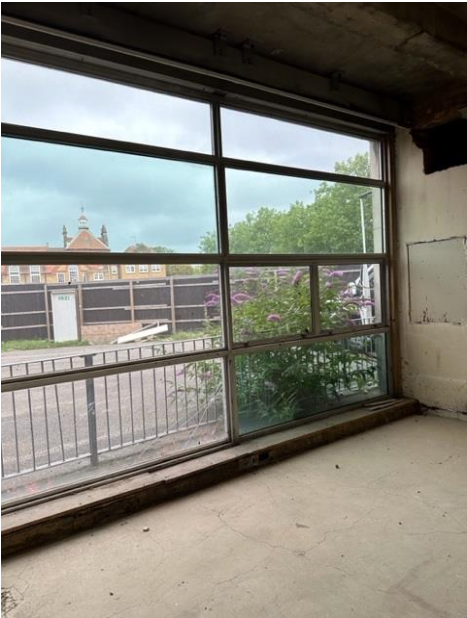
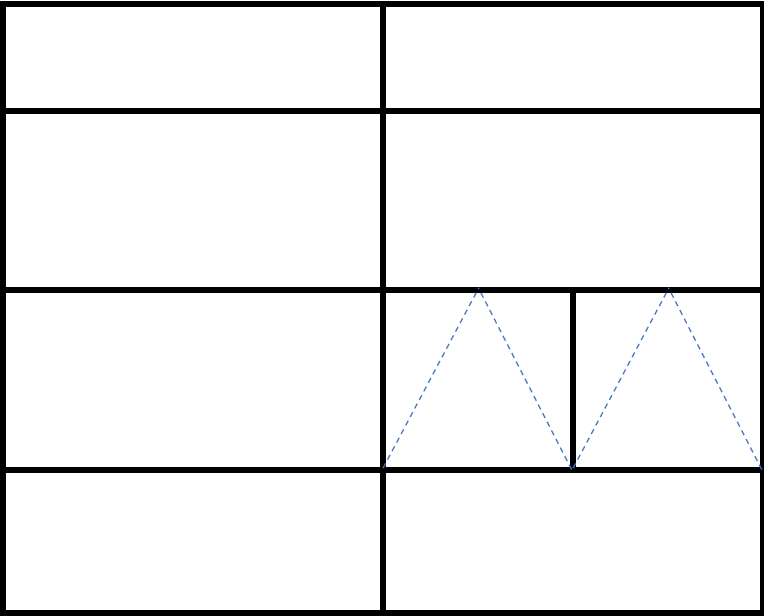
| All surfaces showing signs of deterioration |

| New replacement window |

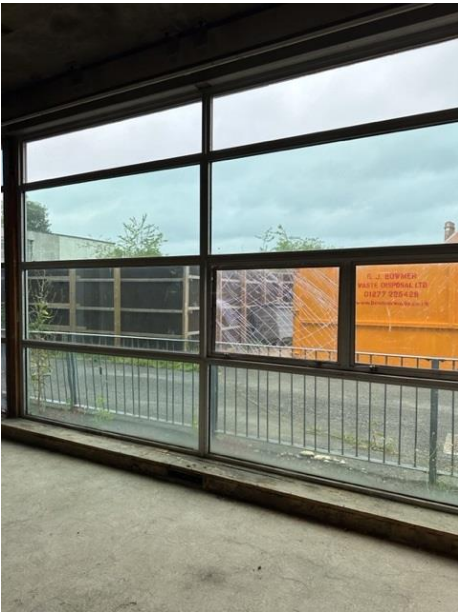
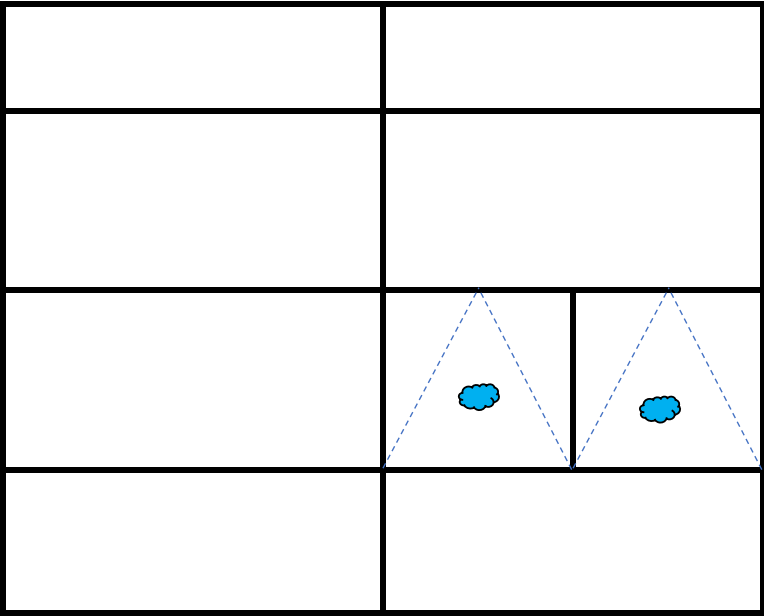
| All surfaces showing signs of deterioration |

| New replacement window |

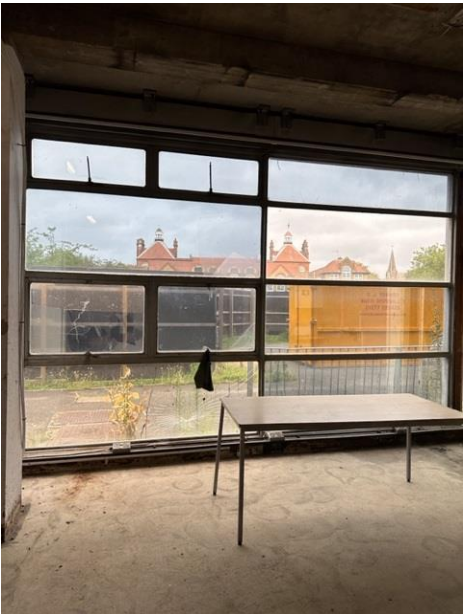
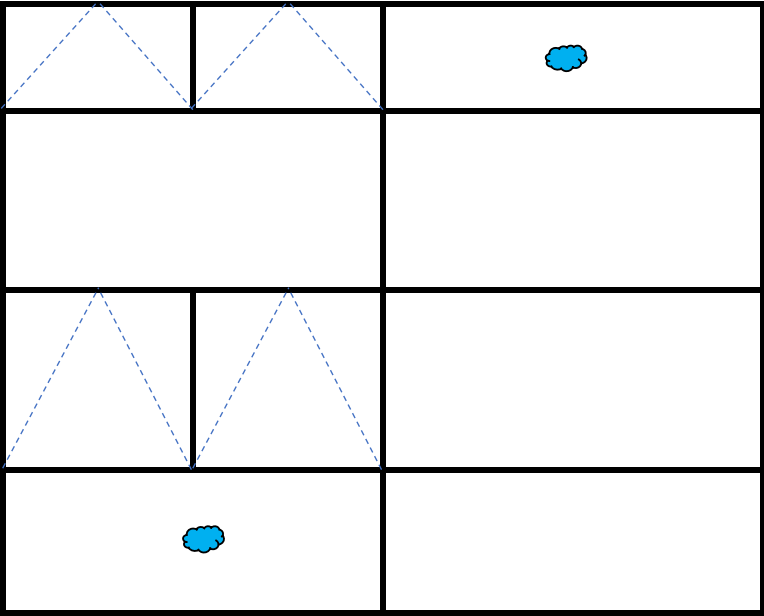
| All surfaces showing signs of deterioration |

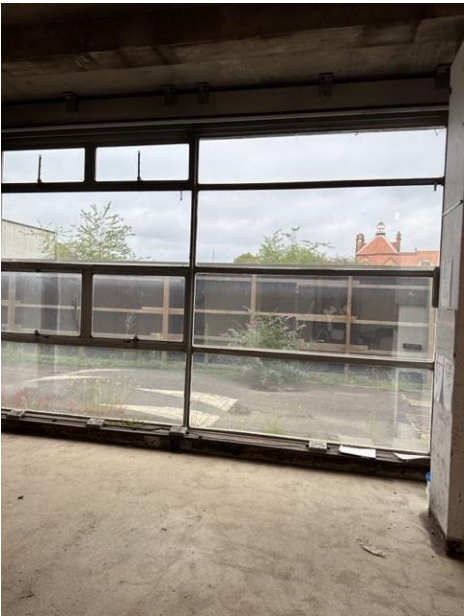
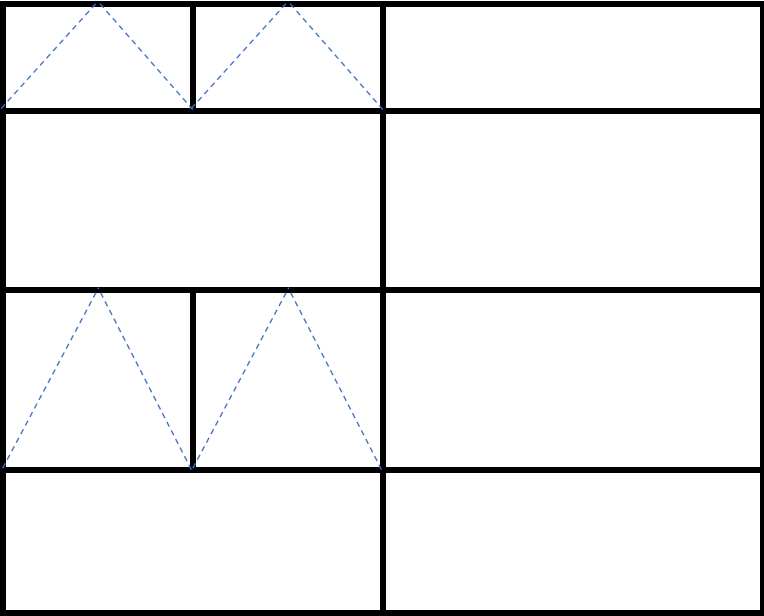
| All surfaces showing signs of deterioration |

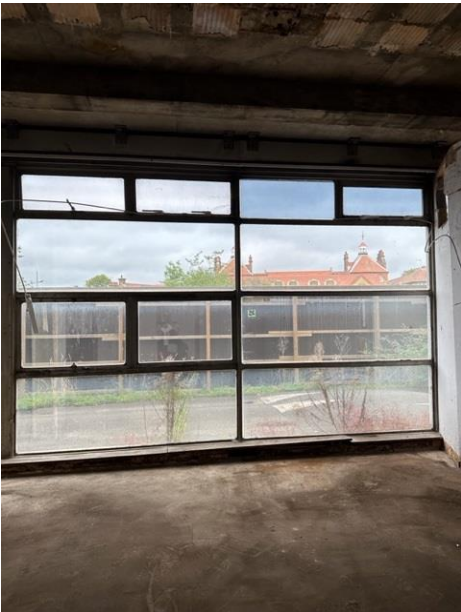
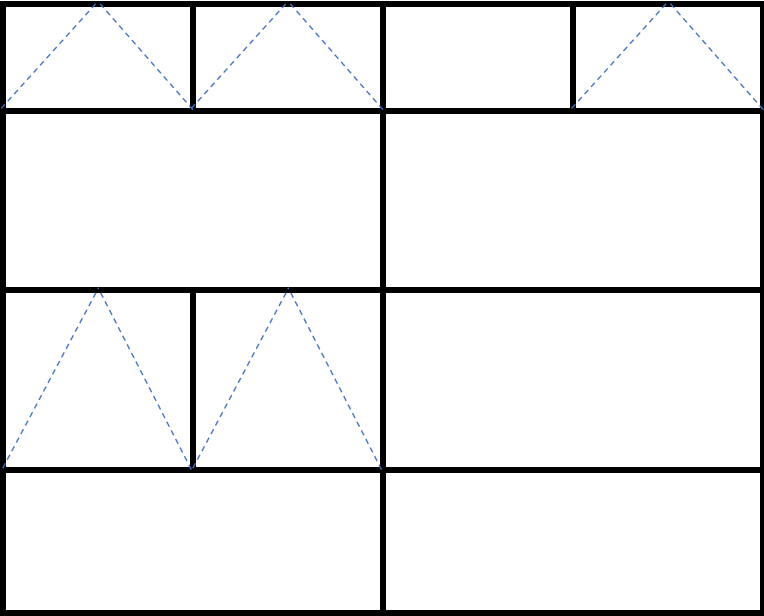
| All surfaces showing signs of deterioration |

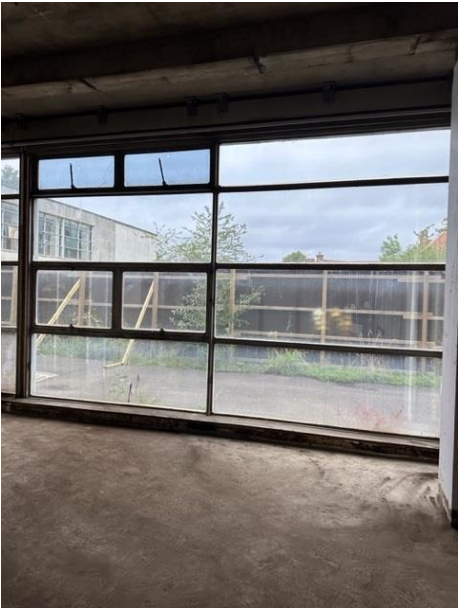
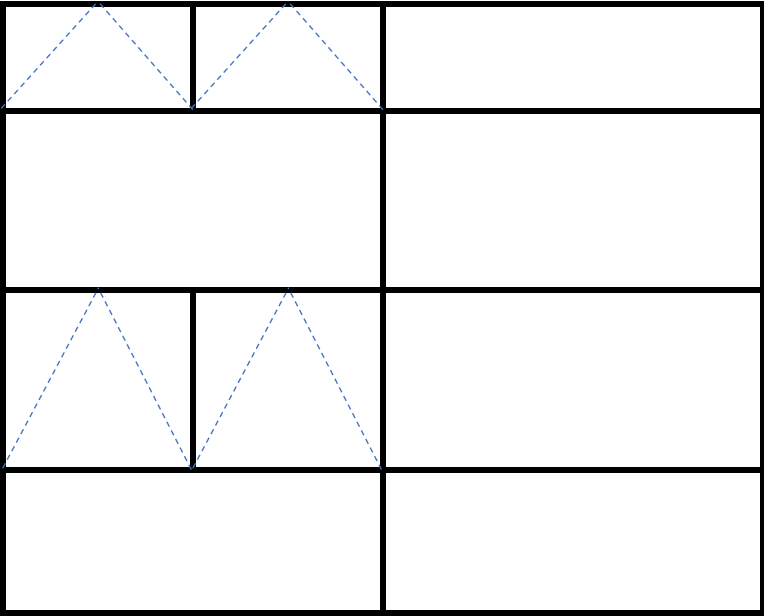
| All surfaces showing signs of deterioration |

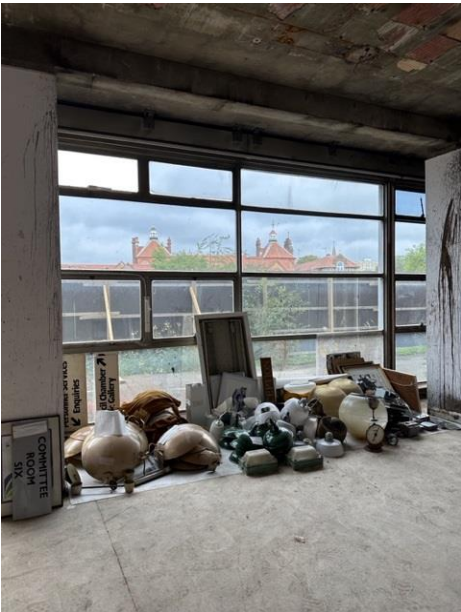
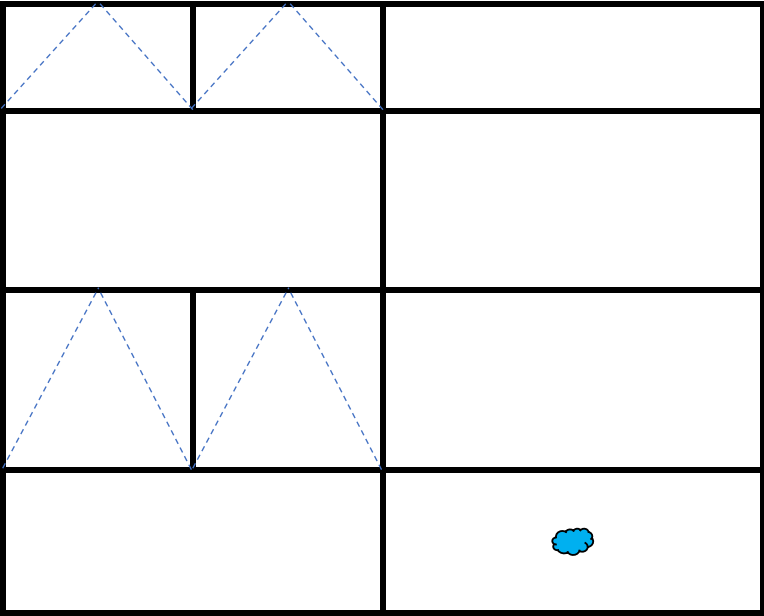
| All surfaces showing signs of deterioration |

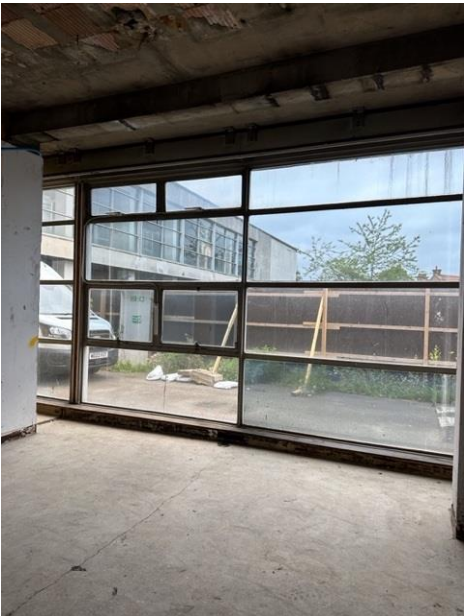
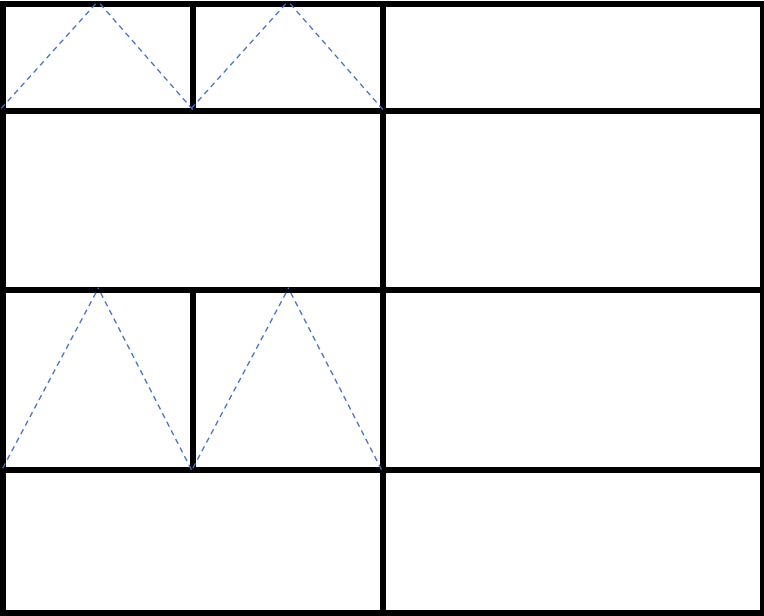
| All surfaces showing signs of deterioration |

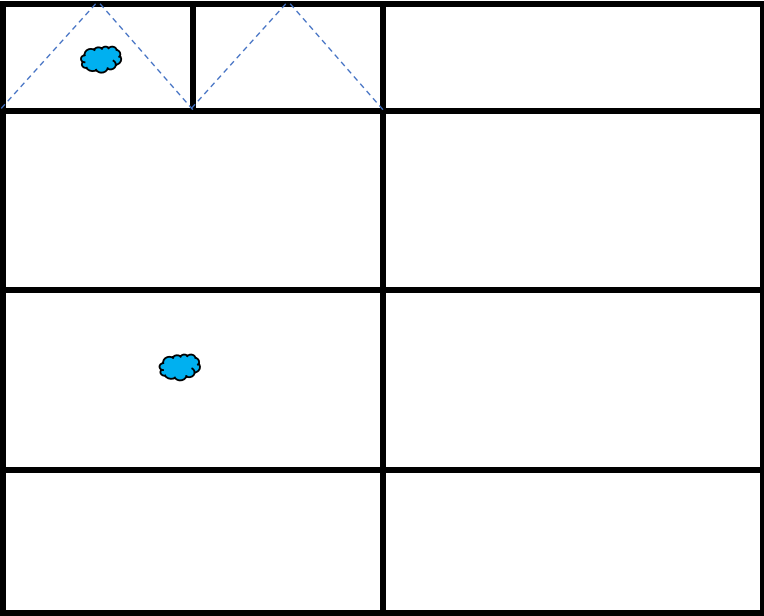
| All surfaces showing signs of deterioration |

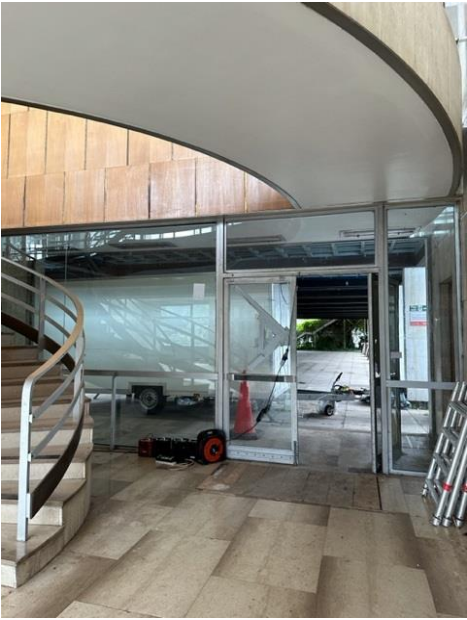
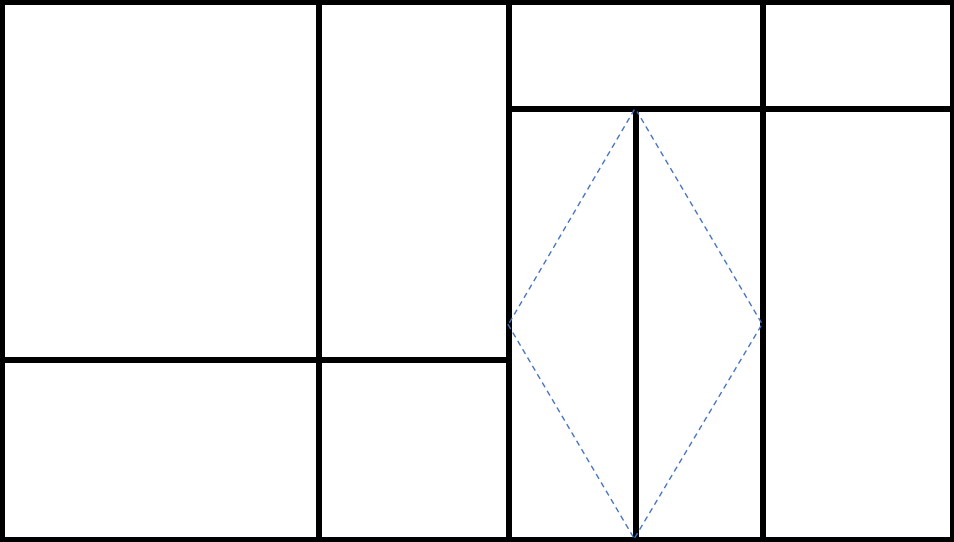
| All surfaces showing signs of deterioration |

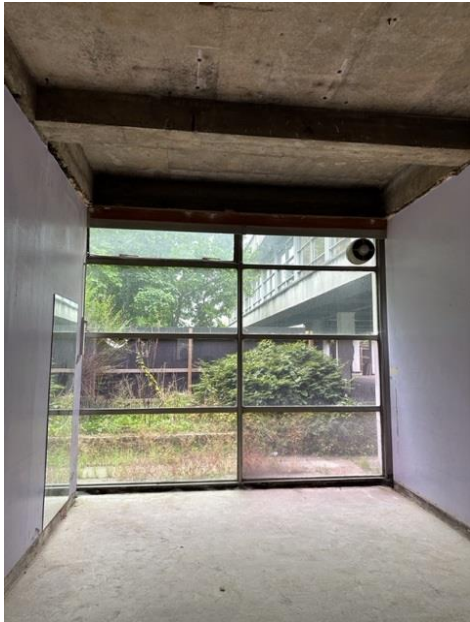
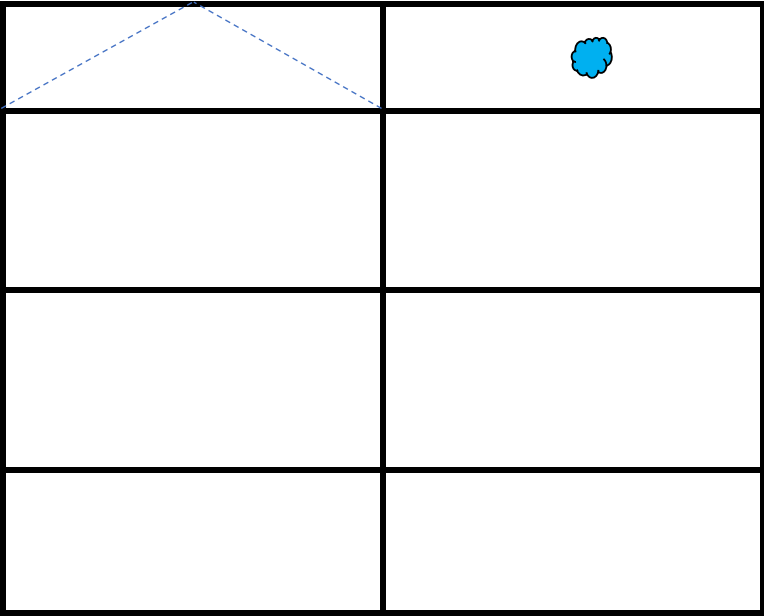
| All surfaces showing signs of deterioration |

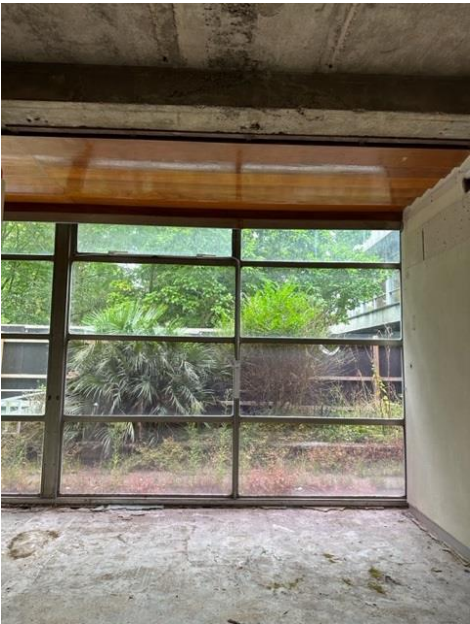
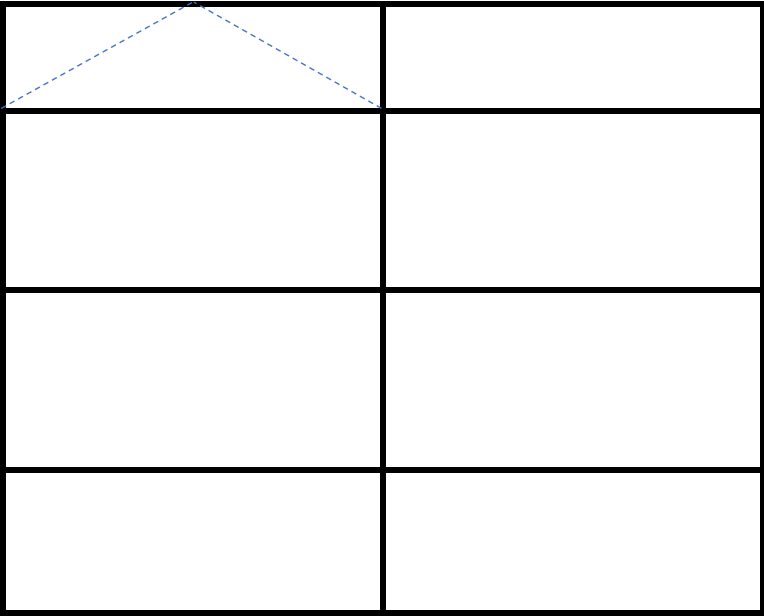
| All surfaces showing signs of deterioration |

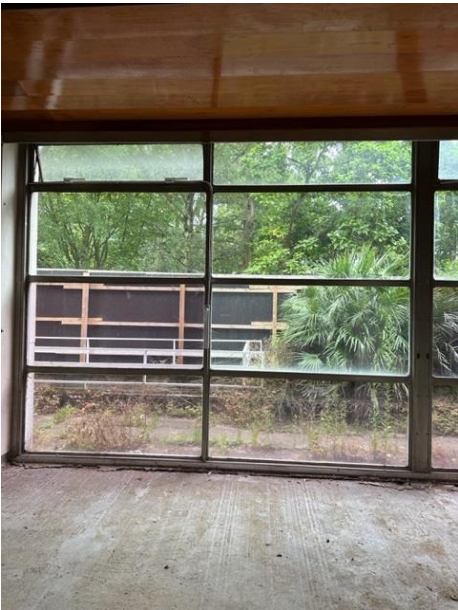
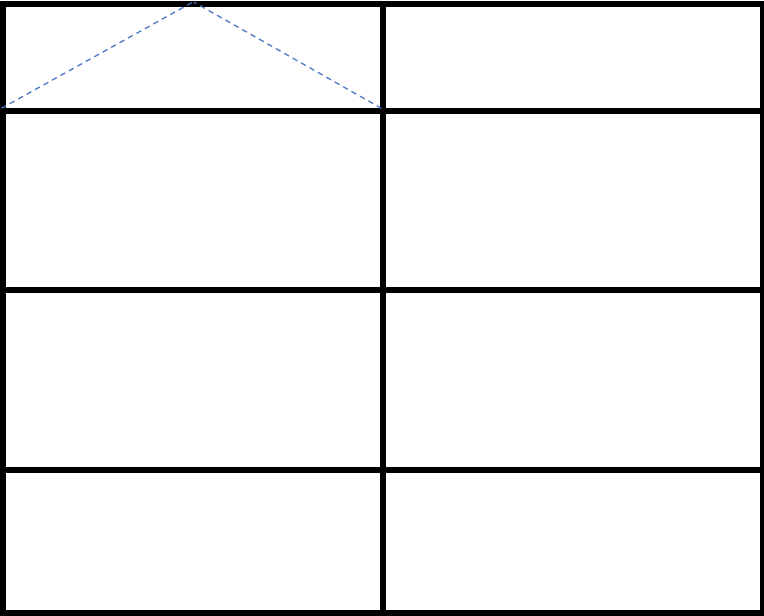
| All surfaces showing signs of deterioration |

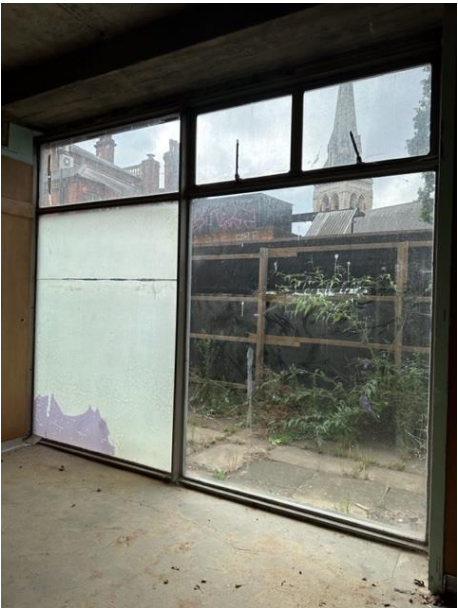
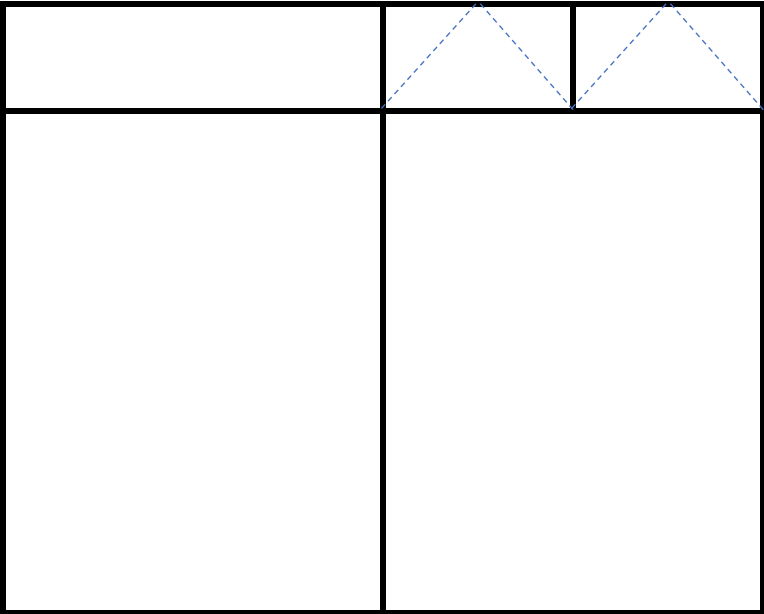
| All surfaces showing signs of deterioration |

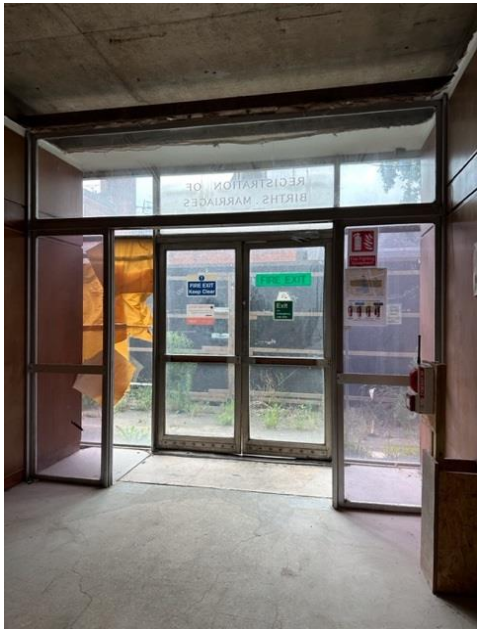
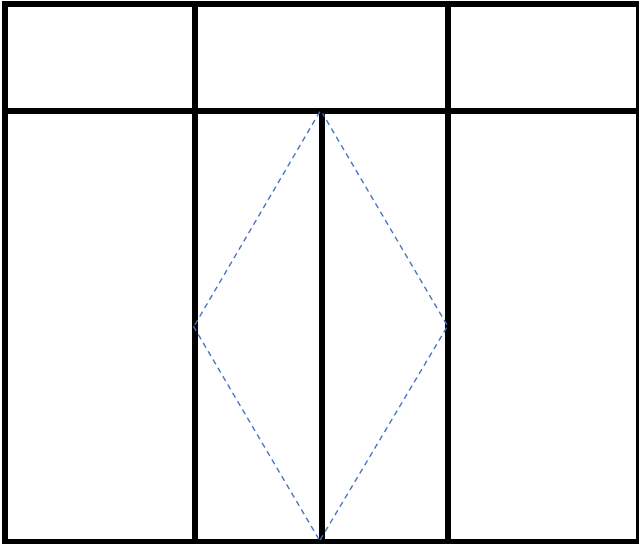
| All surfaces showing signs of deterioration |
| Doors in poor condition |

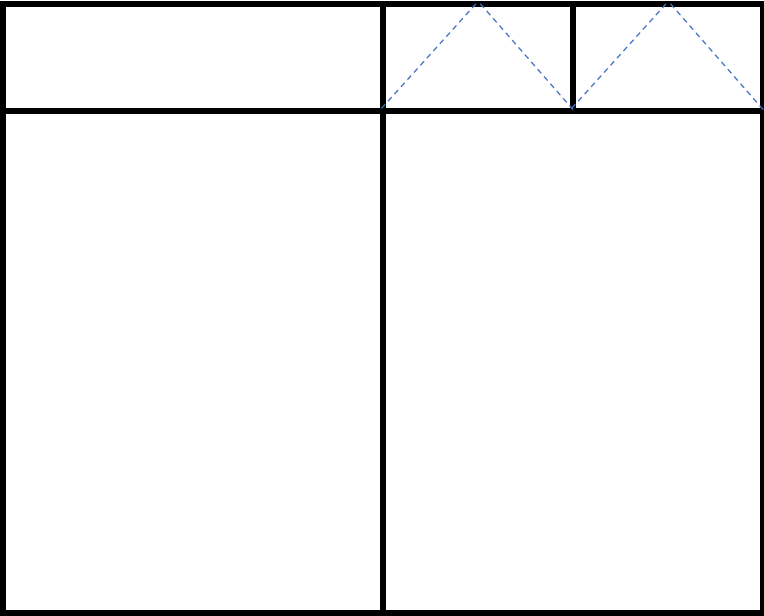
| All surfaces showing signs of deterioration |
