# **Simon Pryce Arboriculture**

## **Report and arboricultural impact assessment**

**Site:** Highgate Tennis Club courts at Shepherds Cot, Park Road, London, N8 8JJ

**Subject:** Trees in connection with proposed court resurfacing and associated works

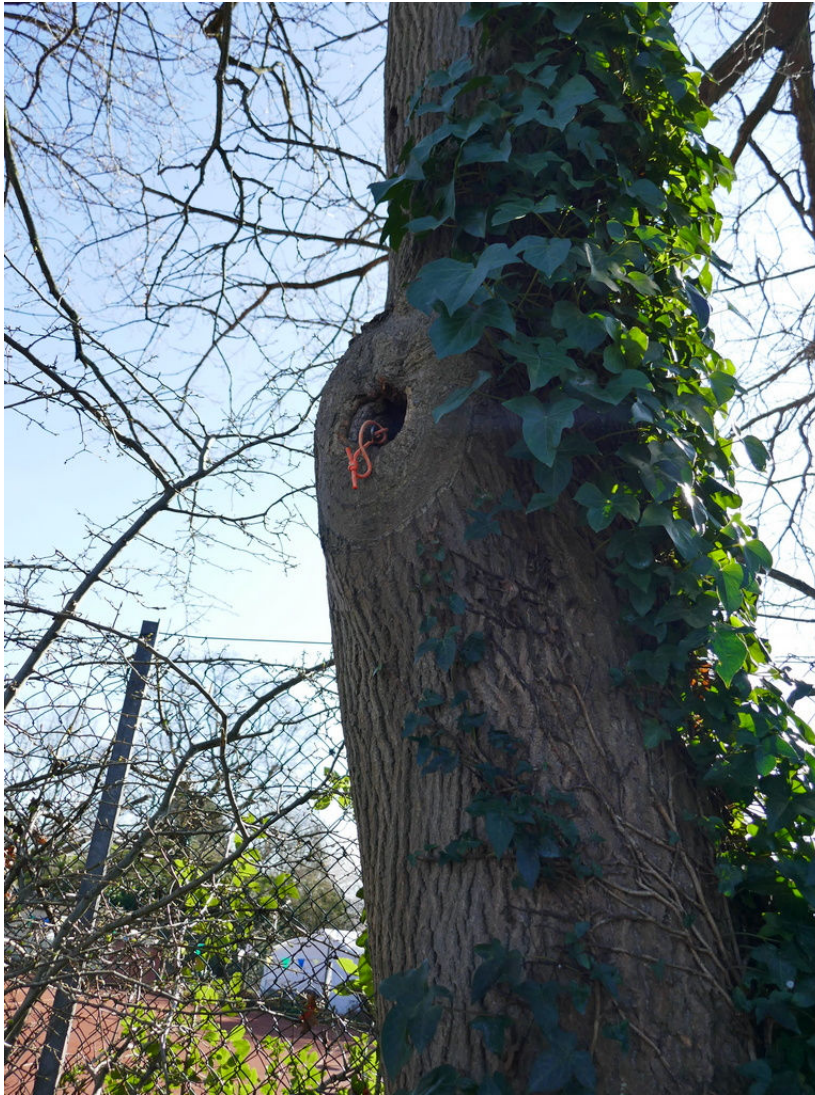
- 3.2 Other mature trees include an ash (tree 3) that has seeded itself between two of the oaks next to Greenways and grown up between them. It has not been unduly suppressed by this, but has a deep decay cavity at about 3m on the side facing Greenways where a branch was removed in the past (photo on p.6). There is also a badly storm damaged Norway maple in the S corner of the site, tree 11.

Cavity opening in the trunk of tree 3. The orange cord is on the end of a 450mm long probe, showing that the decay extends most of the way through the trunk.

| Tree no. | TPO no. | Species | Age / vitality | Ht. m | Spread. m | | | | Dia. mm | RPA rad m | RPA area m <sup>2</sup> | Crwn ht. m | Comments and recommendations | Cat |
|---|---|---|---|---|---|---|---|---|---|---|---|---|---|---|
| 3 | T24? | Ash<br><i>Fraxinus excelsior</i> | M/L | 18 | 6 | 7 | 5 | 5 | 540 | 6.5 | 132 | 6 | Has seeded itself next to tree 2 and grown up through it's crown, so is drawn up and misshapen. At about 3m on the NE side of the trunk is a small hole leading to an extensive decay cavity at least 450mm deep that is being used by squirrels. This has weakened the trunk significantly, although the tree is sheltered to some degree by the oaks. Has some dead wood in the crown but the twig growth is healthy looking at present with no signs of die back. | U |

- 5.1 There is a mixture of soft and hard surfaces round the trees, but no major obstructions to root spread, such as deep foundations, so the circular RPAs shown on the plan will be a reasonably accurate reflection of where roots are likely to be. The only real constraints here are oaks nos. 2 and 4 - 7, which have nearly half their RPAs under the existing court, while trees 1 and 10 have much smaller amounts under them. Apart from the oaks the other trees near the court are poor declining specimens that should be removed in any event, particularly no.3 the ash on the NW side and tree 11, the Norway maple to the SE.
