## **ENGINEERS REPORT – UPDATE**

This is an Engineers Report compiled by Malcolm Baldwyn based on the Video Survey conducted by MyHomeNeeds on 14<sup>th</sup> December 2022 as well as subsequent Site Investigations by Auger on 13<sup>th</sup> June 2023 and the SI Conclusion report by engineer Mark Lightbody.

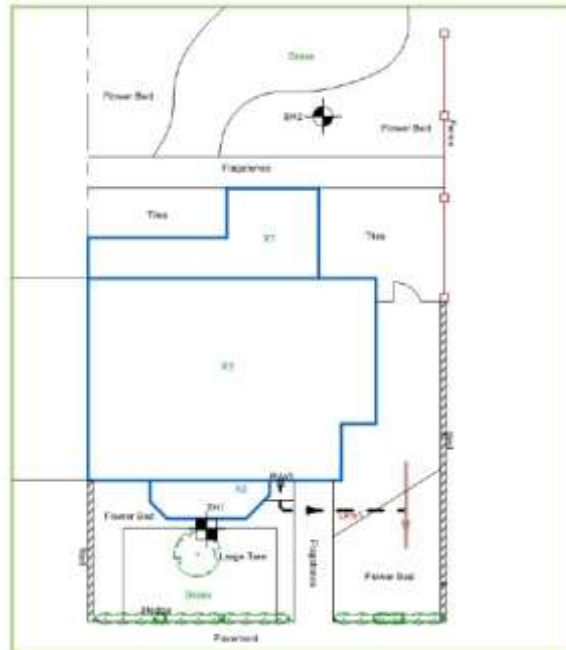
We can confirm that site investigation work around the damaged property has been completed. The site plan, results and conclusions are presented below:

The trial hole was excavated to the front of the building. This revealed the structure is founded on a brick corbel supported by 200mm thick concrete 0.8m below ground level. The trial pit was then extended by a hand augered borehole.

Roots were found immediately to the underside of the footing and down as far as 2.8m depth. The same subsoil continued to the base of the borehole at 3m.

The hole was excavated to the rear of the building and revealed topsoil (bedding) while the underlying subsoil was a moist stiff brown, fine to medium gravelly, silty CLAY, becoming wet at a depth of 2.0. The borehole was then extended by hand auger to a depth of 3.3m.
