# ARBORICULTURAL ASSESSMENT REPORT

37 Southwood Avenue, London, N6 5SA

PRI Ref: 267199

Survey Date: 17/07/2023

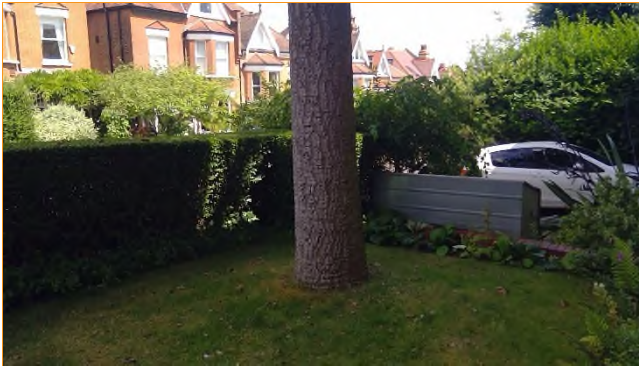
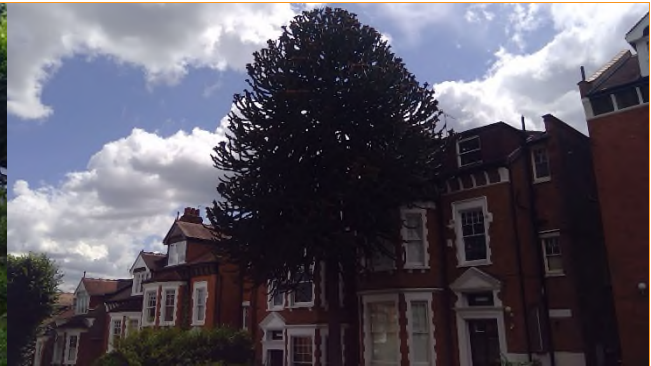
T1 - Monkey Puzzle

| Tree No | Common Name | Age Class | Condition | Height (m) | Crown Spread (m) | Stem diam. (mm) | Dist to bldg. (m) | Roots Implicated | Pruning history | Recommendation | Tree work constraints | Notes | Owner address | Owner |
|---|---|---|---|---|---|---|---|---|---|---|---|---|---|---|
| T1 | Monkey Puzzle | Mature | Fair | 16.2 | 8 | 470 | 2.43 | Y | No significant past tree works. | Fell and treat stump with eco plugs (broadleaved). | Pre cone/signage/ barriers action required - footpaths/public access. Heavily parked. | | 37 Southwood Avenue London N6 5SA | PH |

| Tree No: | Species | Works Required | CA | TPO | Ownership |
|---|---|---|---|---|---|
| T1 | Monkey Puzzle | Fell and treat stump with eco plugs (broadleaved) | Yes | No | PH |

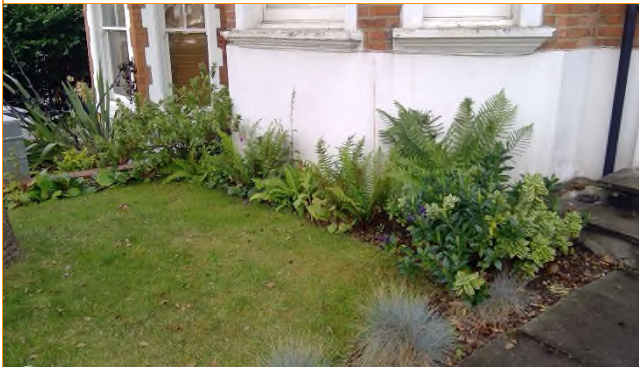
SG1 - Mixed species shrubs

| Tree No | Common Name | Age Class | Condition | Height (m) | Crown Spread (m) | Stem diam. (mm) | Dist to bldg. (m) | Roots Implicated | Pruning history | Recommendation | Tree work constraints | Notes | Owner address | Owner |
|---|---|---|---|---|---|---|---|---|---|---|---|---|---|---|
| SG1 | Mixed species shrubs | Early Mature | Fair | 0.8 | 0.4 | 20 | 0.2 | N | Managed as a shrub group. | No work required. | | Includes Ferns, Hebe, Veronica and Foxglove. | 37 Southwood Avenue London N6 5SA | PH |

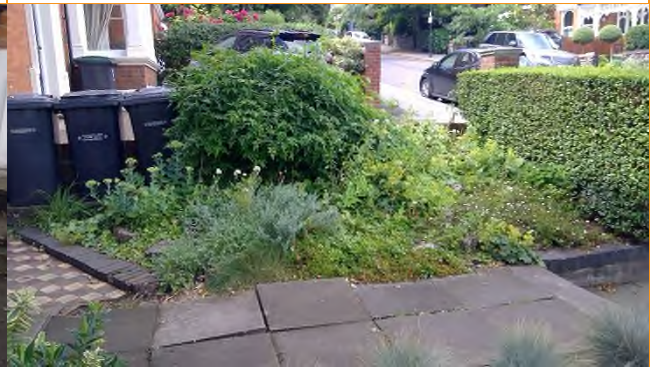
SG2 - Mixed species shrubs

| Tree No | Common Name | Age Class | Condition | Height (m) | Crown Spread (m) | Stem diam. (mm) | Dist to bldg. (m) | Roots Implicated | Pruning history | Recommendation | Tree work constraints | Notes | Owner address | Owner |
|---|---|---|---|---|---|---|---|---|---|---|---|---|---|---|
| SG2 | Mixed species shrubs | Mature | Fair | 1.6 | 2.0 | 35 | 1.7 | N | Managed as a shrub group. | No work required. | | Includes Jasmine, Sedum, Euphorbia and Geranium. | 37 Southwood Avenue London N6 5SA | PH |

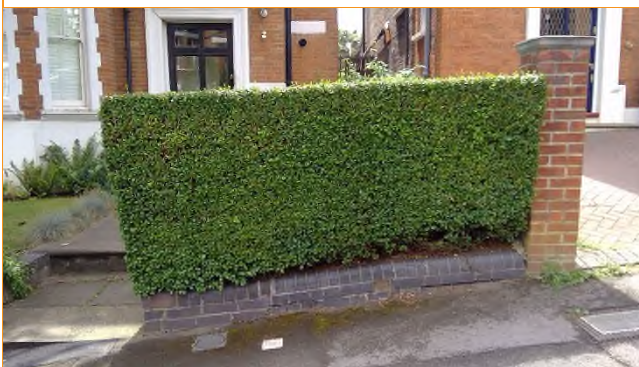
H1 - Privet

| Tree No | Common Name | Age Class | Condition | Height (m) | Crown Spread (m) | Stem diam. (mm) | Dist to bldg. (m) | Roots Implicated | Pruning history | Recommendation | Tree work constraints | Notes | Owner address | Owner |
|---|---|---|---|---|---|---|---|---|---|---|---|---|---|---|
| H1 | Privet | Mature | Fair | 1.5 | 0.8 | 25 | 5.7 | N | Managed as a hedge. | No work required. | | | 37 Southwood Avenue<br>London<br>N6 5SA | PH |

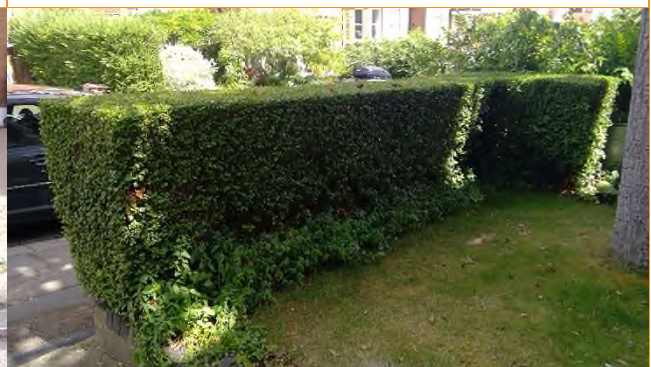
H2 - Privet

| Tree No | Common Name | Age Class | Condition | Height (m) | Crown Spread (m) | Stem diam. (mm) | Dist to bldg. (m) | Roots Implicated | Pruning history | Recommendation | Tree work constraints | Notes | Owner address | Owner |
|---|---|---|---|---|---|---|---|---|---|---|---|---|---|---|
| H2 | Privet | Mature | Fair | 1.5 | 0.8 | 25 | 4.3 | N | Managed as a hedge. | No work required. | | | 37 Southwood Avenue<br>London<br>N6 5SA | PH |

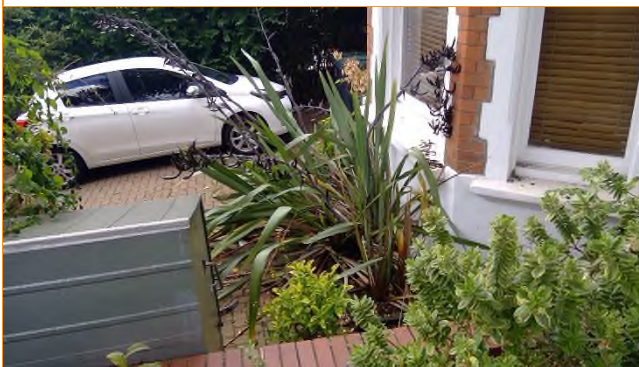
S1 - Yucca

| Tree No | Common Name | Age Class | Condition | Height (m) | Crown Spread (m) | Stem diam. (mm) | Dist to bldg. (m) | Roots Implicated | Pruning history | Recommendation | Tree work constraints | Notes | Owner address | Owner |
|---|---|---|---|---|---|---|---|---|---|---|---|---|---|---|
| S1 | Yucca | Mature | Fair | 2.0 | 3.6* | 45* | 2.9 | N | No significant past tree works. | No work required. | | | 35 Southwood Avenue<br>London<br>N6 5SA | P3P |

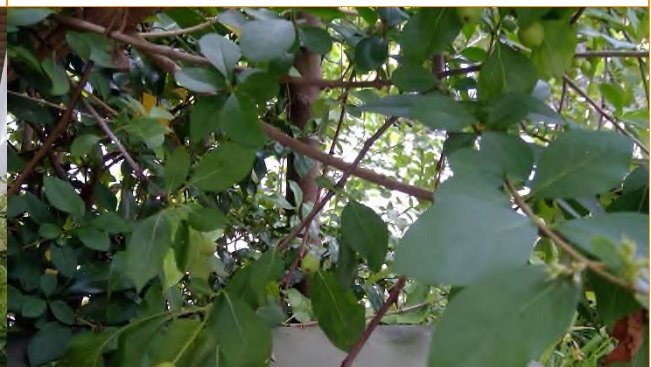
T2 - Apple (Crab)

| Tree No | Common Name | Age Class | Condition | Height (m) | Crown Spread (m) | Stem diam. (mm) | Dist to bldg. (m) | Roots Implicated | Pruning history | Recommendation | Tree work constraints | Notes | Owner address | Owner |
|---|---|---|---|---|---|---|---|---|---|---|---|---|---|---|
| T2 | Apple (Crab) | Early Mature | Fair | 2.4 | 3.8* | 75* | 5.17 | N | Subject to past management. No significant recent management. | No work required. | | | 35 Southwood Avenue London N6 5SA | P3P |

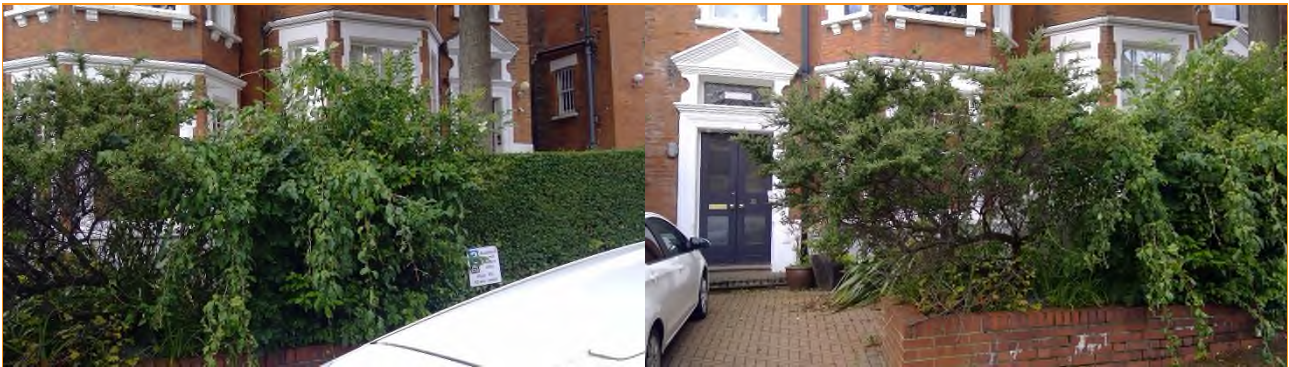
| Tree No | Common Name | Age Class | Condition | Height (m) | Crown Spread (m) | Stem diam. (mm) | Dist to bldg. (m) | Roots Implicated | Pruning history | Recommendation | Tree work constraints | Notes | Owner address | Owner |
|---|---|---|---|---|---|---|---|---|---|---|---|---|---|---|
| S2 | Ceanothus | Mature | Fair | 2.4 | 3.4 | 80* | 6.6 | N | Subject to past management. No significant recent management. | No work required. | | | 35 Southwood Avenue<br>London<br>N6 5SA | P3P |
