# **The Printworks, High Road West**

## **Structural Survey (Existing Buildings)**

**HRW-BHE-PW-XX-RP-S-0001**

28 July 2023

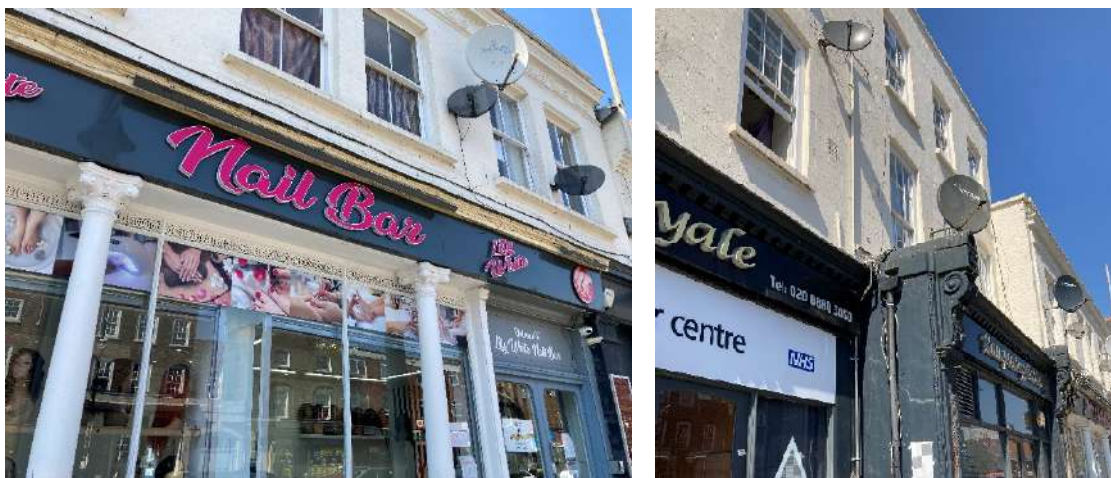
Shop fronts to 825, 827 and 829 at ground floor have been formed with iron/steel pillars and, it is presumed, iron or steel lintels. The shop front of 821 is set forward on the first floor masonry façade; it is presumed that the masonry wall is carried by a structural beam.

Figure 3-2 - a) pillar forming shop front to Unit 823, b) inset of Unit 821's first floor façade relative to ground floor shop front

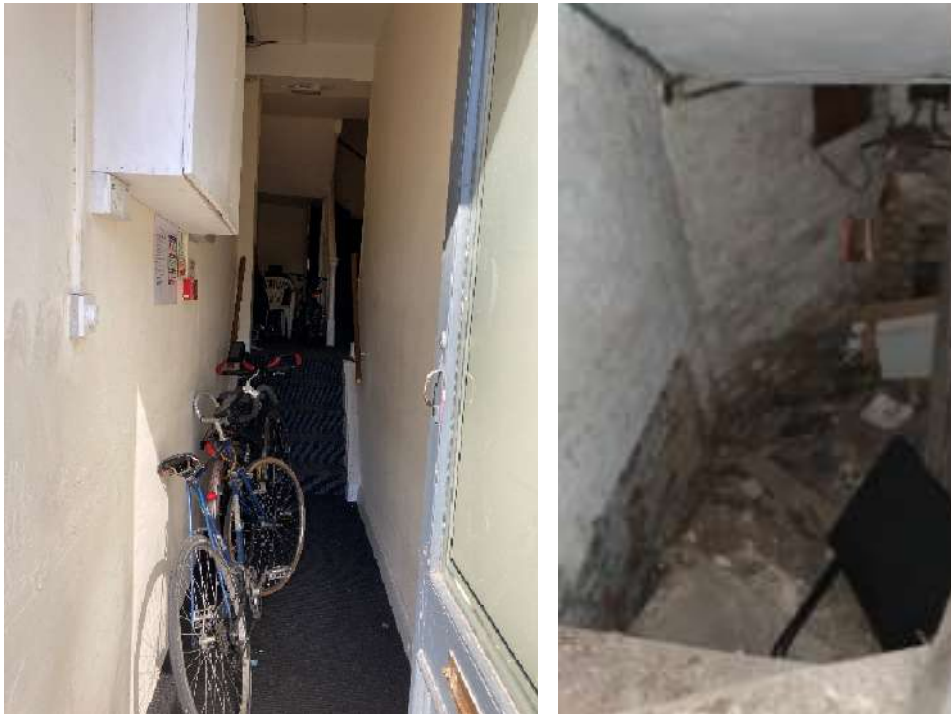
Photos of the front on the buildings from 1908 show railings set forth from unit 819 with a lightwell; this suggests a basement level. Access to a basement to unit 819 was found; further investigation by others suggest that this has approximately 1600mm head height, although the extents of it on plan remain unknown. The basement retaining walls appear to be brickwork and a continuation of the load bearing walls above. This cellar level is not currently in use and the lightwell in front of the building appears to have been filled in and paved over.

**Figure 3-3 – a) Unit 819 communal hall leading to basement access, b) view of basement from ground floor access**

The Unit 819 basement was not accessible, but it could be assumed that this suffers damp, being an abandoned below ground space. Further investigation by others show that the timber stairs leading to the basement were rotting.

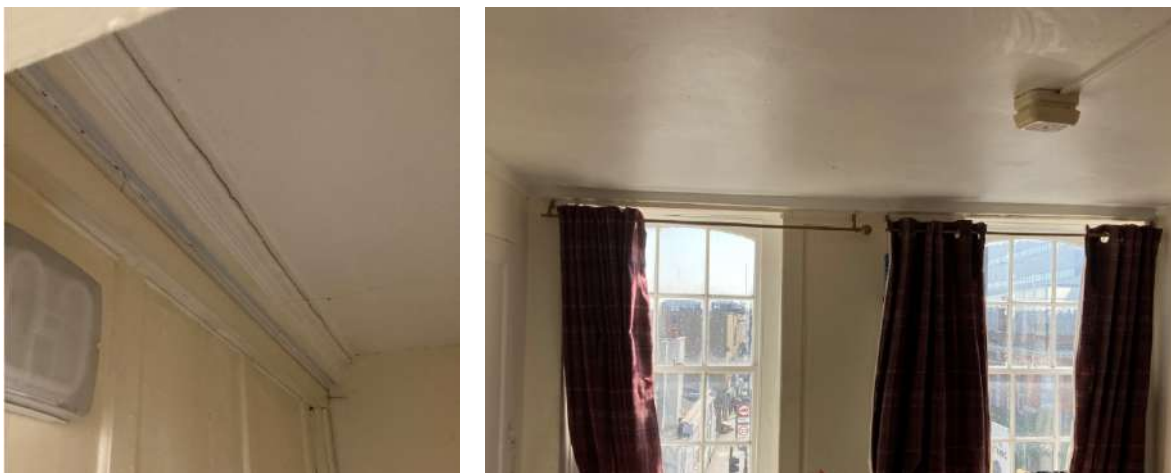
Some crack lines in finishes indicate deflection of floor or roof members relative to the load bearing walls. Deflections can also be perceived in other places, for example over the window line in the figure below. Deflections of this nature would be expected of this form and period of construction and are not of cause for concern with regards to structural integrity.

Figure 4-1 – a) Hall of Unit 823 with superficial cracking in finishes, b) perceived deflections over window line in Unit 819 Flat 3

It is assumed that, as part of the works, finishes such as flooring, ceilings and wall plaster will be removed and replaced, temporarily exposing the structure beneath. At such time it can be verified that cracks do not exist in the load bearing structure behind.

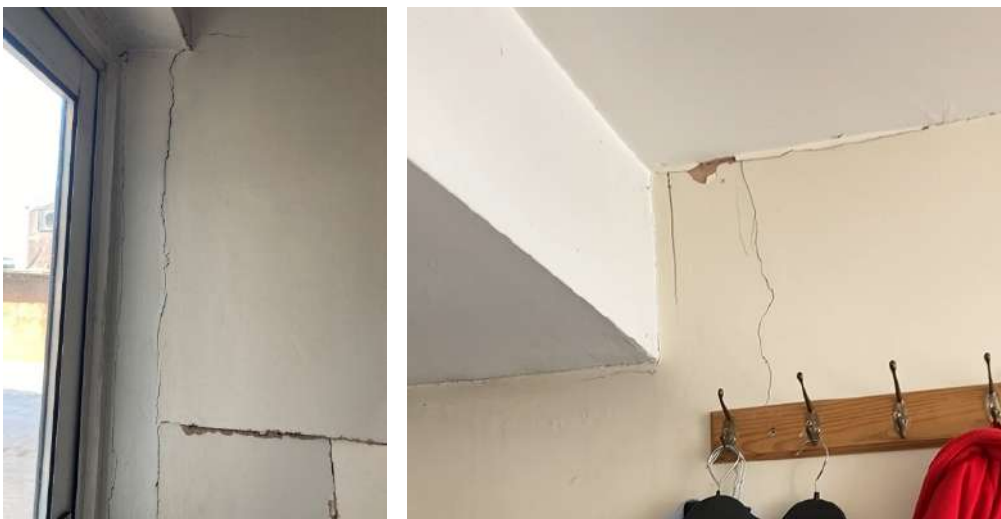
Figure 4-2 -Superficial cracking in finishes in Unit 812 b) Landing and c) Flat C

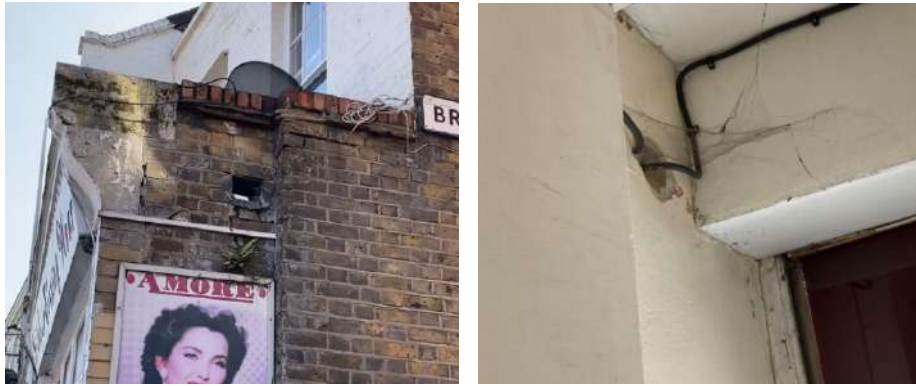
Localised disrepair could be seen in some areas. As shown in the example photos below, this includes weathering of mortar, movements in brickwork, and damage for installation of services.

Figure 4-3 – a) localised cracking of brickwork to parapet of Unit 829, b) damage around drilling for conduits in hallway of Unit 821

- Repointing of masonry
- Localised rebuilding of parapets and/or chimneys to match existing
- Cementitious repair of local damage to masonry walls
- Replacement of localised joists and other timber floor members
- Treatment of timbers for damp
- Replacement of stairs to unit 819 basement, or otherwise barring the entrance to the basement

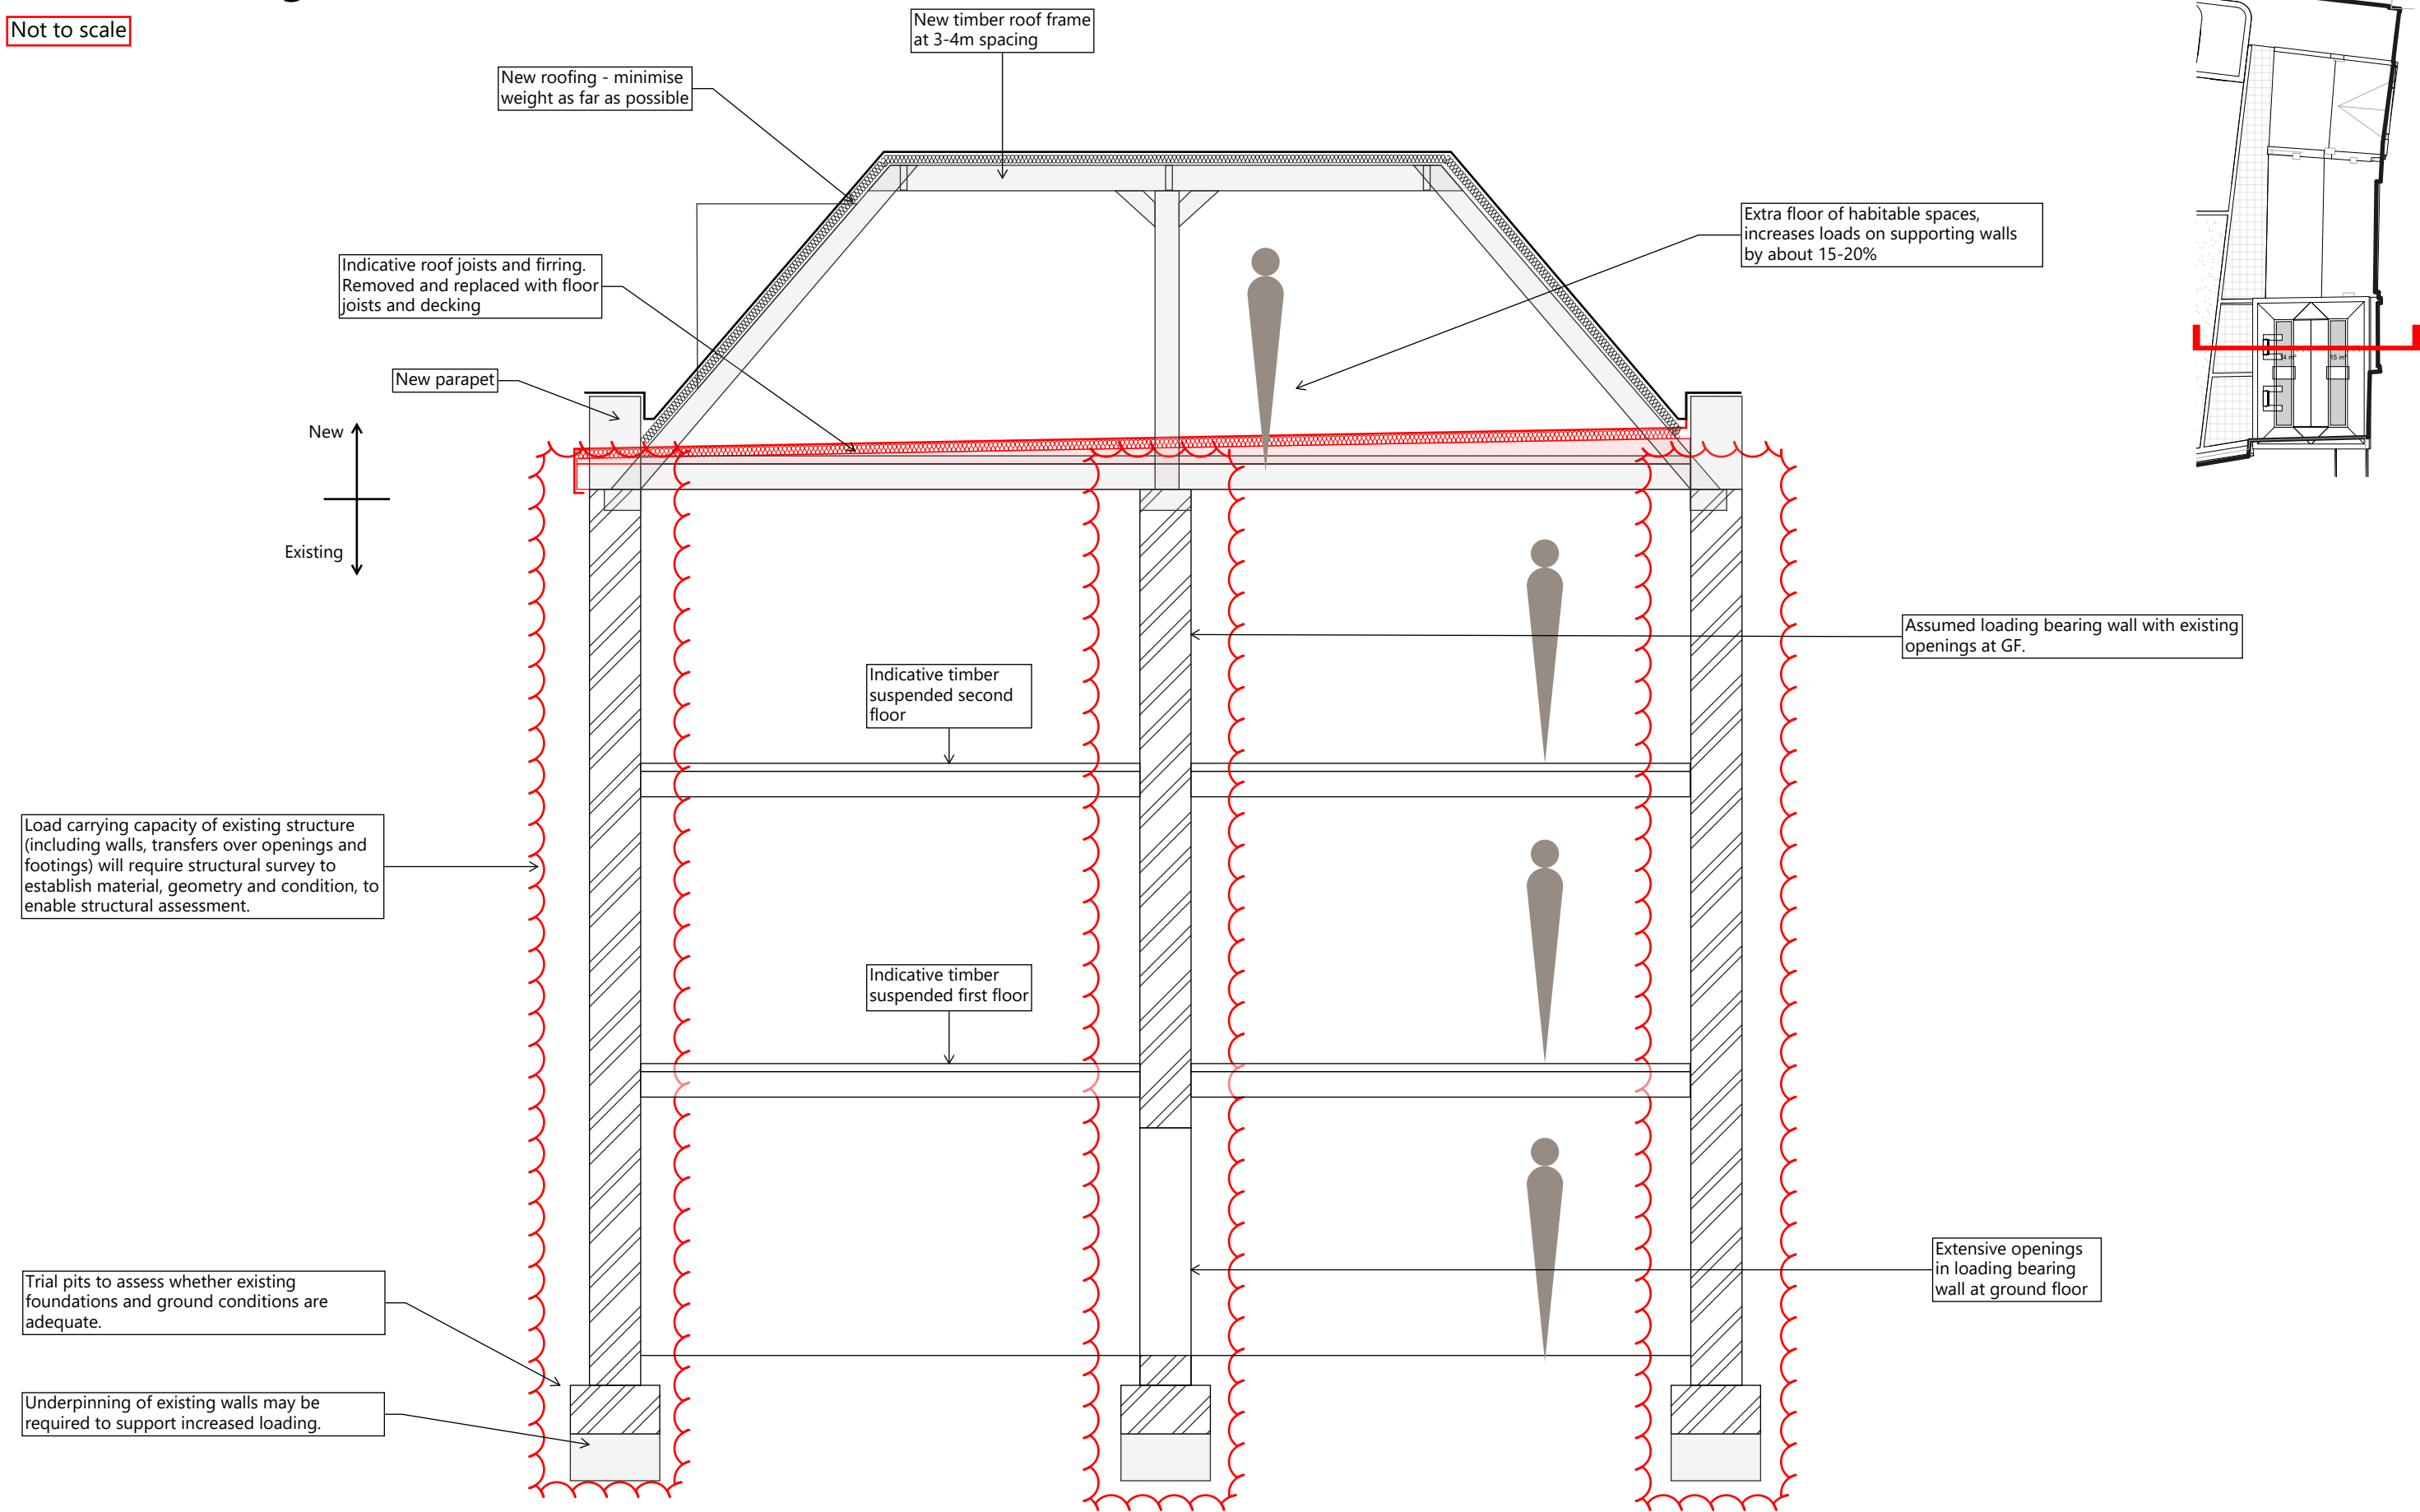
Section through 819 & 821 Roof

The existing masonry walls that were viewable on site appear to be robust and in reasonable condition. Preliminary calculations suggest that the existing load bearing walls will have sufficient strength to carry the additional load and significant strengthening to the walls is unlikely to be required. This assessment should be verified pending detailed surveys as noted above.

The capacity of the existing transfers is difficult to judge until such time as they are exposed. In the event that the existing capacity is deemed to be insufficient to carry the additional loads, strengthening would be required. On the assumption that the existing transfer frames are steel sections, this strengthening works may include stiffener plates welded on site to existing.

The footings of the existing structure are most likely to require strengthening, since buildings of this type often lack a footing detail to spread load. Underpinning of the existing foundations will likely be required to prevent the risk of settlement. This would be carried out in a hit and miss programme.

- Detailed structural surveys (including trial pits to foundations) of existing walls, transfer frames and footings to establish geometry, build up, material and condition of the existing structure.
- Using this information, assessment of load bearing capacity of existing structure and ground.
