# Arboricultural Appraisal Report

## Safety and Condition Survey

Fortismere School  
Tetherdown  
London  
N10 1NE

| REPORT DATE: | 18-07-2022 |

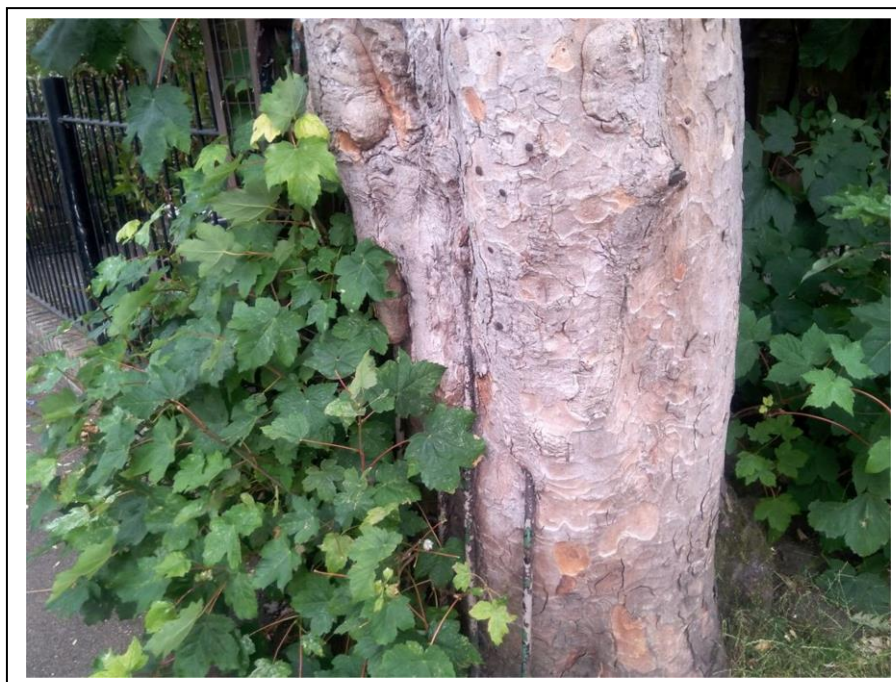
View of T1 Sycamore – fence enveloped by stem growth with basal shoots over footpath

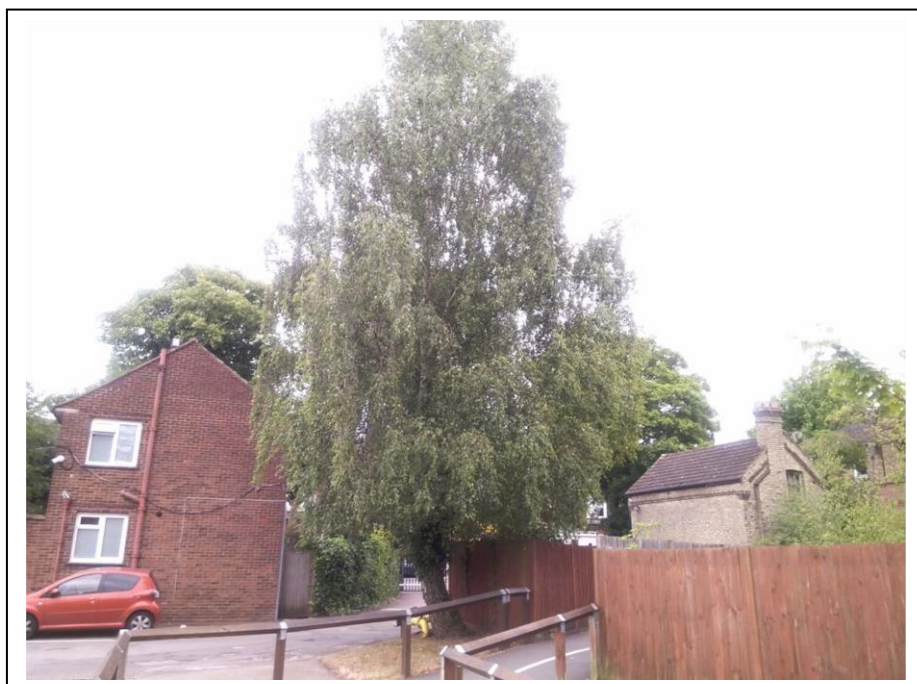
View of T2 Birch

| Ref | Species | Height (m) | DBH (mm) | Crown Spread (m) | Life Stage | Survey Notes | Condition | Risk Level | Works Recommendation | Works Timescale | Inspect Period |
|---|---|---|---|---|---|---|---|---|---|---|---|
| T2 | Birch | 16.5 | 450 | 8.0 | Semi Mature | Low growth over access road.<br>Ivy growth to main stem - obstructed view of stem condition. | Fair | Medium | Crown lift to 4.5m (remove branches at source, do not cut to stumps)<br>Remove Ivy and reinspect. | 3 Months | 6 Months |

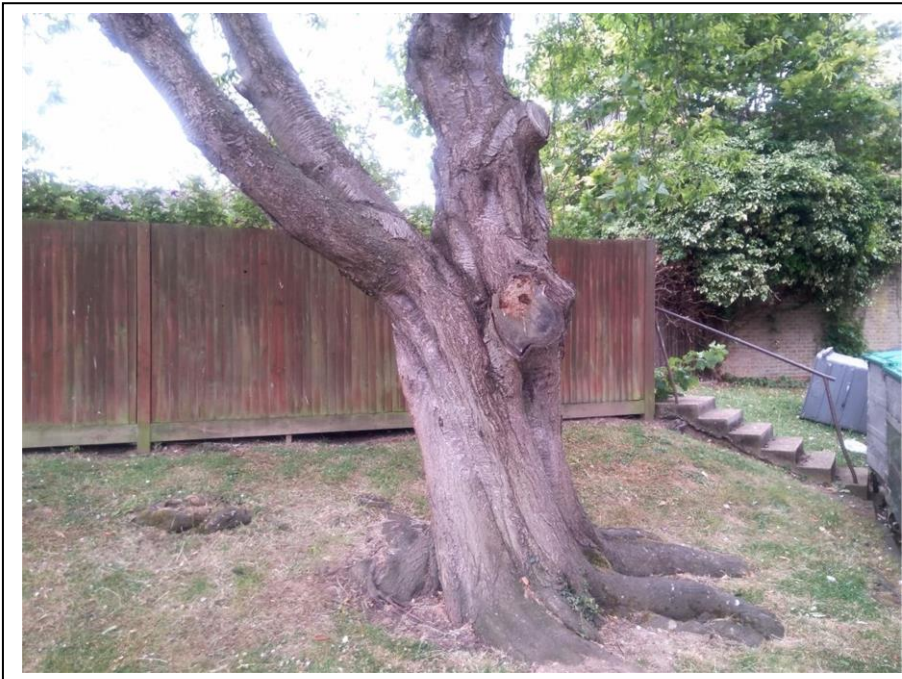
View of T6 Cherry

| Ref | Species | Height (m) | DBH (mm) | Crown Spread (m) | Life Stage | Survey Notes | Condition | Risk Level | Works Recommendation | Works Timescale | Inspect Period |
|---|---|---|---|---|---|---|---|---|---|---|---|
| T6 | Cherry | 13.5 | 790 | 11.0 | Mature | <p>Sparse crown with minor dieback in upper crown. Suppressed asymmetrical crown growth habit with weight bias to E.</p> <p>2x large phototrophic co-dominant stems emanating at approx. 2.0m to E side of stem. Large decaying old pruning wound to N side of stem at approx. 1.5m just below co-dominant stem union. Target canker to SE side of main stem from approx. 2.5m to 3.5m, with further canker to underside of phototrophic stem at 3.0m.</p> <p>Exposed surface roots with decay and canker from historic wounding - likely old mower damage.</p> | Fair | High | <p>Remove deadwood.</p> <p>Monitor rate of dieback through regular inspection.</p> | 3 Months | 1 Year |

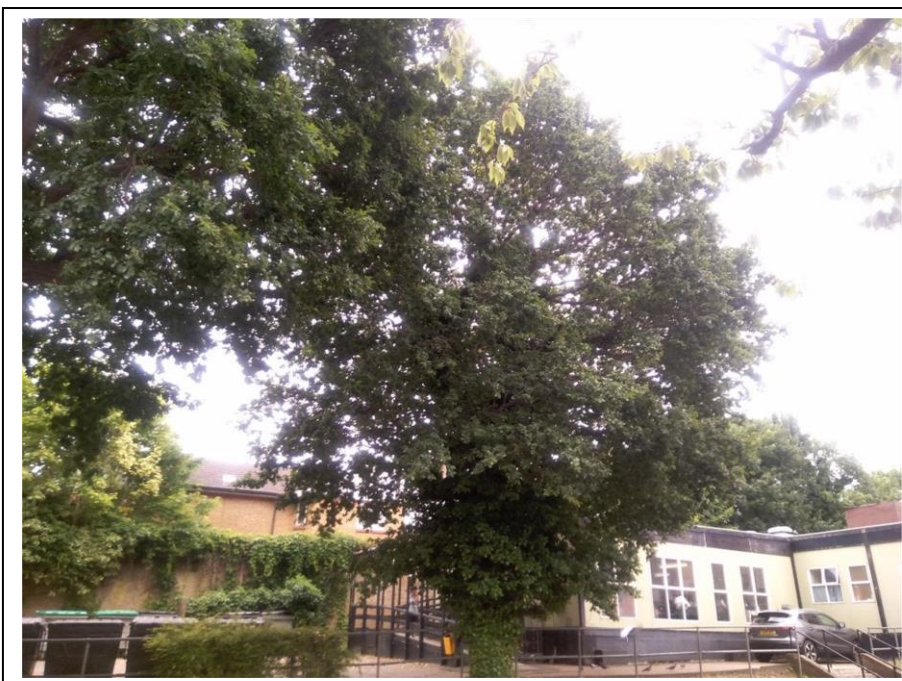
| Ref | Species | Height (m) | DBH (mm) | Crown Spread (m) | Life Stage | Survey Notes | Condition | Risk Level | Works Recommendation | Works Timescale | Inspect Period |
|---|---|---|---|---|---|---|---|---|---|---|---|
| T8 | Oak | 15.5 | 750 | 13.5 | Mature | Ivy growth throughout - no view of stem or limb condition. | Fair | High | Remove Ivy and re-inspect. | 3 Months | 6 Months |

View of T8 Oak – extensive Ivy growth to main stem obstructs view of stem condition

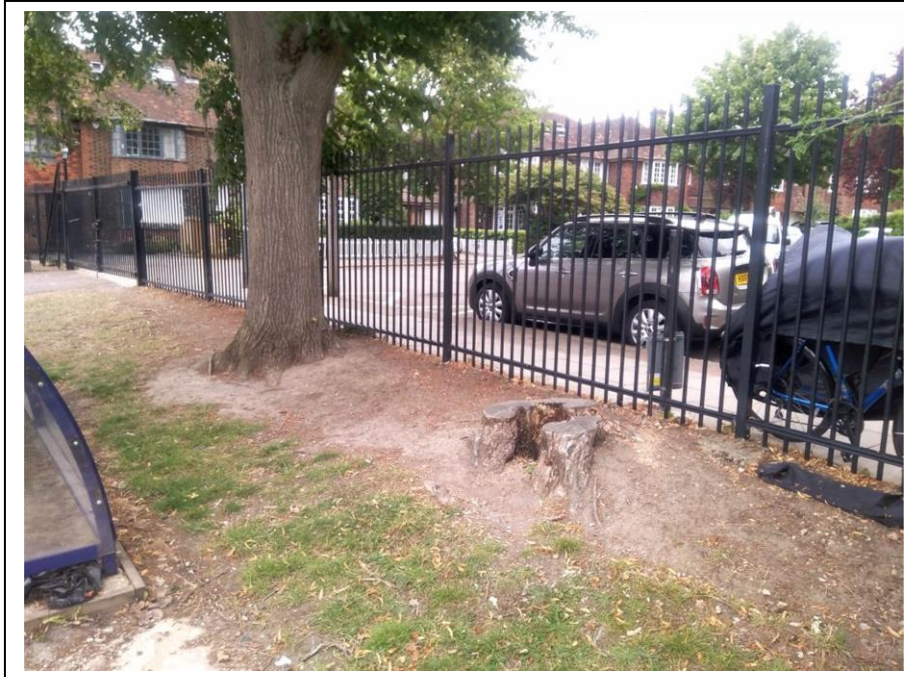
View of T14 Lime – herbicide application around stem base

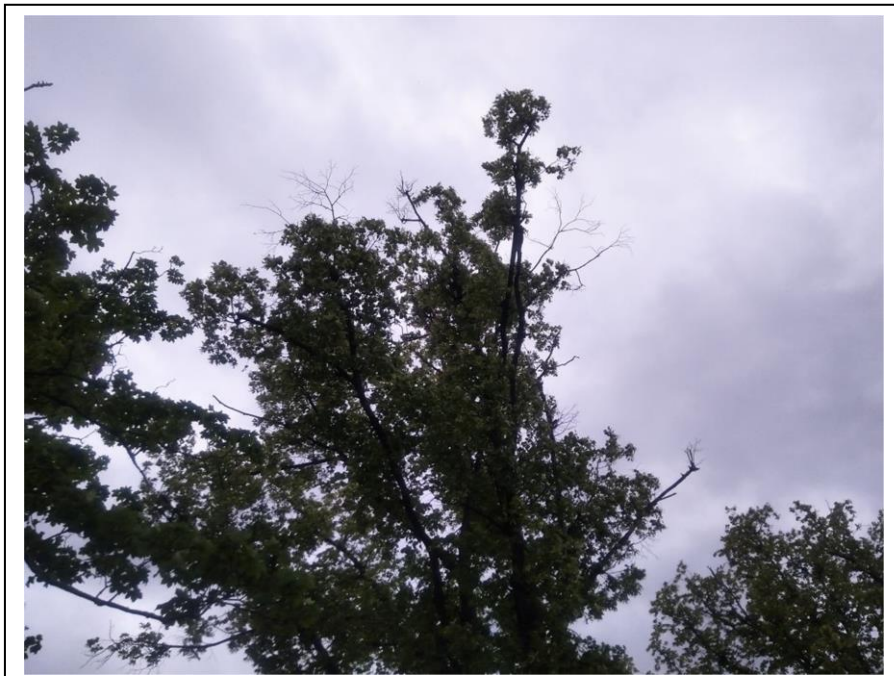
| Ref | Species | Height (m) | DBH (mm) | Crown Spread (m) | Life Stage | Survey Notes | Condition | Risk Level | Works Recommendation | Works Timescale | Inspect Period |
|---|---|---|---|---|---|---|---|---|---|---|---|
| T17 | Lime | 16.0 | 520 | 12.5 | Early Mature | Deadwood and dieback throughout - tree appears in decline.<br>No obvious signs to explain dieback<br>Basal shoots/epicormic growth encroaching over adjacent footpath.<br>Ivy growth to main stem - obstructed view of stem condition. | Fair | High | Remove deadwood.<br>Remove basal shoots and epicormic growth to leave 4.0m clear stem.<br>Remove ivy.<br>Re-inspect.<br>Cease application of herbicide throughout area. | 3 Months | 6 Months |
| T18 | Lime | 15.0 | 490 | 12.5 | Early Mature | Deadwood and dieback throughout - tree appears in decline.<br>No obvious signs to explain dieback.<br>Epicormic growth encroaching over adjacent footpath.<br>Small open decay cavity to N side of stem at GL - ART reveals decaying stem base to approx. 0.5m. | Poor | High | Remove (fell) to near ground level and grind out stump to negate trip hazard.<br>Cease application of herbicide throughout area. | 3 Months | 1 Year |

| Ref | Species | Height (m) | DBH (mm) | Crown Spread (m) | Life Stage | Survey Notes | Condition | Risk Level | Works Recommendation | Works Timescale | Inspect Period |
|---|---|---|---|---|---|---|---|---|---|---|---|
| T20 | Lime | 16.0 | 480 | 13.5 | Early Mature | Deadwood and dieback throughout - tree appears in decline.<br>No obvious signs to explain dieback<br>Basal shoots/epicormic growth encroaching over adjacent footpath.<br>Sporadic bark loss /delamination to W side of stem from GL to approx. 1.5m - bootlace mycelium visible below flaking bark. Honey fungus. | Fair | High | Remove (fell) to near ground level and grind out stump to negate trip hazard. | 3 Months | 1 Year |

Examples of Limes to southern boundary – dieback in upper crown [suspected to be due to herbicide poisoning]

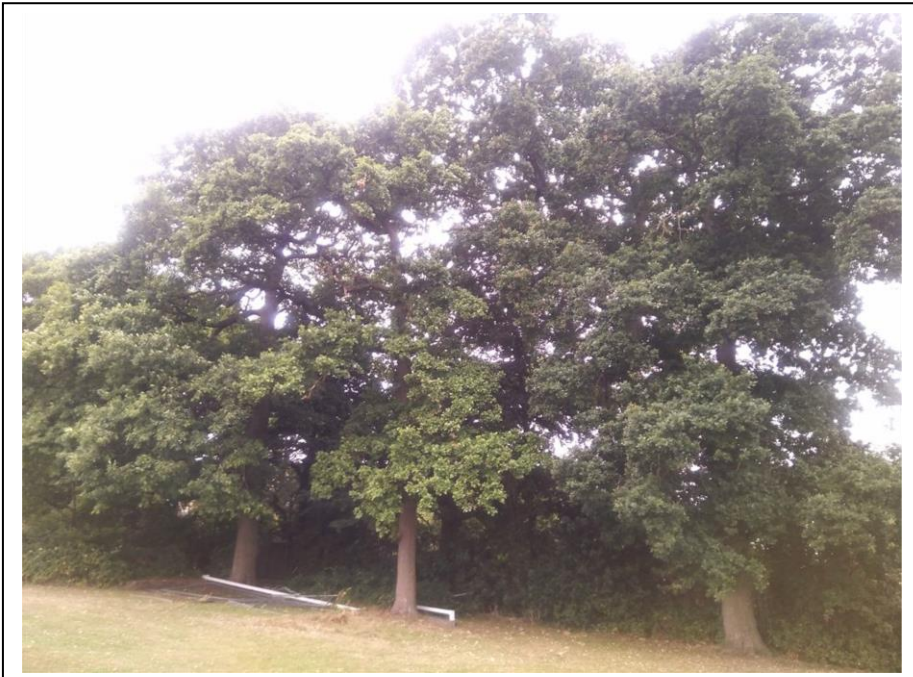
View of Oaks T27, T28 and T29

| Ref | Species | Height (m) | DBH (mm) | Crown Spread (m) | Life Stage | Survey Notes | Condition | Risk Level | Works Recommendation | Works Timescale | Inspect Period |
|---|---|---|---|---|---|---|---|---|---|---|---|
| T27 | Oak | 18.5 | 700 | 13.5 | Mature | Large diameter deadwood in crown.<br>Rooting adjacent to concrete slab.<br>No other significant defects observed. | Fair | High | Remove deadwood from throughout crown. | 3 Months | 1 Year |

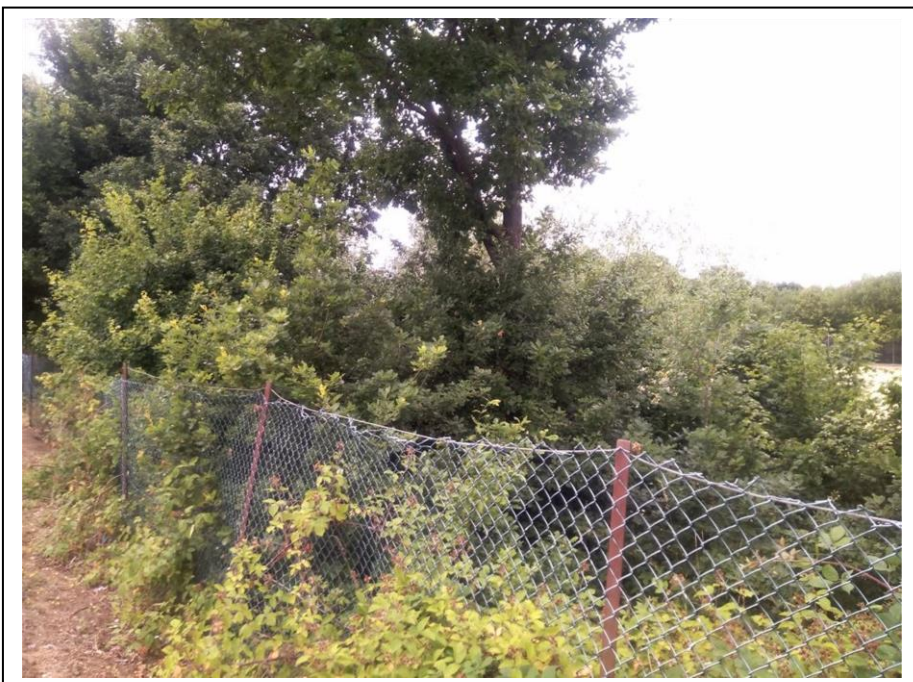
| Ref | Species | Height (m) | DBH (mm) | Crown Spread (m) | Life Stage | Survey Notes | Condition | Risk Level | Works Recommendation | Works Timescale | Inspect Period |
|---|---|---|---|---|---|---|---|---|---|---|---|
| TG16 | Field Maple<br>Cherry<br>Willow<br>Ash<br>Oak<br>Poplar | 15.0 | 400 | 11.0 | Semi Mature | Lapsed tree line growing on embankment - dense scrub understorey.<br>Land locked between field fence and sports centre.<br>Inappropriate location for growth to establish.<br>No access to a inspect larger specimen trees.<br>Poplar to E end of group adjacent to car park recently heavily crown reduced. | Fair | Medium | Strim area and clear all scrub understorey below 70mm dia.<br>Re-inspect. | 3 Months | 6 Months |

View of trees in TG16 – dense scrub understorey obstructs access to inspect

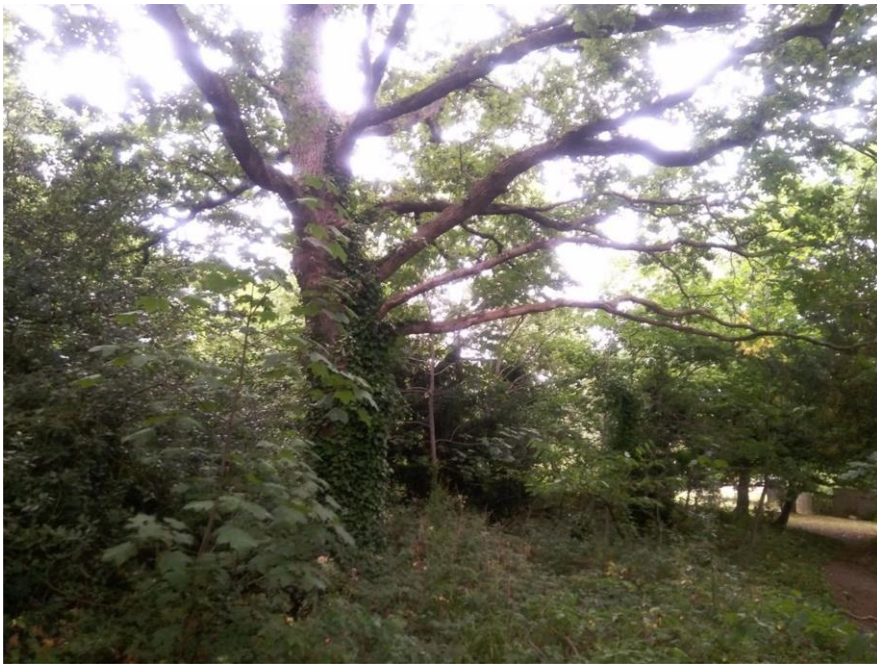
Example of trees in TG13 woodland area – deadwood and ivy throughout larger trees

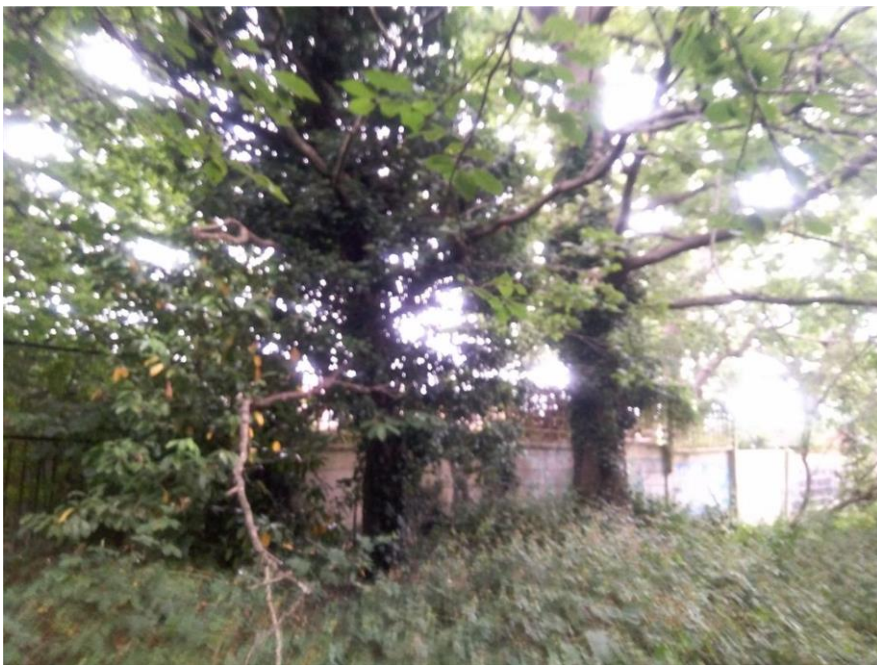
Example of trees in TG13 woodland area –large ivy clad trees adjacent to boundary with 3P land

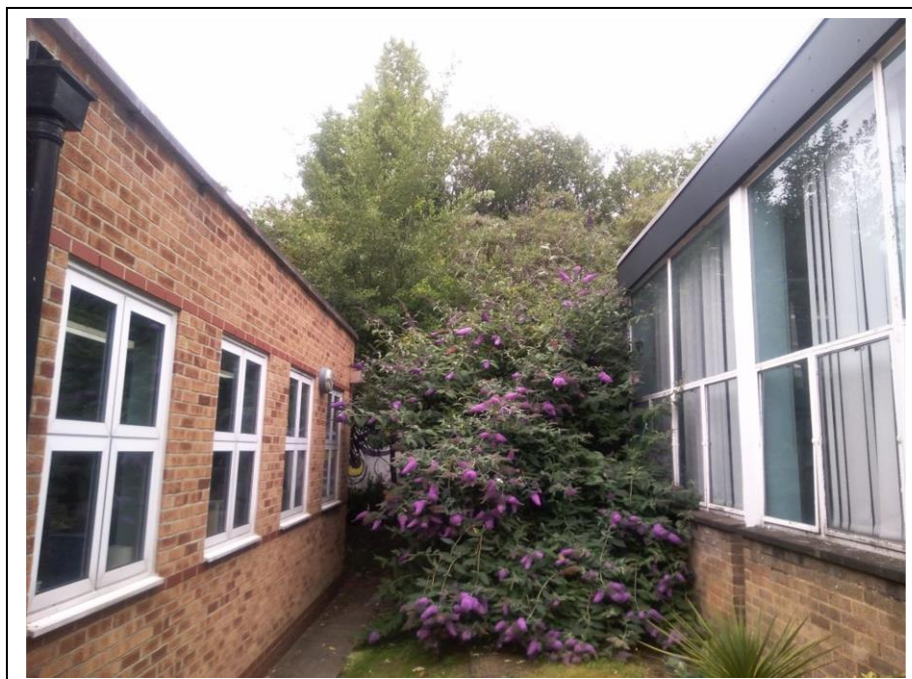
| Ref | Species | Height (m) | DBH (mm) | Crown Spread (m) | Life Stage | Survey Notes | Condition | Risk Level | Works Recommendation | Works Timescale | Inspect Period |
|---|---|---|---|---|---|---|---|---|---|---|---|
| TG11 | Laburnum<br>Yew<br>Goat Willow<br>Almond | 5.5 | 220 | 8.0 | Semi Mature | Lapsed ornamental area with lapsed overgrown shrub understorey. Low crown growth and building encroachment throughout. | Fair | Medium | Remove (fell) Yew, Buddleia, Goat Willow and Laburnum to near ground level and grind out stumps to negate trip hazard. Remove Ivy and deadwood from throughout Almond. Coppice lapsed deciduous shrubs and maintain as part of routine GM. | 6 Months | 2 Years |

View of TG11 – lapsed shrub/scrub understorey in contact with building

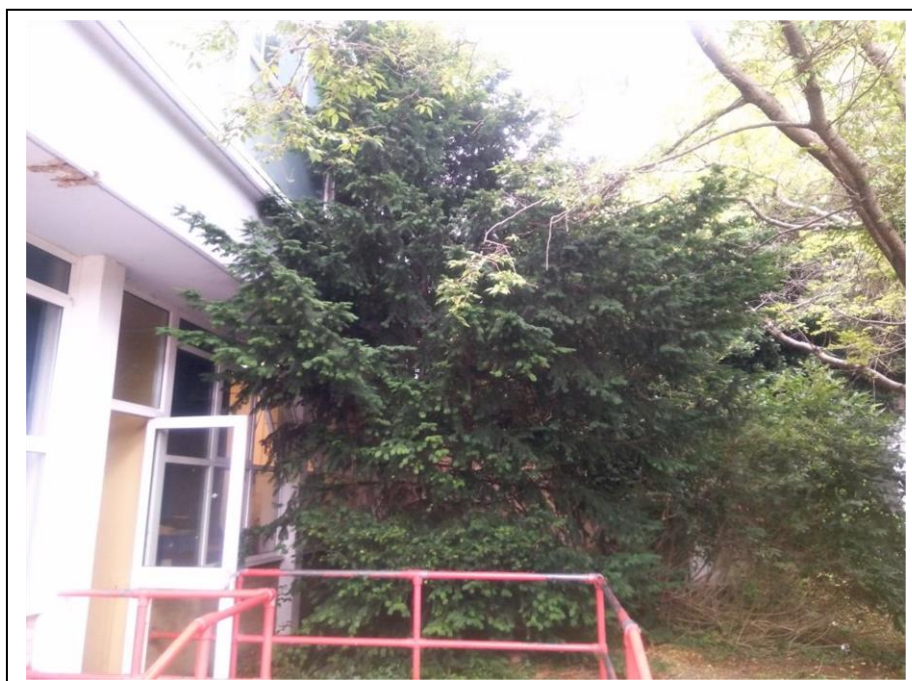
View of TG11 – Yew in contact with building

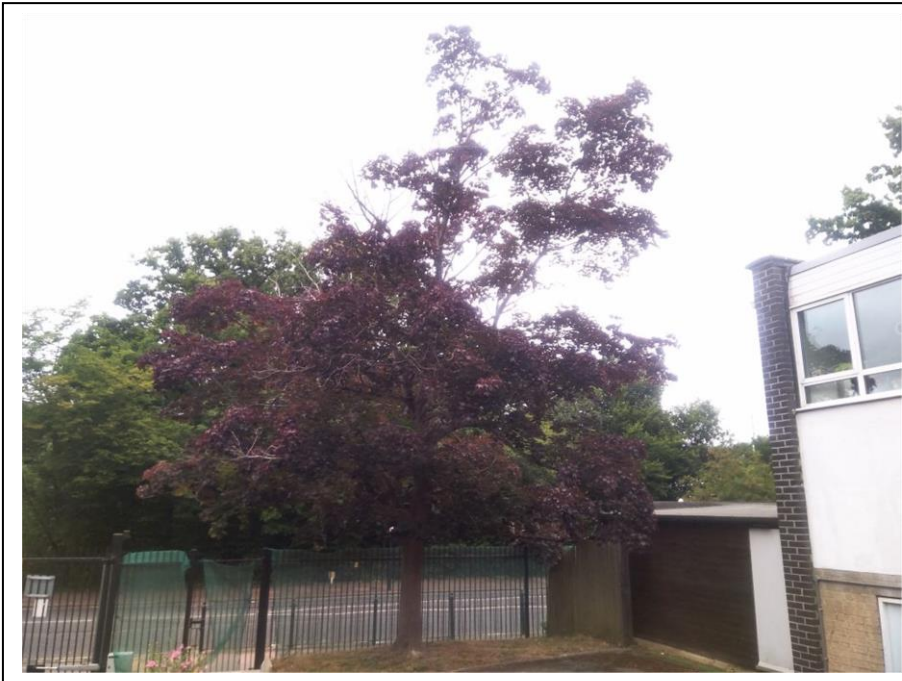
| Ref | Species | Height (m) | DBH (mm) | Crown Spread (m) | Life Stage | Survey Notes | Condition | Risk Level | Works Recommendation | Works Timescale | Inspect Period |
|---|---|---|---|---|---|---|---|---|---|---|---|
| T67 | Maple | 13.5 | 350 | 9.0 | Semi Mature | Bark loss throughout crown. Upper crown dieback - tree is retrenching. Exposed surface roots with mower damage.<br>Tree generally in decline. | Poor | Medium | Remove (fell) to ground level and grind out stump to negate trip hazard. | 3 Months | 2 Years |

View of T67 Maple – bark loss and dieback in upper crown

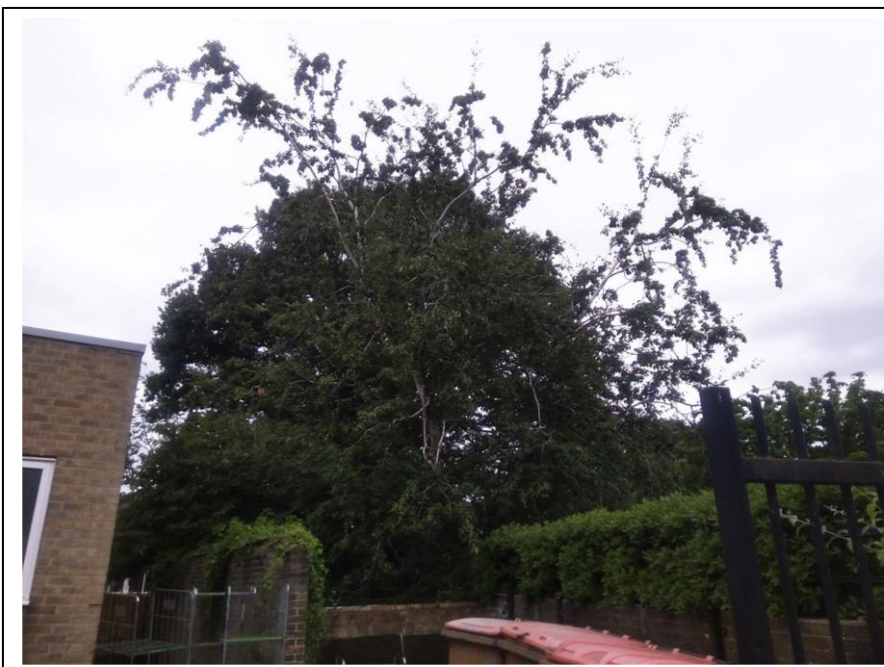
View of T58 Birch - dieback in upper crown

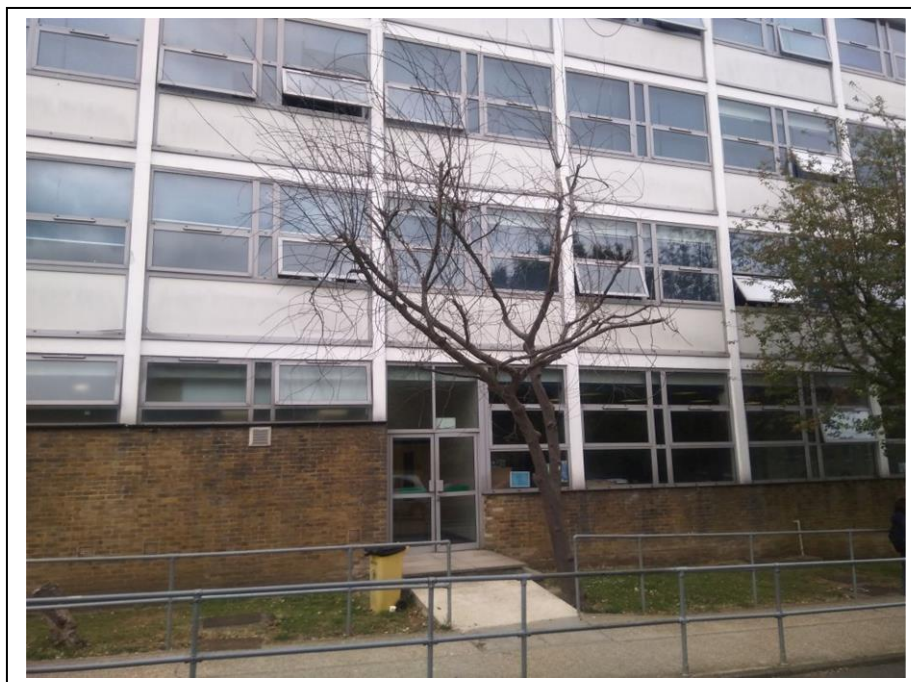
| Ref | Species | Height (m) | DBH (mm) | Crown Spread (m) | Life Stage | Survey Notes | Condition | Risk Level | Works Recommendation | Works Timescale | Inspect Period |
|---|---|---|---|---|---|---|---|---|---|---|---|
| T39 | Bird Cherry | 10.5 | 270 | 6.0 | Dead | Dead tree. | Dead | High | Remove (fell) to near ground level and grind out stump to negate trip hazard. | 3 Months | 1 Year |

View of T39 – dead Bird Cherry

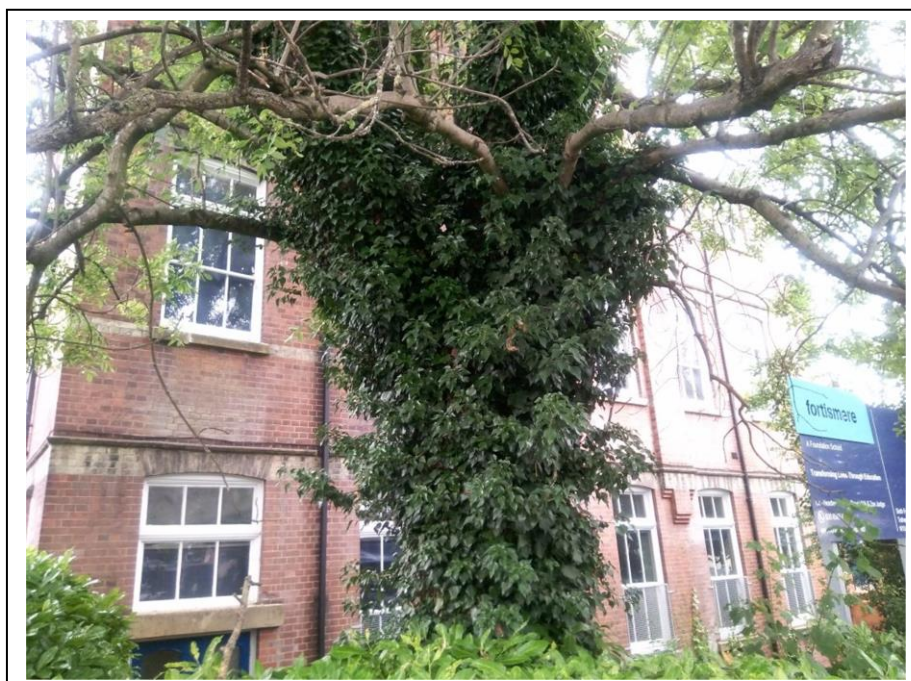
| Ref | Species | Height (m) | DBH (mm) | Crown Spread (m) | Life Stage | Survey Notes | Condition | Risk Level | Works Recommendation | Works Timescale | Inspect Period |
|---|---|---|---|---|---|---|---|---|---|---|---|
| T51 | Ash | 19.5 | 800 | 18.5 | Mature | Ivy colonised main stem and scaffold limb structure - obstructed view of stem condition. Large fully mature tree adjacent to road. | Fair | High | Remove ivy and re-inspect. | 3 Months | 6 Months |

View of T51 Ash - extensive Ivy growth to main stem obstructs view of stem condition
