# Haringey Civic Centre

Additional Architectural Information  
following LBH Carbon Management  
Response

HCC-HBA-XX-XX-RP-A-081001

## **Facade System Condition Survey**

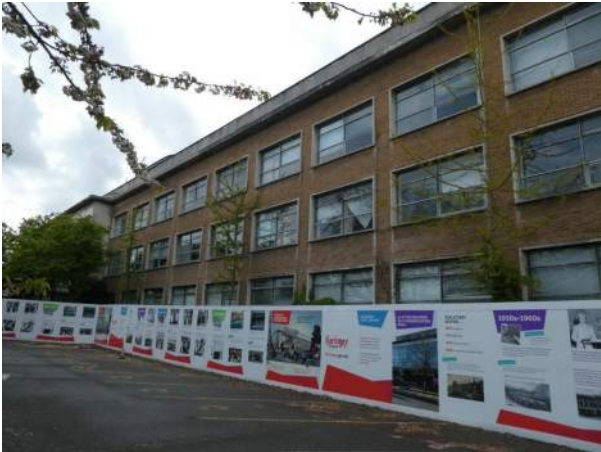
| Selected Photos from Site Inspections<br>Façade Type: Brickwork (1 of 3) | |
|---|---|
| <p><b>Photo 1:</b> East elevation brickwork façade</p> | <p><b>Photo 2:</b> South elevation brickwork façade</p> |

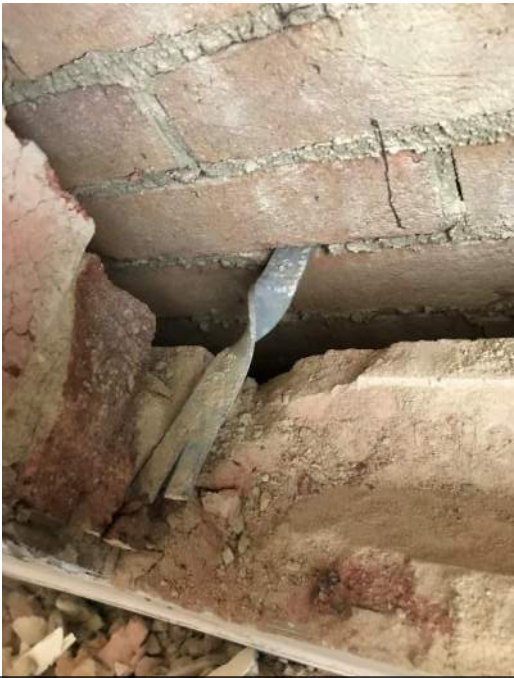
| Selected Photos from Site Inspections<br>Façade Type: Brickwork (1 of 3) | |
|---|---|
| <p><b>Photo 3:</b> Intrusive investigation at location B1, internal, exposing ties and rear face of external brickwork leaf</p> | <p><b>Photo 4:</b> Intrusive investigation at location B2, internal, endoscope imaging, possible corroded metal shelf angle supporting external brickwork leaf</p> |

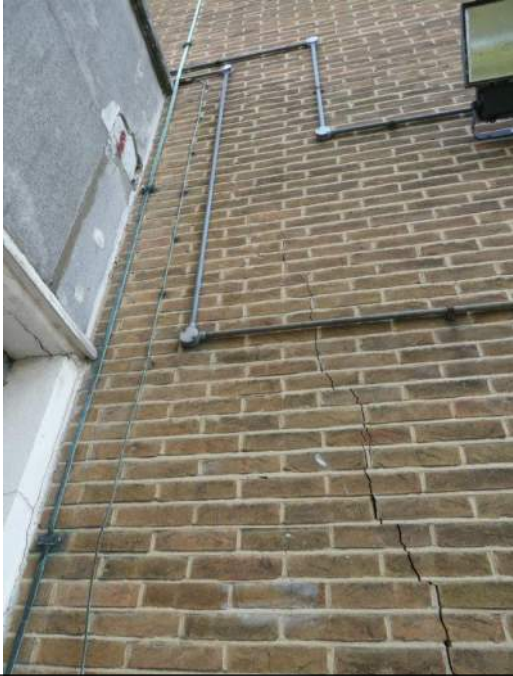
| Selected Photos from Site Inspections<br>Façade Type: Brickwork (2 of 3) | |
|---|---|
| <p><b>Photo 5:</b> Crack in brickwork on South-West corner of the building at fire evacuation staircase</p> | <p><b>Photo 6:</b> Pull-out of fixings between the staircase and outer brickwork leaf</p> |

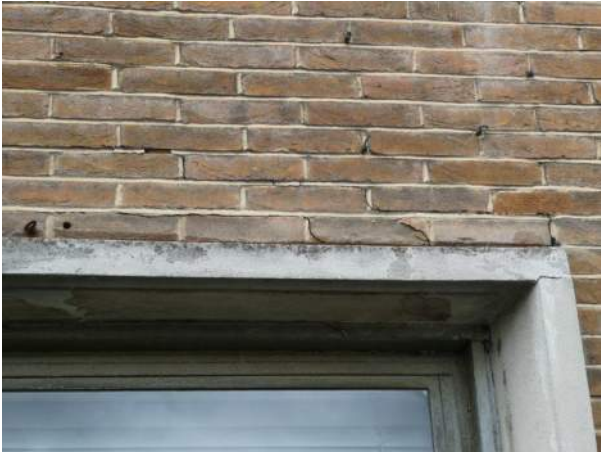
| Selected Photos from Site Inspections<br>Façade Type: Brickwork (2 of 3) | |
|---|---|
| <p><b>Photo 7:</b> Diagonal crack running vertically between window units on North-East corner of the building</p> | <p><b>Photo 8:</b> Articulated crack pattern at North-East corner (alternating between North and East elevations)</p> |

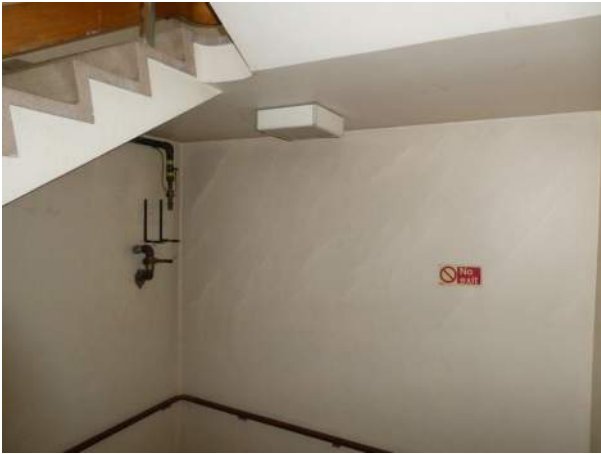
| Selected Photos from Site Inspections<br>Façade Type: Brickwork (3 of 3) | |
|---|---|
| <p><b>Photo 9:</b> Internal diagonal crack pattern at North-East corner</p> | <p><b>Photo 10:</b> Bulging of brickwork on North elevation at Level 2</p> |

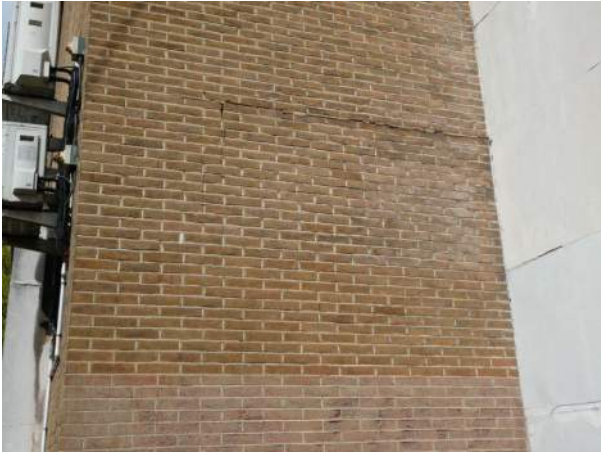
| Selected Photos from Site Inspections<br>Façade Type: Brickwork (3 of 3) | |
|---|---|
| <p><b>Photo 11:</b> South-East corner vertical crack and open joint, brickwork of lighter colour below</p> | <p><b>Photo 12:</b> Concrete surrounding windows deteriorated with some spalling and corroded rebar</p> |

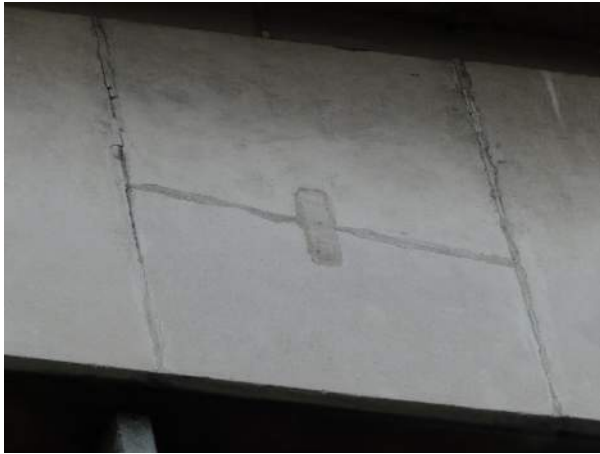
**Photo 17:** Cracking in precast concrete panels above curtain walling (main entrance) on East elevation

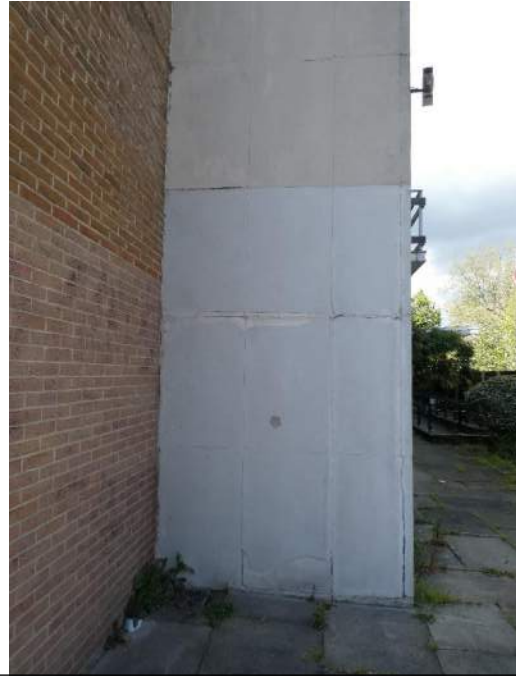
**Photo 18:** Lighter colour concrete panels at South-East corner, with skewed joints in render

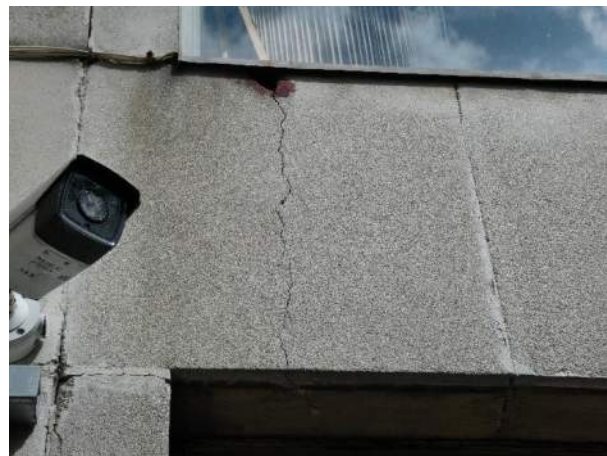
**Photo 20:** Cracking and exposed reinforcement (with red oxide paint) in precast concrete panels

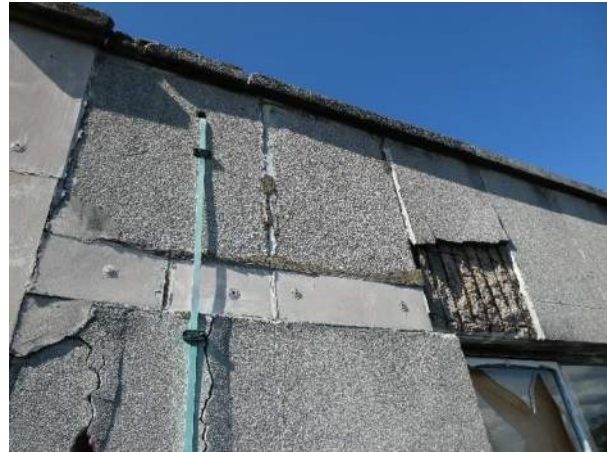
- Panels at level 3 in much worse condition with concrete spalling and extensive reinforcement corrosion generally, replacement of a large number of panels at this level may be needed.

**Photo 22:** Extensive damage to precast panels at Level 3 (South elevation) with spalling/cracking and exposed corroded reinforcement

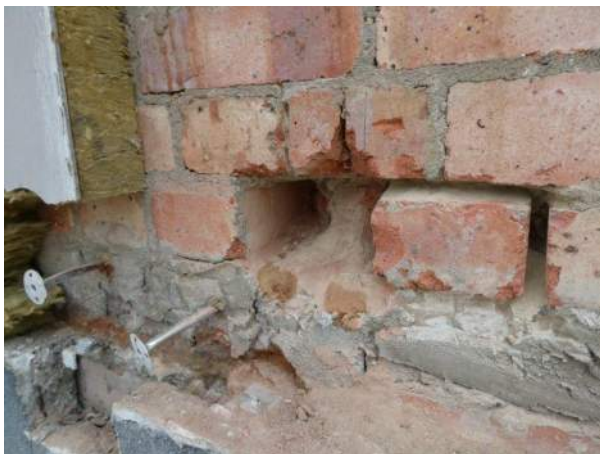
**Photo 23:** Intrusive investigation location P1, outer face of inner brickwork leaf, and steel fixings

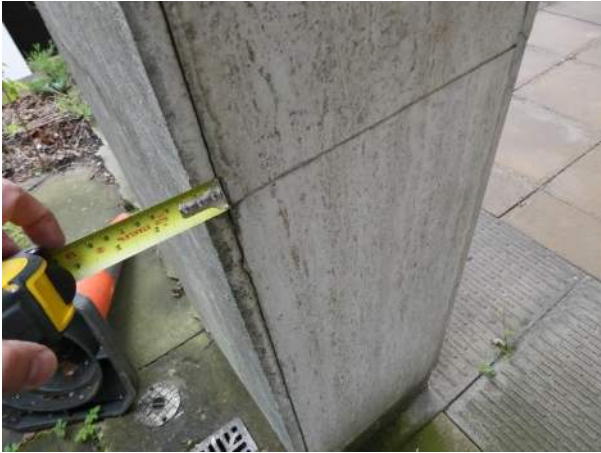
| Selected Photos from Site Inspections<br>Façade Type: Stone Cladding (1 of 1) | |
|---|---|
| <p><b>Photo 27:</b> Small displacements between adjacent stone panels, and degraded seals between panels</p> | <p><b>Photo 28:</b> Chips and cracks observed in some stone cladding panels</p> |

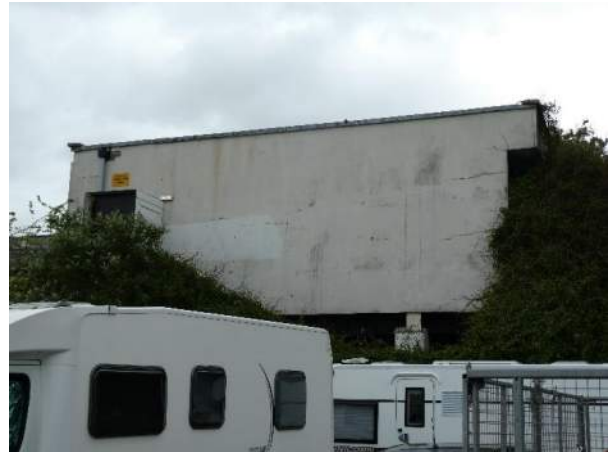
**Photo 30:** Render on West elevation of 'West wing', with extensive cracking, locations of primary structure highlighted through cracking

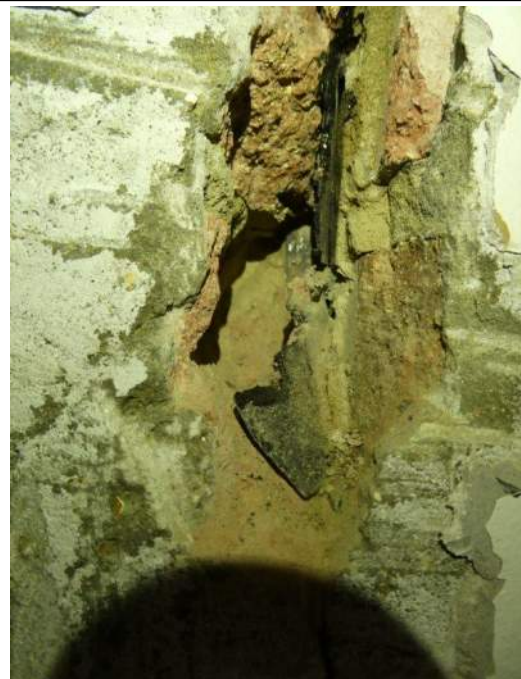
**Photo 32:** Intrusive investigation R1 at movement joint internally with bituminous membrane and compressible board

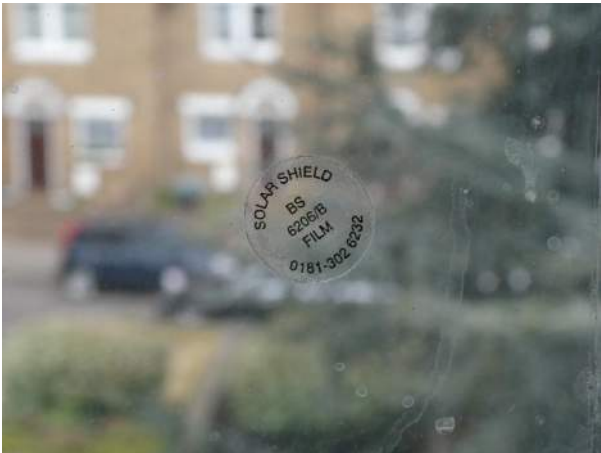
| Selected Photos from Site Inspections | |
|---|---|
| Photo 35: Internal solar shield film label | Photo 36: Glass damage to curtain walling at Level 2 on North elevation |

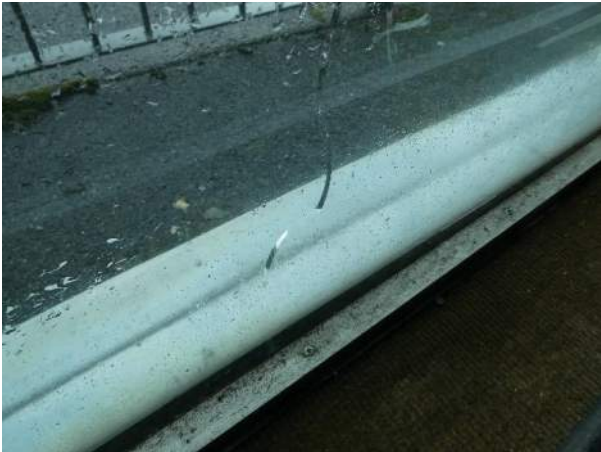
| Selected Photos from Site Inspections | |
|---|---|
| <p><b>Photo 37:</b> Cracking in 'thick' glazing build-up on West elevation at ground level (Northern end)</p> | <p><b>Photo 38:</b> Cracked glass panel on 'West wing' (North Elevation)</p> |

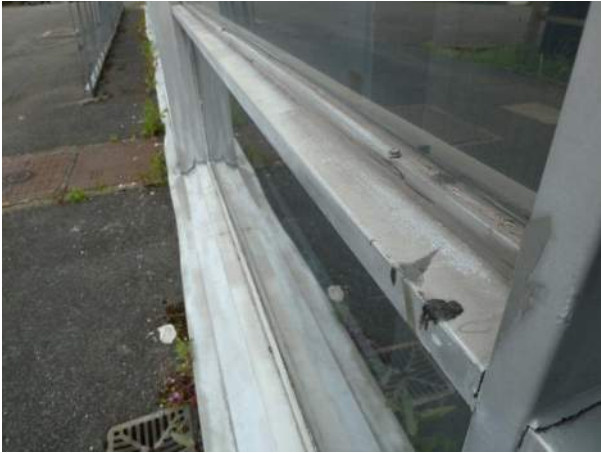
| Selected Photos from Site Inspections | |
|---|---|
| <p><b>Photo 39:</b> Aluminium curtain walling on West elevation (ground level)</p> | <p><b>Photo 40:</b> Example of peeling coating on aluminium finish (West elevation)</p> |

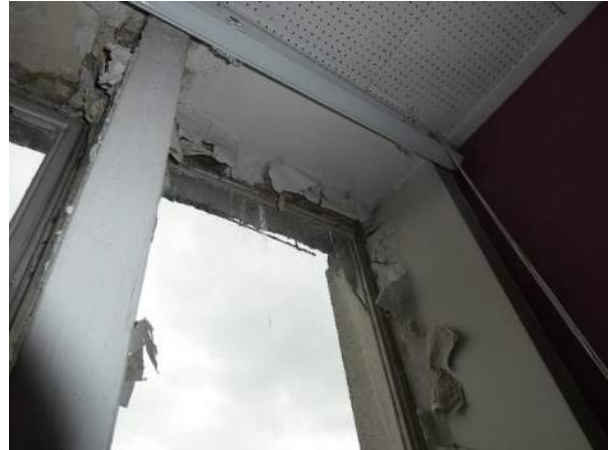
**Photo 42:** Enlarged view of Photo 41, moisture ingress around steel window system

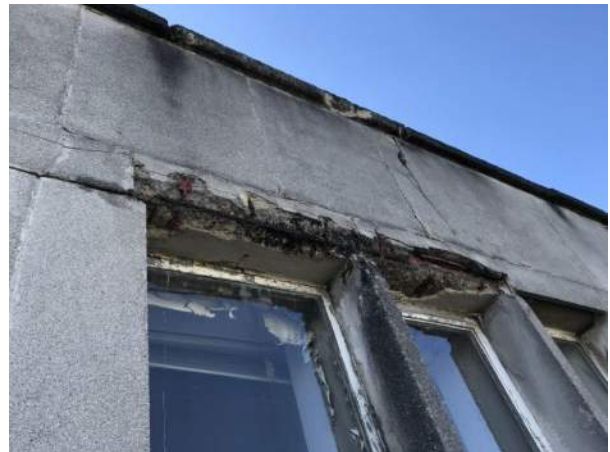
**Photo 44:** Damage to precast concrete panels around perimeter of window system, and degradation of concrete 'fins'

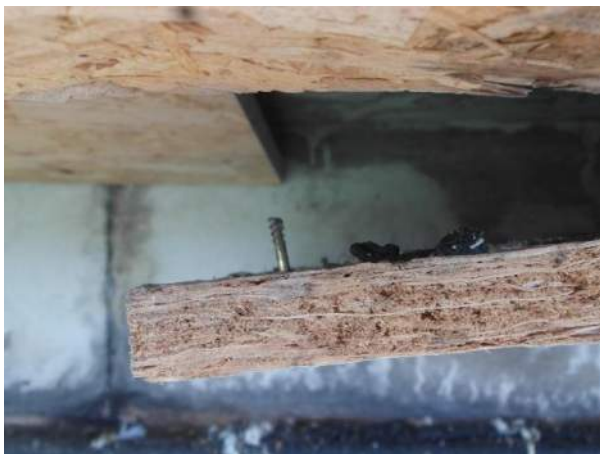
**Photo 47:** Example of failed fixing in Sterling boards installed

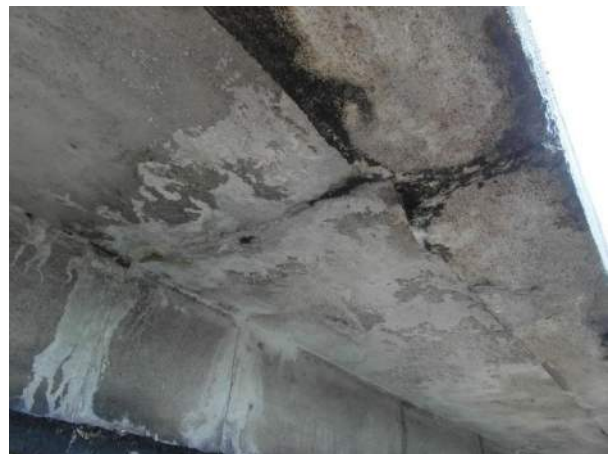
**Photo 48:** Water run-off on stone cladding above brickwork

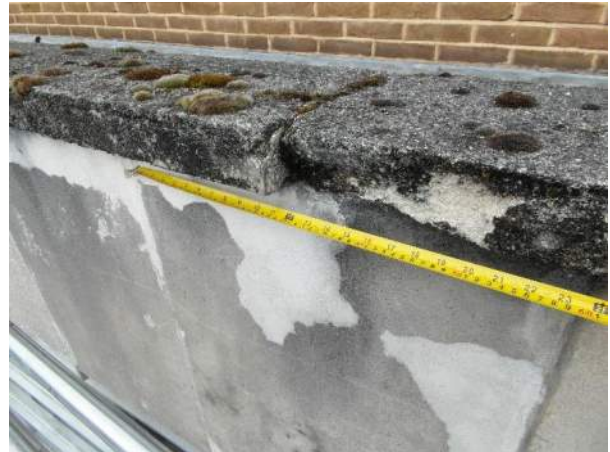
**Photo 50:** Degradation of stone coping above precast concrete cladding (with peeling render layer)

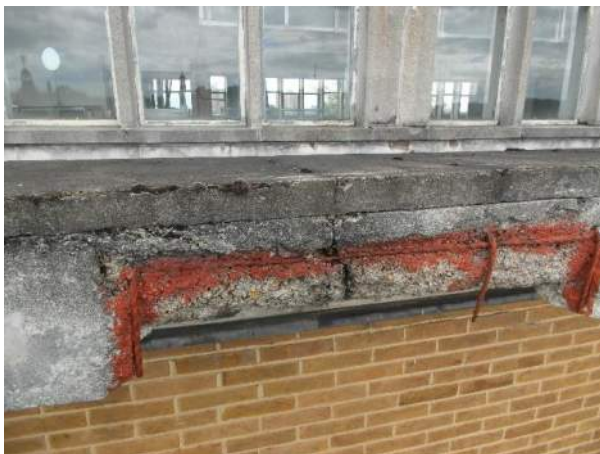
**Photo 51:** Example of failed cornice panels, with exposed corroded rebar (with red oxide paint previously applied)

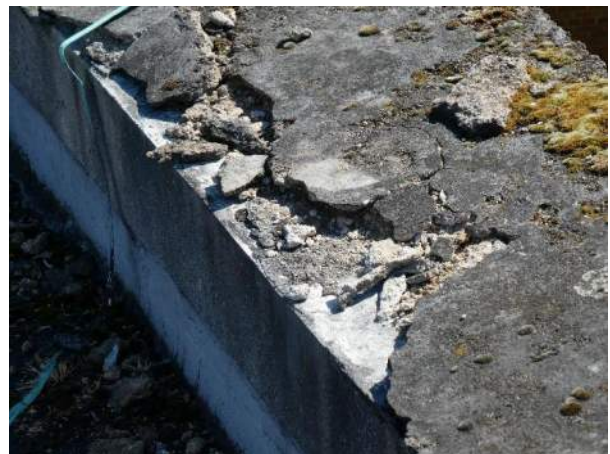
**Photo 52:** Degradation of stone coping on sky face

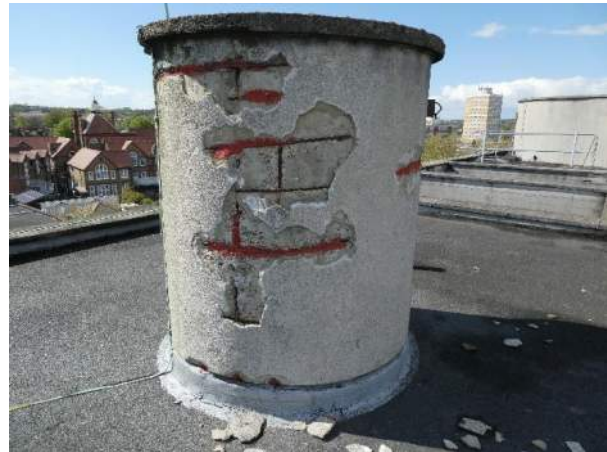
**Photo 54:** Boiler flue with extremely decayed concrete

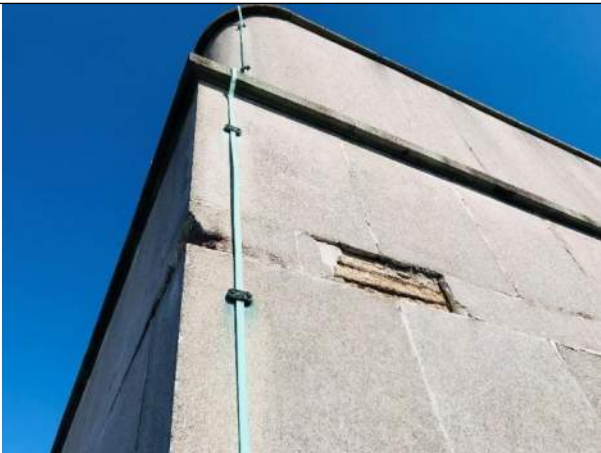
| Selected Photos from Site Inspections<br>Façade Type: Other Items (2 of 7) | |
|---|---|
| Photo 61: Spalled concrete at corner | Photo 62: Evidence of water ingress through panel joints |

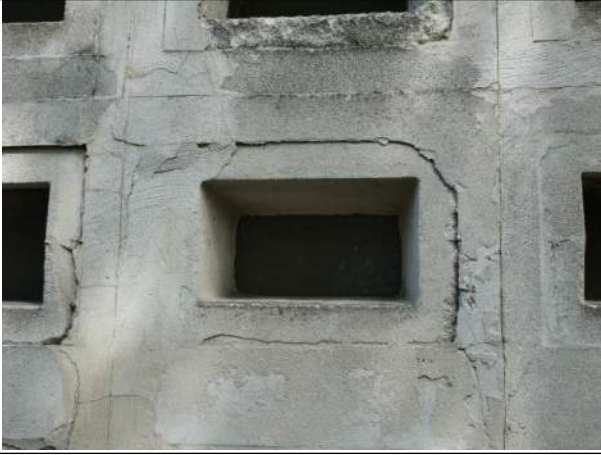
| Selected Photos from Site Inspections<br>Façade Type: Other Items (3 of 7) | |
|---|---|
| Photo 63: Wood panels replacing missing precast concrete cladding elements | Photo 64: Glazing in punched concrete panels replaced with wood |

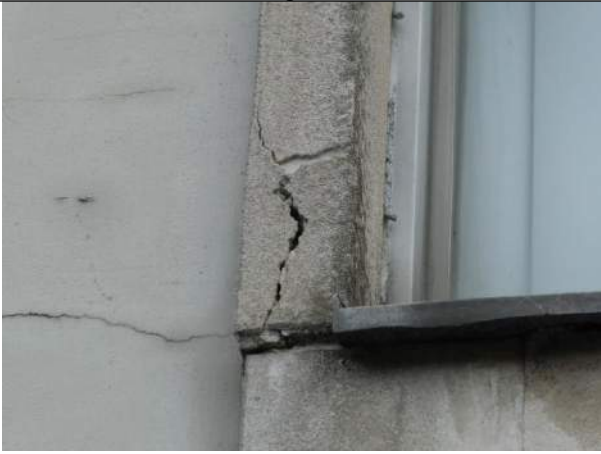
| Selected Photos from Site Inspections<br>Façade Type: Other Items (3 of 7) | |
|---|---|
| Photo 65: Cracking in jamb | Photo 66: Wood panels replacing missing precast concrete cladding elements |

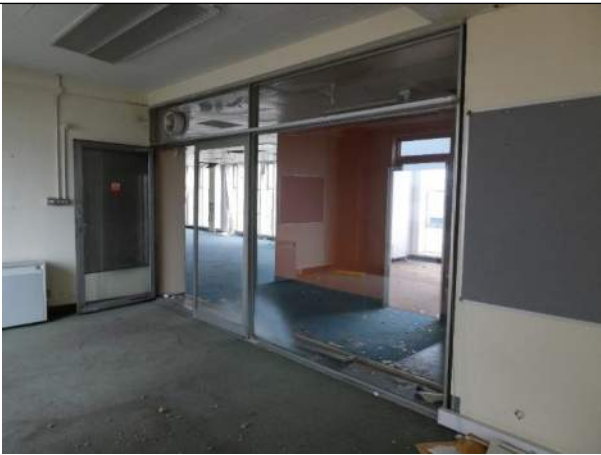
| Selected Photos from Site Inspections<br>Façade Type: Other Items (3 of 7) | |
|---|---|
| Photo 67: Possible previous external glazing, now internal | Photo 68: Cracking and exposed reinforcement in concrete panel |

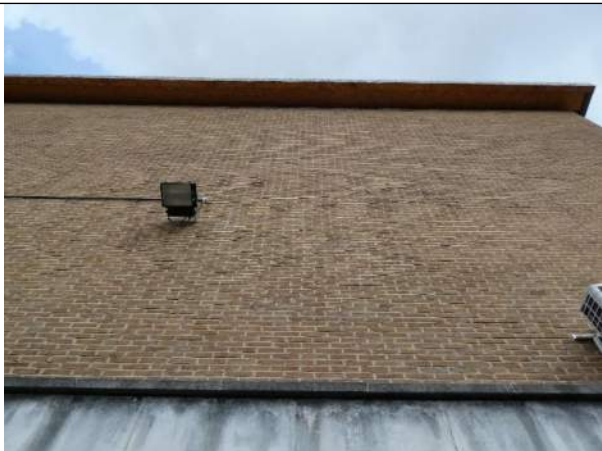
| Selected Photos from Site Inspections<br>Façade Type: Other Items (5 of 7) | |
|---|---|
| Photo 79: spalled concrete, exposed reinforcement (note: no evidence of red oxide paint / possible recent event) | Photo 80: Vertical mortar joints misaligned in brickwork |

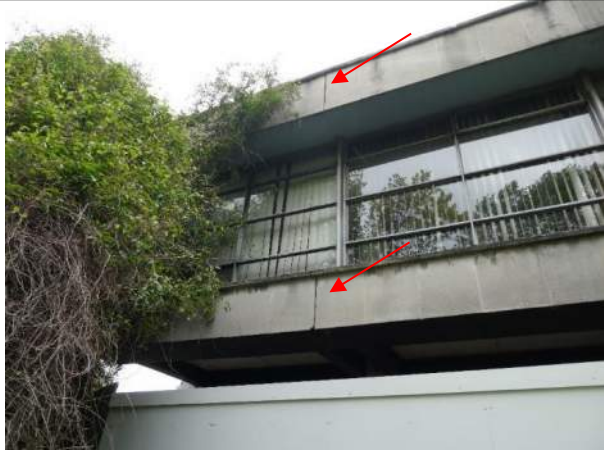
| Selected Photos from Site Inspections<br>Façade Type: Other Items (7 of 7) | |
|---|---|
| <p><b>Photo 87:</b> Open gap between panels, possibly expression of the movement joint / tree branches in close proximity of glazing</p> | <p><b>Photo 88:</b> Metal panel to access the external walkway</p> |

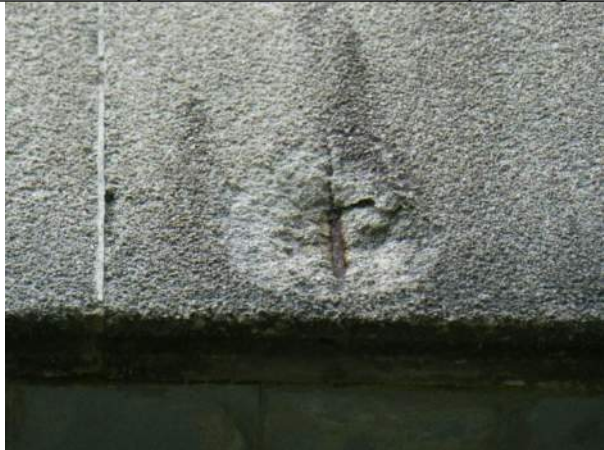
| Selected Photos from Site Inspections<br>Façade Type: Other Items (7 of 7) | |
|---|---|
| <p><b>Photo 89:</b> Degraded concrete panels</p> | |

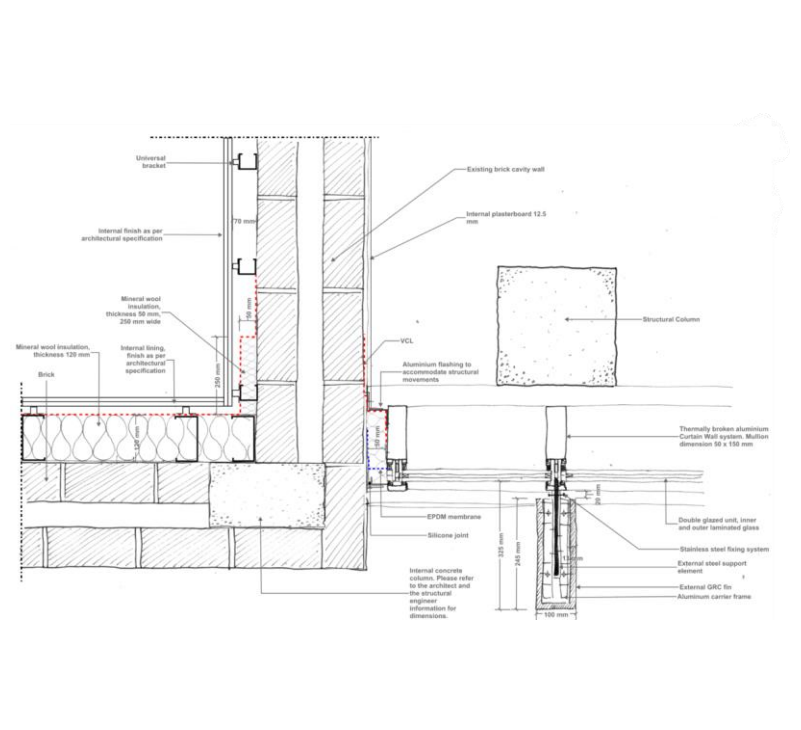
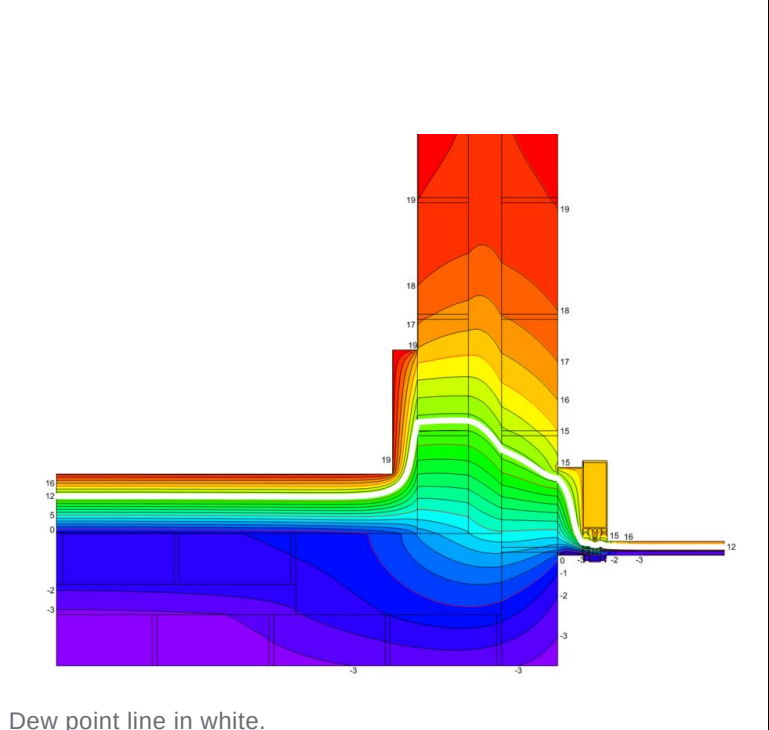
| Boundary conditions | | Detail | Condensation analysis results | Comments |
|---|---|---|---|---|
| | D21 | | <p>Dew point line in white.</p> | <p>Insulation is placed to the inner face of the existing civic centre north brick wall to achieve the required façade thermal performances. The façade of the north link consists of an insulated curtain wall.</p> <p>An insulation panel 250mm wide and 50 mm thick is placed to the left side of the internal wall to avoid thermal bridge due to the existing west brickwork wall penetrating the thermal line.</p> <p>VCL is required between the insulation and plasterboard layer to prevent possible condensation phenomena.</p> |
