# Arboricultural Consultancy for Aviva

| Insured | Ms Rachel Palin | Address | 44 Lancaster Road, London, N4 4PR | | |
| Client | Subsidence Management Services | Contact | Ian Domigan | Claim No. | IFS-AVI-SUB-22-0104436 |
| Report Date | 27/01/2023 | | | | |

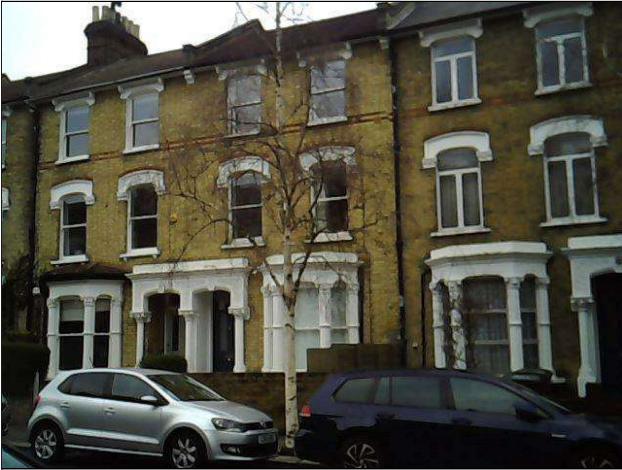
T1 - Birch

| Tree No. | Species | Age Cat | Approx. Height (m) | Distance to Building (m) * | Ownership | Action | Requirement |
|---|---|---|---|---|---|---|---|
| T1 | Birch | 1 | 11.5 | 9.5 | B - Local Authority | Action to avoid future risk | Maintain at broadly current dimensions by way of regular pruning. |

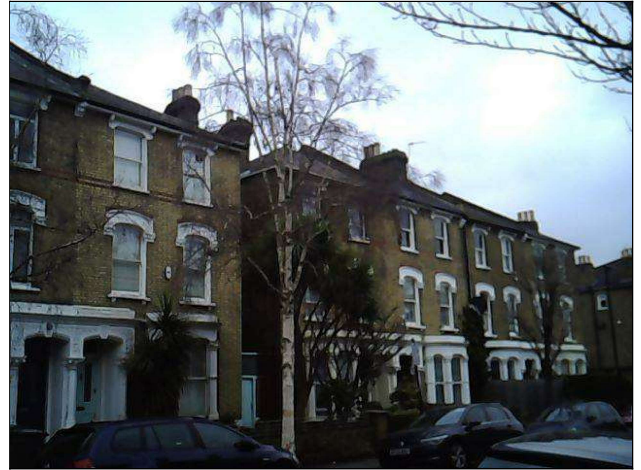
T2 - Birch

With due regards to species profile, size and proximity, T2 (Birch) and T5 (Cherry) are considered the dominant features proximate to the focal area of movement and accordingly, where vegetation is confirmed as being causal, we have identified them as the primary cause of the current subsidence damage.

| Tree No. | Species | Age Cat | Approx. Height (m) | Distance to Building (m) * | Ownership | Action | Requirement |
|---|---|---|---|---|---|---|---|
| T2 | Birch | 1 | 13.5 | 5.2 | B - Local Authority | Remove | Remove close to ground level; do not treat stump due to translocation risk. Where such a risk exists, we advise that any emergent regrowth is removed annually. |

Consequently, we have advocated the complete removal of T2 (Birch), T3 (Palm), T4 (Palm) and T5 (Cherry) as it will offer the most certain arboricultural solution likely to restore long-term stability.

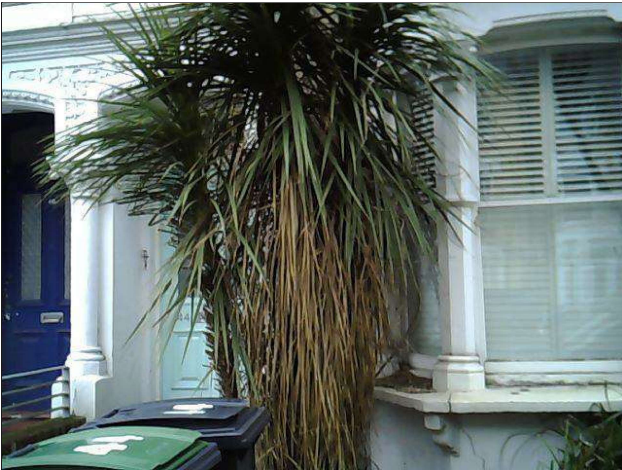
T3 - Palm

T3 (Palm) and T4 (Palm) are also considered to retain a contributory influence, albeit in a secondary capacity when compared to the above.

| Tree No. | Species | Age Cat | Approx. Height (m) | Distance to Building (m) * | Ownership | Action | Requirement |
|---|---|---|---|---|---|---|---|
| T3 | Palm | 1 | 4 | 1 | C - Insured | Remove | Remove close to ground level and treat stump to inhibit regrowth. |

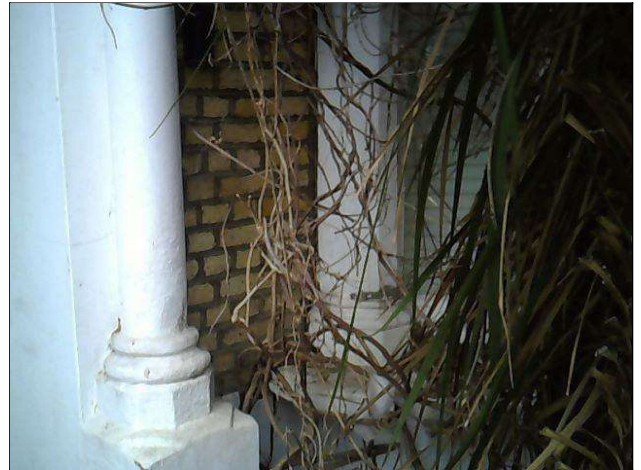
C1 - Vine

| Tree No. | Species | Age Cat | Approx. Height (m) | Distance to Building (m) * | Ownership | Action | Requirement |
|---|---|---|---|---|---|---|---|
| C1 | Vine | 1 | 3 | 0.2 | C - Insured | Action to avoid future risk | Do not allow to exceed current dimensions by way of regular pruning. |

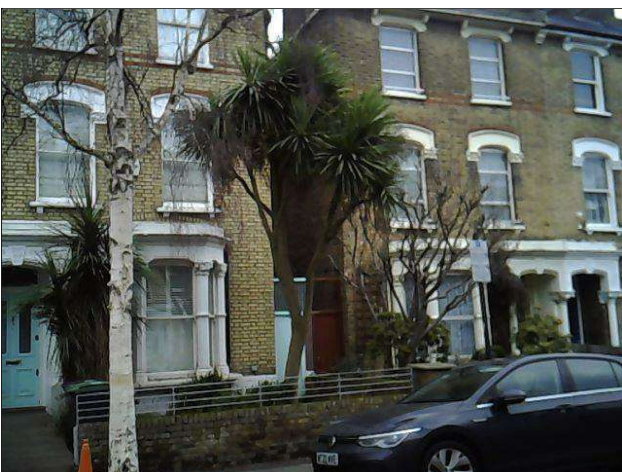
T4 - Palm

| Tree No. | Species | Age Cat | Approx. Height (m) | Distance to Building (m) * | Ownership | Action | Requirement |
|---|---|---|---|---|---|---|---|
| T4 | Palm | 1 | 6.5 | 2.7 | C - Insured | Remove | Remove close to ground level and treat stump to inhibit regrowth. |

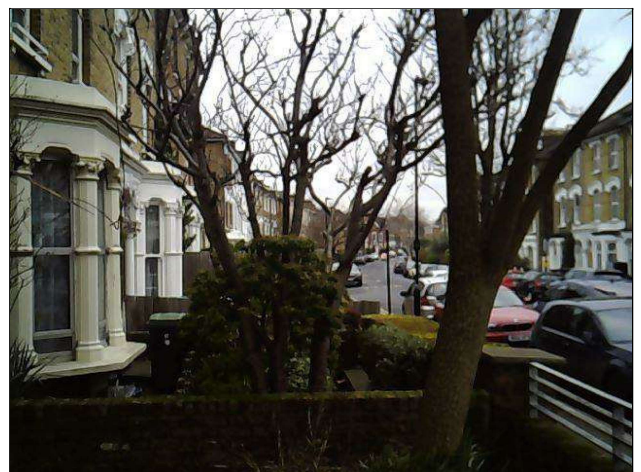
T5 - Cherry

| Tree No. | Species | Age Cat | Approx. Height (m) | Distance to Building (m) * | Ownership | Action | Requirement |
|---|---|---|---|---|---|---|---|
| T5 | Cherry | 1 | 4.3 | 3.3 | A - Third Party | Remove | Remove close to ground level and treat stump to inhibit regrowth. |

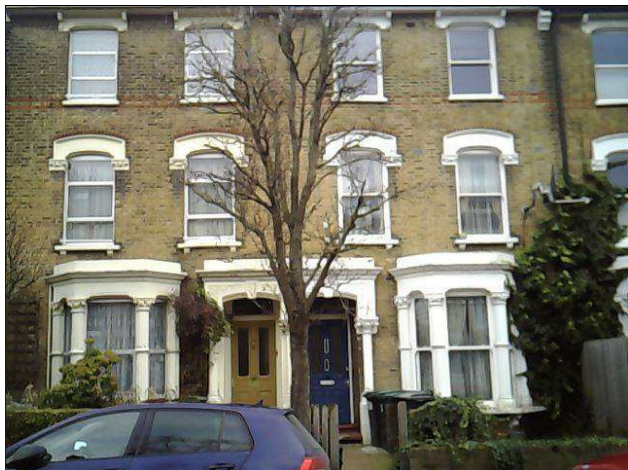
T6 - Ornamental pear

| Tree No. | Species | Age Cat | Approx. Height (m) | Distance to Building (m) * | Ownership | Action | Requirement |
|---|---|---|---|---|---|---|---|
| T6 | Ornamental pear | 1 | 7 | 10.5 | B - Local Authority | Action to avoid future risk | Maintain at broadly current dimensions by way of regular pruning. |

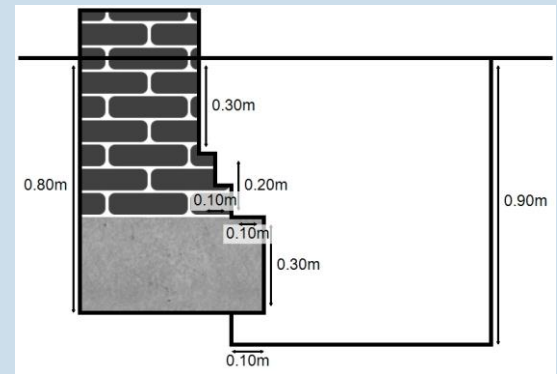
## TP/BH1 Foundation Detail and Borehole Log

Bay foundation comprised of brick wall to 300mm bgl, bearing on stepped brickwork to 500mm bgl with a total projection of 100mm from the elevation. In turn, bearing on concrete to 800mm bgl with a total projection of 200mm from the elevation. Underside of foundation (USF) was exposed to 100mm back from the face of the foundation and probed 450mm back from the face of the foundation.
