# **Hutton + Rostron Environmental Investigations Limited**

## **Hornsey Town Hall: Façade masonry condition investigation**

**Site note 1 for 3 and 8 August 2018, job no. 405.73**

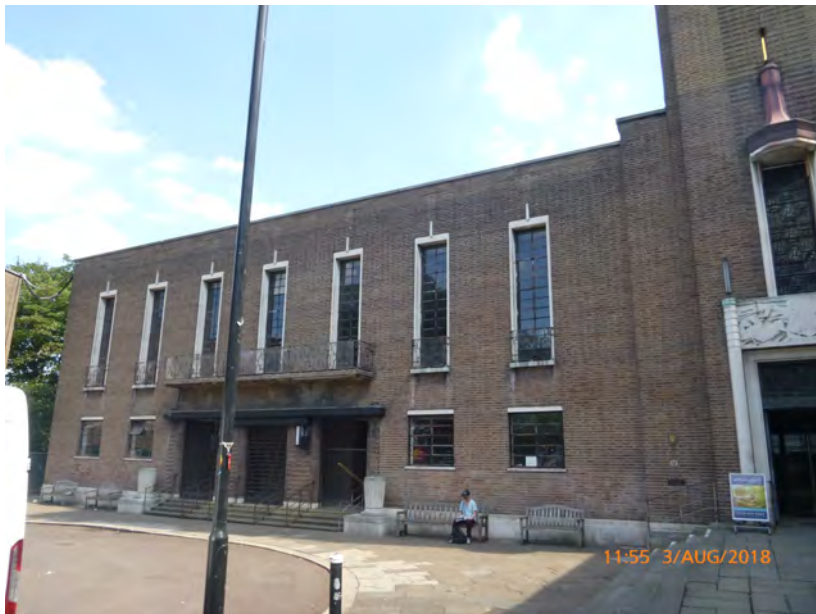
**Fig 1:**

Elevation 1; showing general view.  
Note previous re-point to parapet

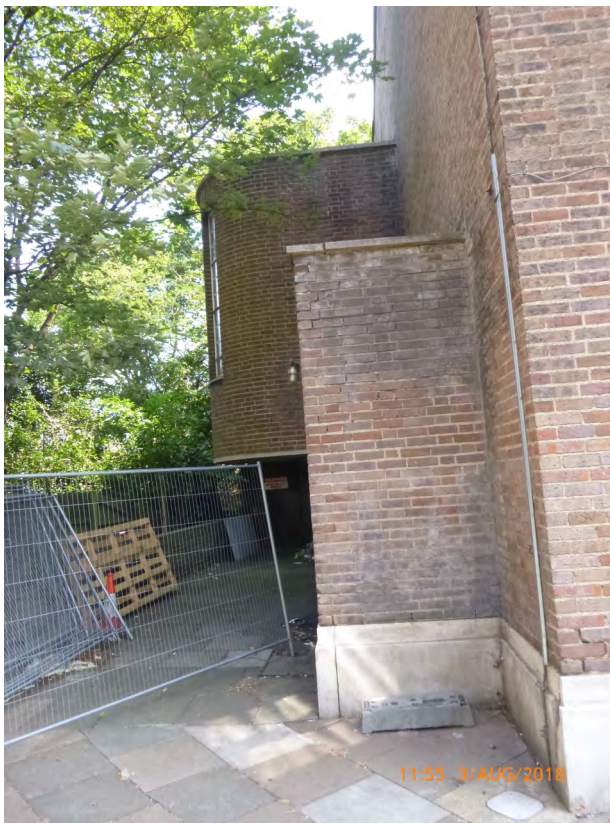
**Fig 3:**

Elevation 1; showing north end. Note water staining associated with failure of the flat roof/drainage

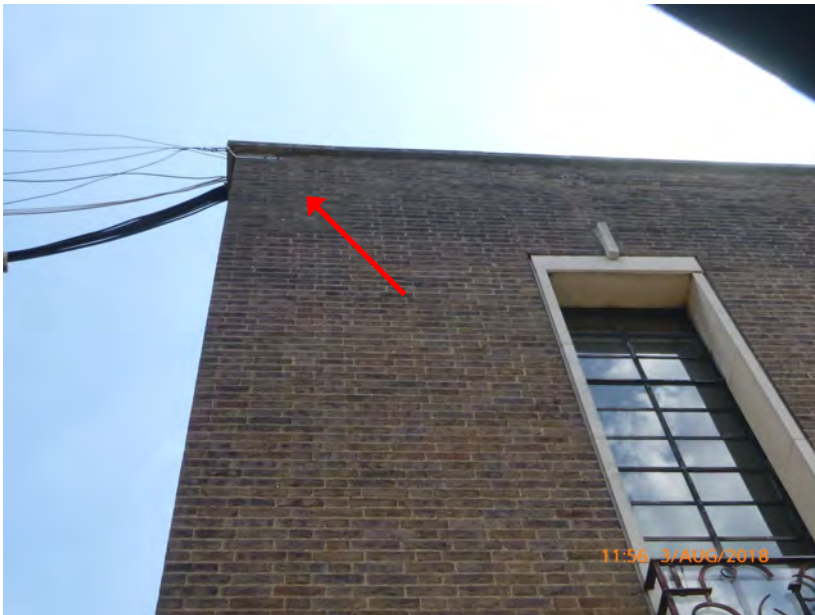
**Fig 4:**

Elevation 1; showing north end. The upper corner appeared to have been partially re-built in the past. Cracking and displacement was noticed around window apertures

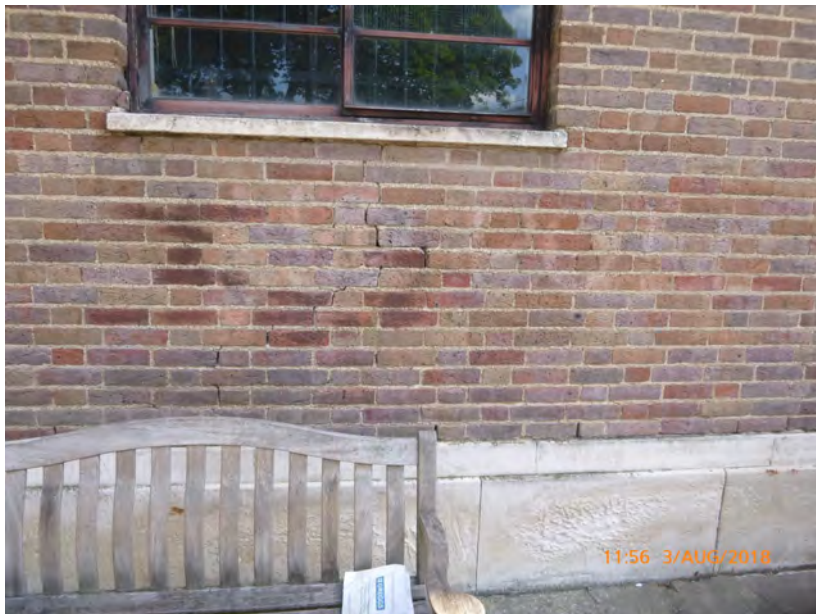
**Fig 5:**

- 4 Previous graffiti removal at the base of the west elevation has been poorly executed. Use of excessive force has resulted in damage/abrasion to the surface of bricks. Fortunately, the extent of damage does not appear to have significantly compromised the durability of bricks. However, when viewed closely, the original aesthetic has been degraded

Elevation 1; showing base of wall superficially damaged by aggressive cleaning works in the past

- 5 *In the view of H+R, wholesale cleaning of the Town Hall is not necessary or recommended. Localised cleaning of stained areas can be considered for aesthetic improvement, although this would only be worthwhile after water ingress defects have been rectified. An over-all light clean could be undertaken during a staged scaffold strike so as to remove construction debris and light soiling at the end of the works*

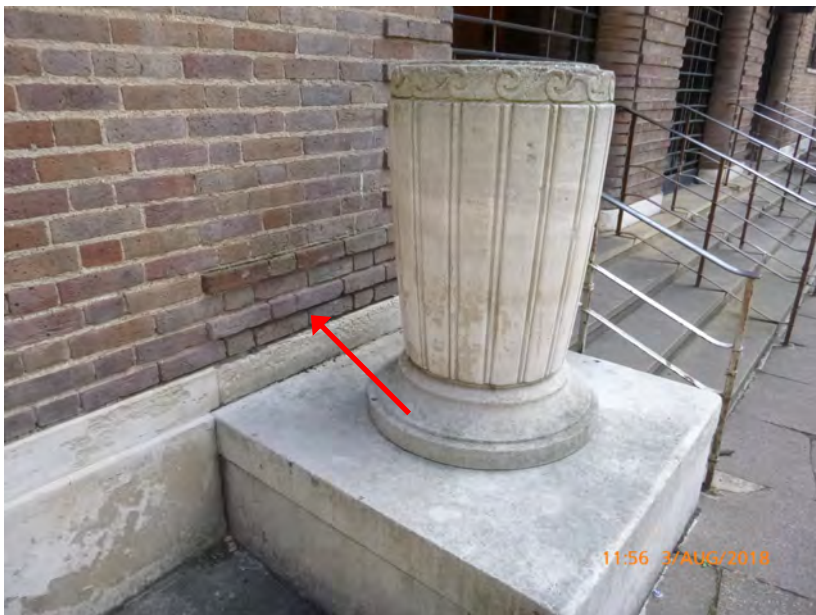
**Fig 6:**

Elevation 1; showing localised mortar failure at base of wall. The damp-proof course was not readily apparent (asphalt found elsewhere). Perhaps the stone plinth was intended as a damp-proofing course

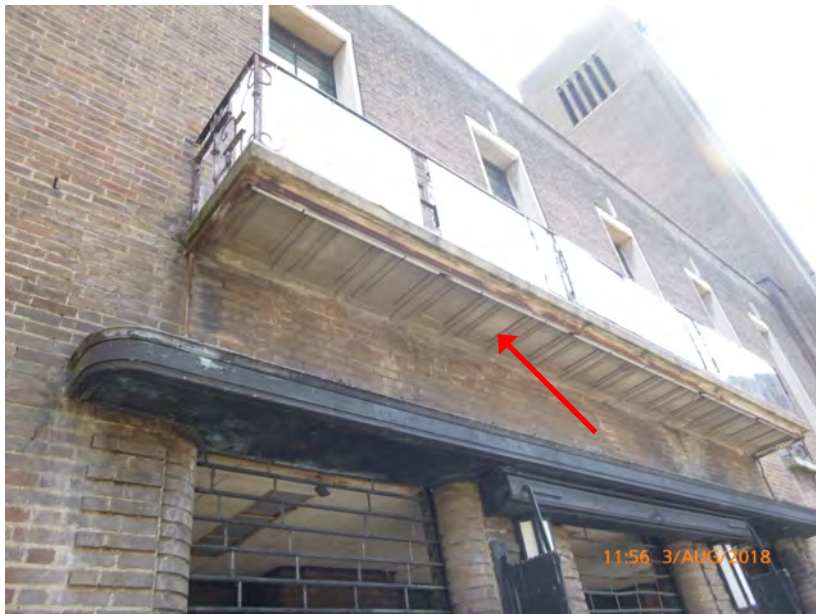
**Fig 7:**

Elevation 1; showing concrete cantilever balcony. Water staining below indicated drainage failure. There were no visible defects affecting the underside although embedded steel may be vulnerable to corrosion

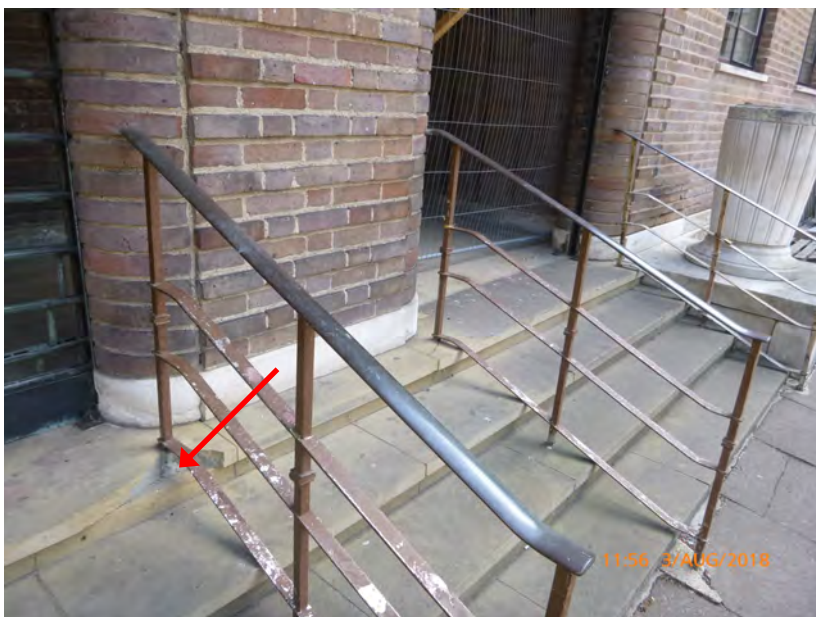
**Fig 8:**

Elevation 1; showing entrance steps subject to localised damage. These may or may not be original

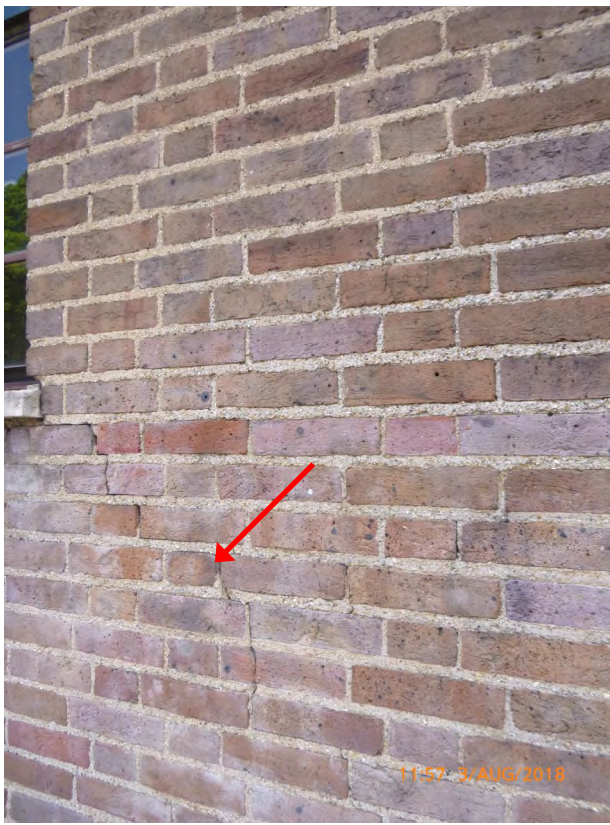
**Fig 9:**

Elevation 1; showing crack emanating from window aperture

Also note irregular brick bond pattern

- 6 *The Structural Engineer should review cracking and direct remedial works. Provisionally allow for cutting-out and replacing brickwork in areas of cracking using matching materials and possibly also including bed joint reinforcement (e.g. helix rods). It may also be necessary to expose and remediate defective embedded steel framework*

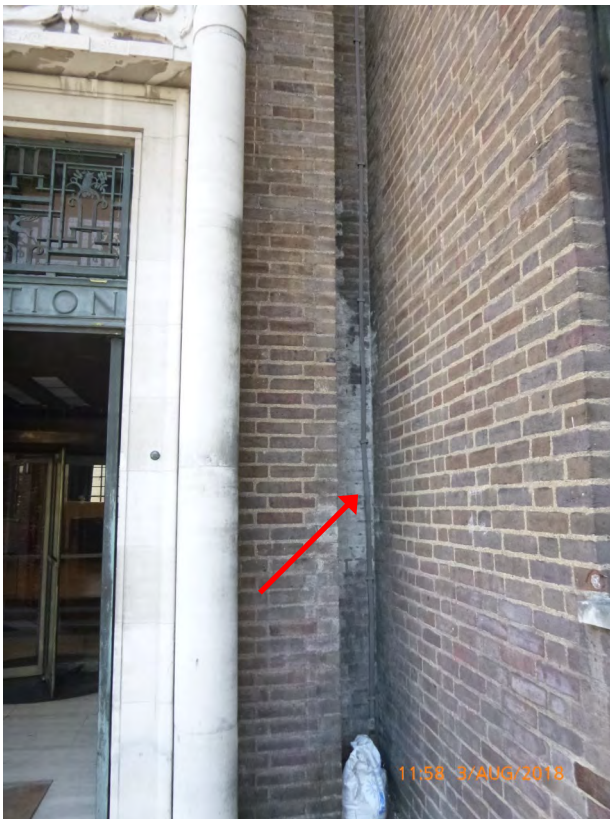
**Fig 10:**

Elevation 1; showing localised staining suspected to relate to a plumbing leak

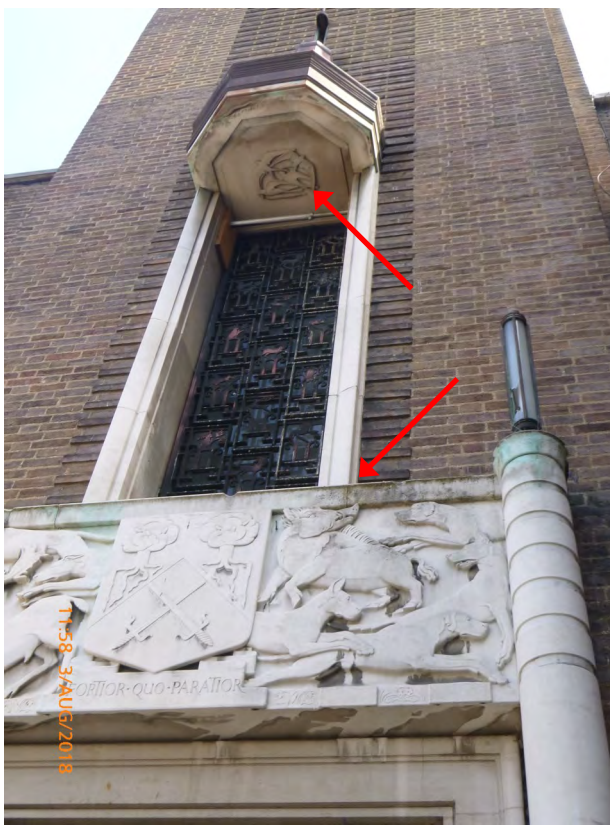
**Fig 11:**

Elevation 1; showing brace fitted across window opening, purpose unknown

Also note cosmetic damage to stone frieze and copper-oxide run-off staining

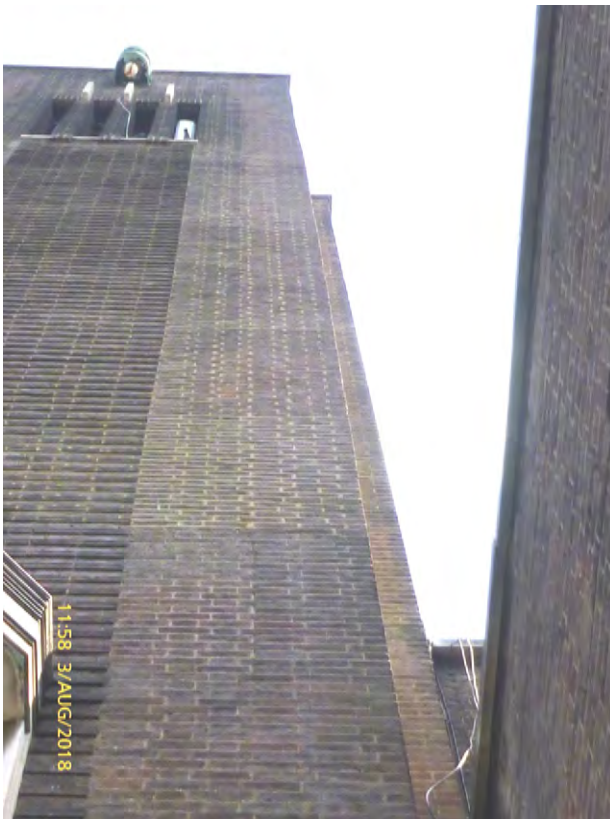
**Fig 12:**

Elevation 1; showing view of re-pointed and partially re-built brickwork to tower

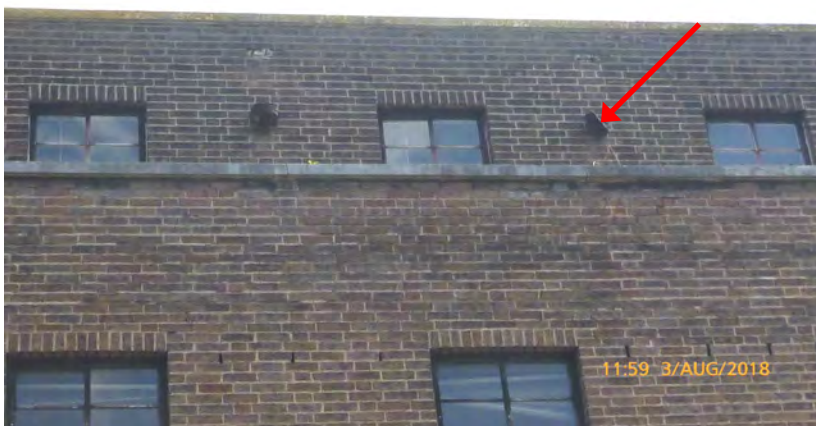
**Fig 14:**

Elevation 1; showing degraded pointing below copings and redundant flagpole brackets

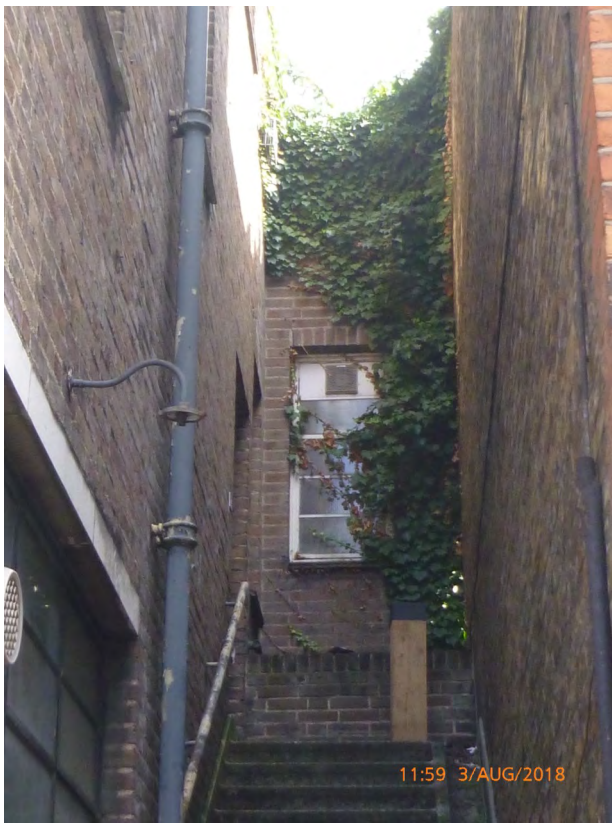
**Fig 15:**

Elevation 1; showing south end. Plant overgrowth restricted survey

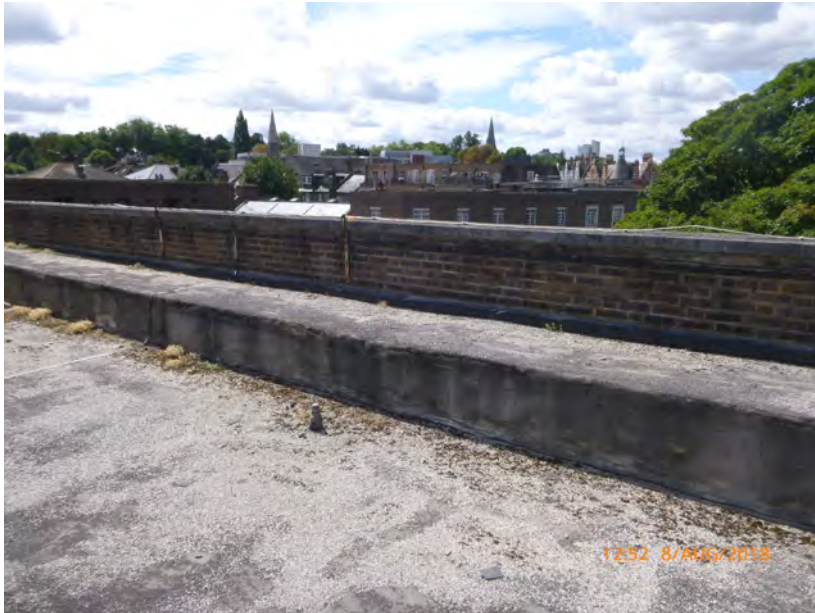
**Fig 17:**

Elevation 1, north side; showing high level view

Note upstand in roof may correspond with structural framework

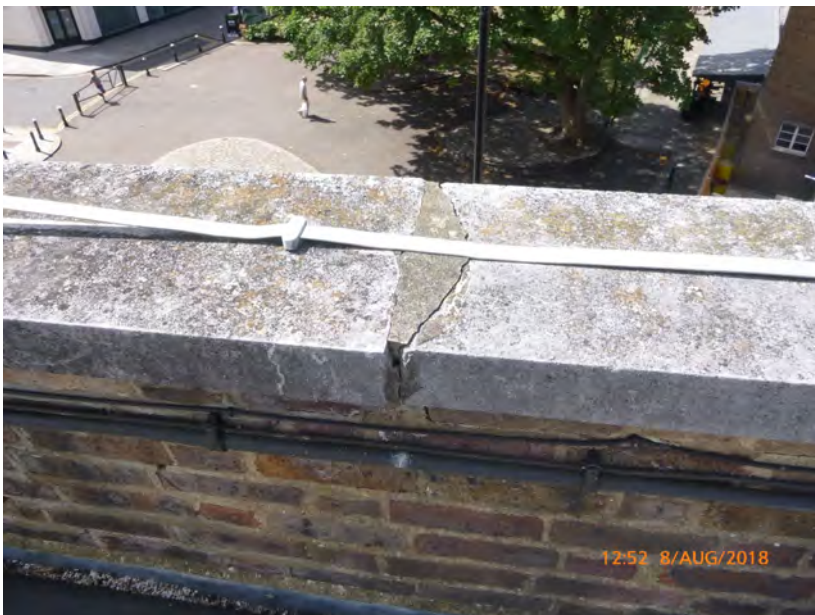
**Fig 18:**

Elevation 1, north side; showing previous damage to copings, apparently where cramp fixings did not allow for normal thermal movement

- 2 *Damaged stone units may be replaced in matching limestone or repaired in-situ using colour matched stone repair mortar (e.g. a mix of hydraulic lime binder and limestone-dust aggregate). Subject to the view of the Structural Engineer, it may be prudent to omit cramps from the top face of new/refurbished copings so as to avoid recurrent damage by movement stresses (alternative restraint could be achieved by using stainless steel dowels located into lugs at the underside of copings)*

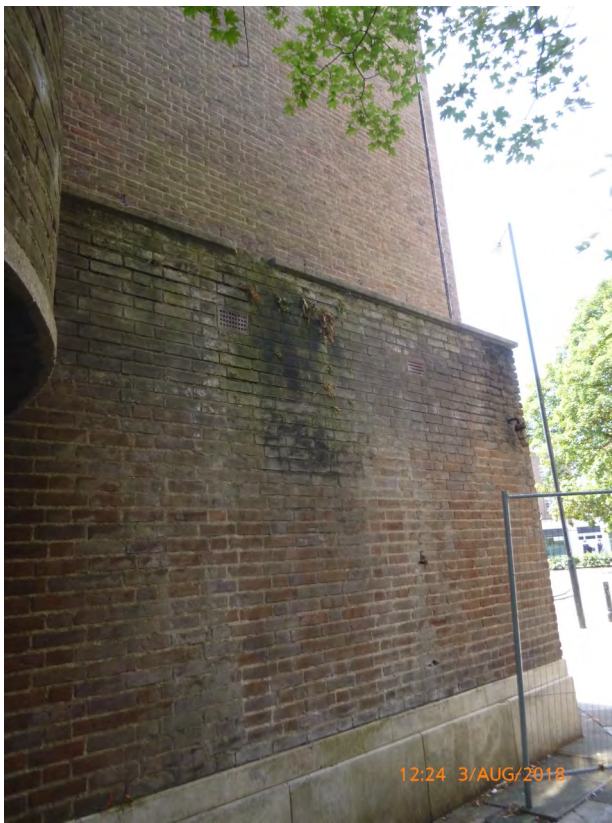
**Fig 19:**

Elevation 2, west side; showing damp affected brickwork subject to staining and rooted plant growth

Note damaged stone coping

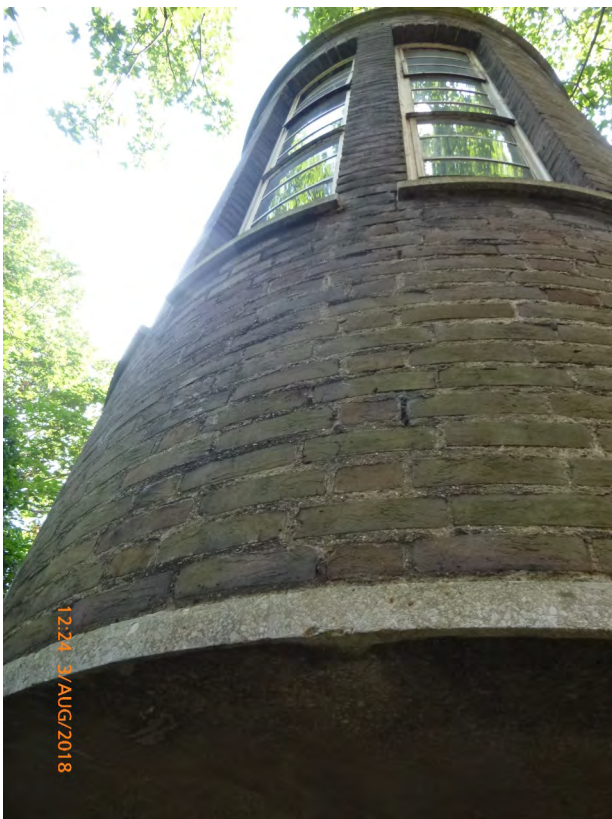
**Fig 20:**

Elevation 2, west side; showing stair structure supported onto a projecting cantilever structure

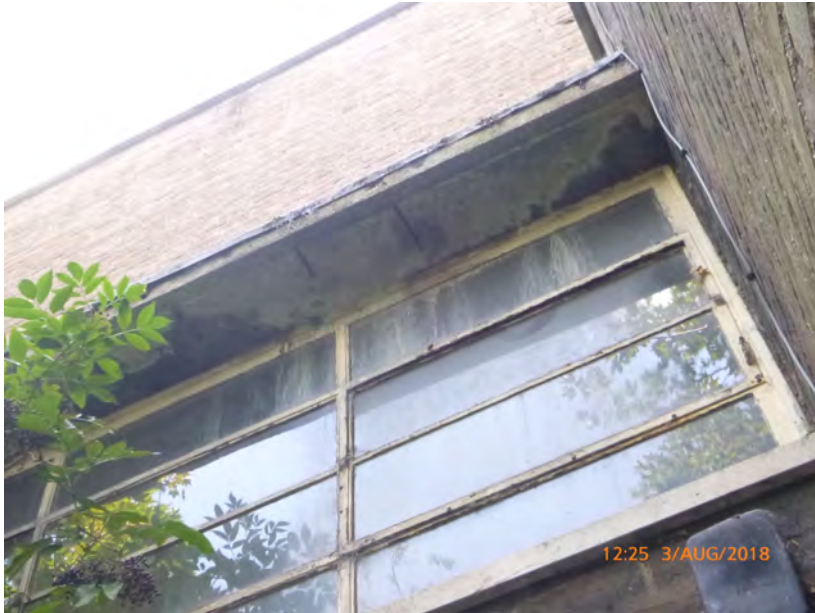
**Fig 21:**

Elevation 2, west side; showing spalled RC roof soffit

- 3 *RC features represent a high risk of latent damage and falling masonry due to inherent construction flaws. The most robust risk management option would be to entirely replace these units using modern reconstituted stone products of a matching appearance*

- 4 *Alternatively, defective areas can be repaired in-situ. This would involve removing all loose fragments, cutting back underlying corroded steel (or cleaning to expose bare metal), priming and decorating steel in rust inhibitor and patch repairing in a matching mortar. In some areas, this is likely to be a more realistic approach in relation to time and cost incurred. However, the landlord and/or building operator will be at risk in terms of latent failures. Mitigation measures can be put in place such as;*

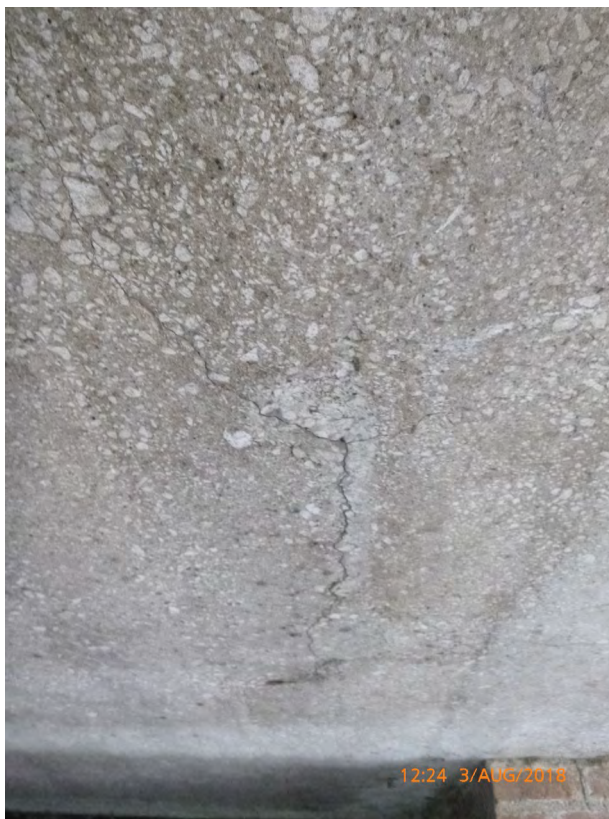
**Fig 22:**

Elevation 2, west side; showing spalled RC soffit (below cantilever stairwell)

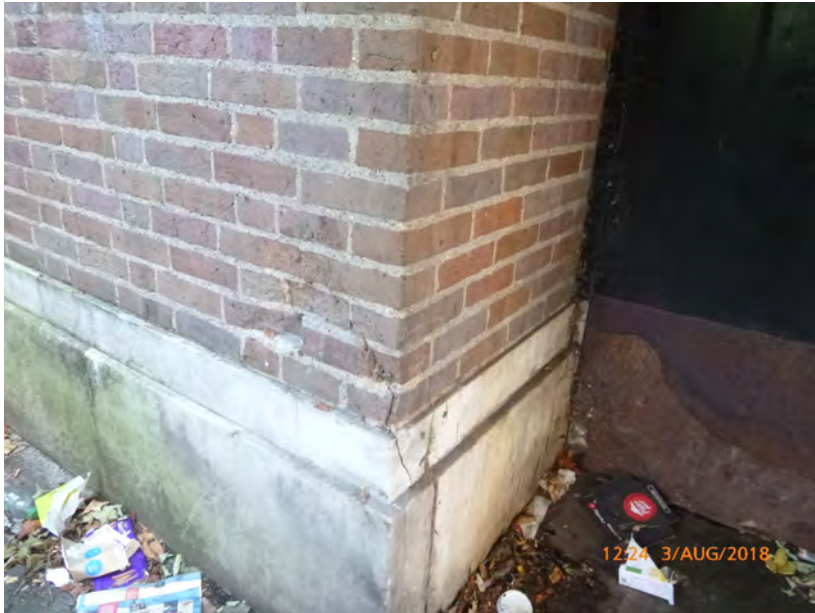
**Fig 23:**

Elevation 2, west side; showing cracked and displaced brickwork. This may correspond with the base of a steel frame stanchion. This could be subject to corrosion and/or without adequate provision for differential movement

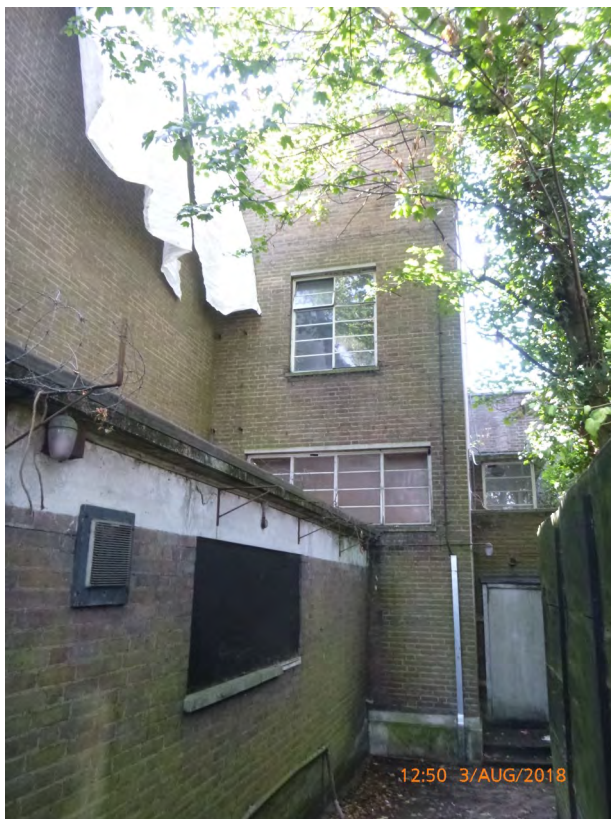
**Fig 24:**

Elevation 2, return wall; showing section of wall not shown on plans

Brickwork was subject to significant diagonal cracking

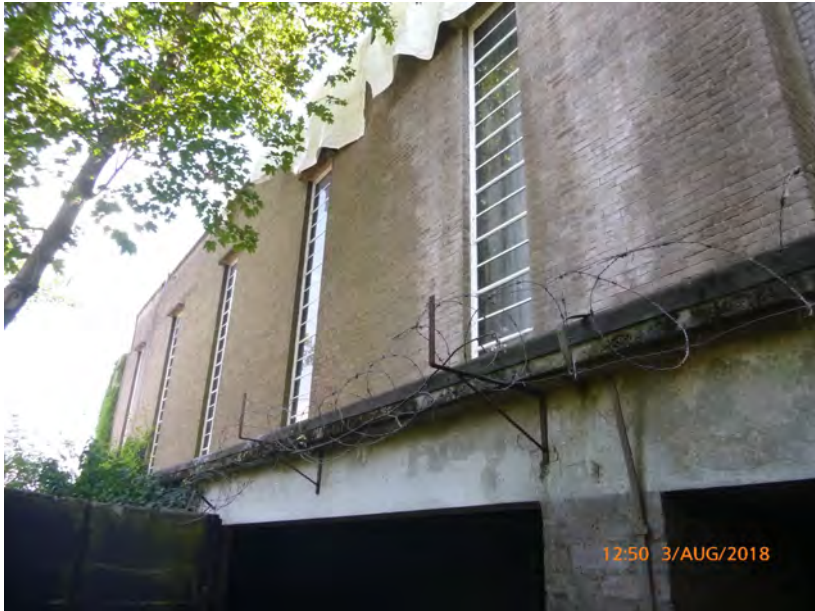
**Fig 25:**

Elevation 2, east side; showing spalled RC roof soffit at low level

Also note tarpaulins laid over the roof at high level. These were an inappropriate and ineffective attempt to shed water from the main roof

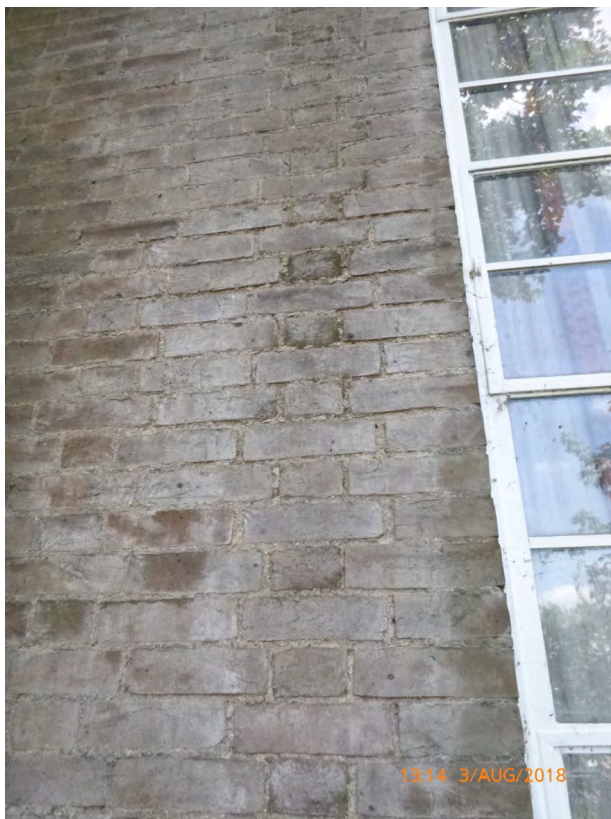
**Fig 26:**

Elevation 2, east side; showing surface deterioration to mortar in areas subject to water penetration and salt emergence

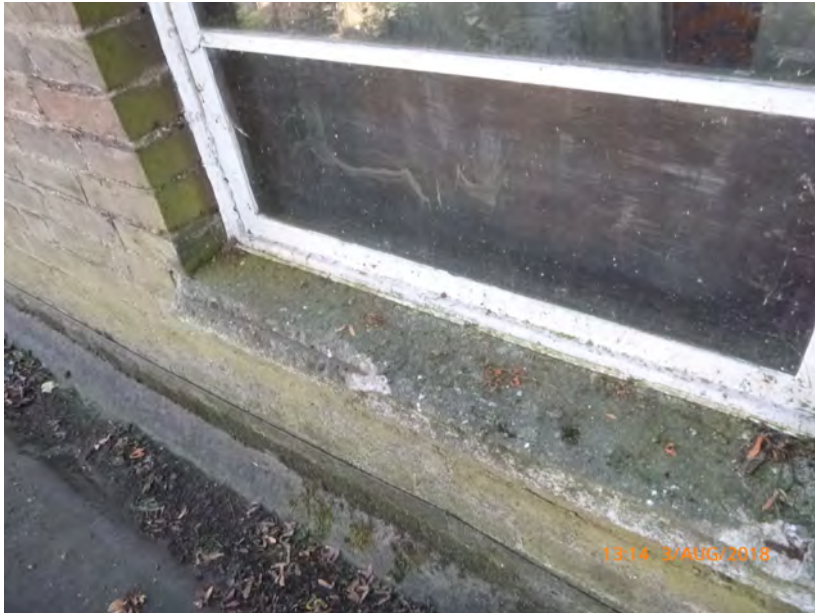
**Fig 27:**

Elevation 2, east side; showing spalled RC sill

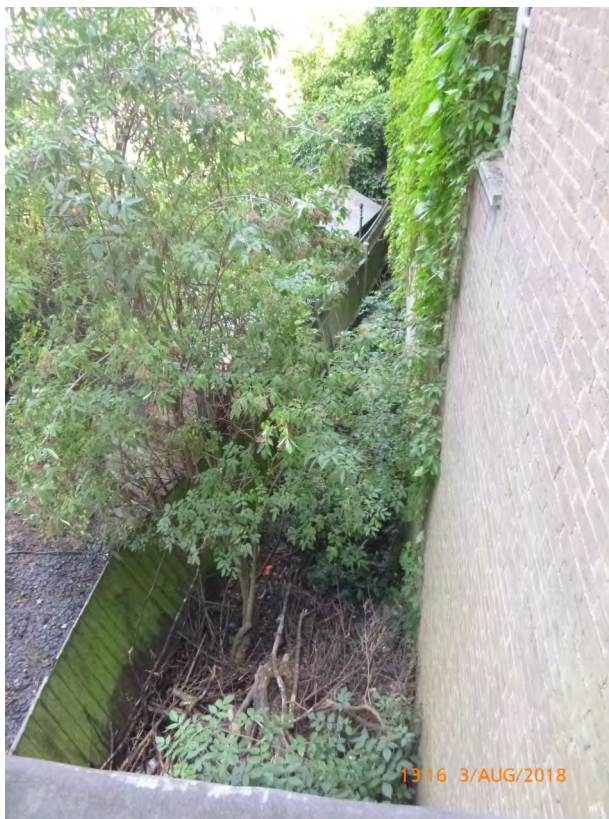
**Fig 28:**

Elevation 2, east end; showing inaccessible and overgrown area

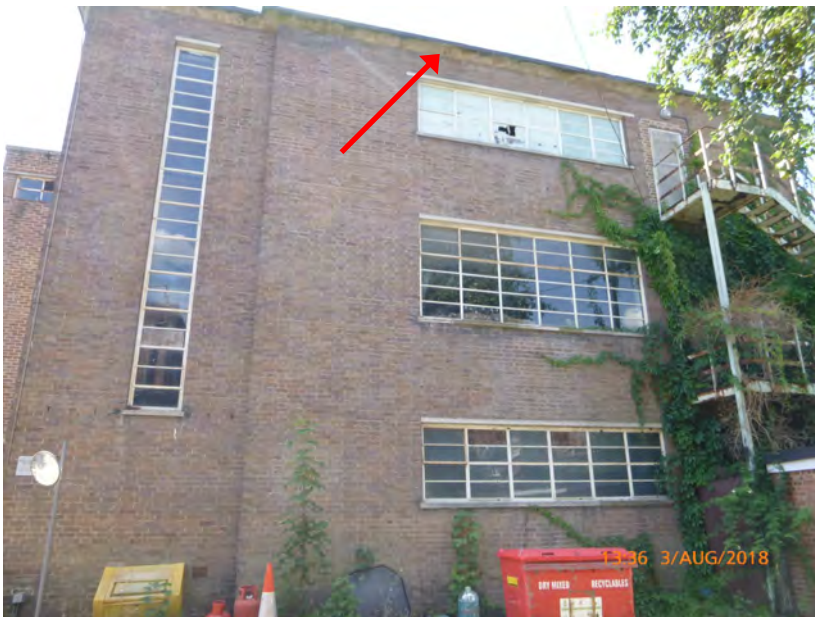
**Fig 30:**

Elevation 3, north side; showing general view. Note overgrown and inaccessible fire escape area

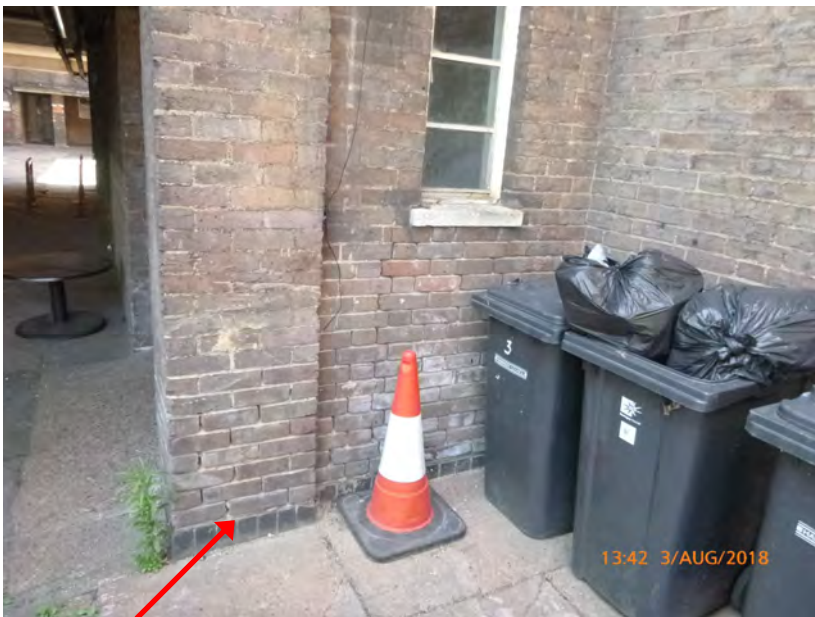
**Fig 32:**

Elevation 3; showing general view.  
Showing washed-out mortar where  
hard landscaping appeared to be  
compromising the damp proof course

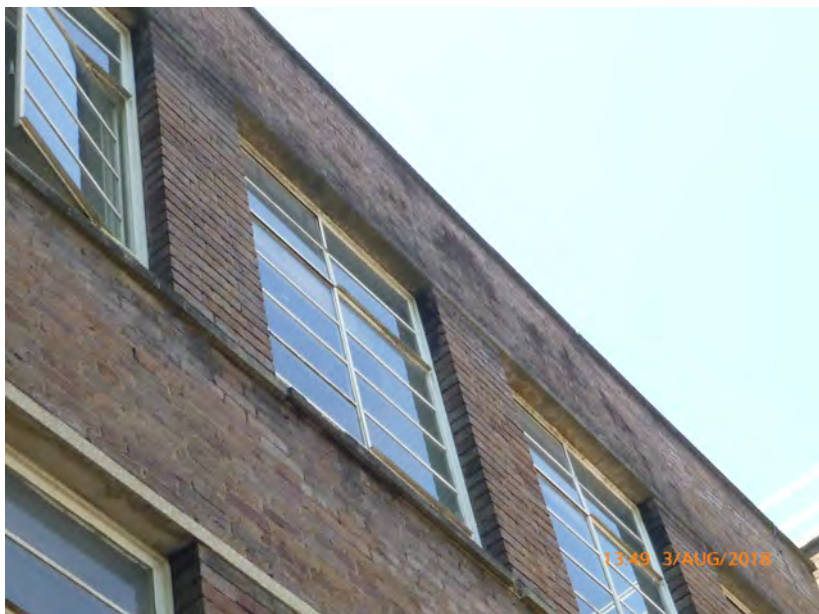
**Fig 33:**

- 1 Fundamentally, RC features were suspected to have been used as a low cost alternative to limestone. As shown on plans, these suffered widespread failure due to embedded steel corrosion. It was suspected that these units had been custom made for the town hall, possibly on an 'experimental' basis. Use of RC, especially for external features, was relatively new at time of original construction which may explain some technical flaws

- 2 It appeared that steel was not stainless nor protected by galvanic/paint layers. Also, there appeared to be inadequate 'cover' of concrete between the outer surface and embedded steel. These factors made the units highly vulnerable to steel corrosion and 'rust jacking' of the concrete surfaces

Elevation 3; showing continuous sills and lintels formed in RC

There had been extensive failure by spalling to these elements, some of which had been repaired in mortar

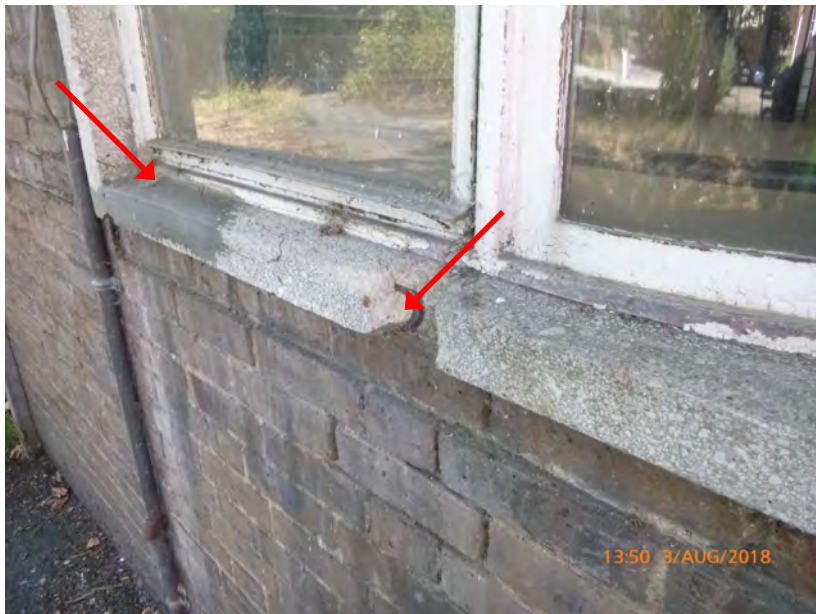
**Fig 35:**

Elevation 3; showing detail view of typical RC failure

Also note typical previous mortar repair; these were a poor aesthetic match and may be vulnerable to recurrent failure

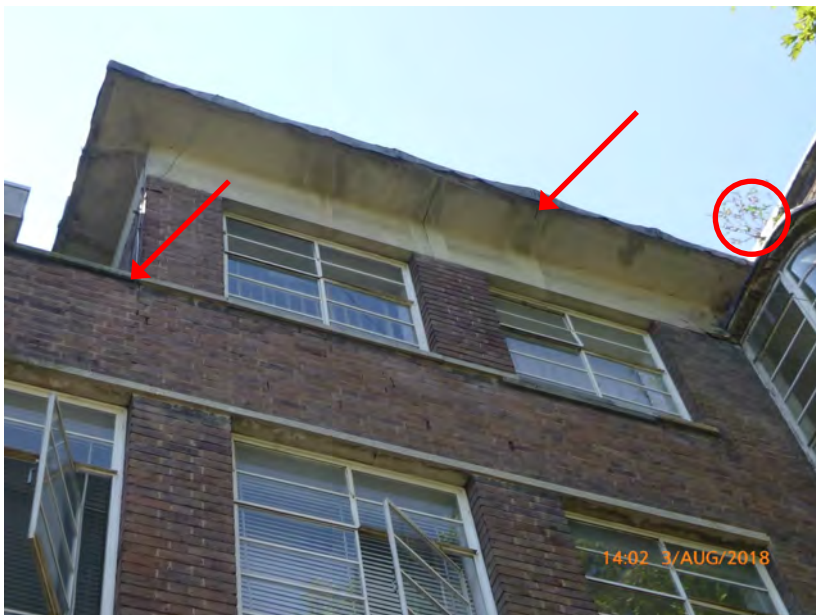
**Fig 36:**

Elevation 3; showing evidence of ongoing RC failure at the large soffit overhang

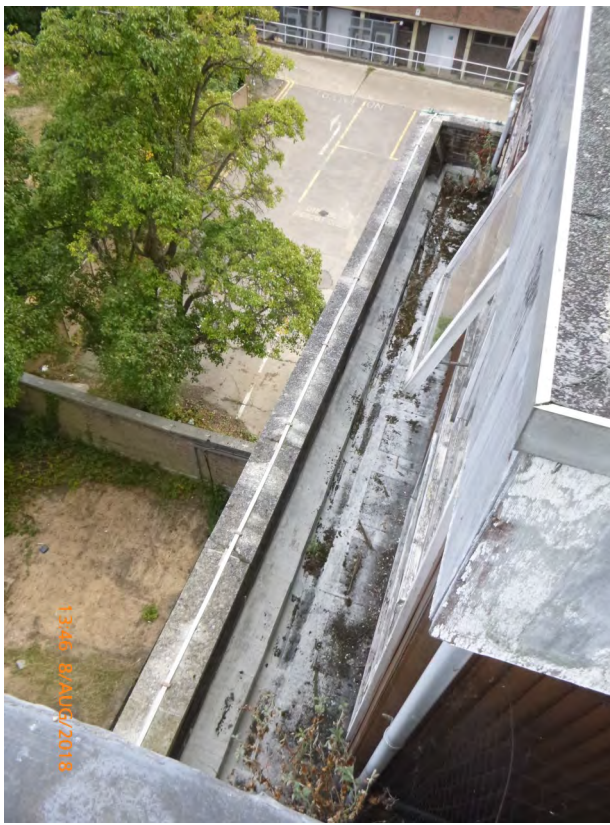
**Fig 37:**

Elevation 3; showing high level view of damaged RC copings

Damage appeared to have occurred at cramp fixings, likely due to restriction of thermal movement

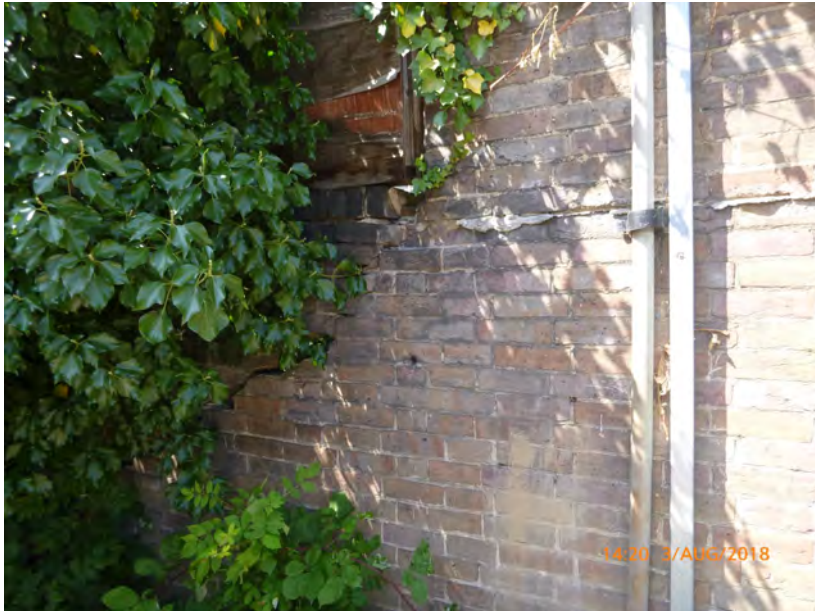
**Fig 39:**

Elevation 4; showing associated boundary wall

Typically, these were in a poor state due to cracking and movement

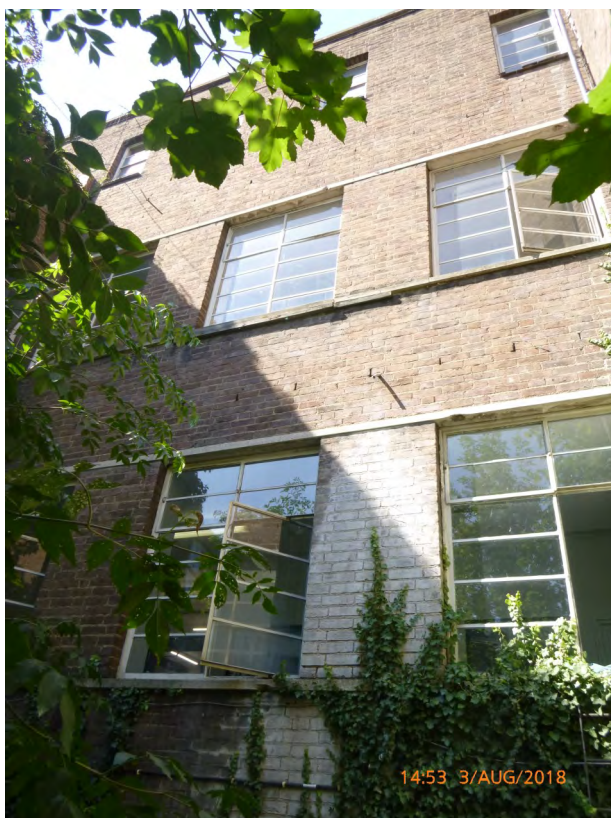
**Fig 42:**

Elevation 4; showing widespread RC failure

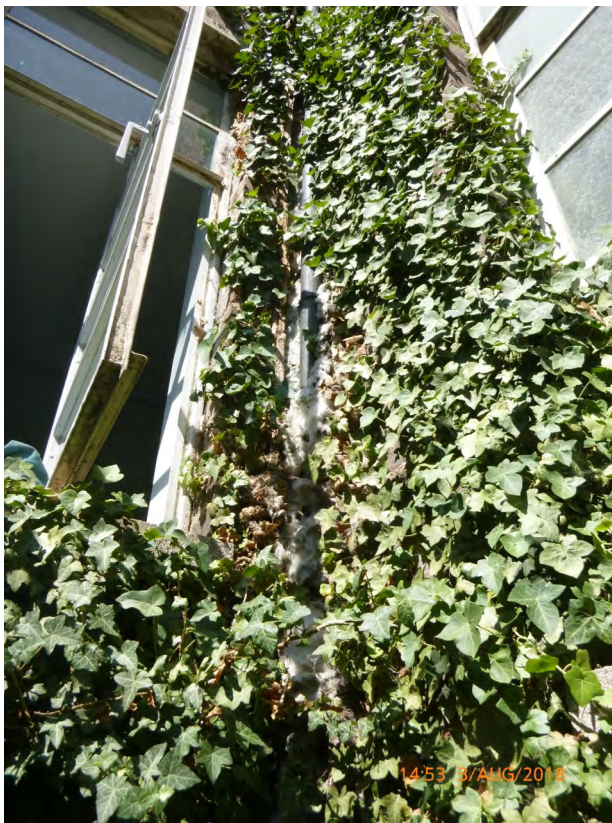
**Fig 43:**

Elevation 4; showing overgrowth by ivy

Also note external pipe clad in fibrous lagging. This should be checked against the asbestos register to determine its material type

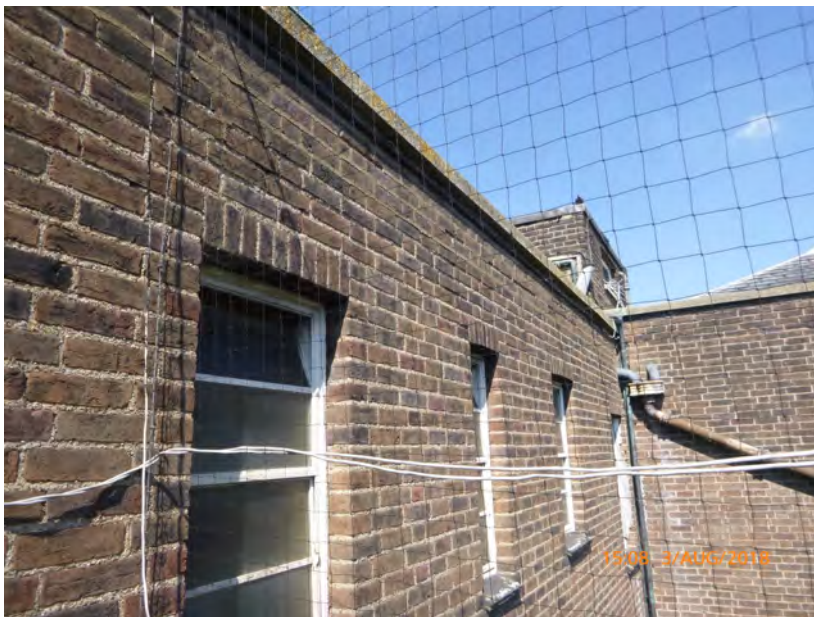
**Fig 44:**

Elevation 4; showing parapet re-pointed in the past. The grey cement mortar was a poor aesthetic match for the original and had suffered recurrent failure

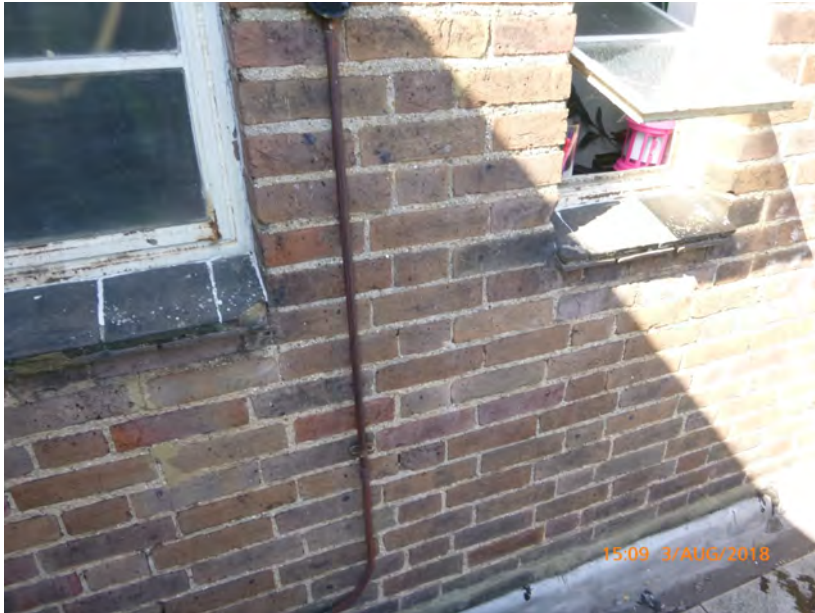
**Fig 45:**

Elevation 4; showing clay tile sills used at the upper floors

Much of the original pointing had washed-out and a small number of tiles had broken

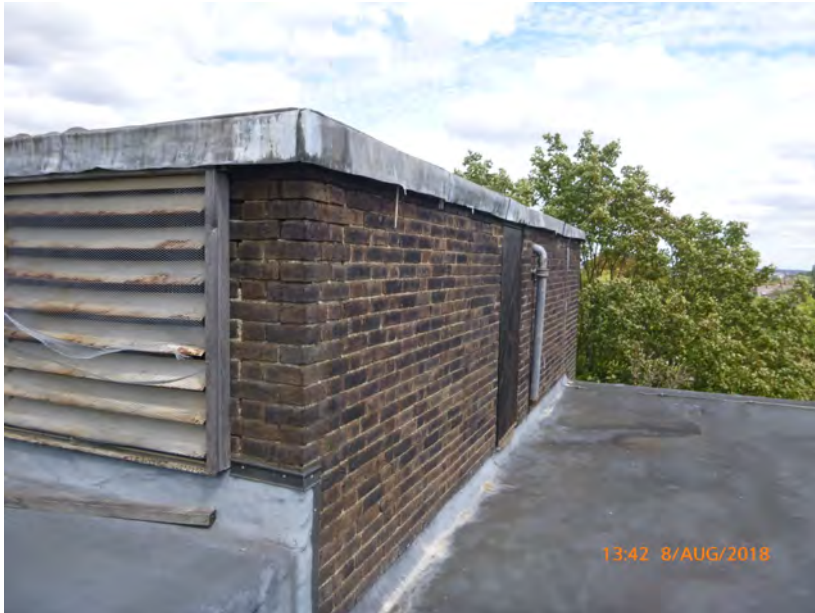
**Fig 49:**

Elevation 4; showing lift plant room with washed-out pointing and localised RC spalling at the roof overhang

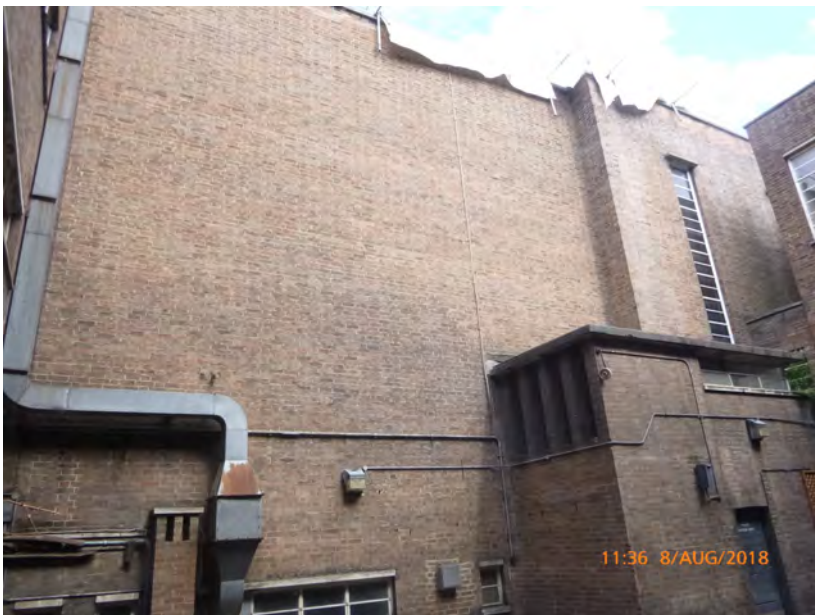
**Fig 50:**

Elevation 5; showing general view. Note poor temporary roof protection using tarpaulins

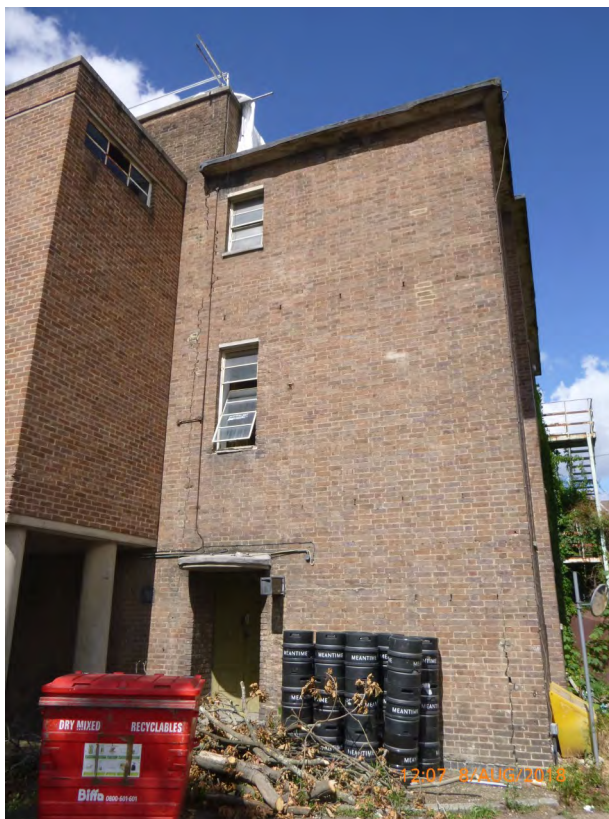
**Fig 52:**

Elevation 5; showing area of significant vertical cracking where the auditorium and stage areas may be on separate foundations

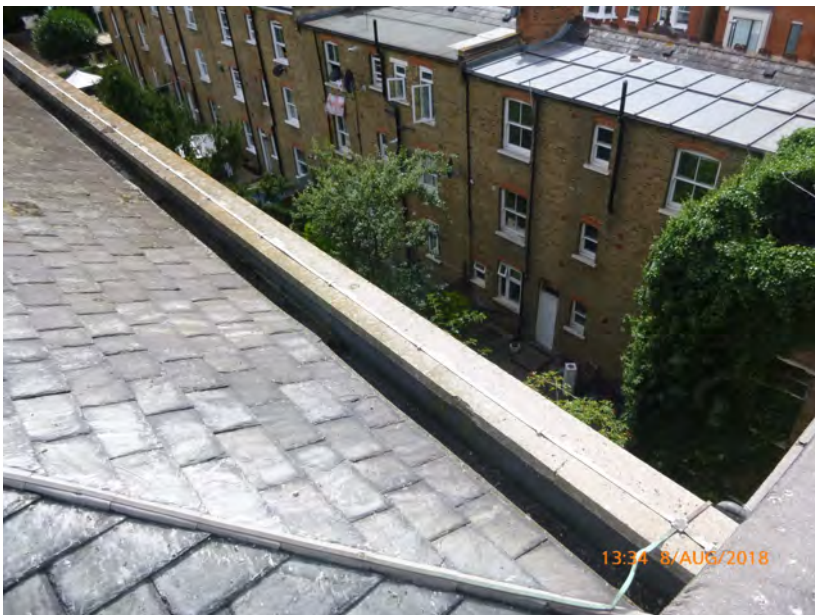
**Fig 54:**

Elevation 6; showing copings subject to localised damage and displacement

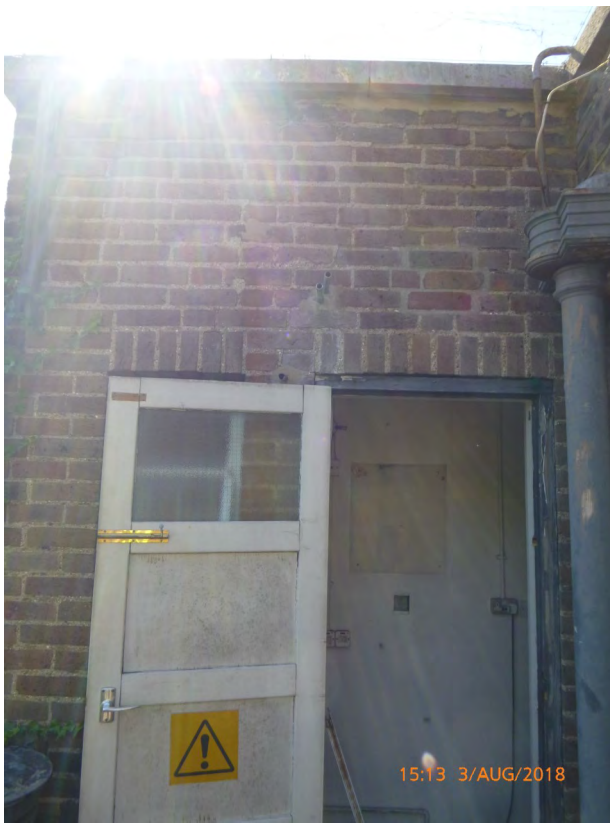
**Fig 55:**

Elevation 7; showing upper section

The parapet had been re-pointed in the past but suffered recurrent failure
