# **Hutton + Rostron Environmental Investigations Limited**

## **Hornsey Town Hall: Façade masonry condition investigation**

**Site note 1 for 3 and 8 August 2018, job no. 405.73**

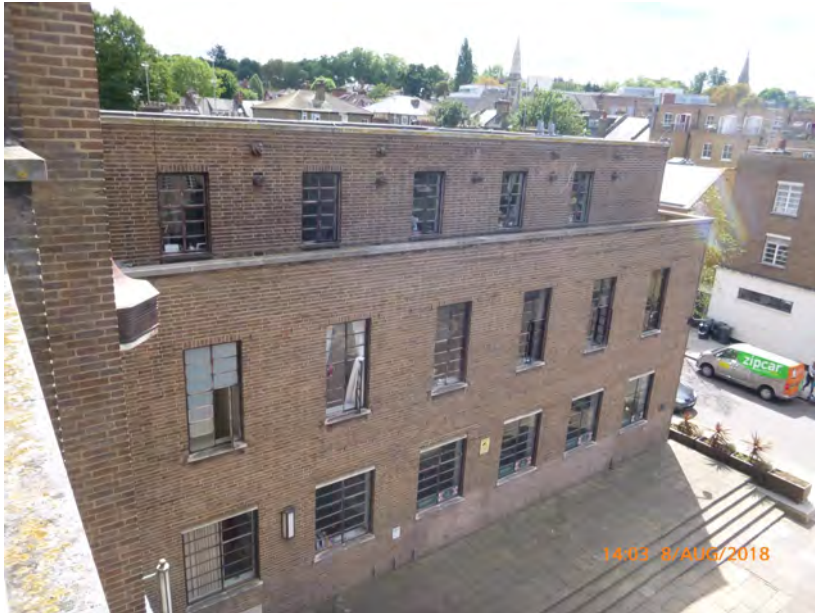
**Fig 61:**

Note discolouration to base of walls where damage has been sustained by previous aggressive cleaning

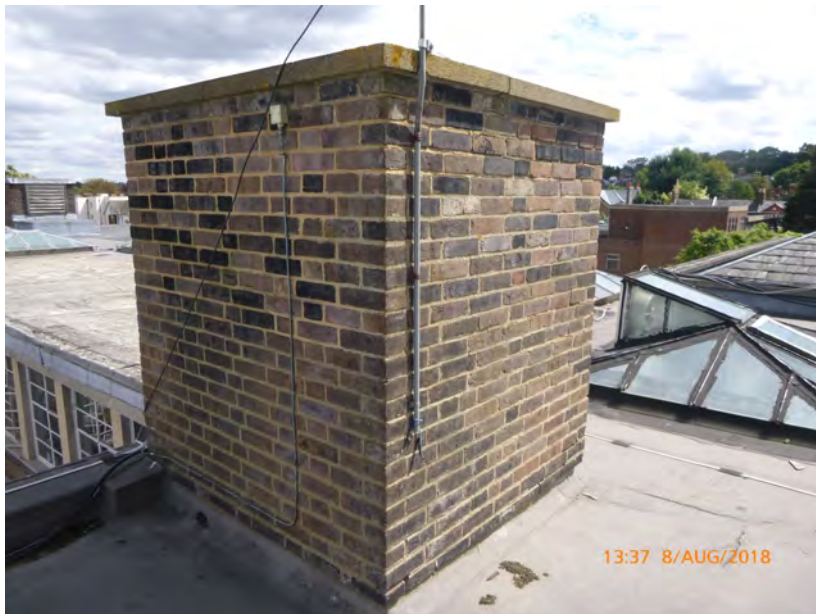
**Fig 63:**

Pointing mortar degradation and vertical cracking was noted locally due to weathering and flue gasses

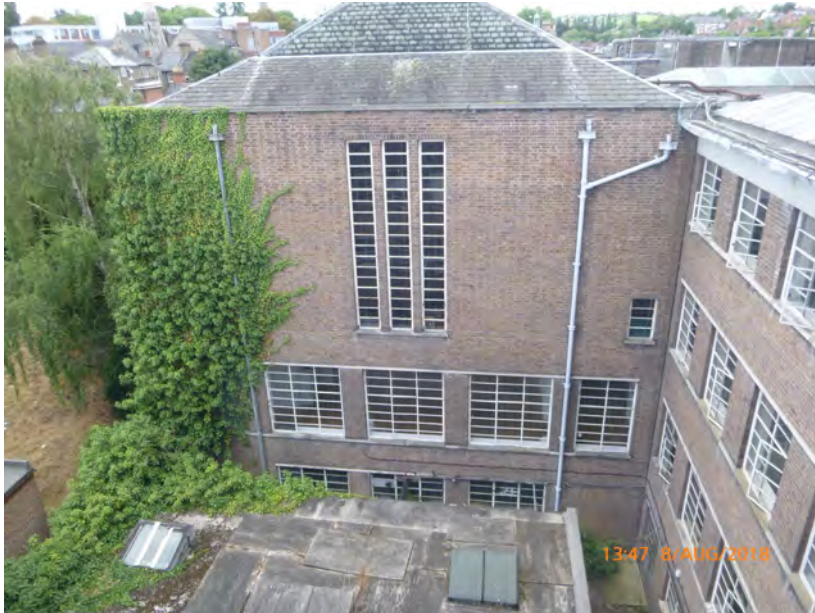
**Fig 65:**

Also note vertical cracking was quite widespread at the base of the wall
