## E: Council Chamber

Council Chamber

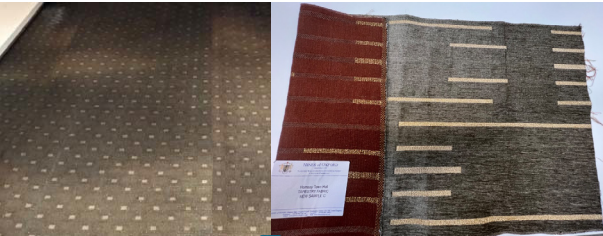
LIN-905 Replacement replica tapestries with acoustic absorption

Existing tapestry shown left - replaced with new tapestry by Hines of Oxford as approved on site with LBH and EH

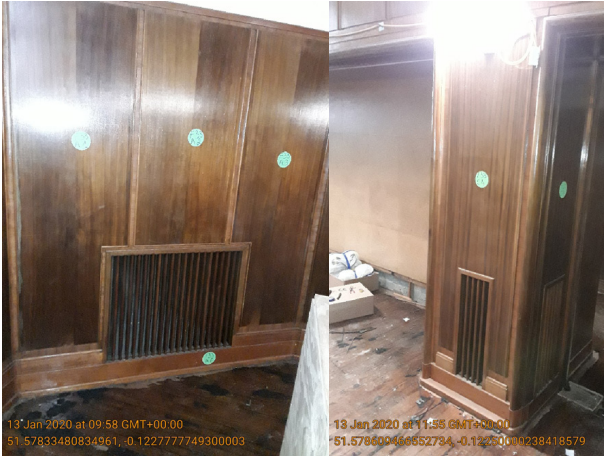
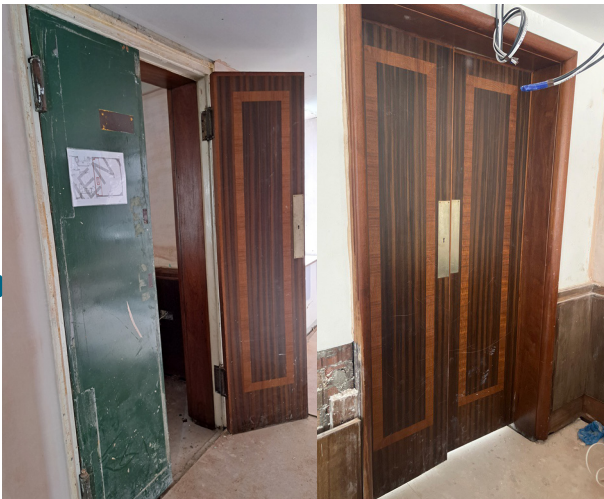
Existing top floor council chamber door has been painted on the corridor side, as part of the refurbishment of the door, the paint is to be removed and door refurbished back to original finish as visible on the chamber side.

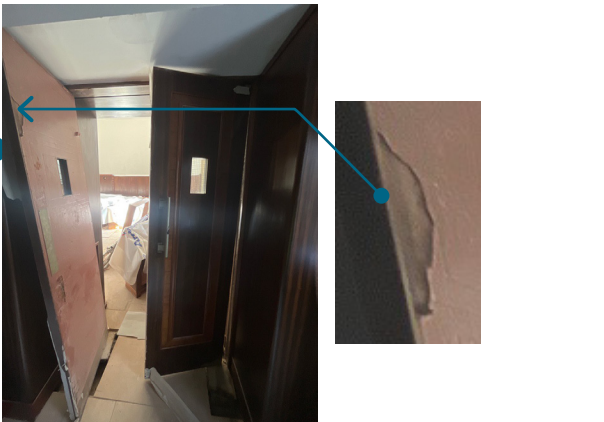
Similarly ground floor doors have been painted on the inside - with existing finish visible from cracking of new finishes. Due to site damage some existing doors are to be replaced with replicas. With matching existing doors used as reference for finish.

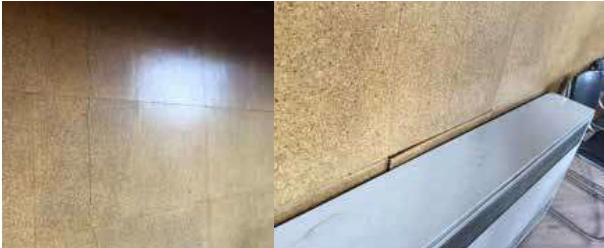
ALT-515 Refurbishment of Cork Walls

Existing cork wall showing some sign of cracking down the middle assumed from long term deflection. Lose cork is to be re-adhered and light polishing and refurbishment.

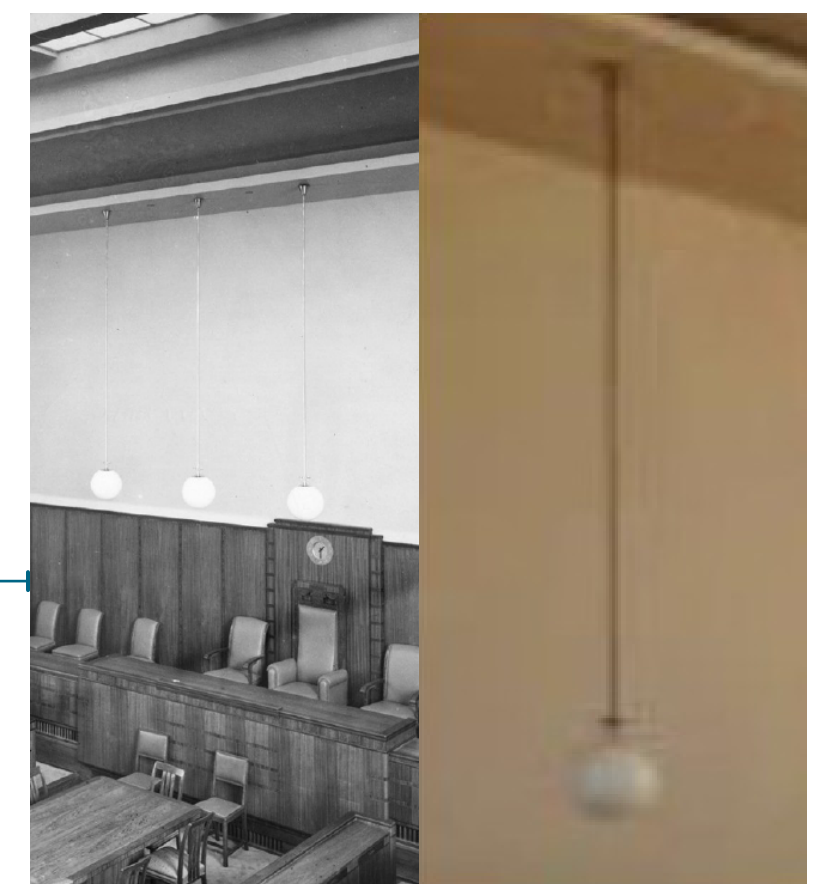
Existing long drop globe pendant's are to be refurbished and relamped with led fittings as overall heritage lighting strategy and method statement.
