## F: Committee Room

Committee Rooms

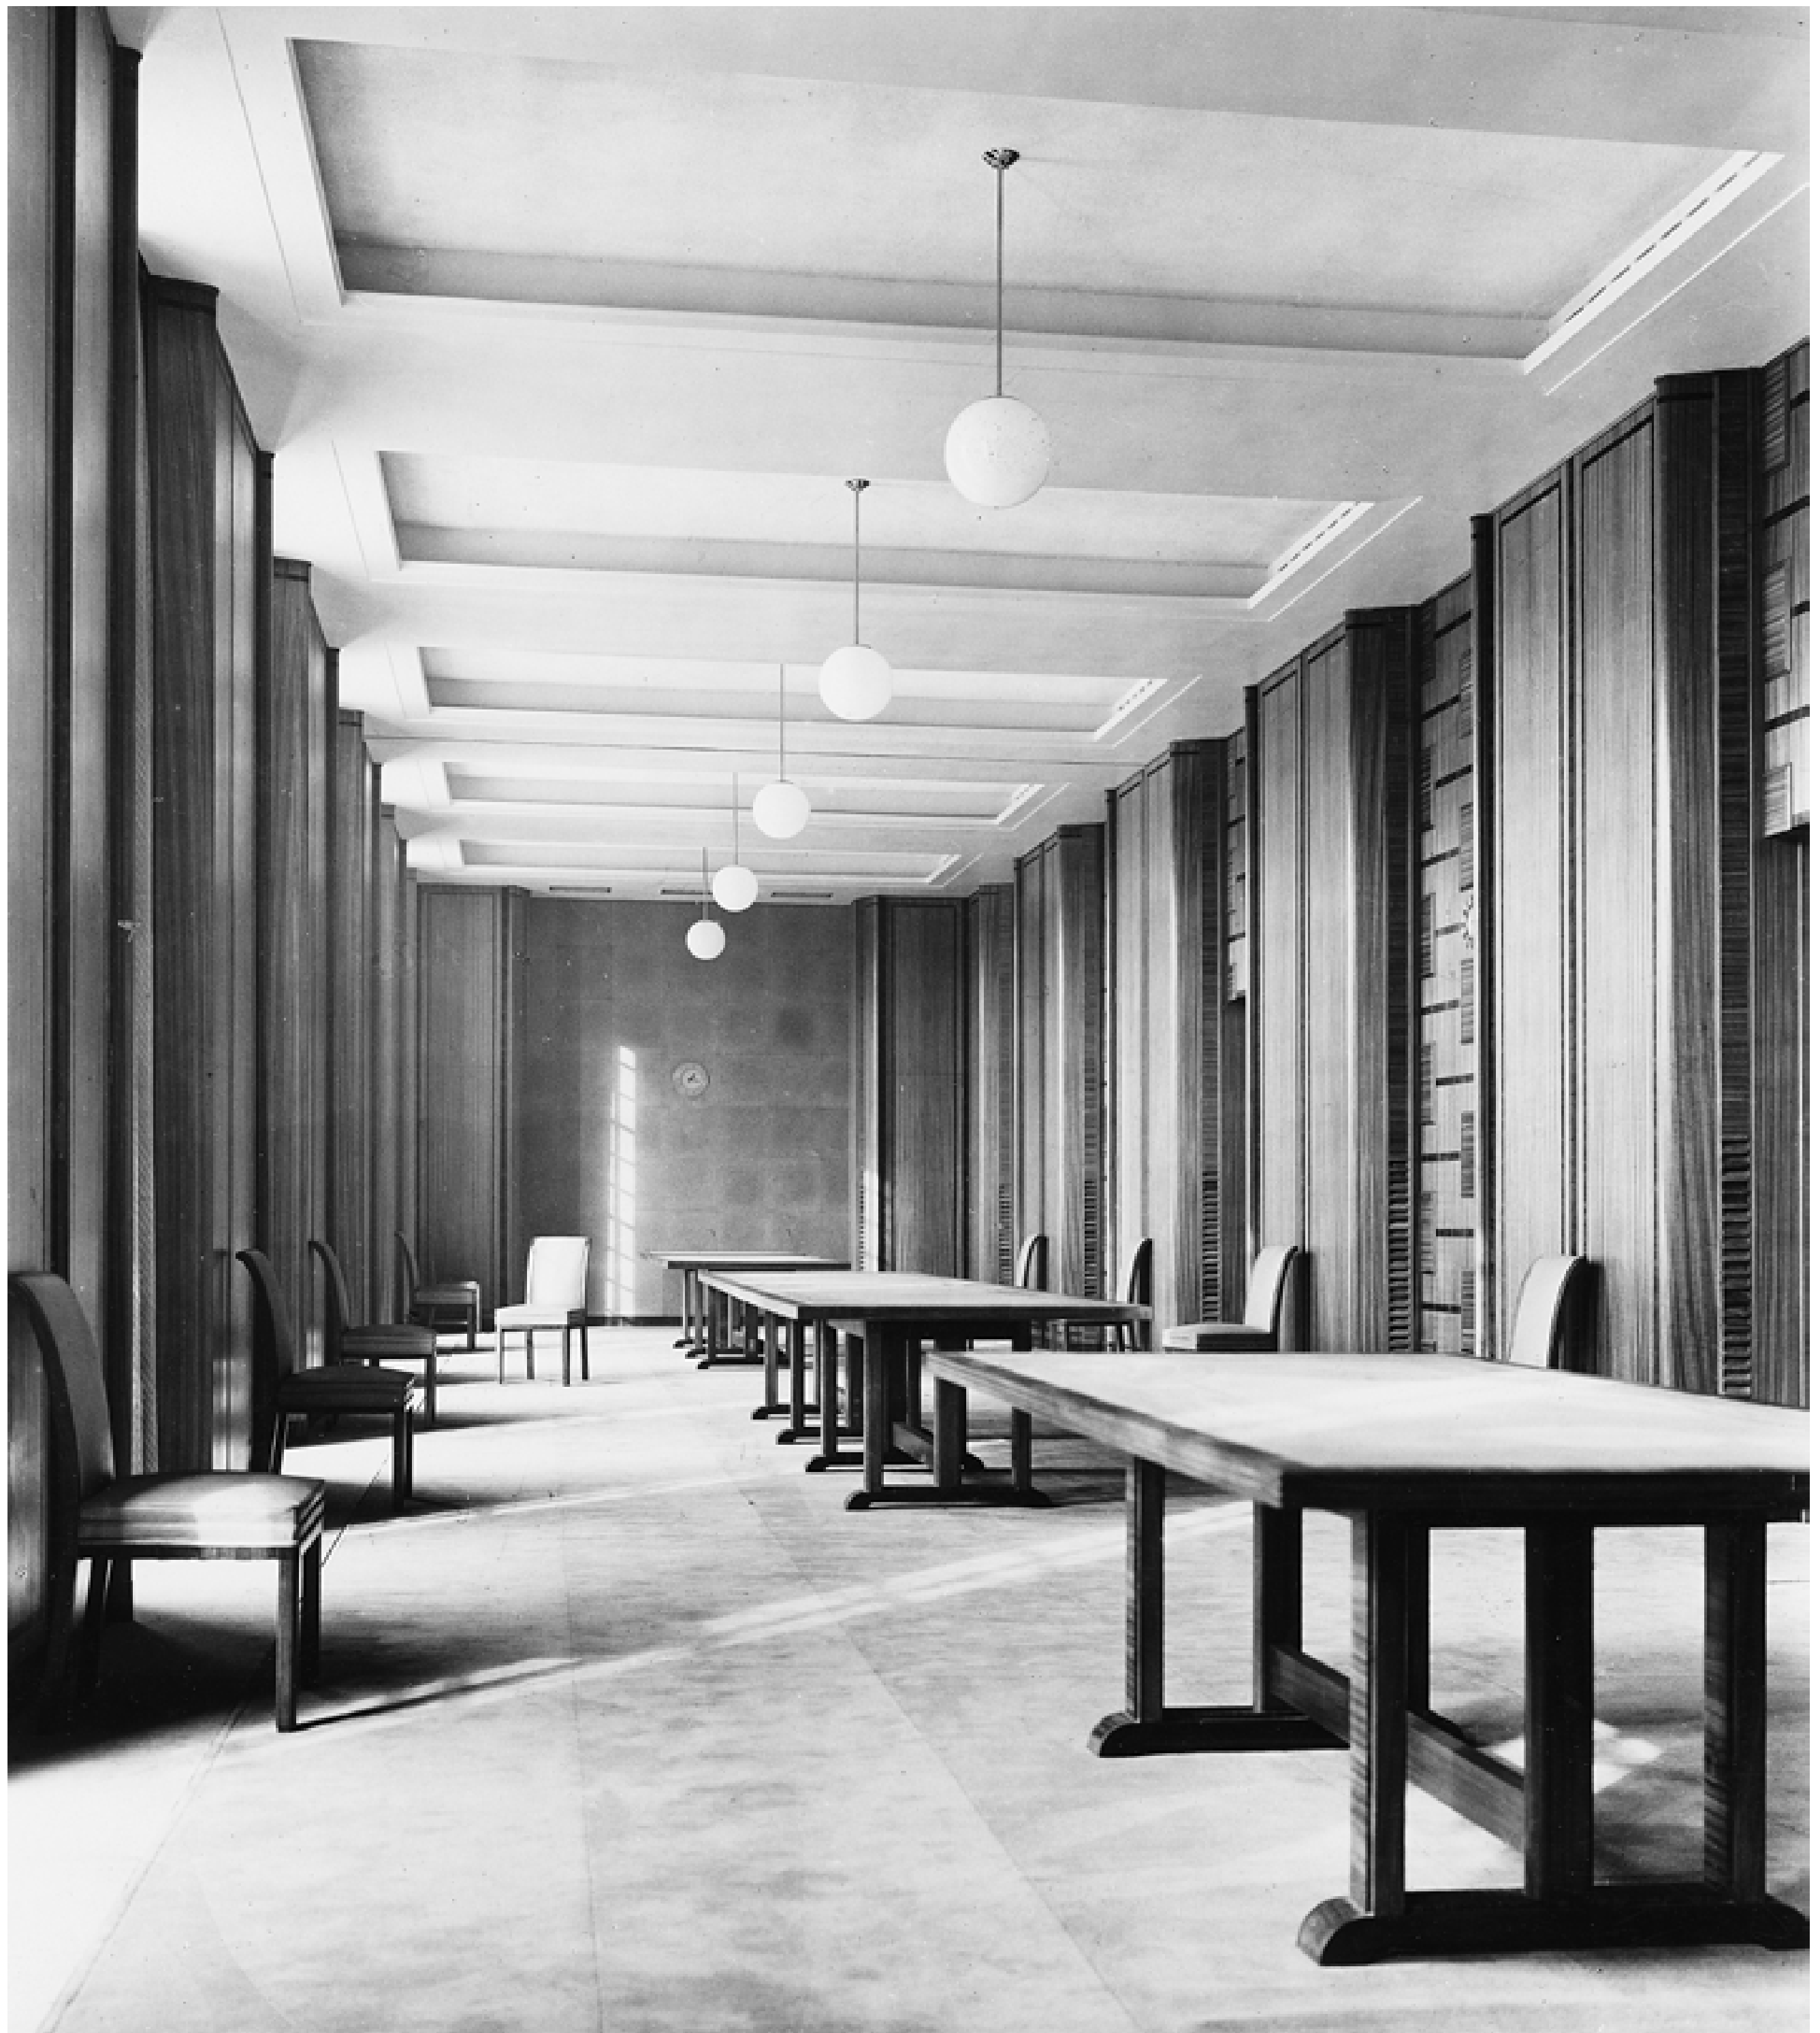
Former Committee Rooms. These grand rooms are set over the Foyer to the Assembly Hall; they are currently in use as a single room, though have the capacity to be broken down into three rooms by concertina doors, hidden within the full-height walnut panelling [Plate 83]. The end walls are faced in cork and the floor is parquet, with a Perrycot stone border. There are three sets of double doors flanked by two outer single doors (for service); all are faced in walnut with decorative banding to match the Committee Room and have original ironmongery including Britten door closers. There are seven tall bronze-framed casements with timber beading in the west wall. The ceiling contains large rectangular recesses, which was part of the heating / cooling system. It is faced in modern acoustic tiles. There are globe pendants, clock and switch plates. The furniture is not original to this room. There are photographs of the Committee Rooms on completion in the 1930s in the Photograph Collection of the British Architectural Library at the Royal Institute of British Architects. (shown right)

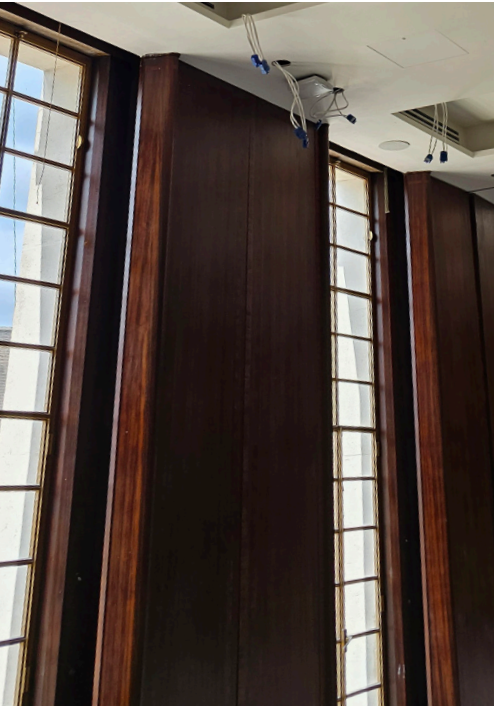
ALT-559 Refurbishment of veneered wall lining  
The existing walnut veneered panelling was in a general condition and it to be refurbished to a near new condition. An approved sample of repair has been review and agreed on site and a detailed method statement of the works as the approved sample has been submitted.

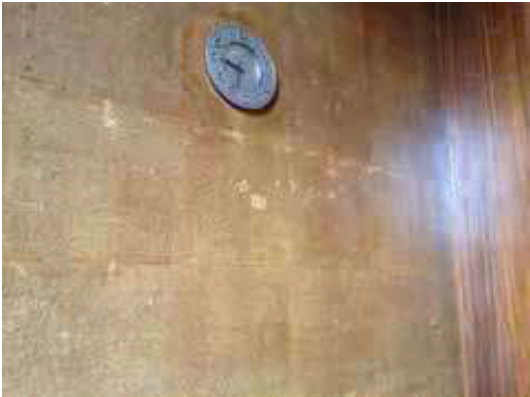
Original clocks are at opposite ends within the cork walling. The clocks were previously wired and connected to the Synchronome master clock. Due to the relocation of the clock to a central location on the

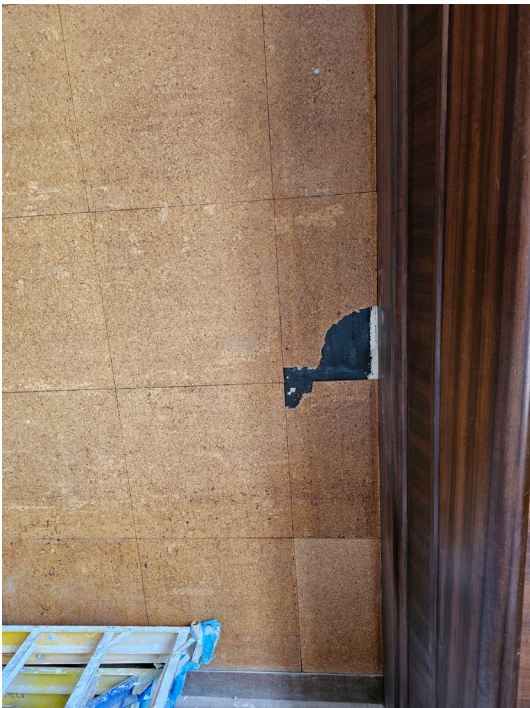
ALT-559 Refurbishment of veneered wall lining  
Existing cork wall shows signs of wear, a sample of refurbishment has been approved on site (as bottom right panel). The cork is to be repaired in situ and where significant damage to tiles as middle right hand side, tiles are to be replaced with matching tiles as the approved sample

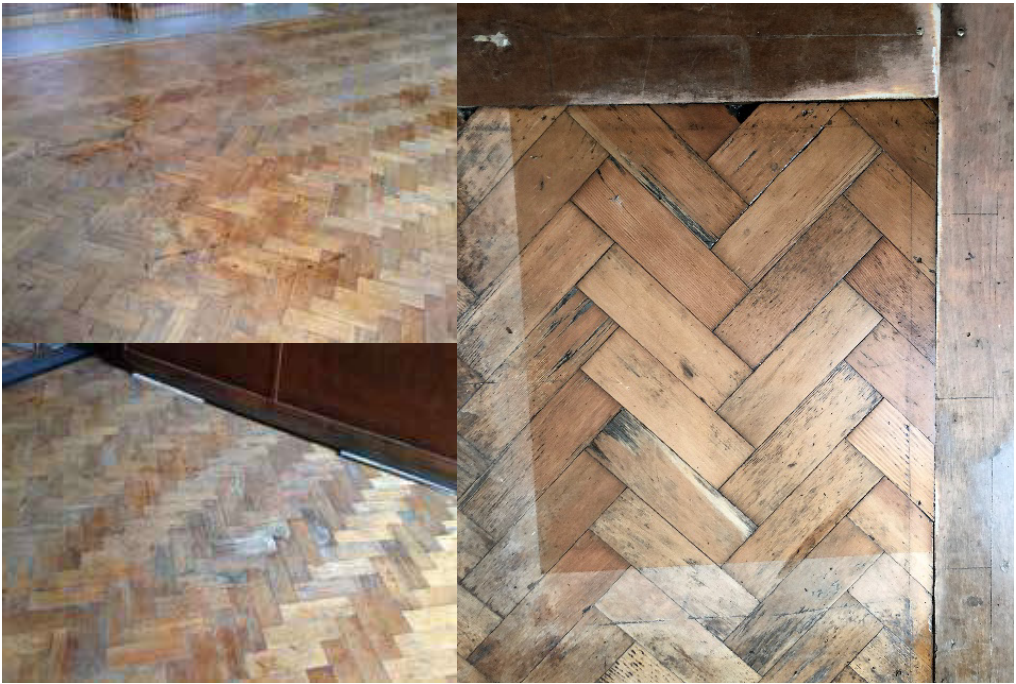
ALT-535 Repairs to Herringbone Flooring  
Existing timber herringbone flooring had localised damage that was apparent with areas heavily scratched and surface inconsistencies with marks and stain - the refurbishment of the flooring is bring the floor up to a good quality while maintaining its aged appearance.

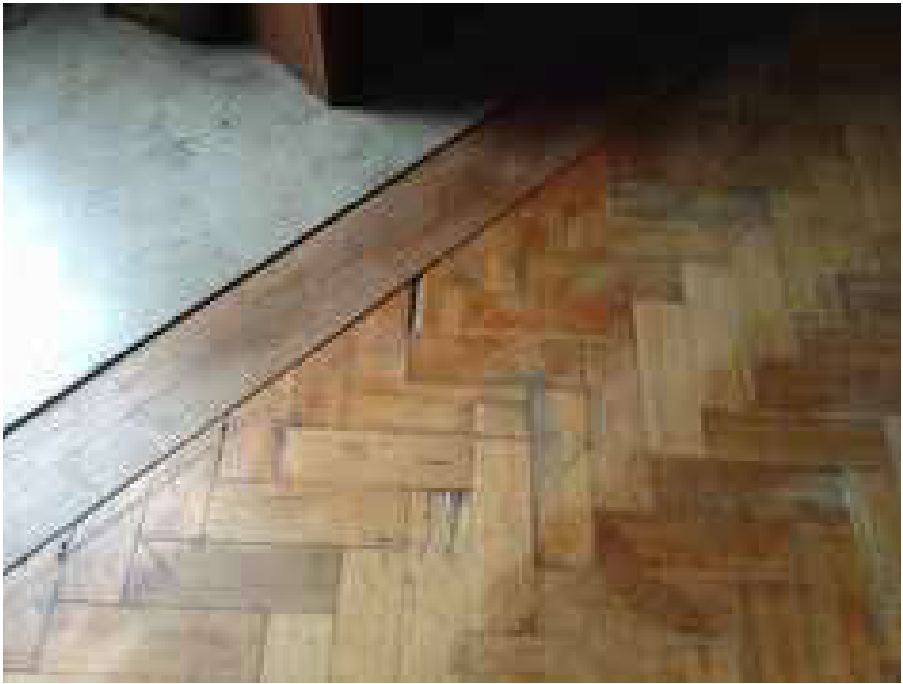
ALT-415 Stone Floor Repairs  
Stone borders to perimeter of flooring. The stone is generally in good condition but appears worn with some hairline cracks - to be refurbished as relevant method statement.

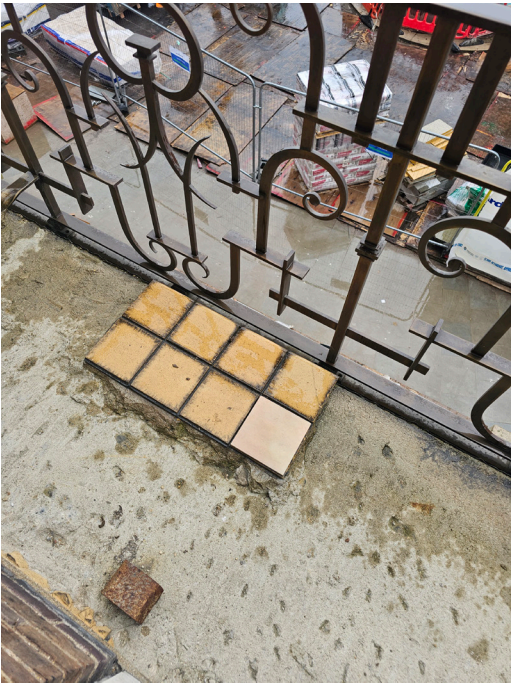
Existing tiles on balcony are to be replaced with new like-for-like replacement tiles.

Balustrade is to be repaired and refurbished - previous poor quality plastic guard has been removed as approved scheme.

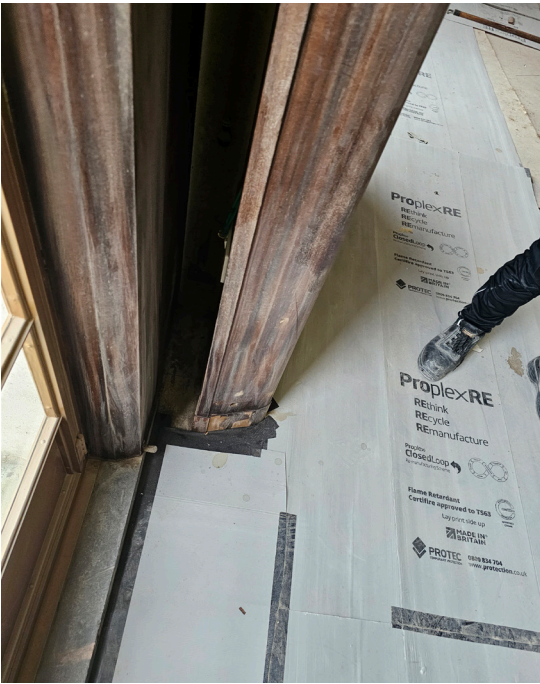
To reduce the impact on the original panelling, sockets have been installed within the original curtain recesses

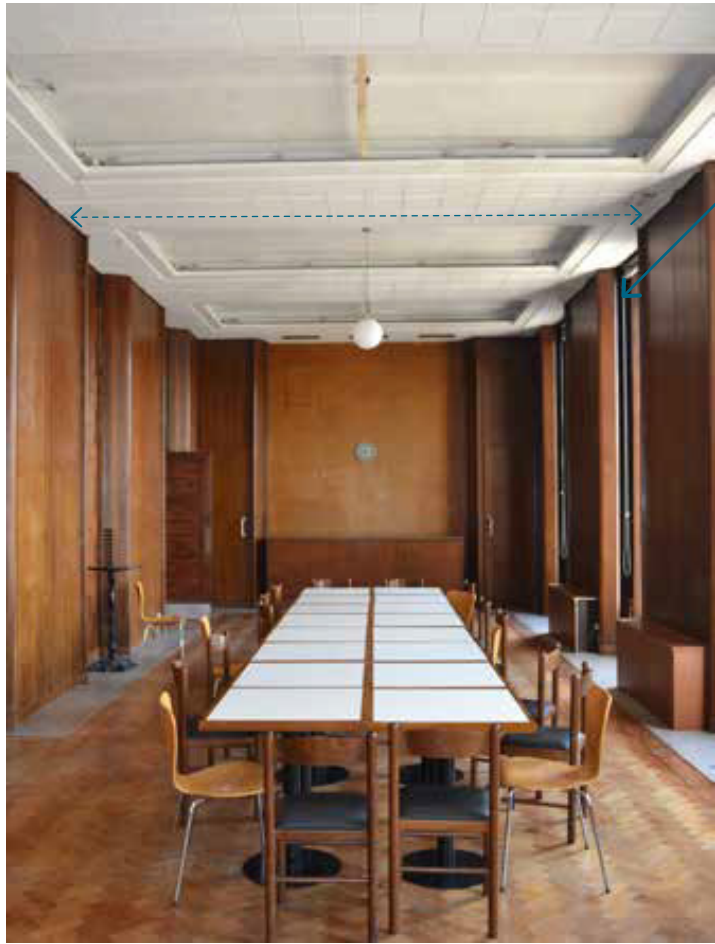
Modern introduction of acoustic ceiling panels blocking function of sliding dividing panels removed.

New flush plasterboard ceiling installed replacing acoustic panels, with track for partitions refurbished

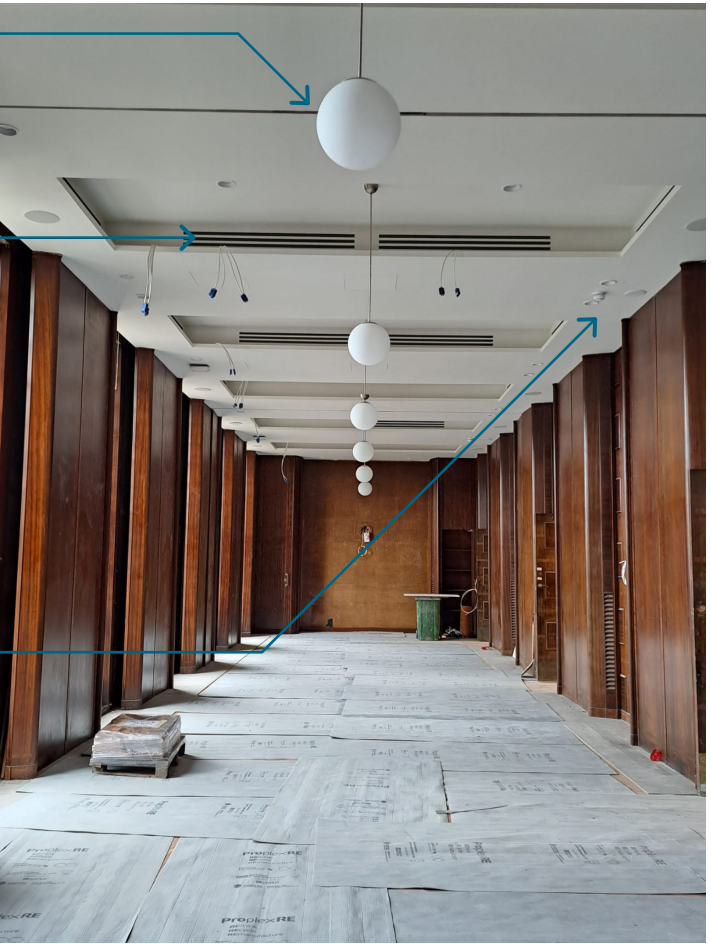
Modern fixings such as downlights, fire alarm and speakers have been introduced to meet the modern requirements of the room. These have been chosen to have minimal visual impact
