Foyer

Detailed method statements have been submitted for the refurbishments of different architectural items. Referenced on the drawings with relevant codes to below drawings as below;

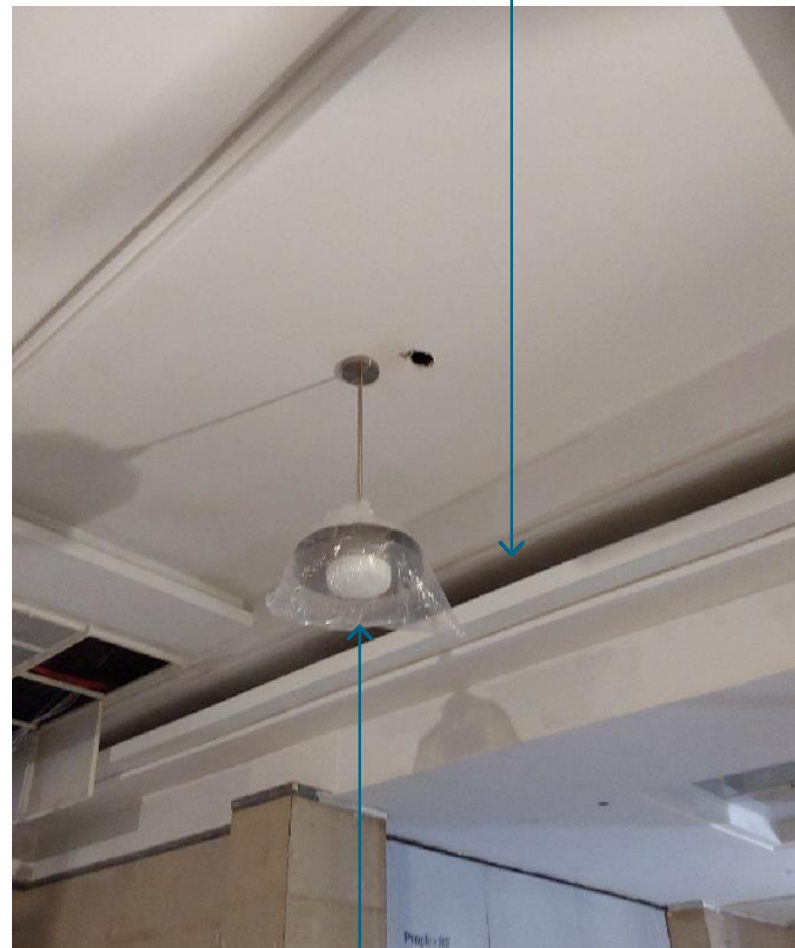
Existing pendent lights relamped, refurbished and reinstalled into existing locations

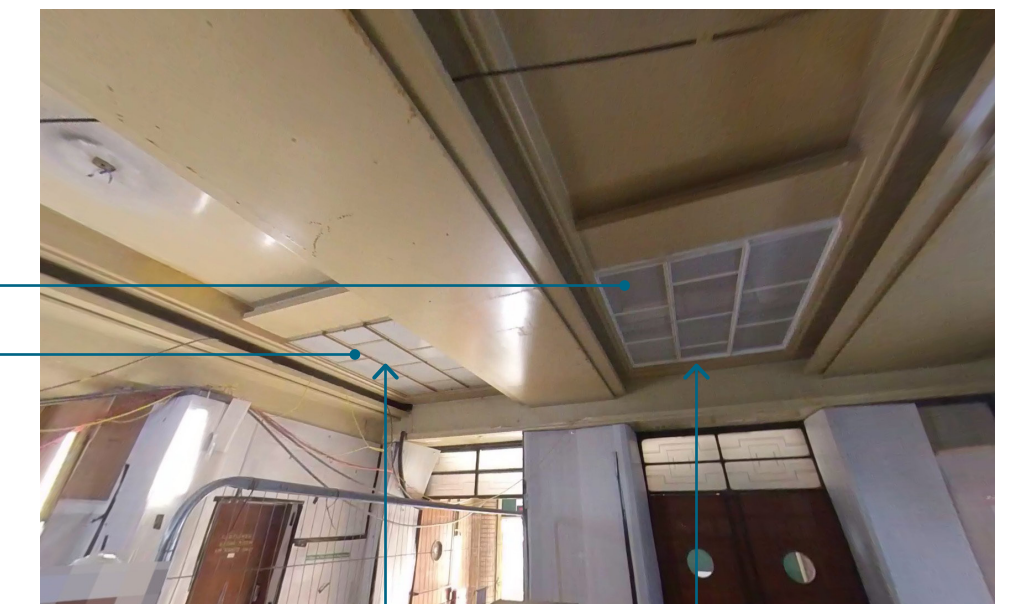
The majority of lighting is supplied from light-panels in the ceiling. These are off various configurations and are made up of a steel casement with glazing. They are to be repaired and refurbished with new LED lamps above.

Light panel in existing condition

Each panel carefully released from position to be individually repaired and refurbished. Hinges, screws and ironmongery to be refurbished back to working order and replaced if missing. New paint finish to be applied and any broken glazing to be replaced like for like.
