**Geo-Serv Limited**  
**17 Hoveden Road**  
**London NW2 3XE**

Monitoring visit **2** of **8**

## Monitoring Plus Report

| Address | 22 Methuen Park<br>London<br><br>N10 2JS | Principal area of damage | to be advised | Installed | 03/04/2023 |

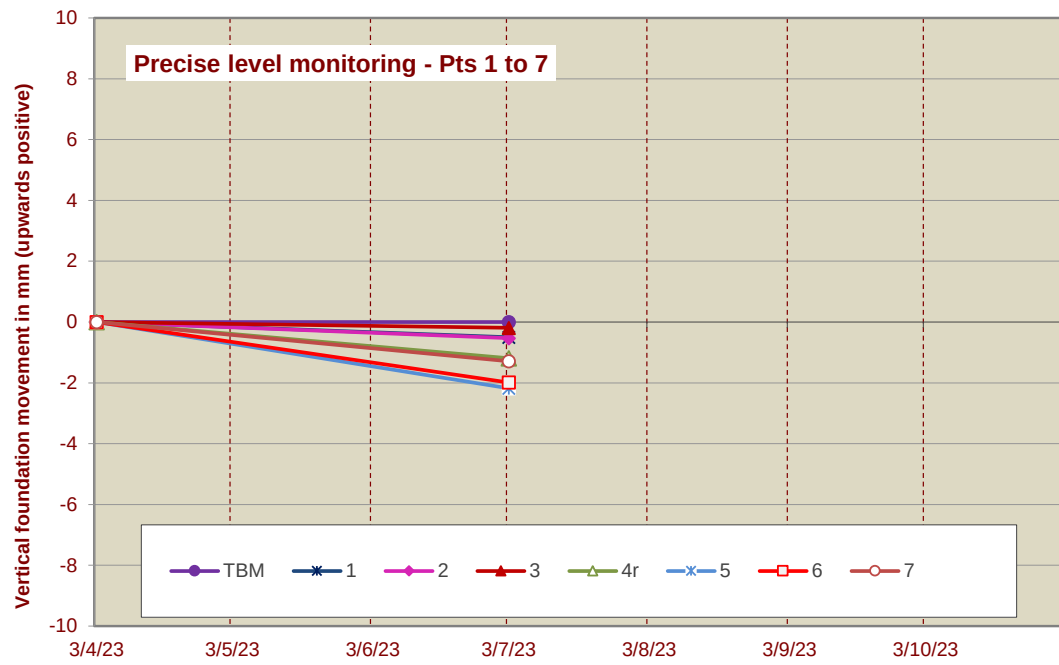
## Precise level monitoring related to drain

| Max move 2.2 mm | no feedback for this visit | | | | |
| Focal area Pts 5, 6, | | | | | |

| 5 | 607.48 | <b>0.0</b> | 605.30 | <b>-2.2</b> | | #N/A | | #N/A | | #N/A |
| 6 | 620.29 | <b>0.0</b> | 618.30 | <b>-2.0</b> | | #N/A | | #N/A | | #N/A |

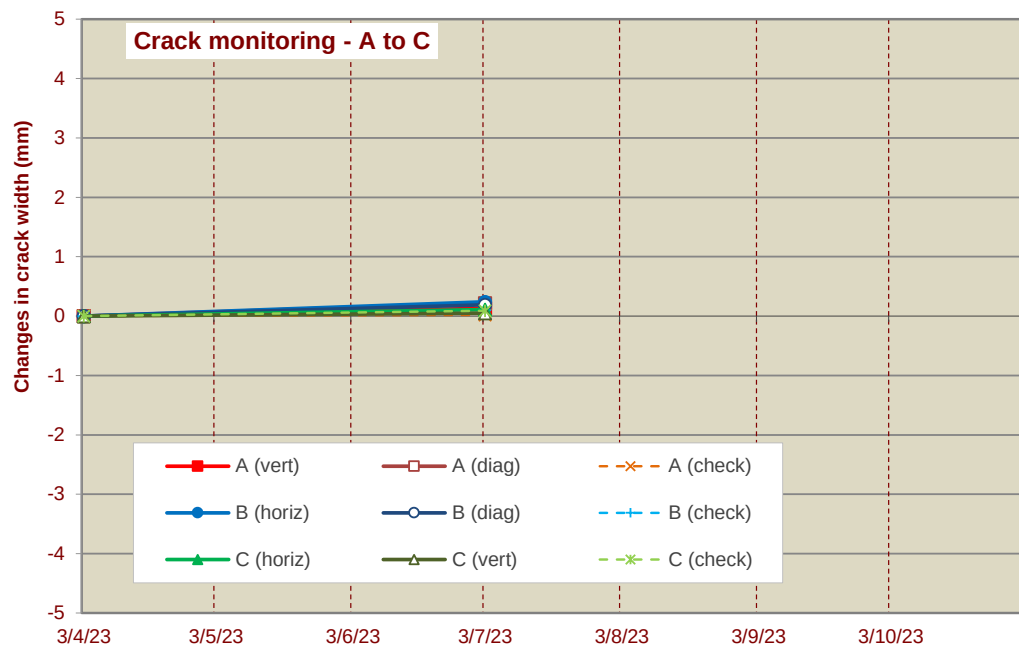
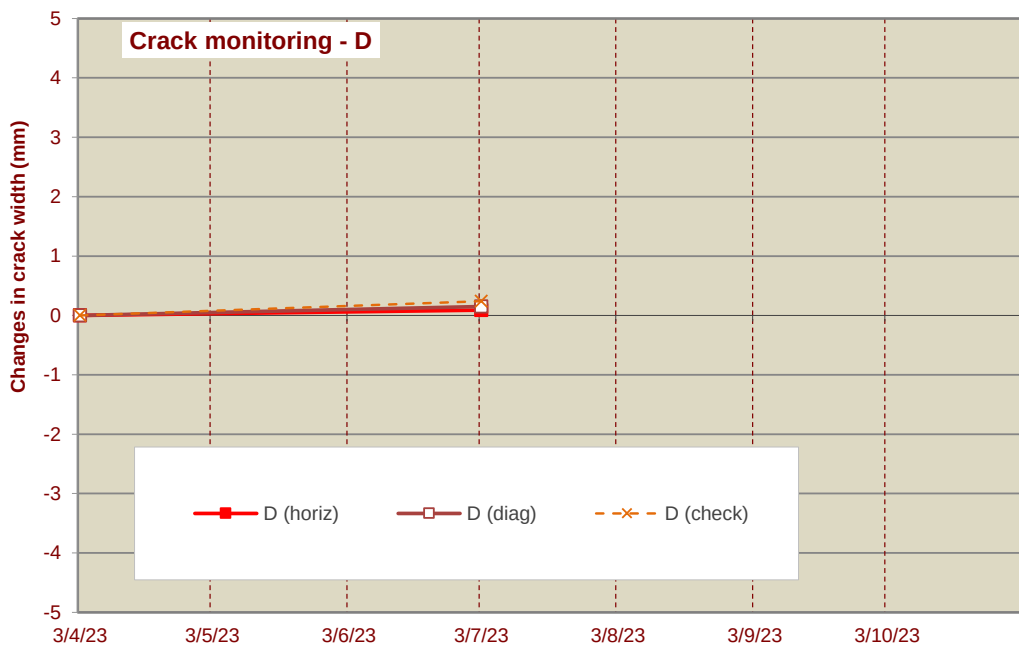
Crack monitoring

A (vert) External RHS bay wall RHS of the front door - -  
 B (horiz) Internal GF RHS front room RHS party wall - -  
 C (horiz) Internal Hall RHS wall Top left corner of door - -  
 D (horiz) Internal FF landing RHS wall Top left corner of door - -
