Arboricultural Report

Trees nearby

22 Methuen Park  
London  
N10 2JS

Site Visit Date:  
12<sup>th</sup> July 2023  
Report Date:  
28<sup>th</sup> July 2023

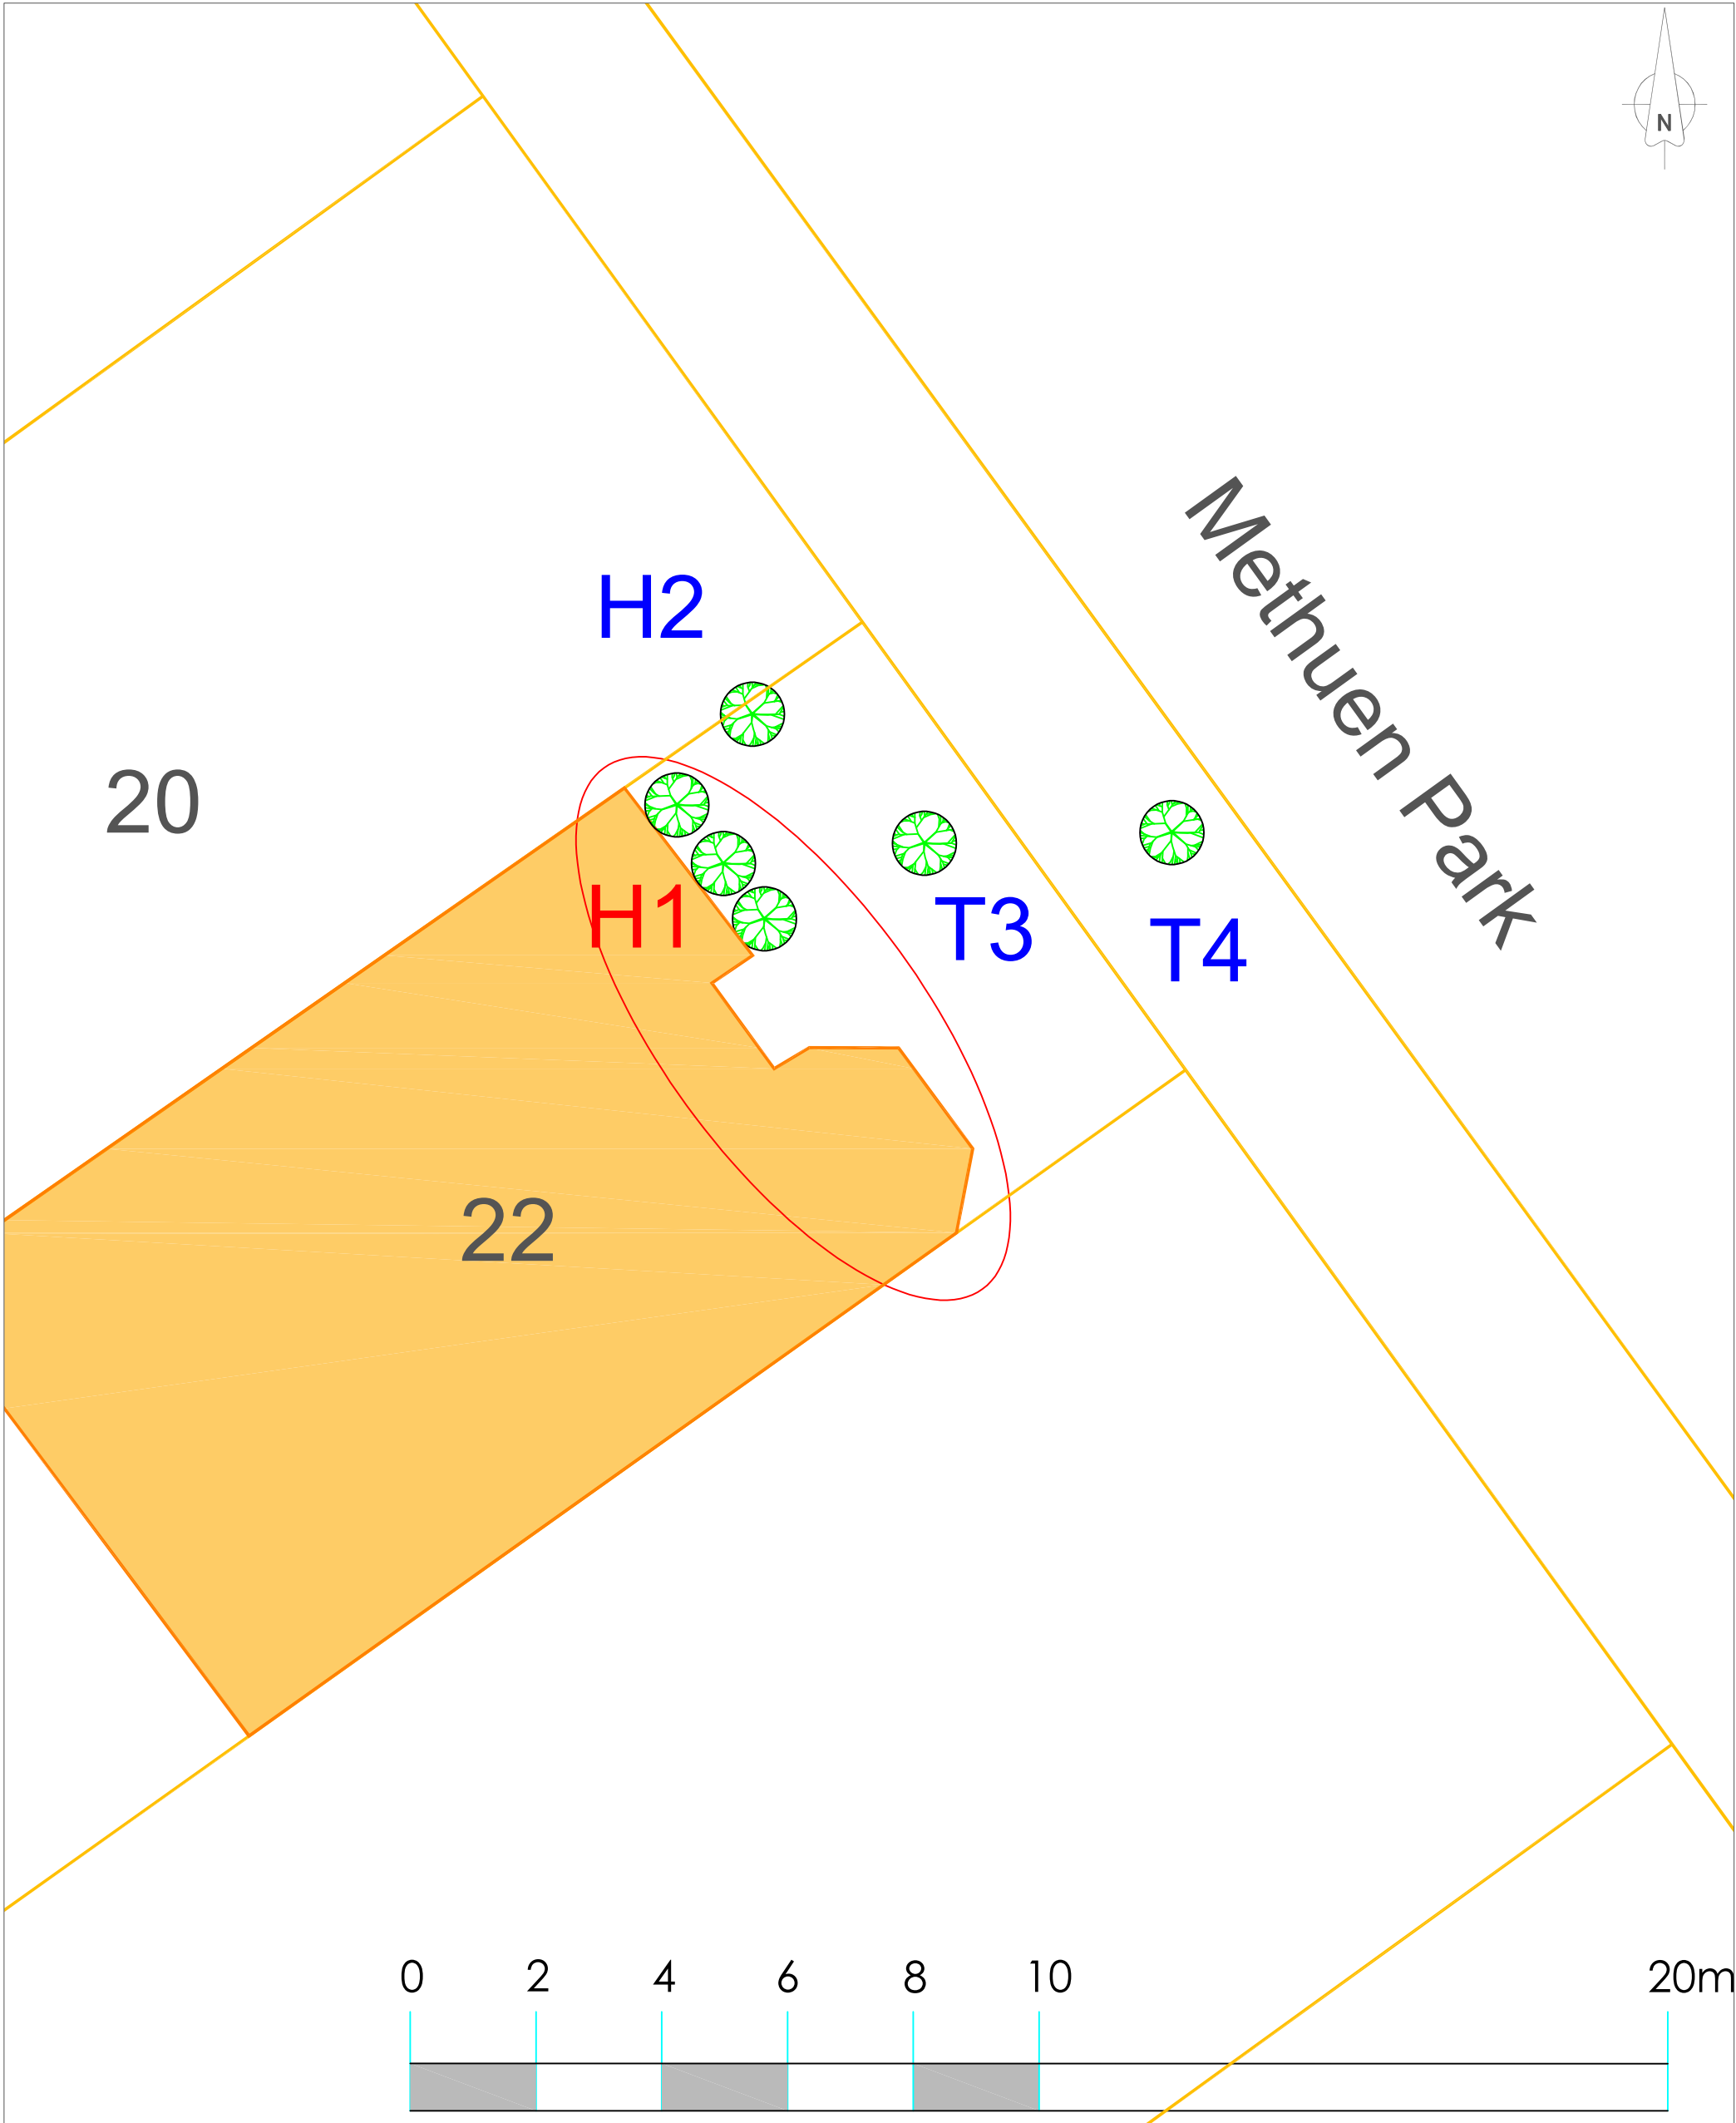
| Figure Number: 1 | Rev: A | |

Areas of building  
damage noted

- 6.1 Removal of all of the pyracantha H1 around the window is recommended along with treatments of all stumps to prevent regrowth.

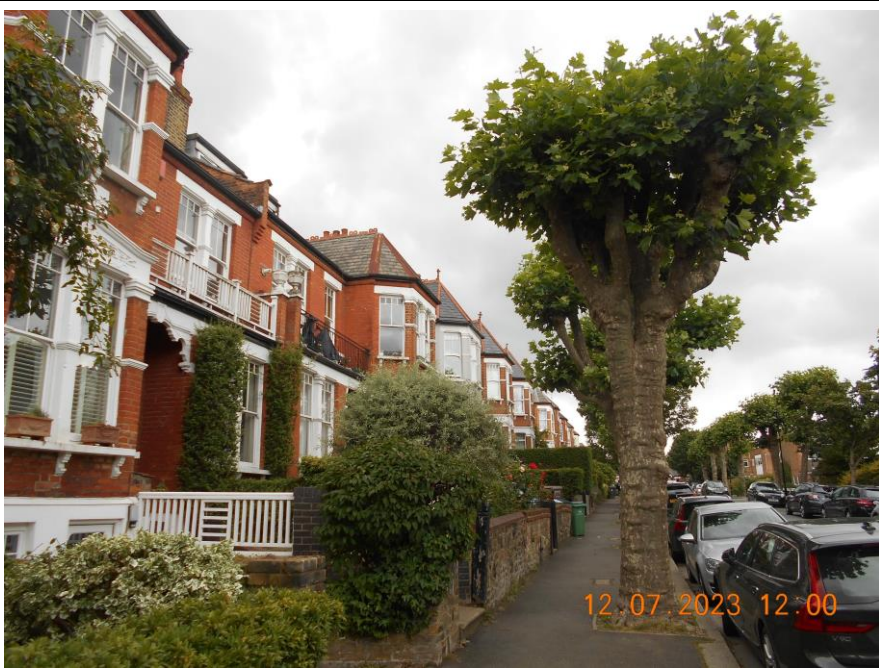
**Figure 2:** H1 on front of building with T4 street tree.

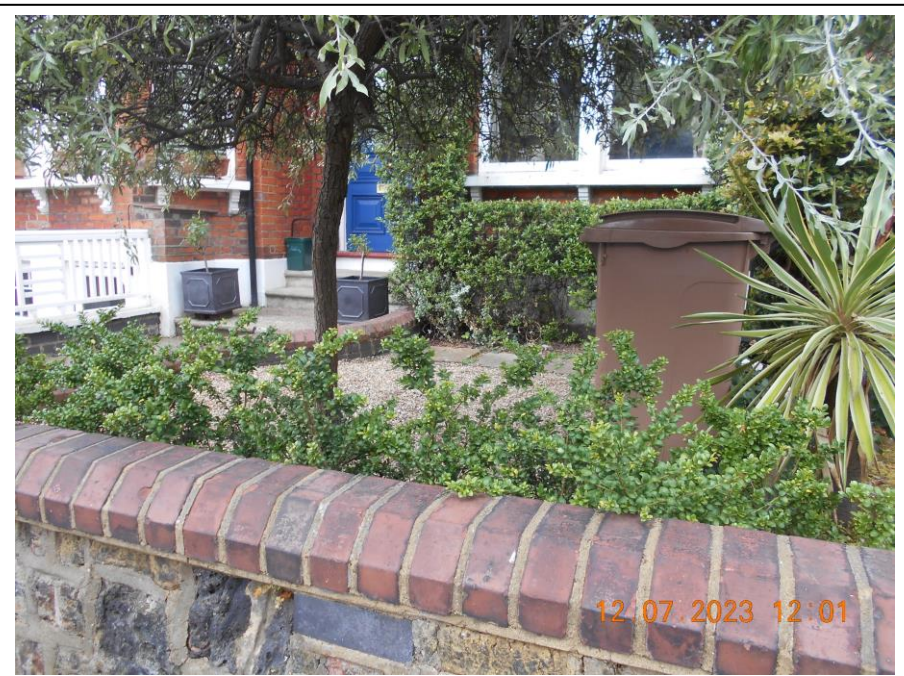
**Figure 3:** Lower part of H1 with trunk of T3.

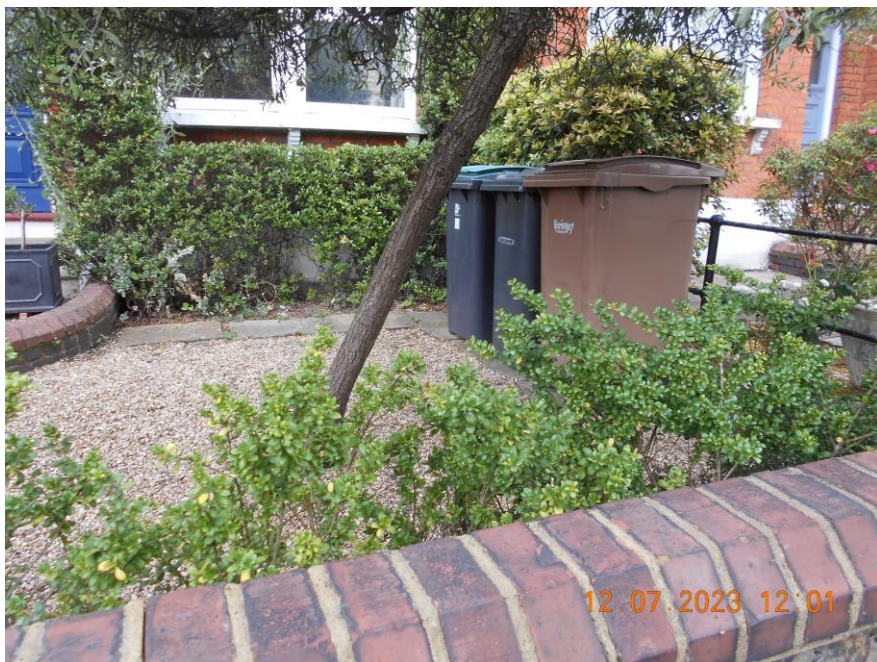
**Figure 4:** Trunk of T3 and lower part of H1.
