## Report on Structural Inspection

**23b Cranbrook Park  
Wood Green**

**Job No. 21-113  
March 2021**

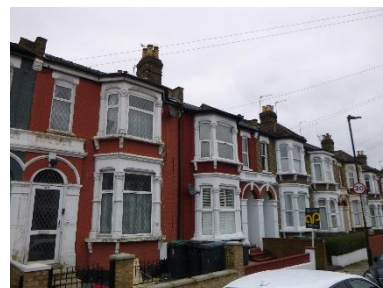
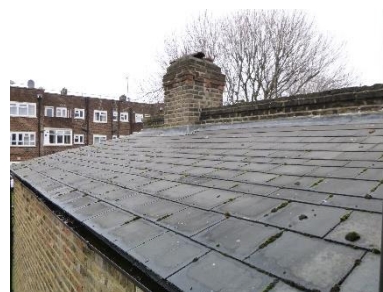
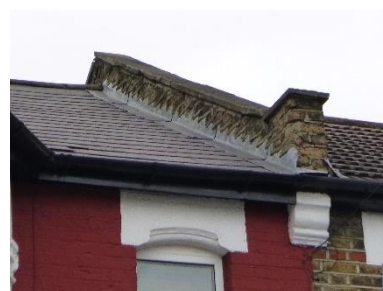
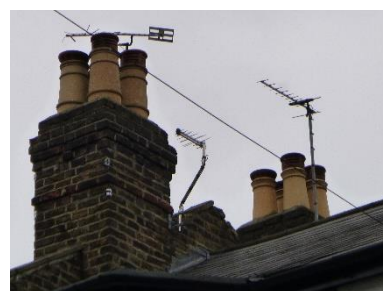
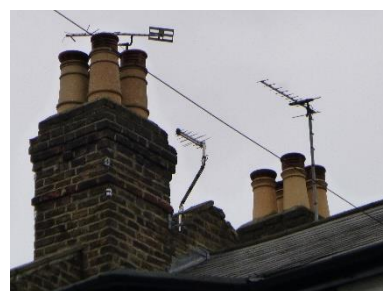
Regarding the roof coverings, it is quite likely that the artificial slates will have been manufactured before asbestos-containing materials were banned in 1999.

The roof coverings were in a fair condition, and the abutments with the parapets of the party walls were sealed with lead flashings. The existing tiles will be expected to last long enough to serve until the roof structure is upgraded.

The pots had been relatively recently fitted with ventilated cowls, although prior to this the flues had been open, allowing rainwater to drain down the chimneys into the loft.

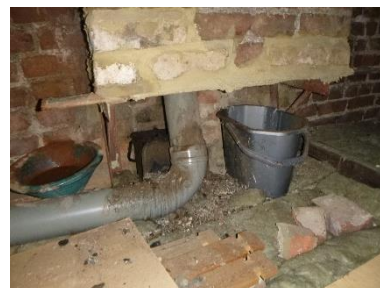
The buckets and bowls placed beneath the chimney were presumably intended to catch the rainwater, but would have overflowed onto the ceiling as soon as they were full.

The plastic pipe leads from the extractor fan to the chimney, but was not connected. The fan would not be powerful enough to overcome the draught of the chimney, and so this arrangement would be useless in any case.

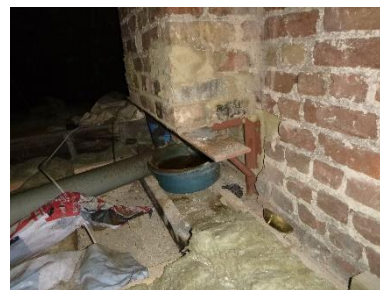
There were also signs of leakage down the face of the chimney from the back-gutter up-slope from the stack; however it is possible that this may have been repaired at the time the chimney cowls were fitted.

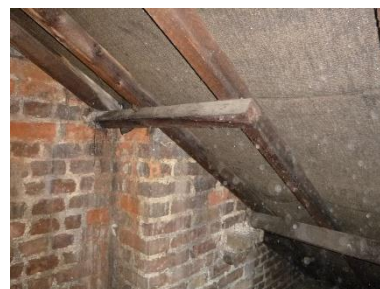
The strength of the chimney support depends on the security of the anchor bolts in the party wall, which is governed by the strength of the brickwork.

The anchors are too closely-spaced in a vertical direction to resist the pull-out force exerted by the offset weight of the chimney, and so would not meet the design criteria for the anchorage. Fortunately, the chimneys remained bonded to the party wall and so had not exerted their full weight onto the support brackets.

- v. The chimneys can then be securely pinned up on steel beams running parallel to the party wall and supported on the main beams, rendering the existing brackets superfluous.

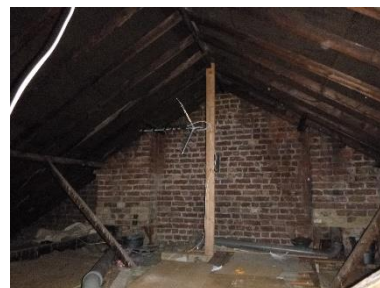
The roof structure is a traditional site-cut timber carcase with softwood rafters coupled at eaves level by the ceiling joists and supported by purlins braced with struts.

The size of the rafters and purlins was completely inadequate for the size of the roof and it is fortunate that the replacement tiles were not heavier concrete as used on the next-door property.

- ii. The rafters will not bear the weight of additional insulation and ceilings, and will most likely need to be replaced.
- iii. The ceiling joists (even if the normal size) would not support the imposed load on a domestic floor, and so would normally be augmented by timber joists laid parallel. The ceiling joists will need to be suspended from this new floor platform to allow the binders to be removed.

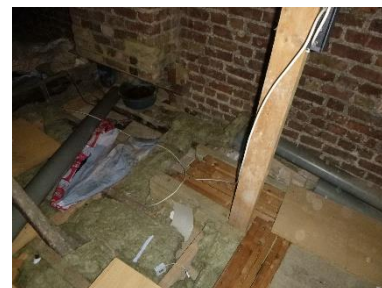
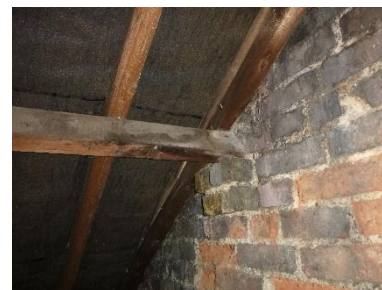
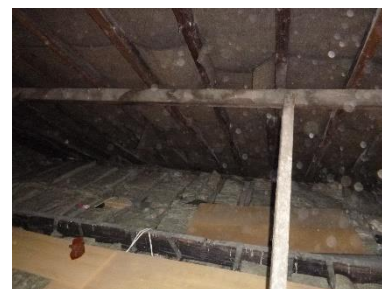
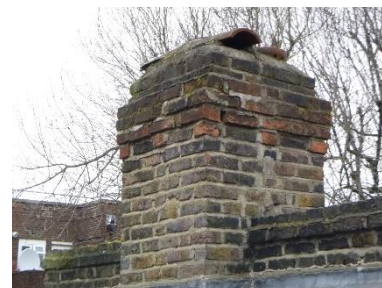
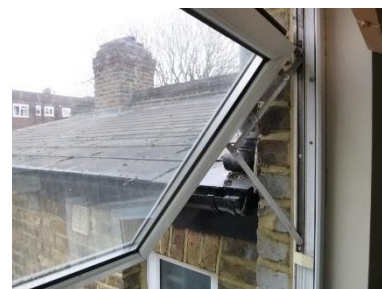
The loft relies on the internal loadbearing wall for support as well as the outside walls. This had been modified during the conversion to flats to allow a kitchen to be inserted between the front and rear rooms, separated by studwork partitions.

The newer post supported on timber members spanning across the kitchen was presumably an attempt to reinforce the roof by supporting the ridge board at the apex of the rafters.

The purlins are supported on the chimneys at one end instead of on the party wall. The brick corbels projecting from the wall are a means of ensuring fire separation between the adjoining properties to comply with contemporaneous London Building Regulations.

The weight imparted to the chimney supports by the purlins will add to the force on the masonry anchors, but this is a relatively small proportion of the mass of the chimney.

The capacity of the ceiling joists to support the weight of items stored in the loft is very limited, and so nothing should be stored there, to avoid damage to the ceilings.

As the ceiling joists are only  $\frac{5}{8}$  of the usual size, the ceilings should be treated as even more flimsy than normal. The beams referred to in the Building Survey are actually the original ceiling binders, but again are undersized.

The chimney breast in the rear wing had also been removed from the bedroom. This part of the roof was inaccessible as there was no hatch, and so the presence of a chimney support could not be verified.

The rear roof could not be inspected either, but by opening the bedroom window (which binds against the gutter), the profile of the roof could be seen to dip between the kitchen and the gable wall at the back.

Such distortion would not be unusual but hints at weakness in the roof structure similar to that identified in the main roof.

The roof might be expected to have a residual service life not exceeding ten years before major repairs or replacement will be necessary.

In the case of constructing a loft conversion, most of the inherent flaws in the roof structure and the chimney supports can be addressed in the process of design. However, it will be necessary to verify the responsibility for upkeep of the roof structure with regard to freehold ownership before commencing construction, and Party Wall Agreements will also need to be secured with the adjoining owners.

The design of the loft conversion would need to deal with the following issues:

- i. The internal walls flanking the kitchen cannot be used as supporting walls, as they do not align with the position of the original spine wall remaining on the storey below.

- iv. The attic floor platform will need to be supported on steel beams spanning between the party walls, since the internal walls cannot be counted on to provide support.

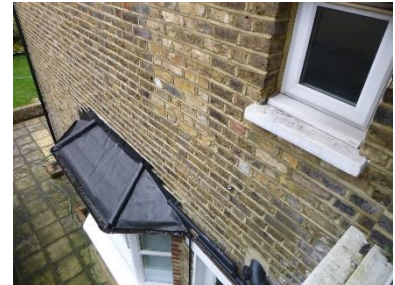
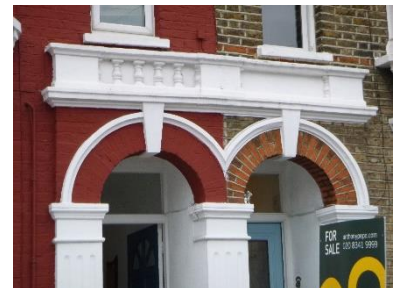
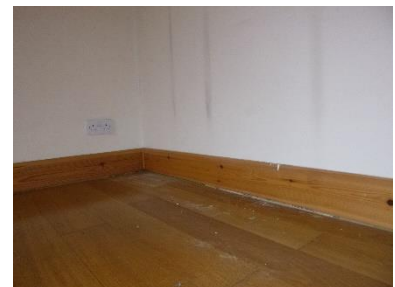
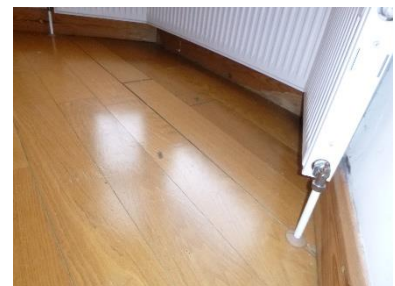
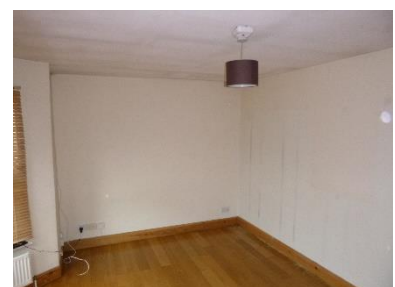
There were no obvious signs of recent or active movement, and cracking was confined to a hairline-width separation crack between the party wall and the ceiling of the front room, which is most likely to reflect the flimsiness of the ceiling.

The pediments over the entrance doors of the adjoining properties were slightly distorted, but this is likely to be the result of historic settlement and is judged as not being active or progressive.

The internal walls were of modern timber studwork, replacing the brick spine wall. Shadow lines on the plasterboard are a sign of condensation or moisture damage, which was probably the result of water leaking down the chimney flues.

The laminate flooring was in fair condition but the joints had opened up into the front bay, and there was a gap between the floor and the skirting board at the back wall.

The first floor joists are, since the conversion, required to bear the additional load of the partition walls and the loft transferred from above, which will increase the deflection of the joists leading to a sag in the floor.

This will dry out over time with proper ventilation but if the problem persists it will be necessary to strip off and replace the plasterboard before redecorating.

However, the loadbearing capacity of the floor will have been somewhat reduced, and heavy items of furniture such as wardrobes will need to be carefully placed to avoid overloading the floor.
