**Our Ref :** 4047/L230605.skp.jbd

**RE : 1 CROMWELL PLACE, LONDON N6 5HR  
INSPECTION OF FRONT ELEVATION & FRONT BOUNDARY WALL AREAS**

#### **INSPECTION ON 1<sup>ST</sup> JUNE 2023**

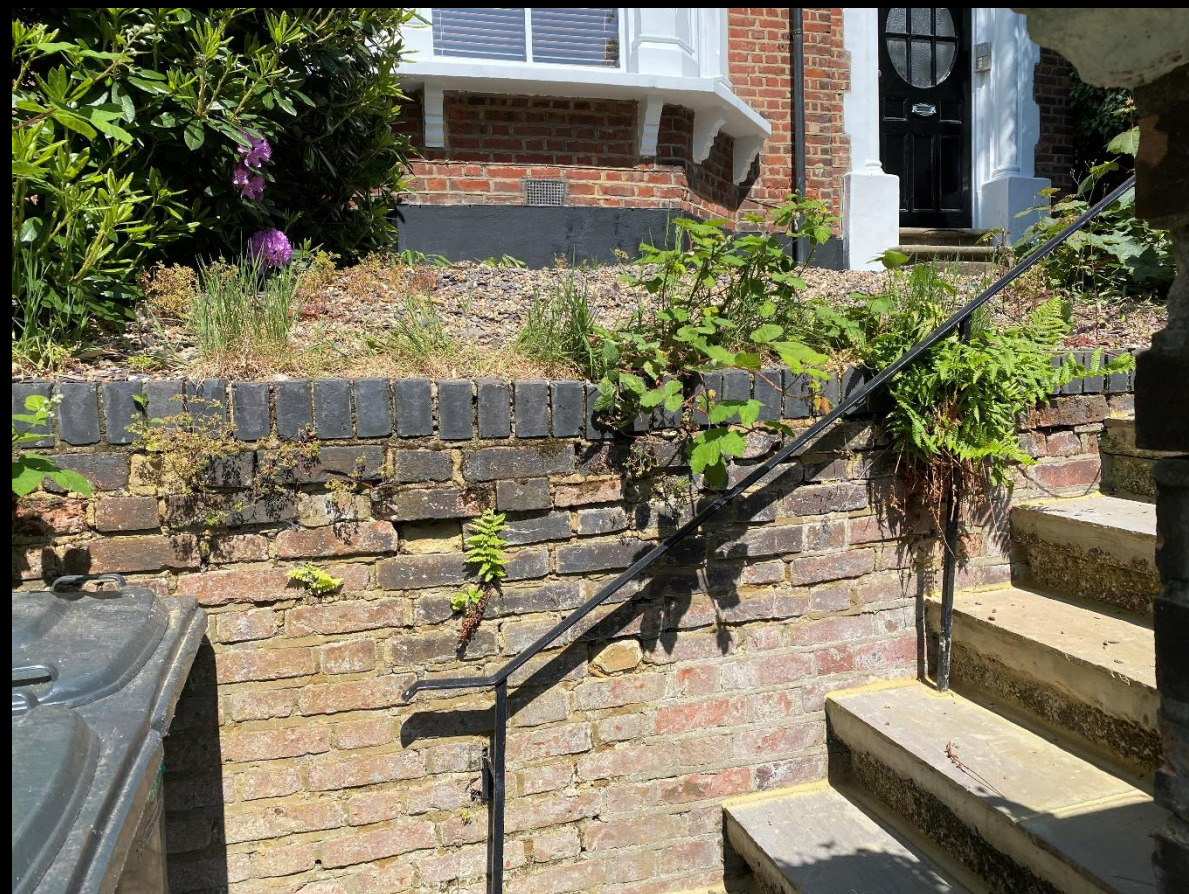
Photograph No. 8

Behind this area there are then 2 retaining wall structures, retaining the upper front garden area. Again, these are in structurally sound order, but the upper 4 or 5 courses are clearly slightly leaning and have general pointing defects throughout these areas (see Photographs 8 & 9). In my opinion thus, it would be sensible for these areas to be repointed, although you could consider re-building the upper 3 or 4 courses both to the

front face and the return where there are a number of bins. Any repointing should ideally be in lime mortar.
