2 Tree Claim - 20a Crescent Rd

#### **REQUEST FOR TREE REMOVAL**

We have been asked by AXA Retail - Avantia to comment on movement that has taken place to the above property. We are required to briefly describe the damage, establish a likely cause and list any remedial measures that may be needed.

# Arboricultural Appraisal Report

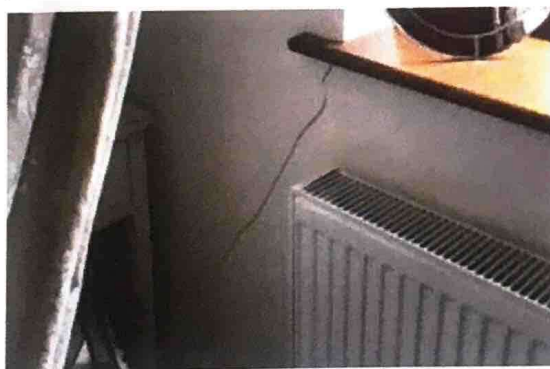
Crack to left of radiator to front bedroom window.

- Diagonal crack to front plastered wall to left hand side and right hand side of window - 3mm.
- Minor separation of coving from plastered wall finish.

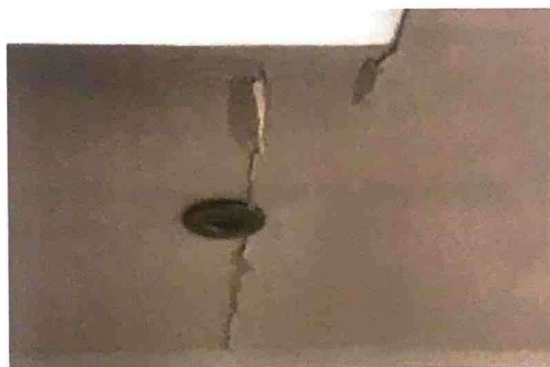
Crack to ceiling in kitchen / living area.

- Distortions to front window and door frame near kitchen area preventing opening and closing freely due to movement.
- Crack noted to ceiling - separation of plasterboard at joint line.
- Diagonal crack to either side of the entrance door plasterboard surface finish - hairline - 1mm.

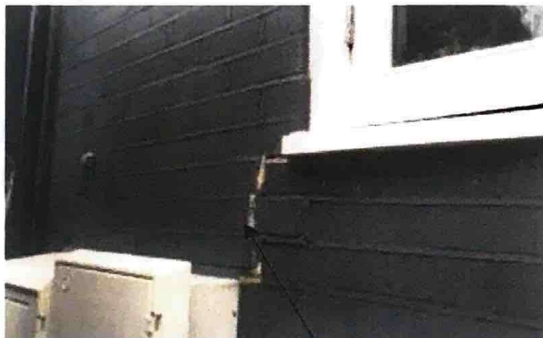
Crack to front left brickwork.

- Left hand corner brickwork appears to have dropped slightly. Stepped cracking noted to cover 12 courses of brickwork - crack width approximately 1-10mm.

In structural terms the damage falls into Category 3 of Table 1, Building Research Establishment<sup>8</sup> Digest 251, which describes it as "**moderate**".

The pattern and nature of the cracks is indicative of an episode of subsidence. The cause of movement appears to be either clay shrinkage or subsoil softening/erosion due to drains leakage.

- Trial pit and borehole investigations to include foundation depth detail, soil analysis, root retrieval and laboratory testing.
- CCTV Drainage inspection.
- Arboriculture Survey and TPO investigation.
- Level Monitoring - 12 months.

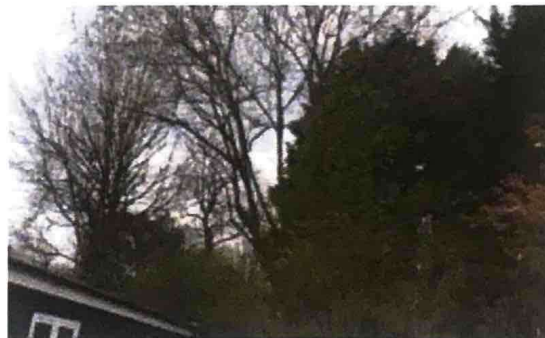
Localised vegetation to right of property in neighbours garden.

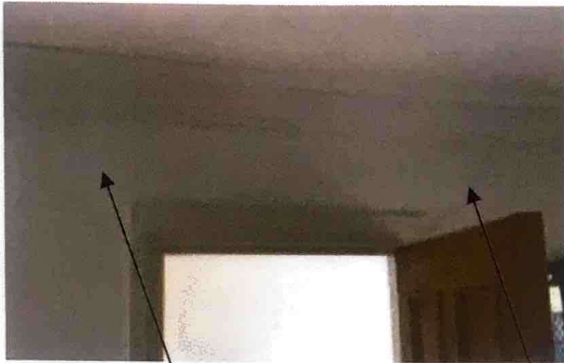
- Diagonal crack above entrance door to Kitchen / Living Room area.
- Minor separation of coving from plastered wall finish.

Cracks to plastered wall entrance to kitchen living room.

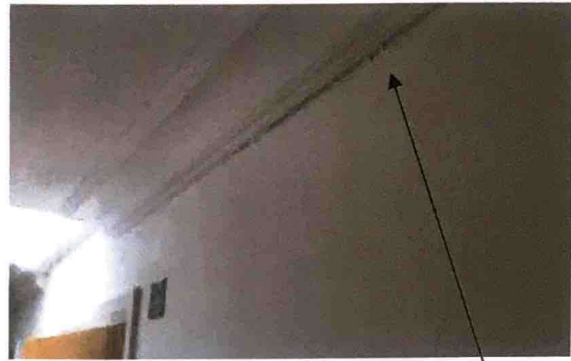
Coving separation in hallway.

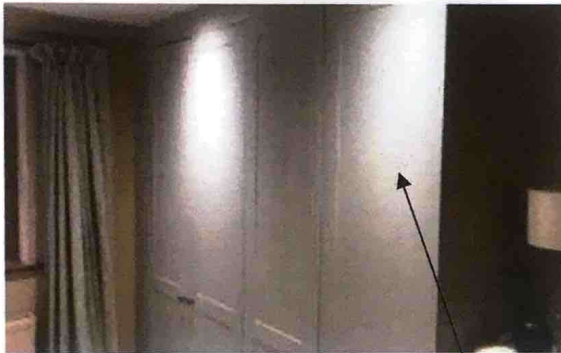
- Diagonal crack to front plastered wall to right hand side of window - hairline to 1mm.
- Wardrobe doors appear to be sticking slightly as does the door to the walk in wardrobe which is now wedged to the floor finish and will neither open or close.

Bedroom wardrobes sticking.

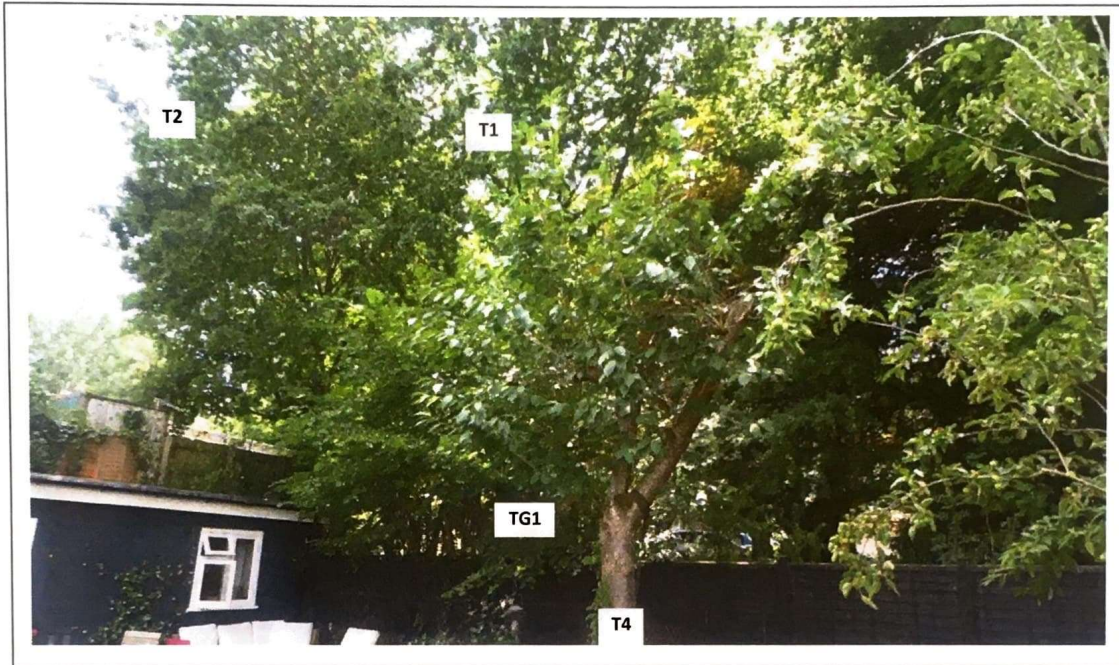
The most significant of the retrieved samples are the *Quercus* spp. roots. These will originate from T1 Oak to the right-hand side of the building. Given that the focus of movement is downwards towards the right-hand side, T1 Oak is considered the likely principal cause.

View of T1 Oak, with TG1 Hazel group and T4 Cherry to foreground and T2 Sycamore visible to rear of T1 Oak

If an arboricultural solution is to be implemented to mitigate the influence of the implicated trees/vegetation we recommend that T1 Oak is removed. Other vegetation recorded presents a potential future risk to building stability and management is therefore recommended. Recommended tree works may however be subject to change upon receipt of additional information.

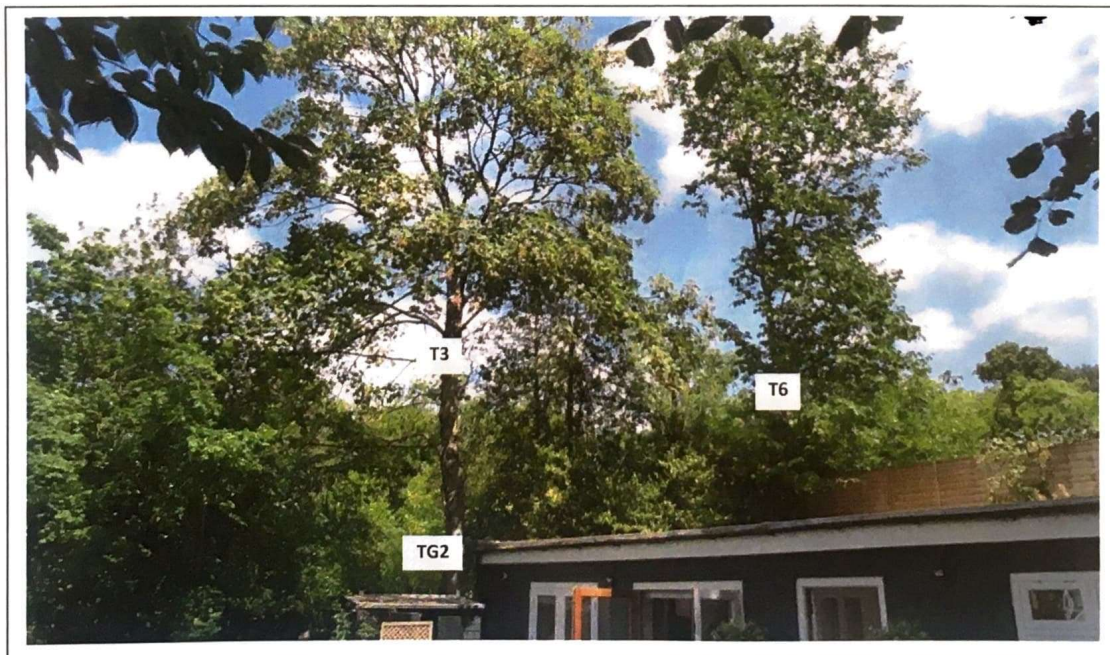
View of T3 Sycamore and T6 Hornbeam with TG2 understorey

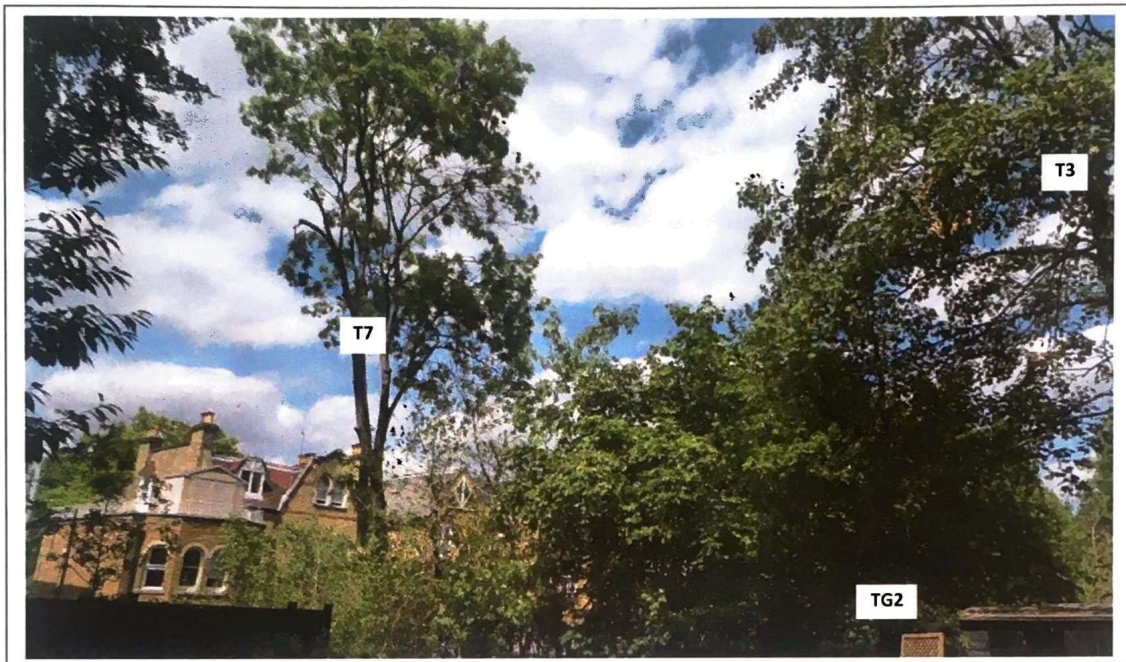
View of T7 Ash, with T3 Sycamore to left of frame and TG2 understorey

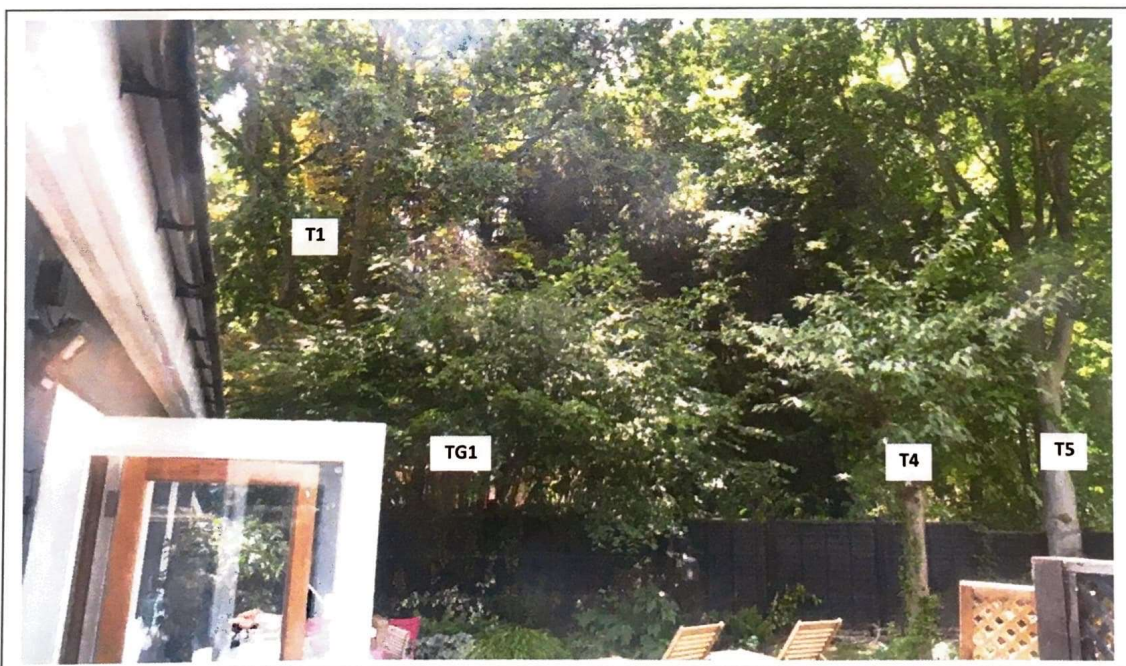
View of T1 Oak, with TG1 Hazel group and T4 Cherry to foreground and T5 Beech to right of frame
