# Broadwater Farm Estate

## Mural mosaic

Condition Survey  
September 2023

Authored by Paolo Volpi & Ian Devine  
Reviewed by Adrian Attwood ACR

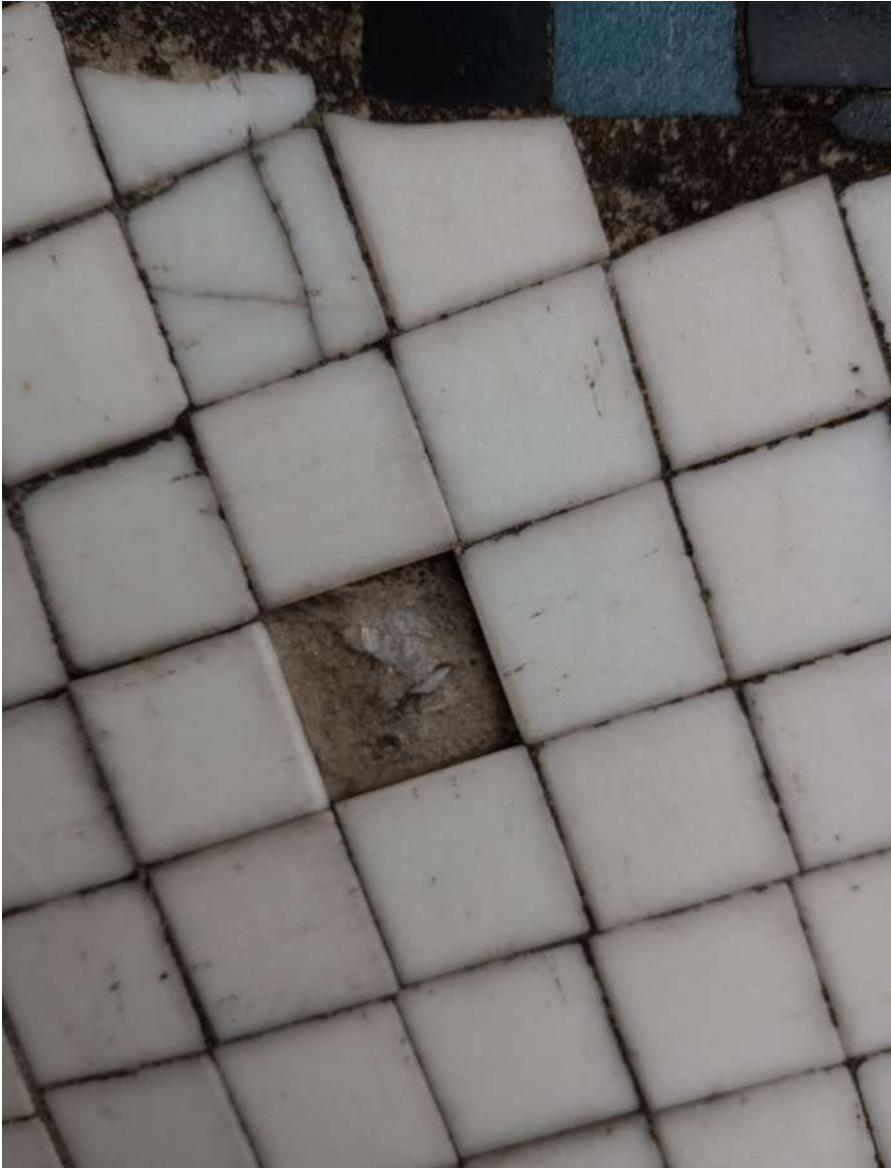
Panel B, section 4

## Missing/Losses

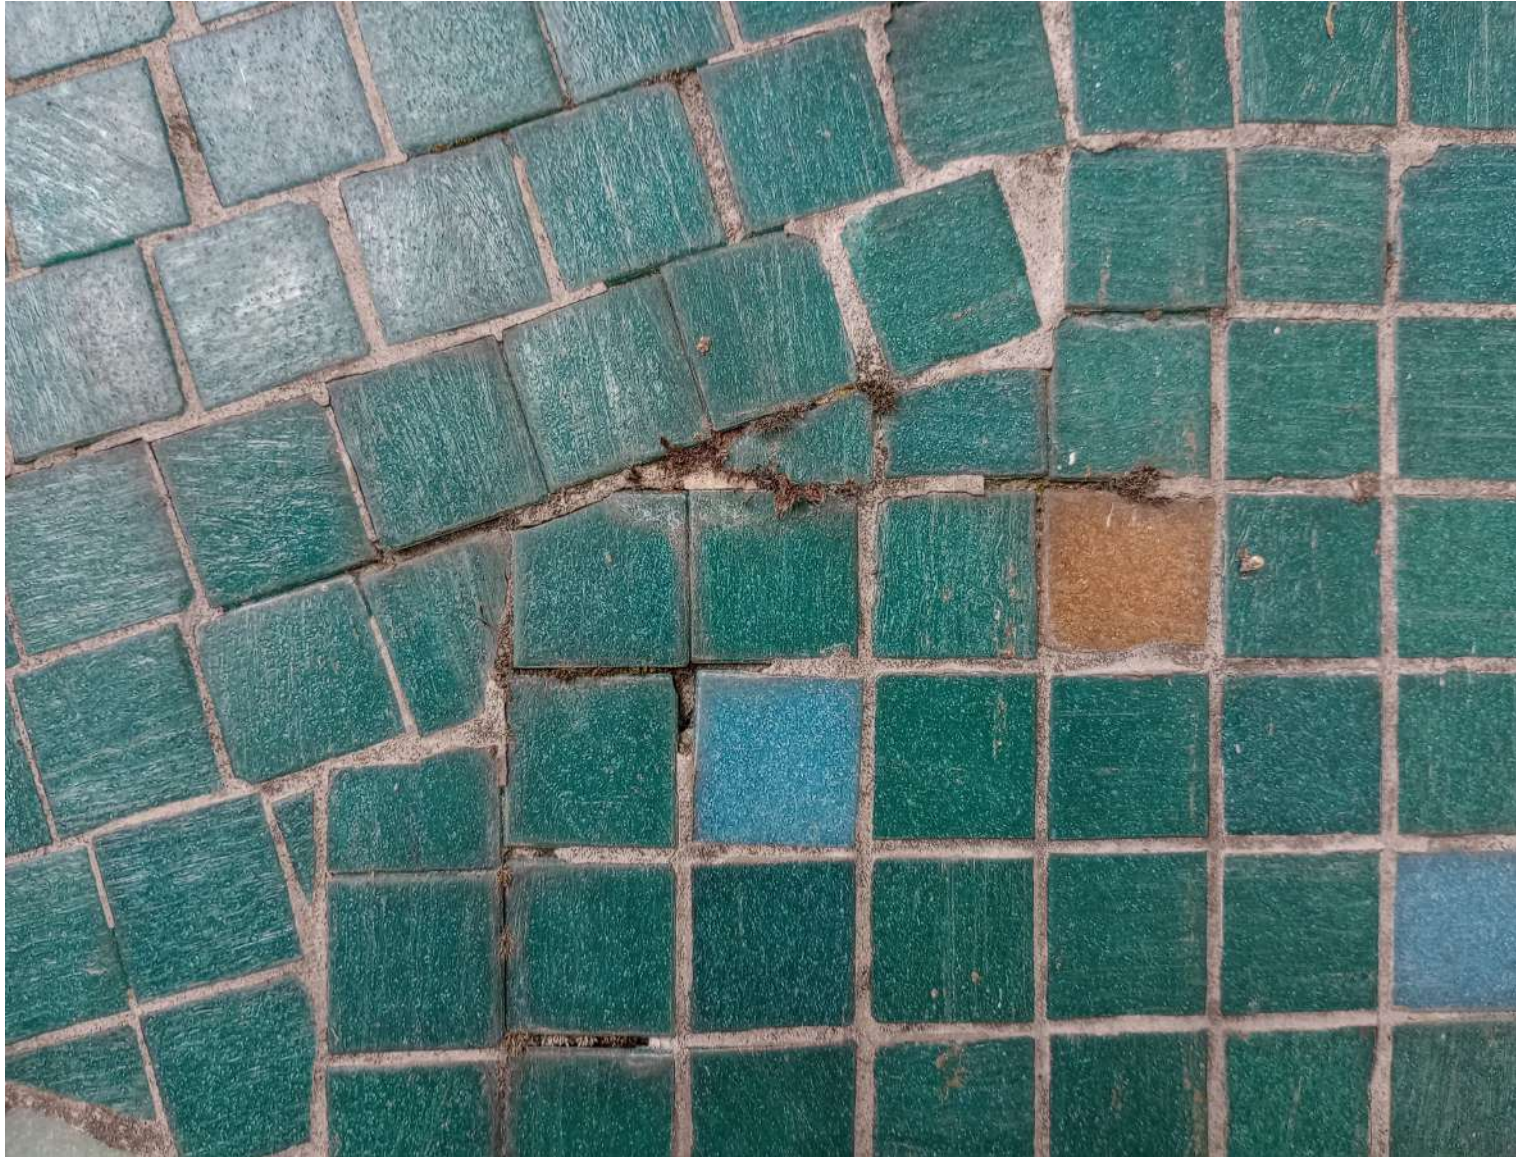
Panel Q, section 4

## Hollow tesserae

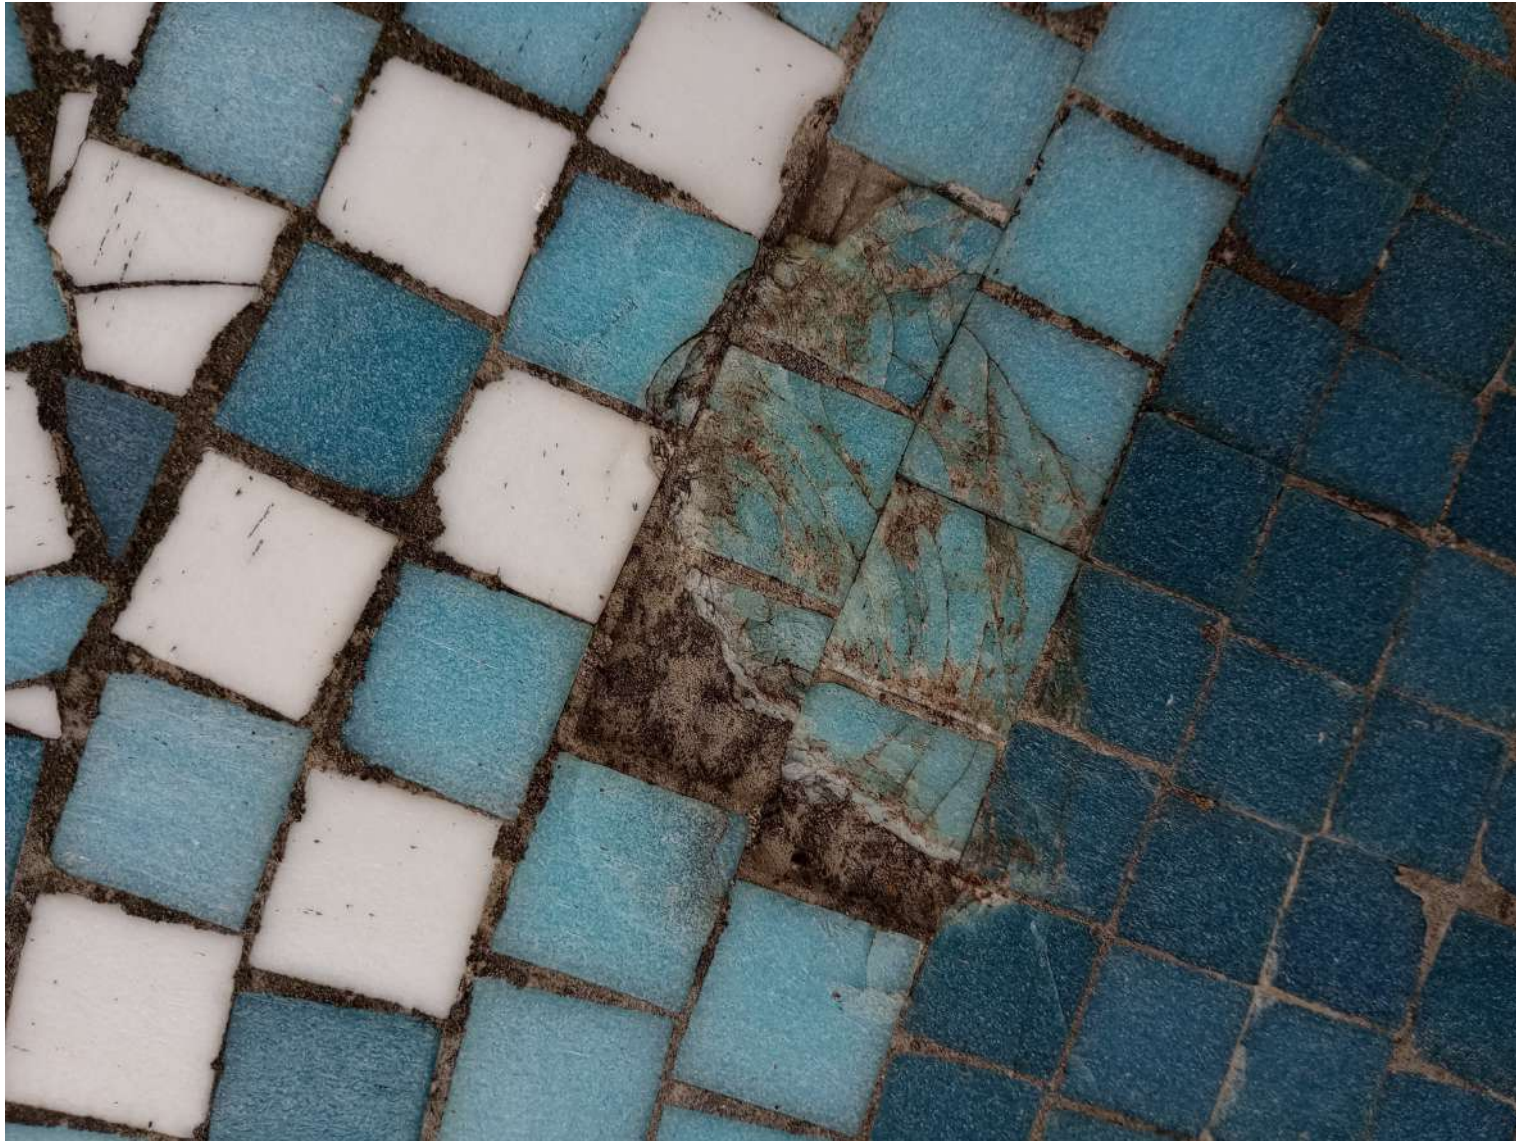
Panel D, section 1

# Cracks

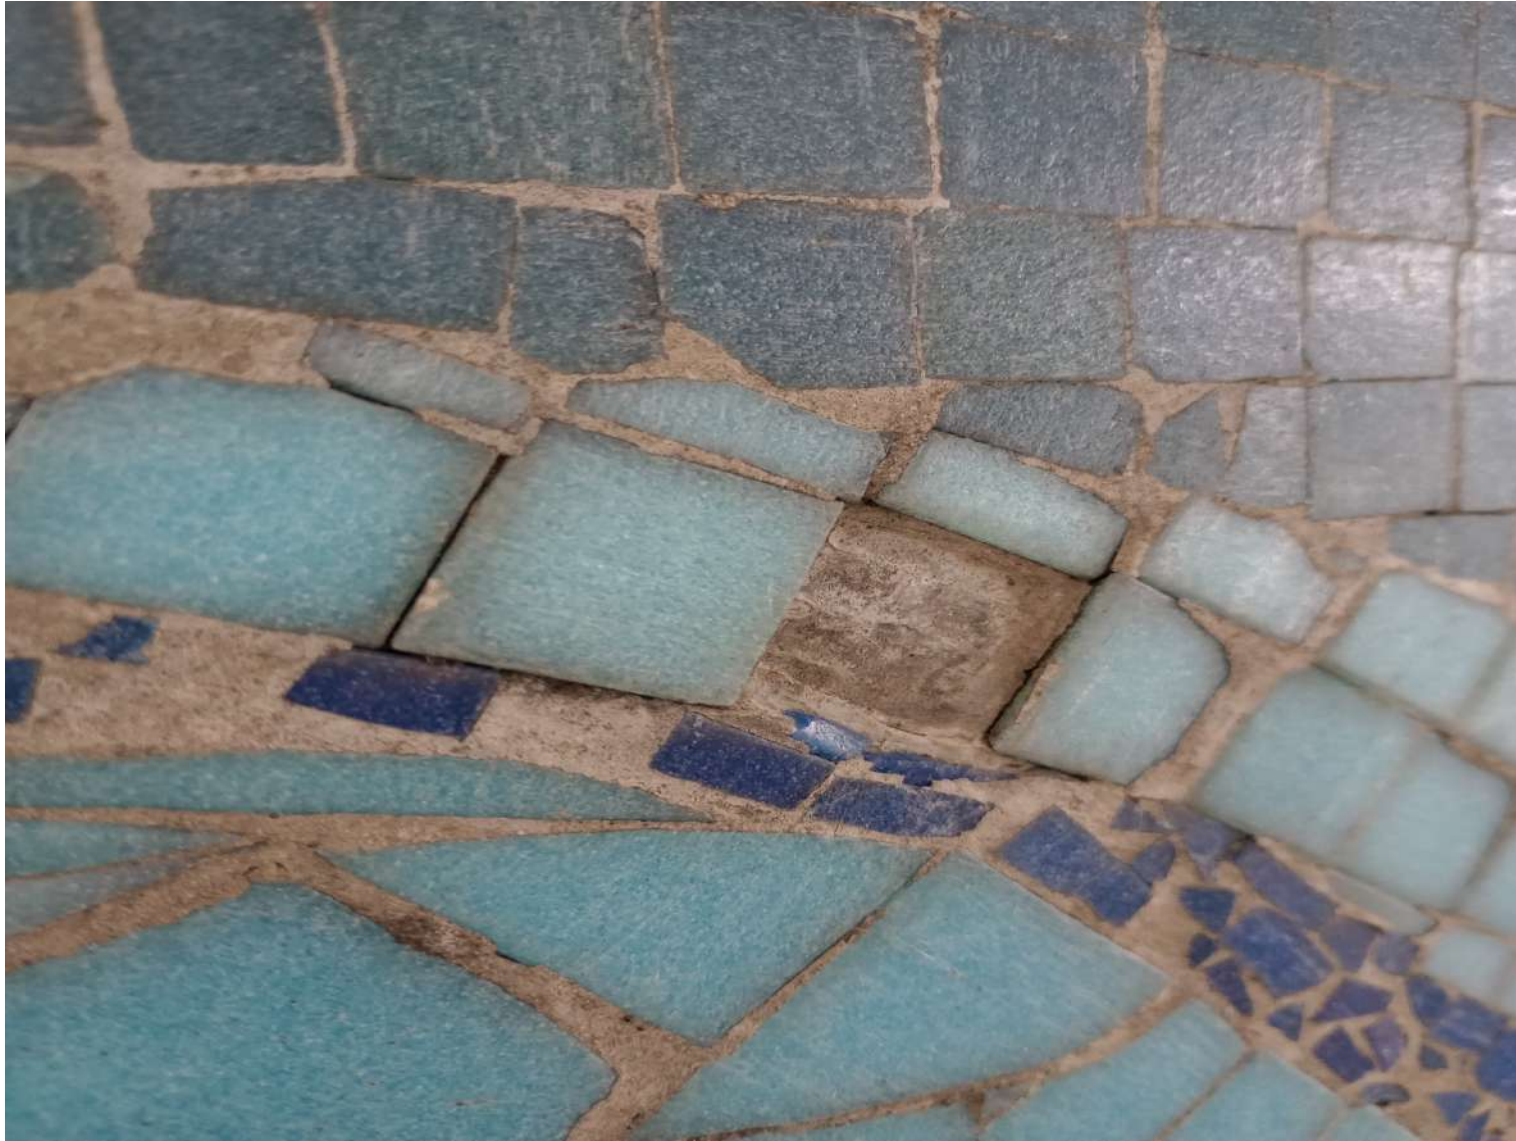
Panel F, section 4

## Loose tesserae

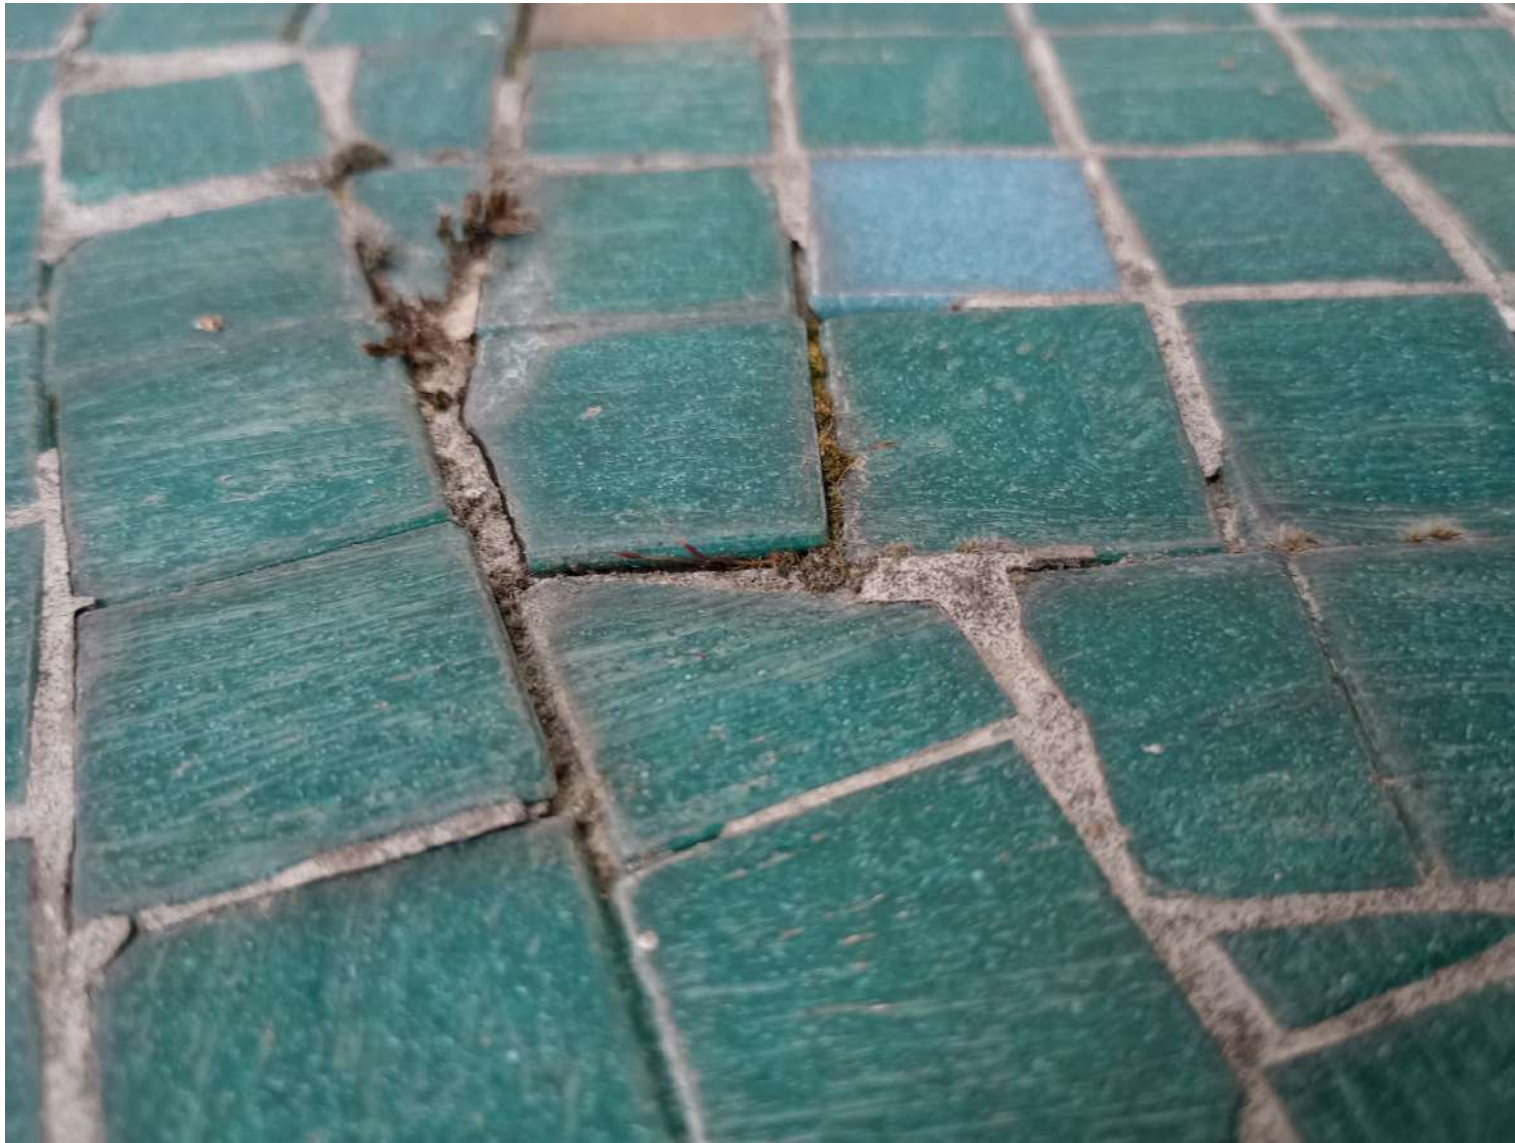
Panel Q, section 4

## Missing mortar

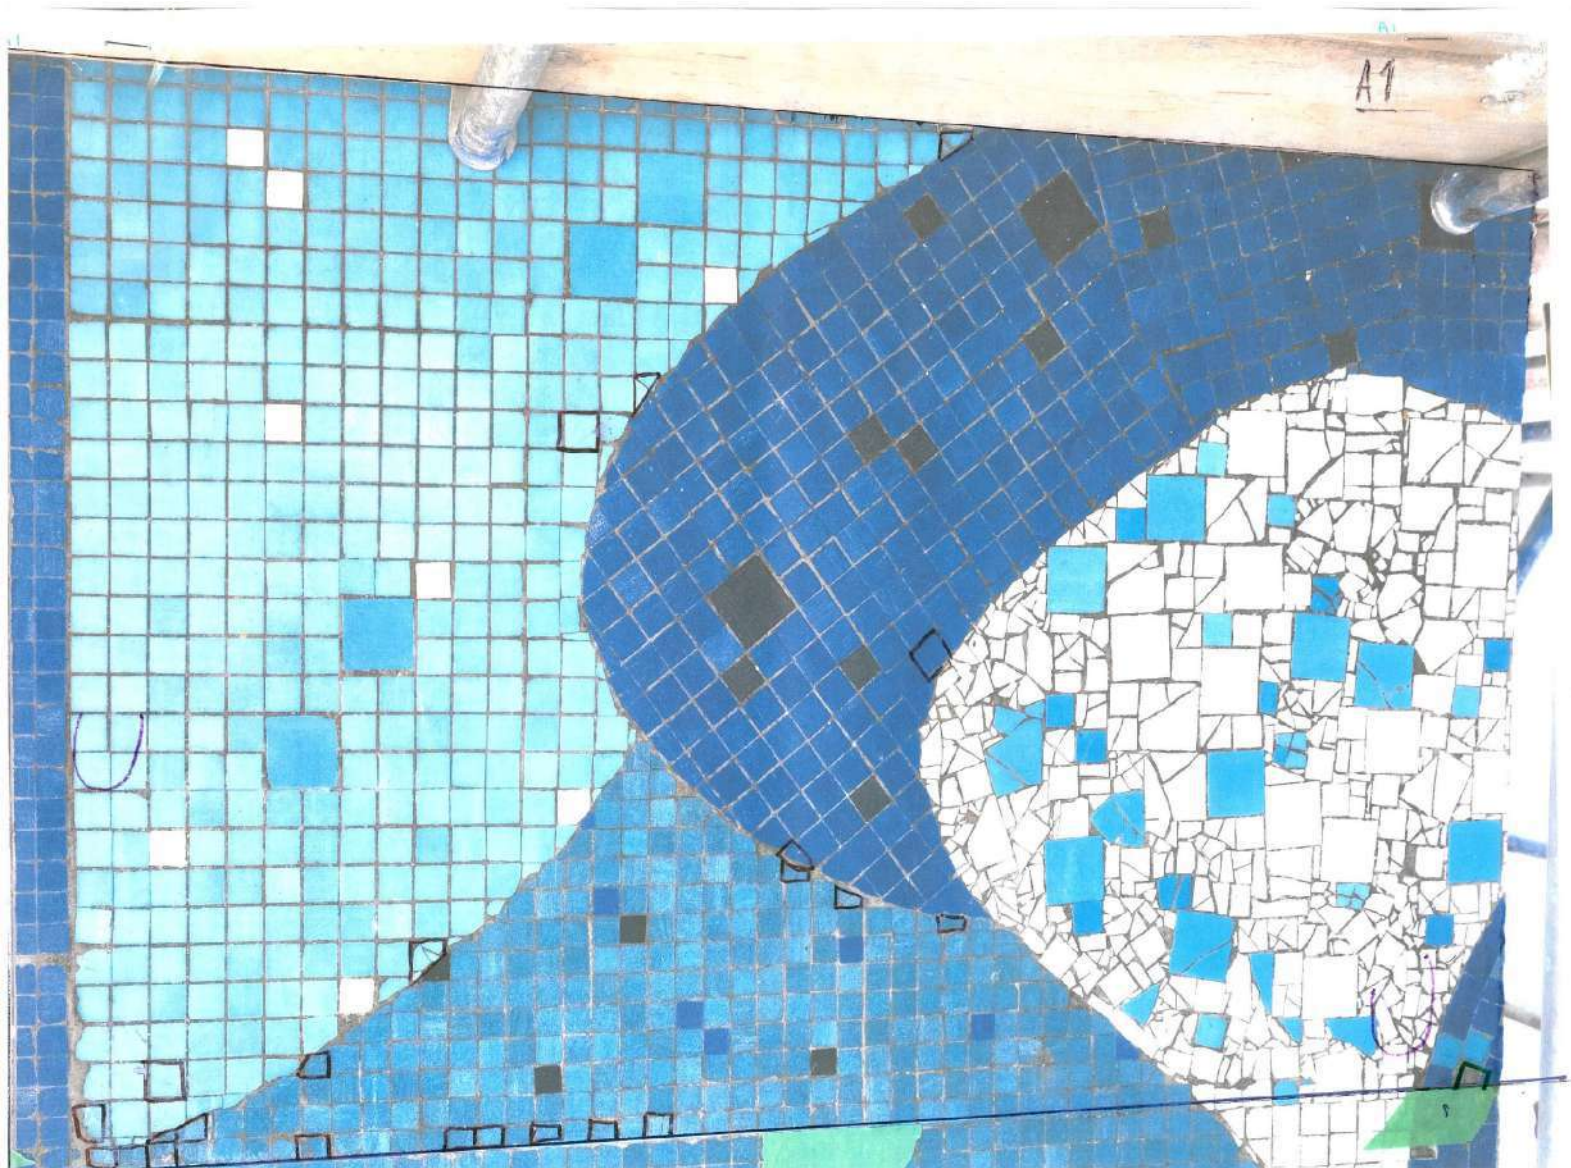
## Panel A1

1200mm x 750mm  
General Fair condition

Superficial dirt: 100%\*  
Biological growth: 100%\*  
Guano: 2%\*

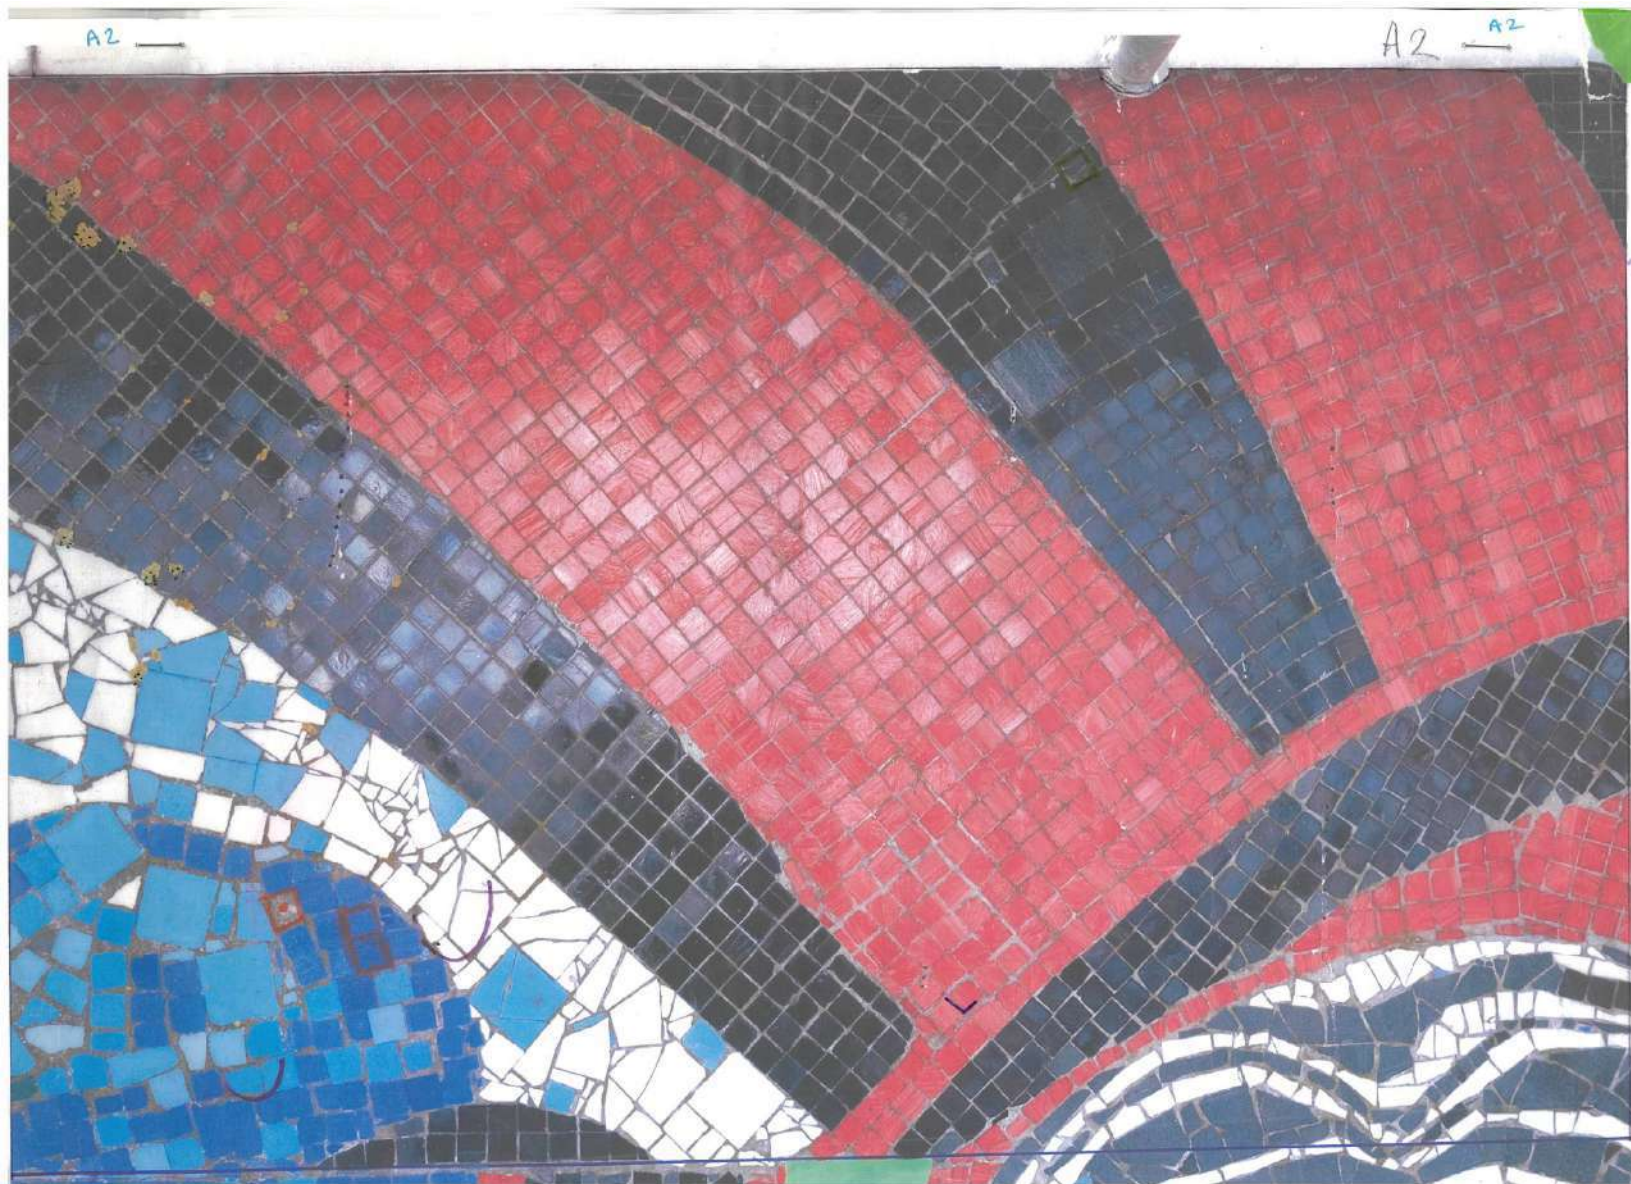
## Panel A2

1530mm x 750mm

General Fair condition

Superficial dirt: 100%\*

Biological growth: 100%\*

Guano: 2%\*

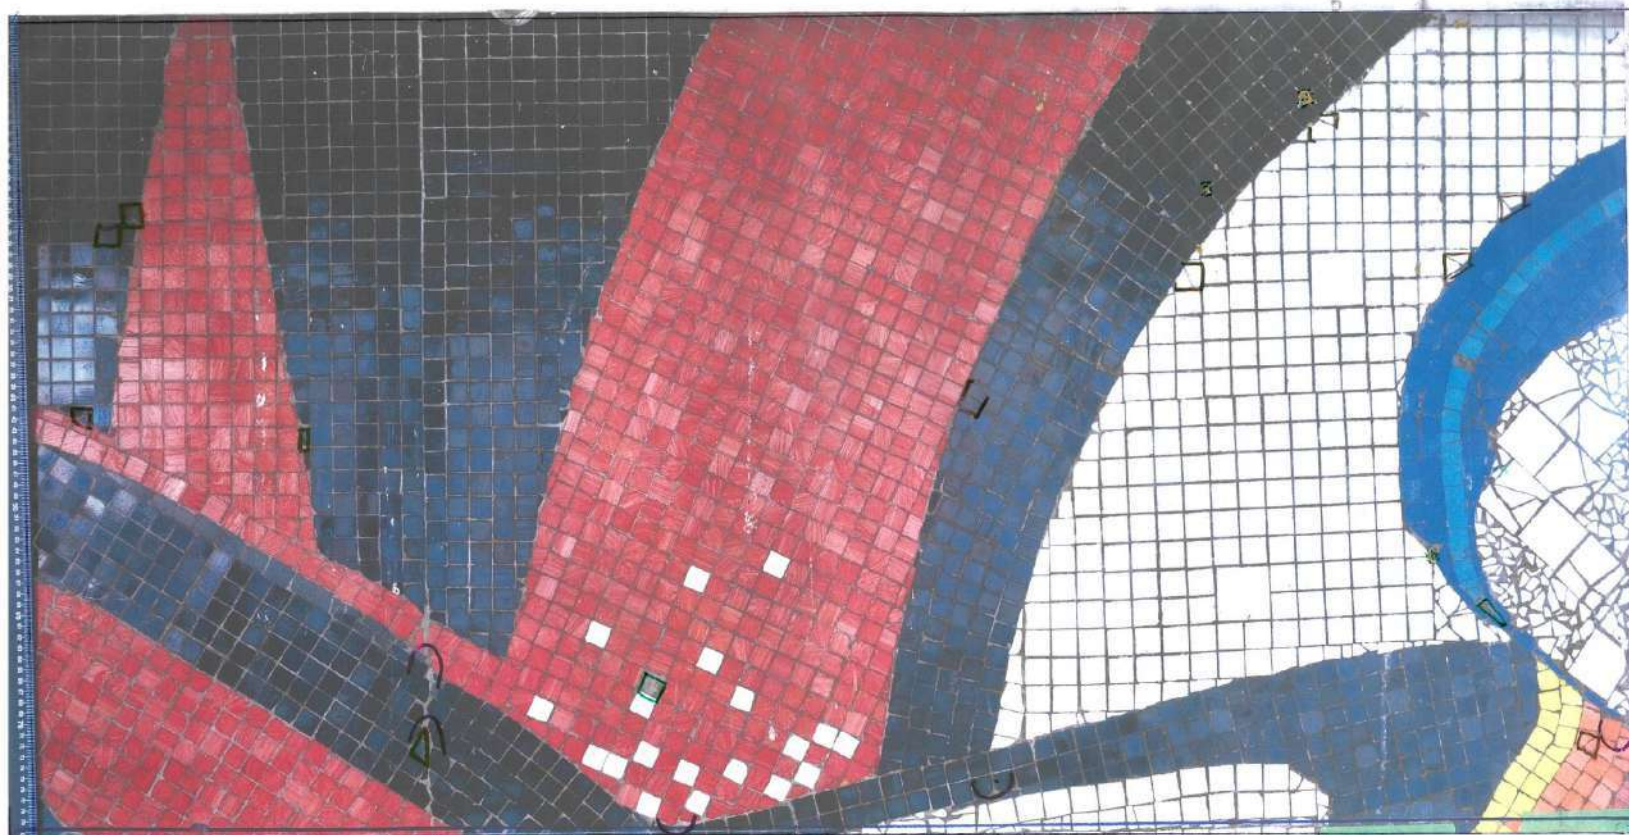
## Panel A3

1510mm x 750mm

General Fair condition

Superficial dirt: 100%\*

Biological growth: 100%\*

Guano: 2%\*

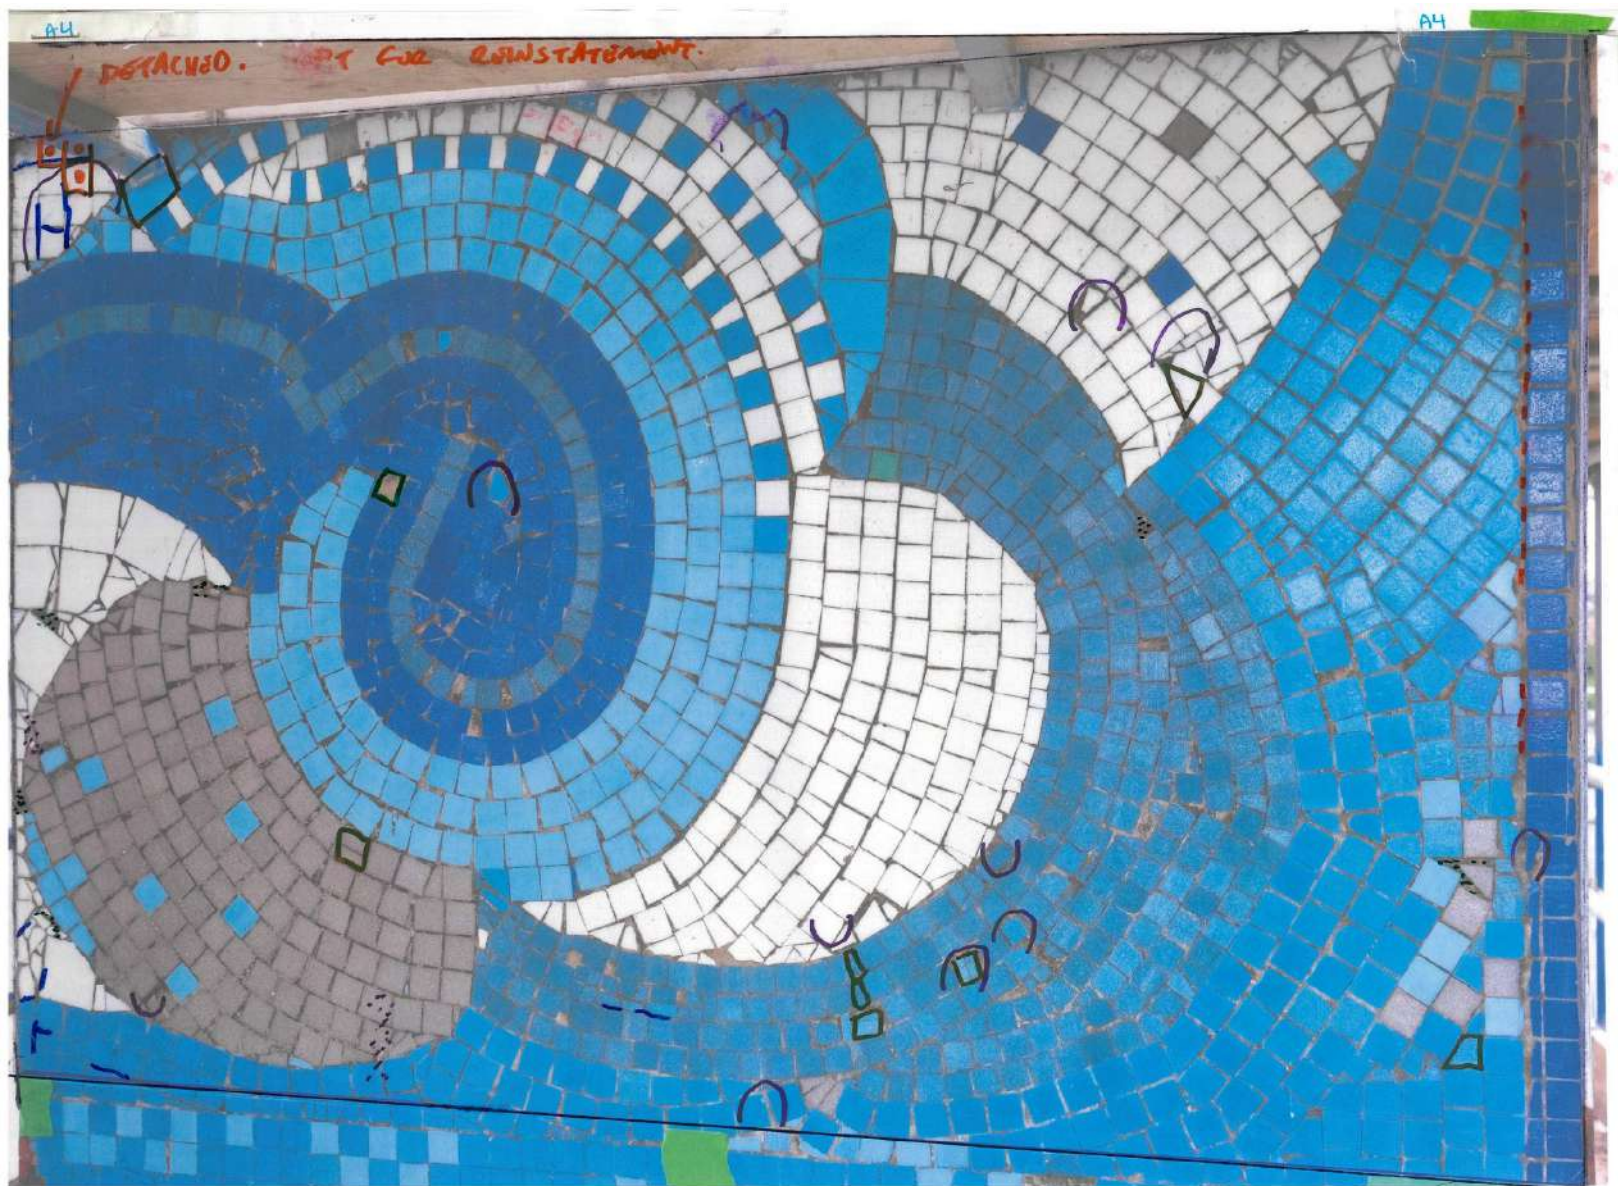
## Panel A4

1200mm x 750mm

General Fair condition

Superficial dirt: 100%\*

Biological growth: 100%\*

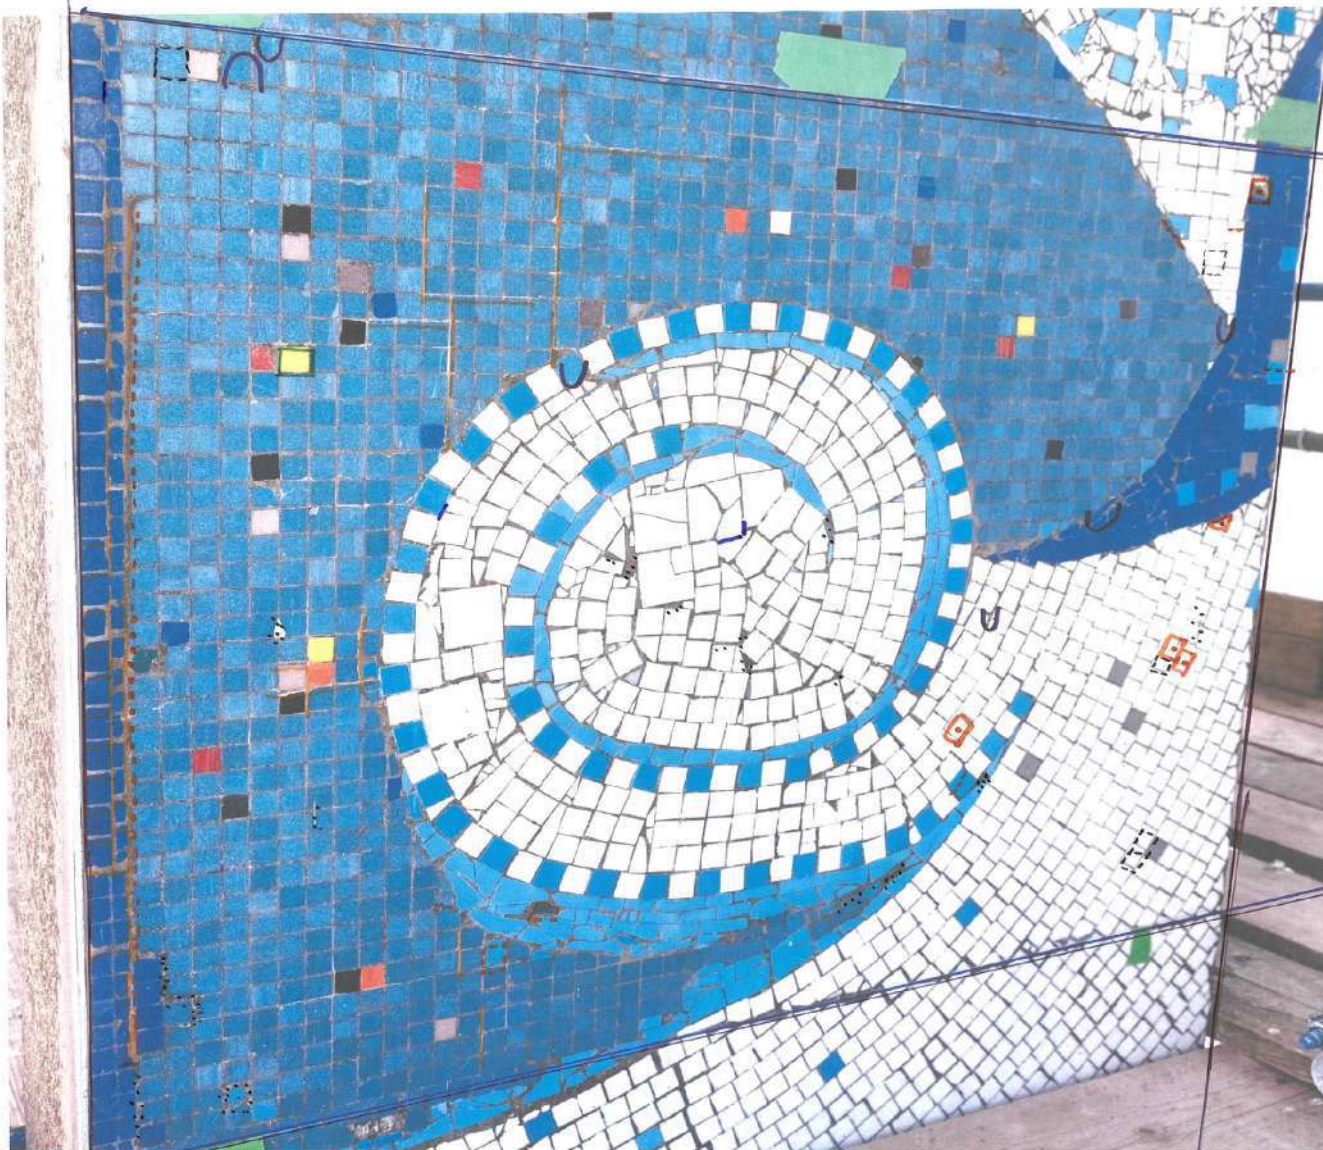
## Panel B1

1195mm x 900mm

General Fair condition

Superficial dirt: 100%\*

Biological growth: 100%\*

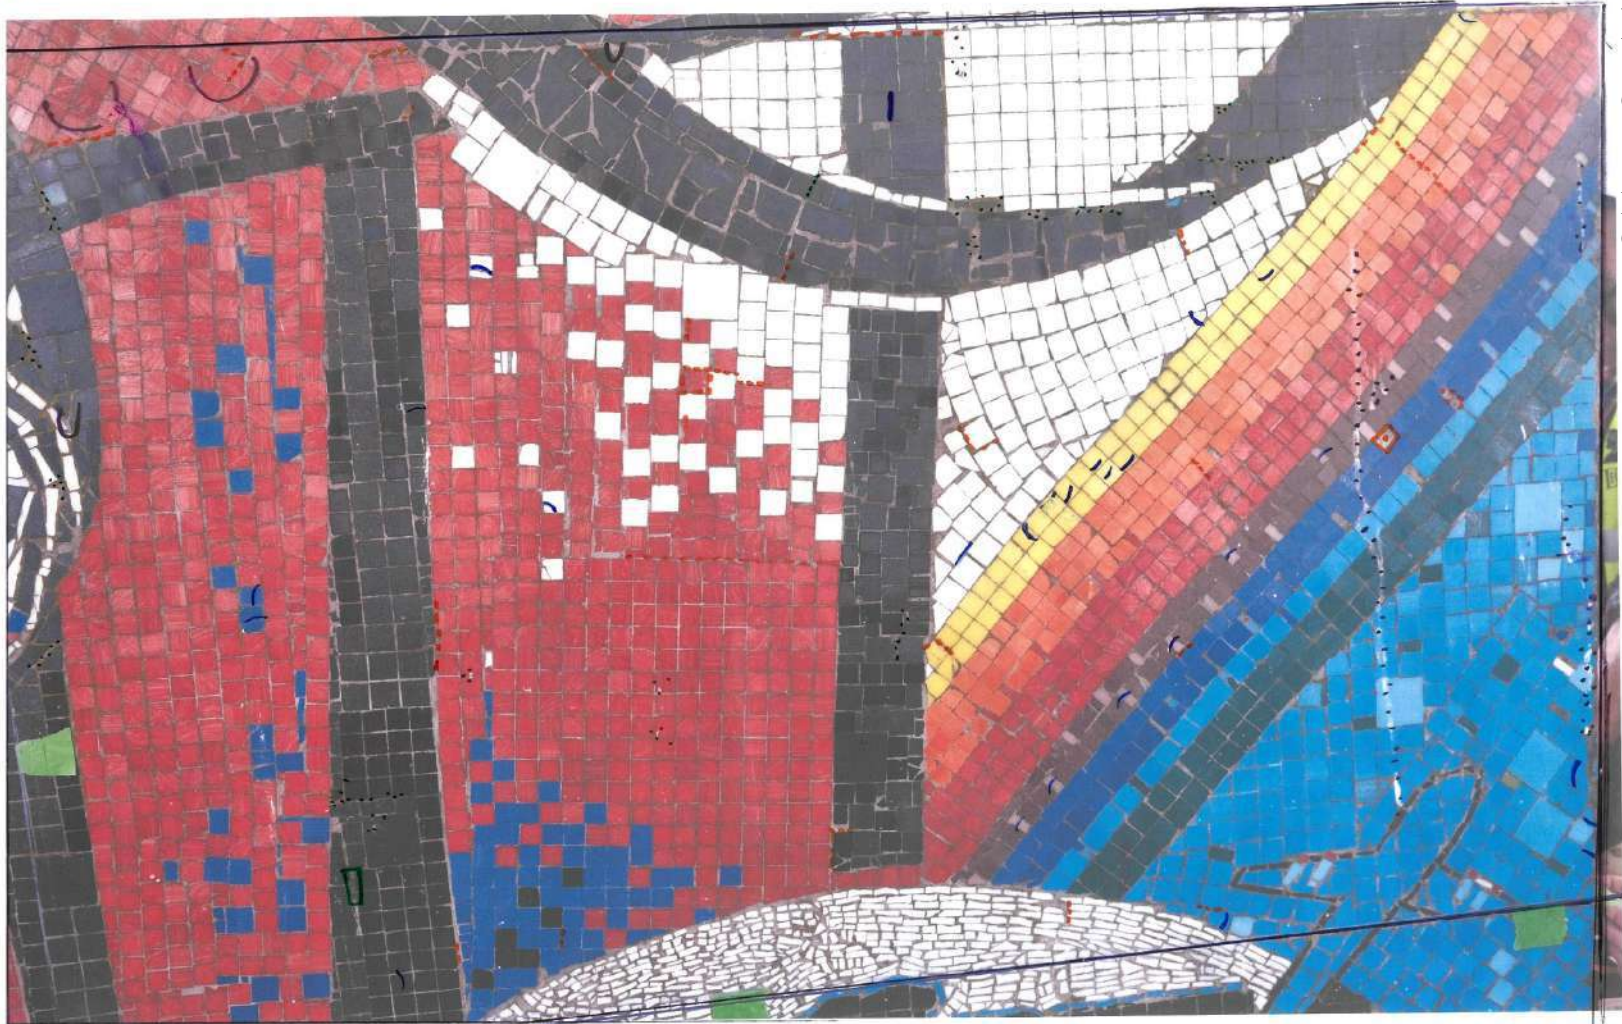
### Panel B3

1510mm x 900mm  
General Fair condition

Superficial dirt: 100%\*  
Biological growth: 100%\*  
Guano: 2%\*

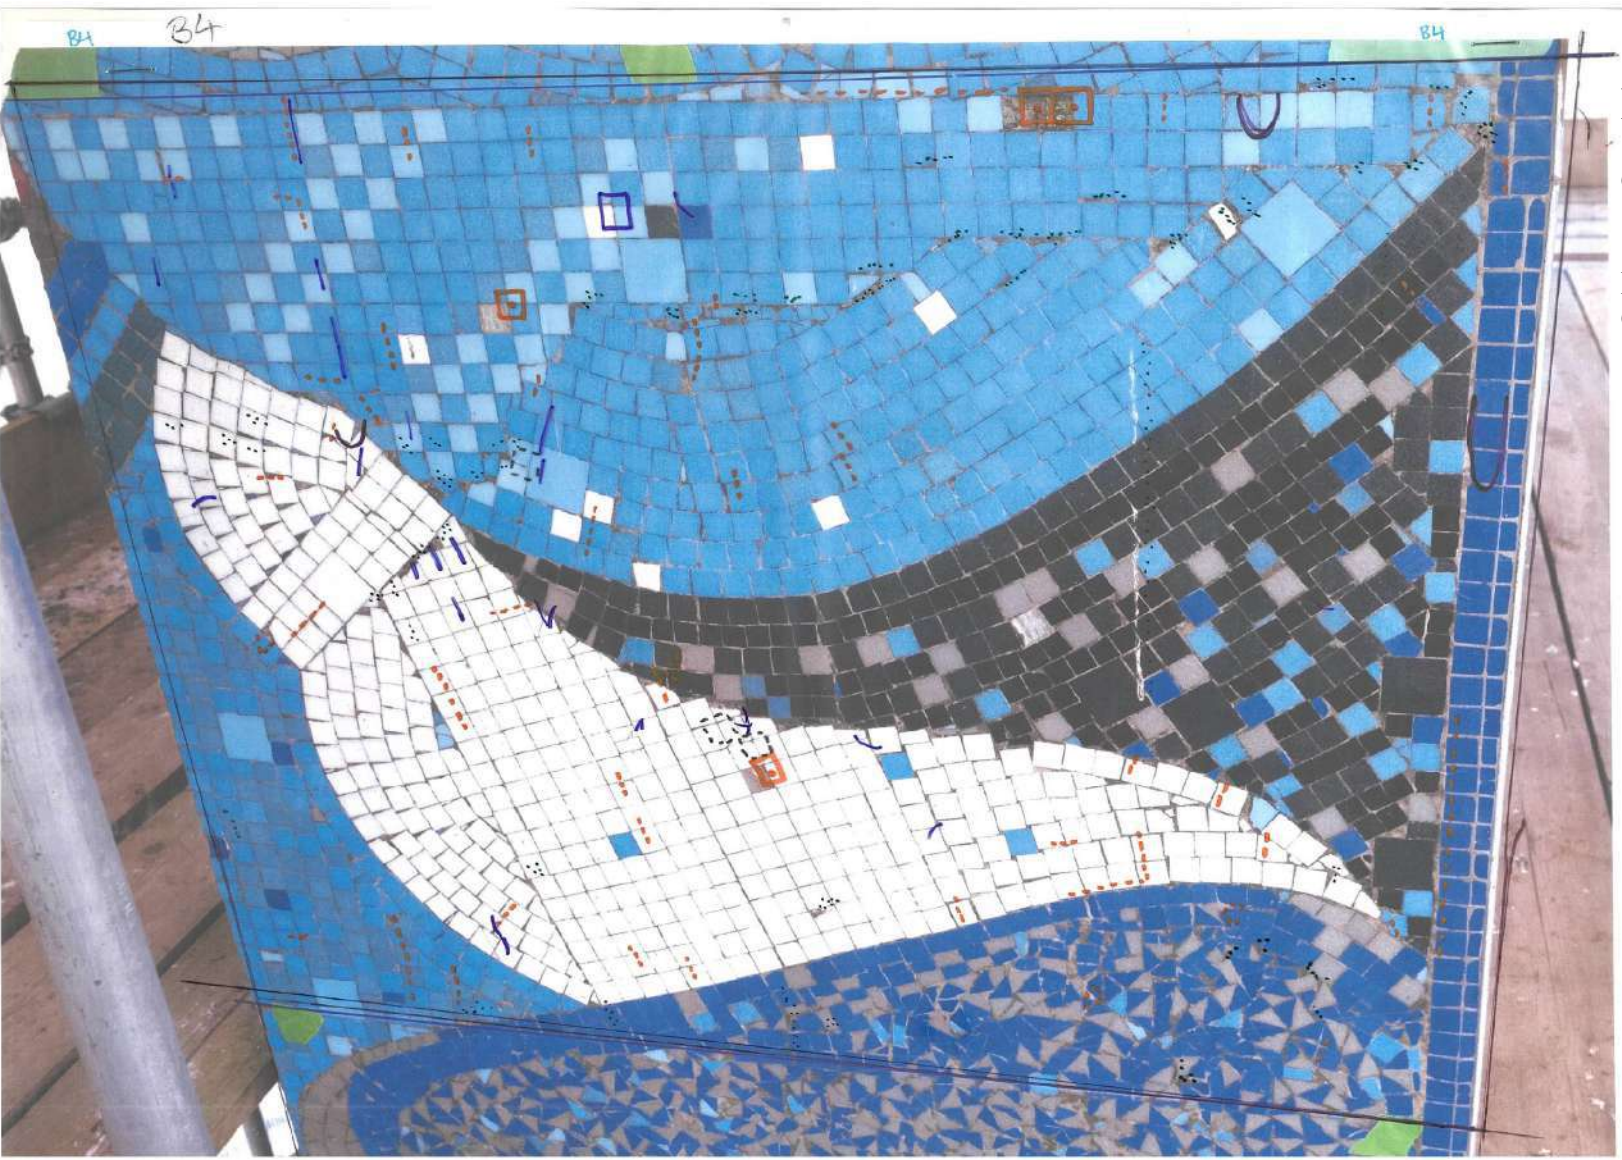
**Panel B4**  
1200mm x 900mm  
General Fair condition

Superficial dirt: 100%\*  
Biological growth: 100%\*  
Guano 2%\*

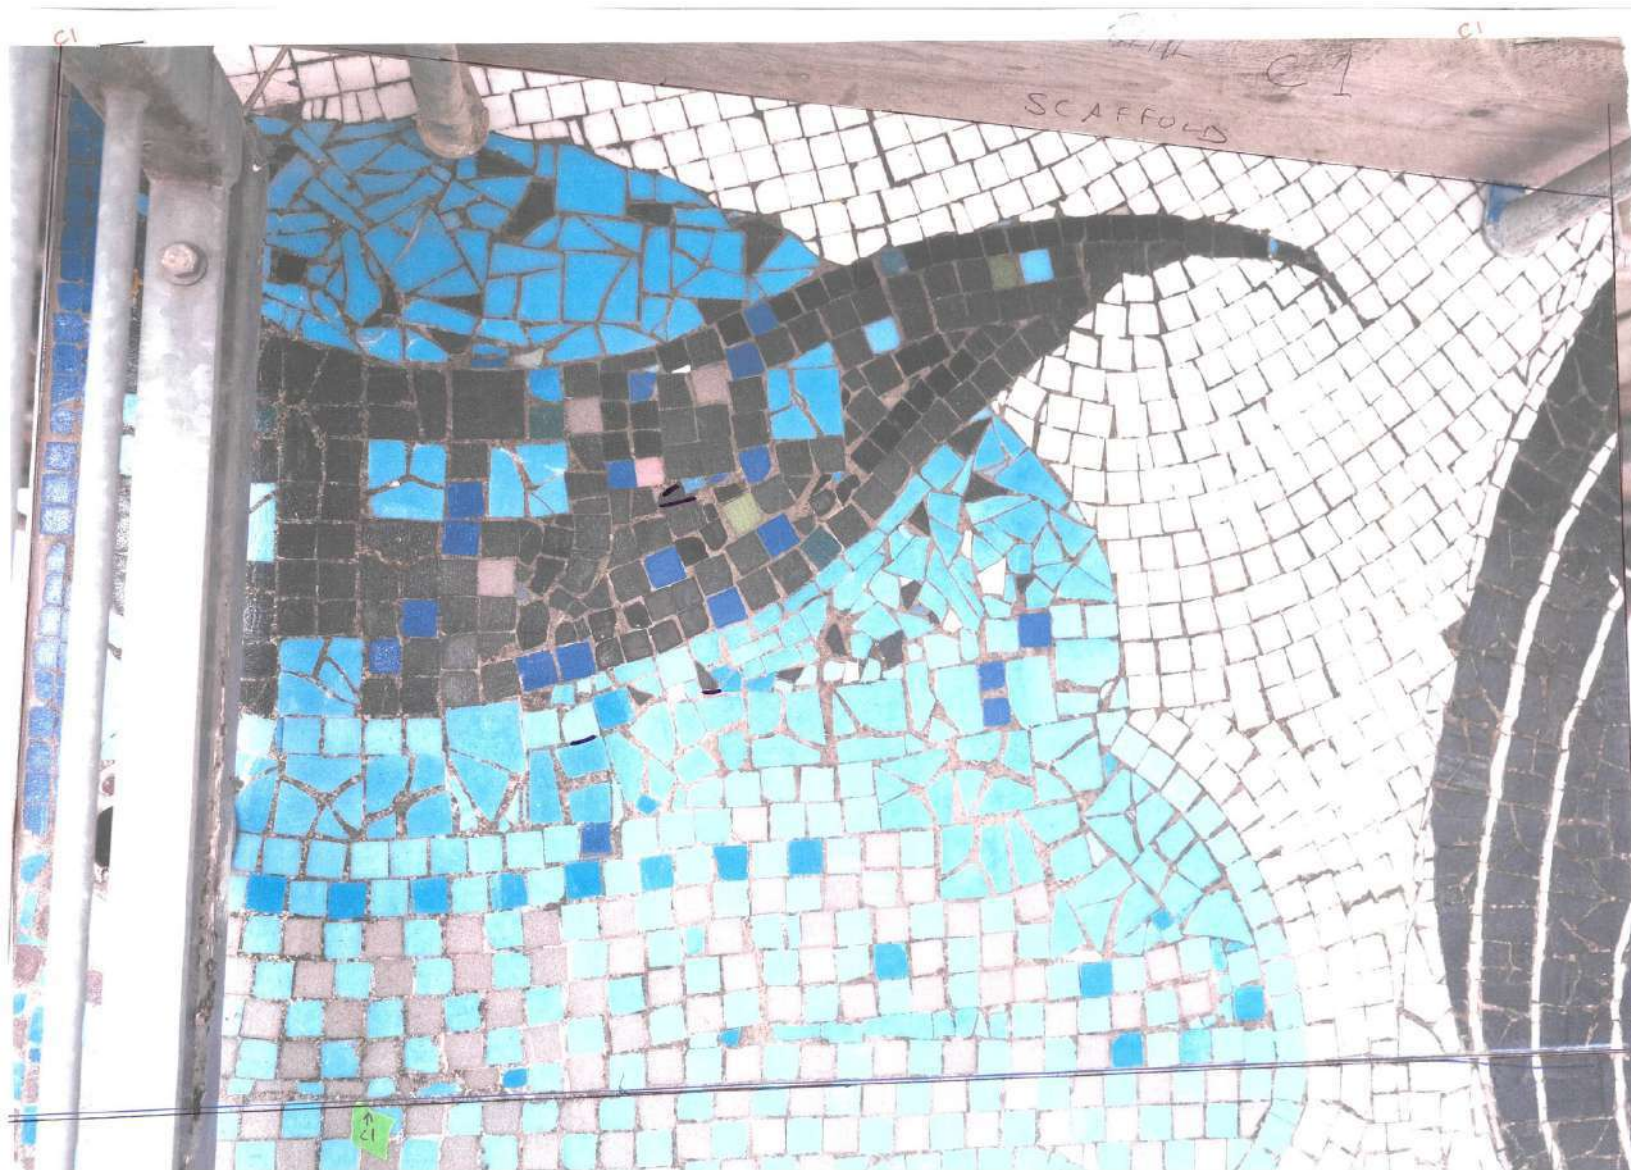
## Panel C1

1195mm x 900mm

General Fair condition

Superficial dirt: 100%\*

Biological growth: 100%\*
