# Broadwater Farm Estate

## Mural mosaic

Condition Survey  
September 2023

Authored by Paolo Volpi & Ian Devine  
Reviewed by Adrian Attwood ACR

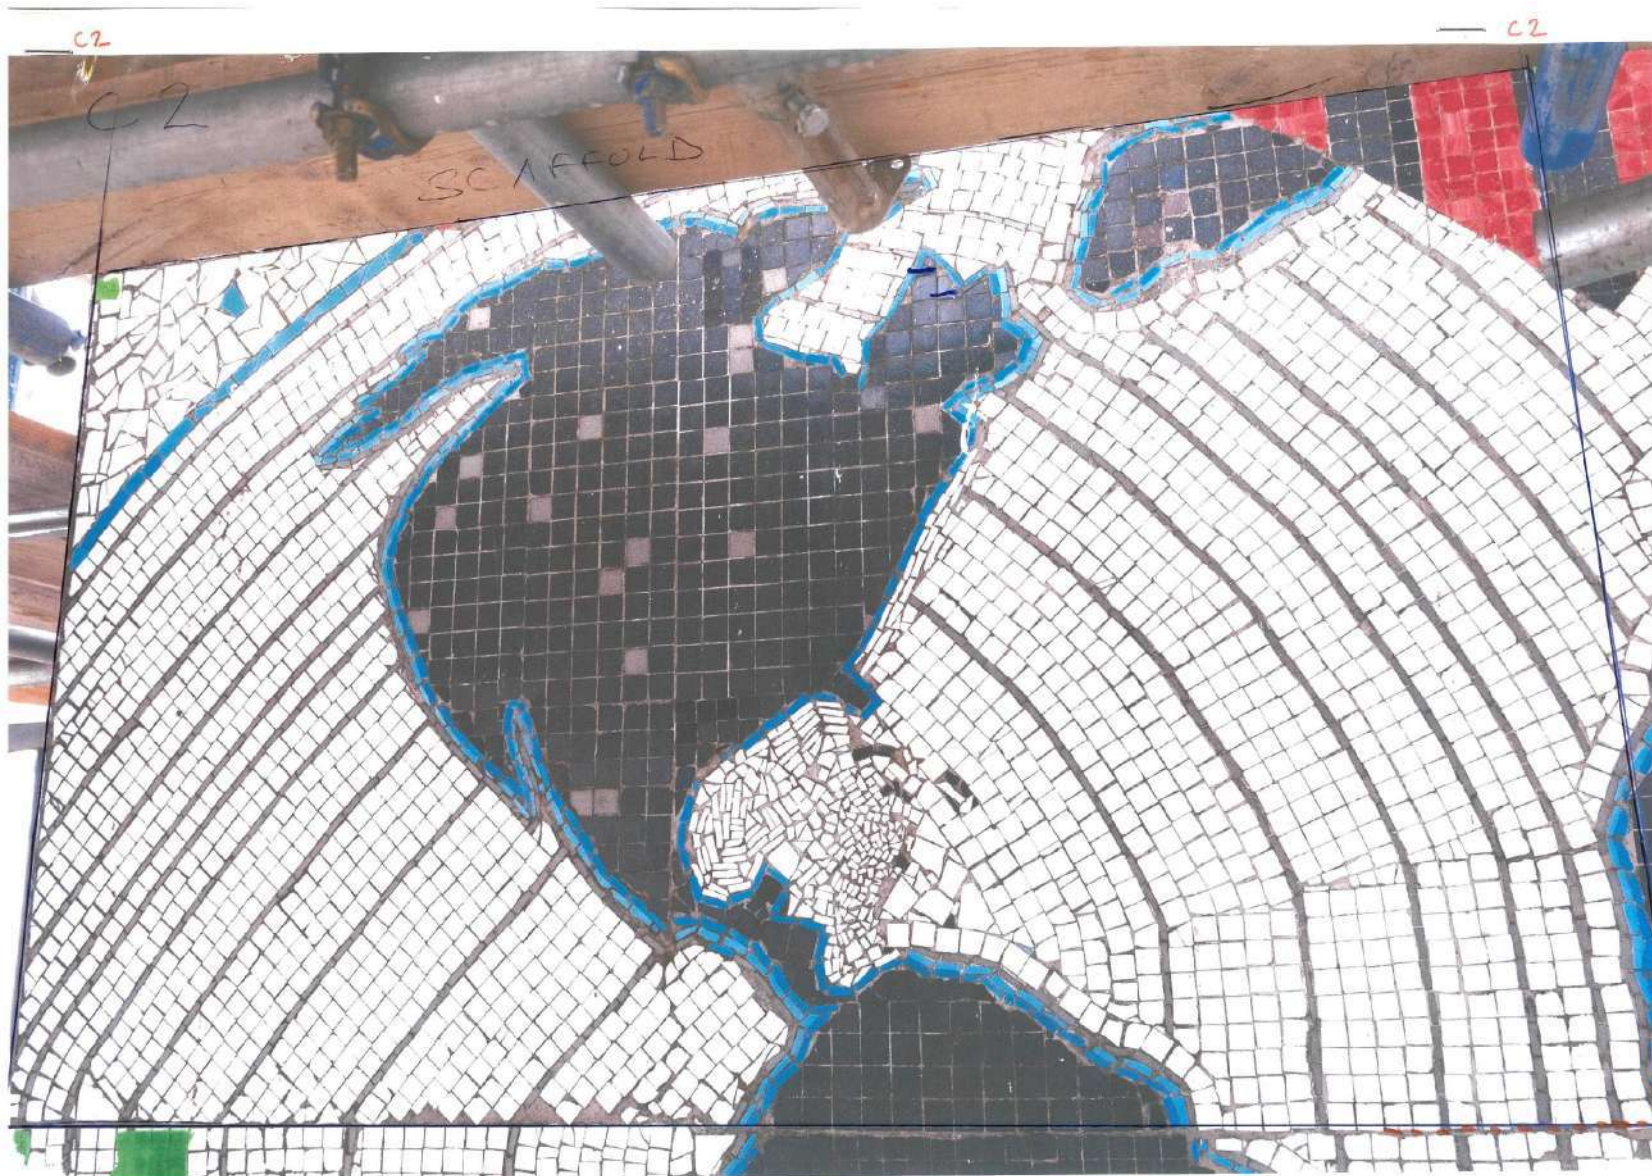
## Panel C2

1520mm x 900mm

General Fair condition

Superficial dirt: 100%\*

Biological growth: 100%\*

Guano: 2%\*

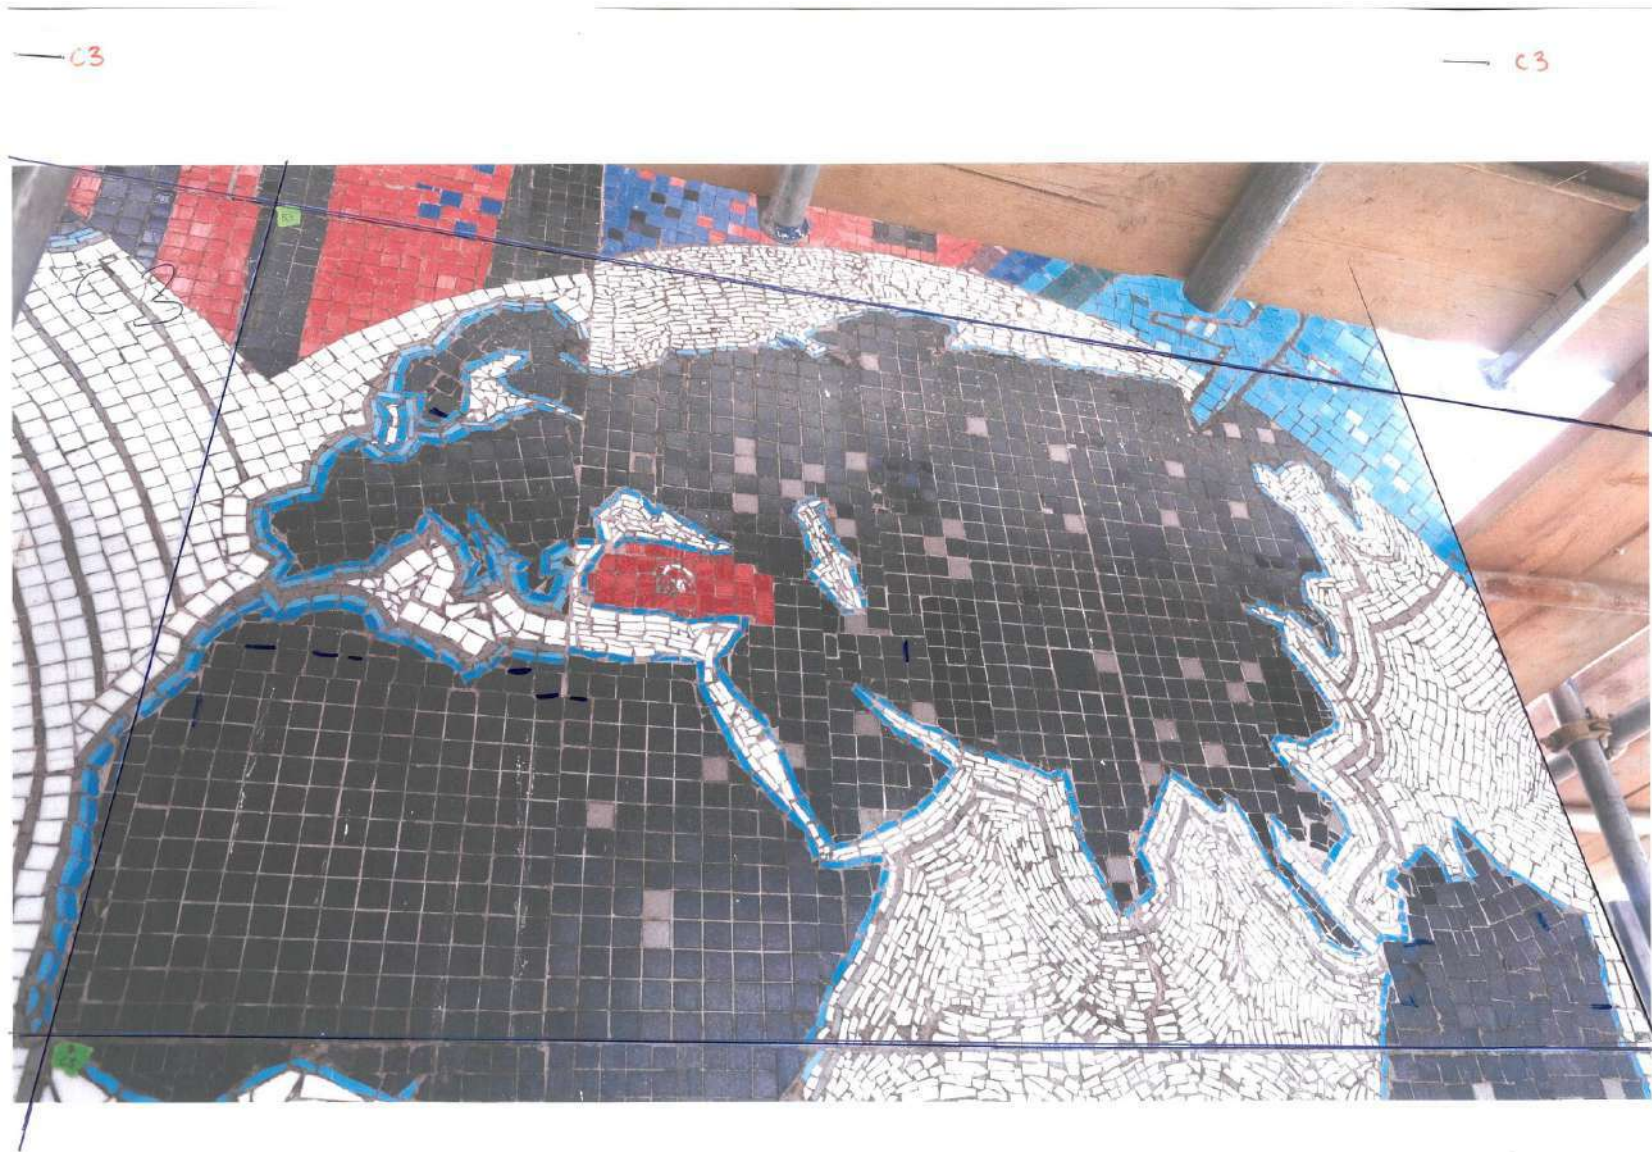
## Panel C3

1515mm x 900mm  
General Fair condition

Superficial dirt: 100%\*  
Biological growth: 100%\*  
Guano: 2%\*

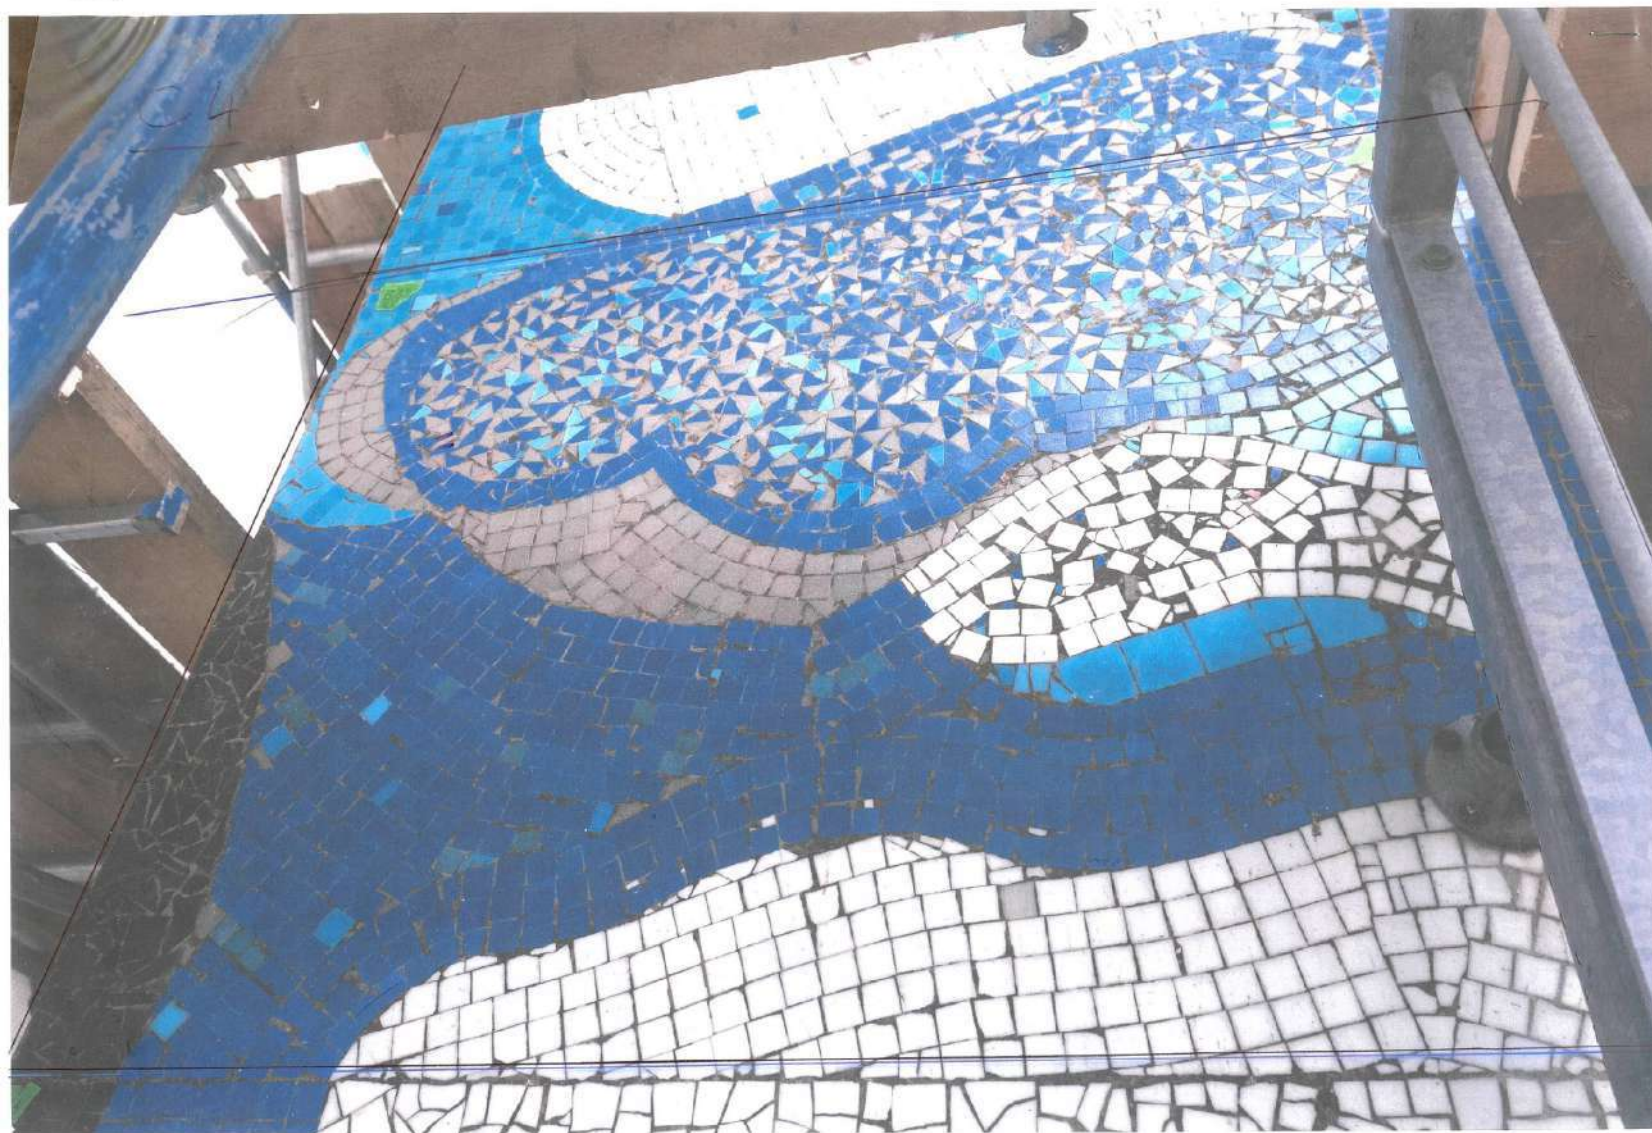
## Panel C4

1200mm x 900mm  
General Fair condition

Superficial dirt: 100%\*  
Biological growth: 100%\*

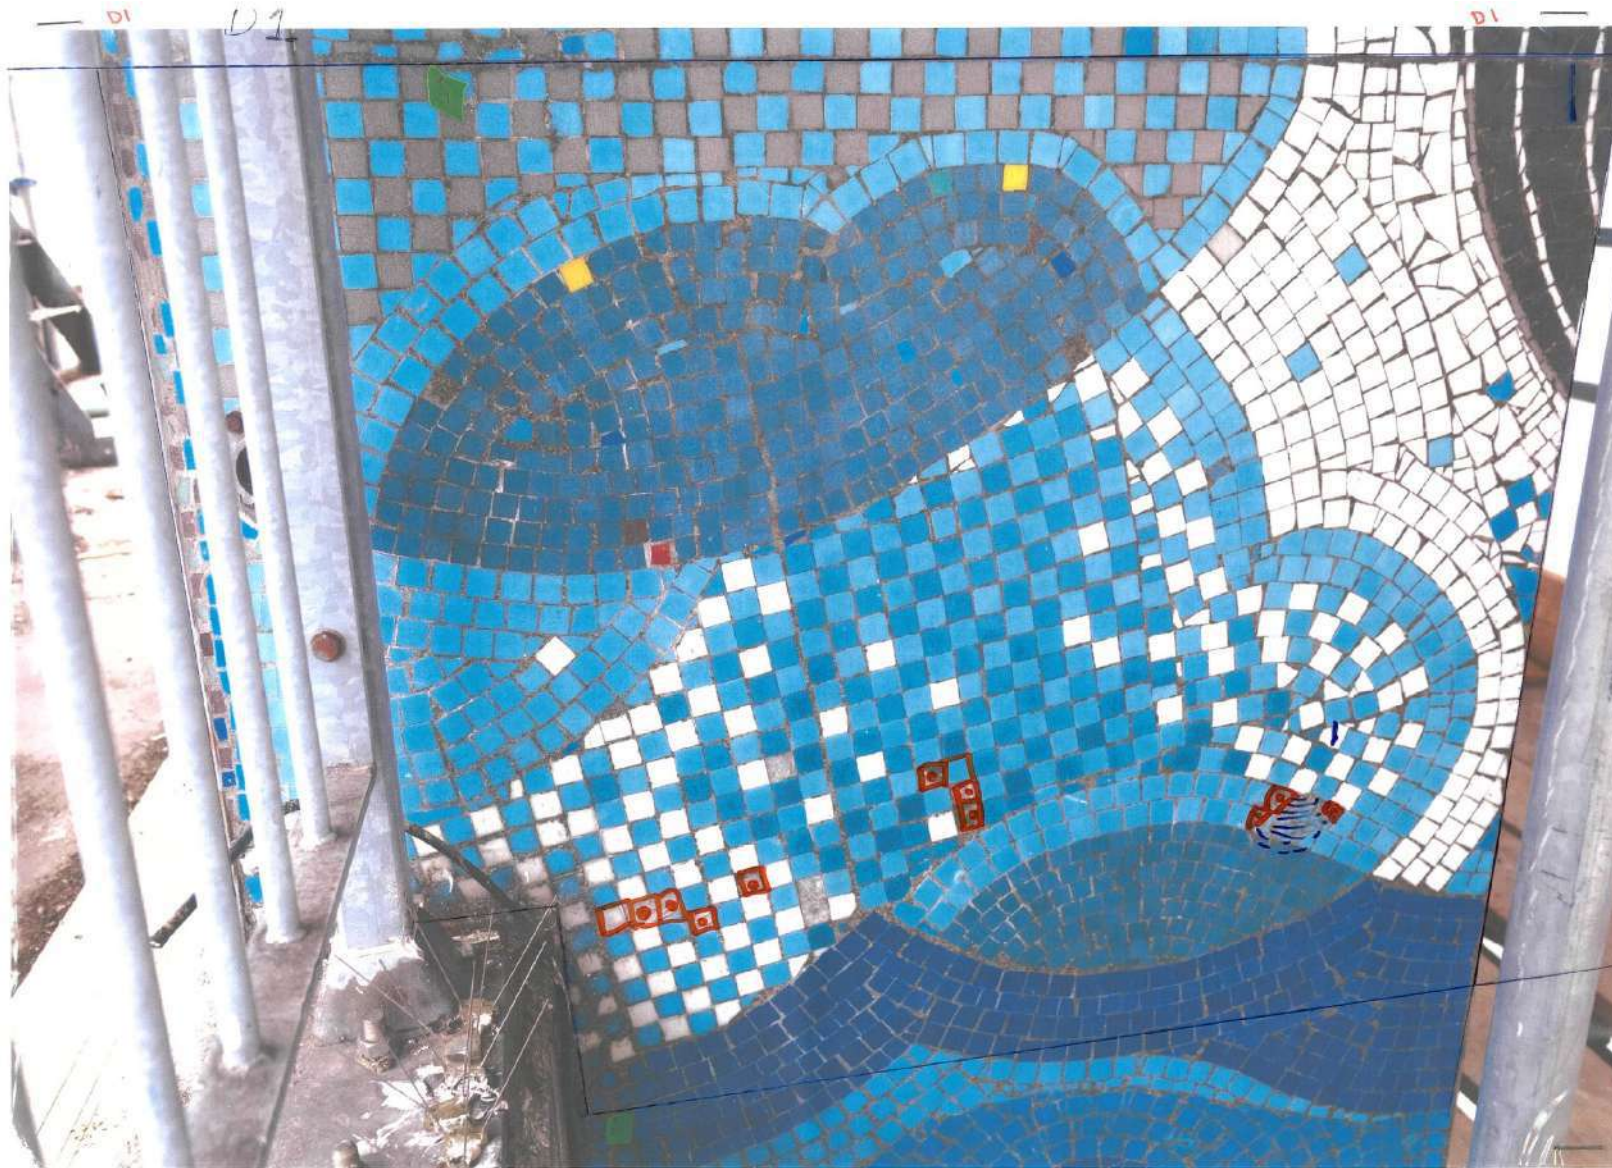
## Panel D1

1200mm x 900mm

General Fair condition

Superficial dirt: 100%\*

Biological growth: 100%\*

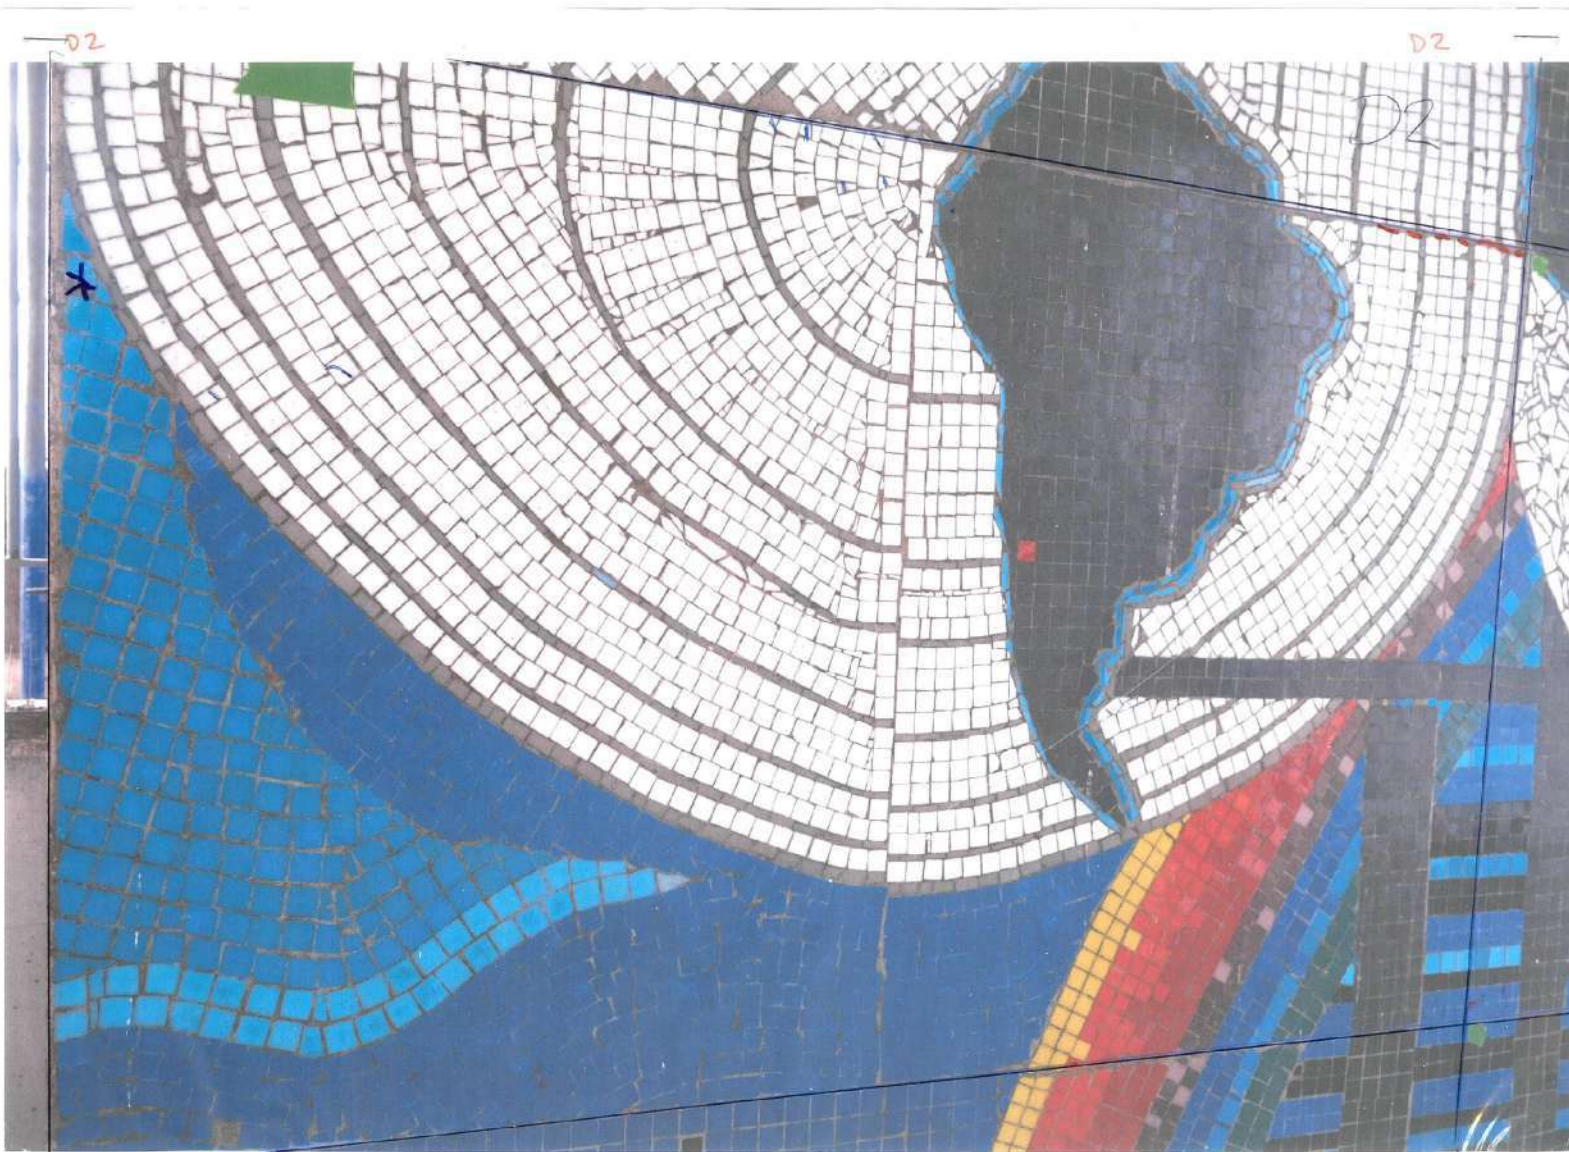
## Panel D2

1520mm x 900mm

General Fair condition

Superficial dirt: 100%\*

Biological growth: 100%\*

Guano: 2%\*

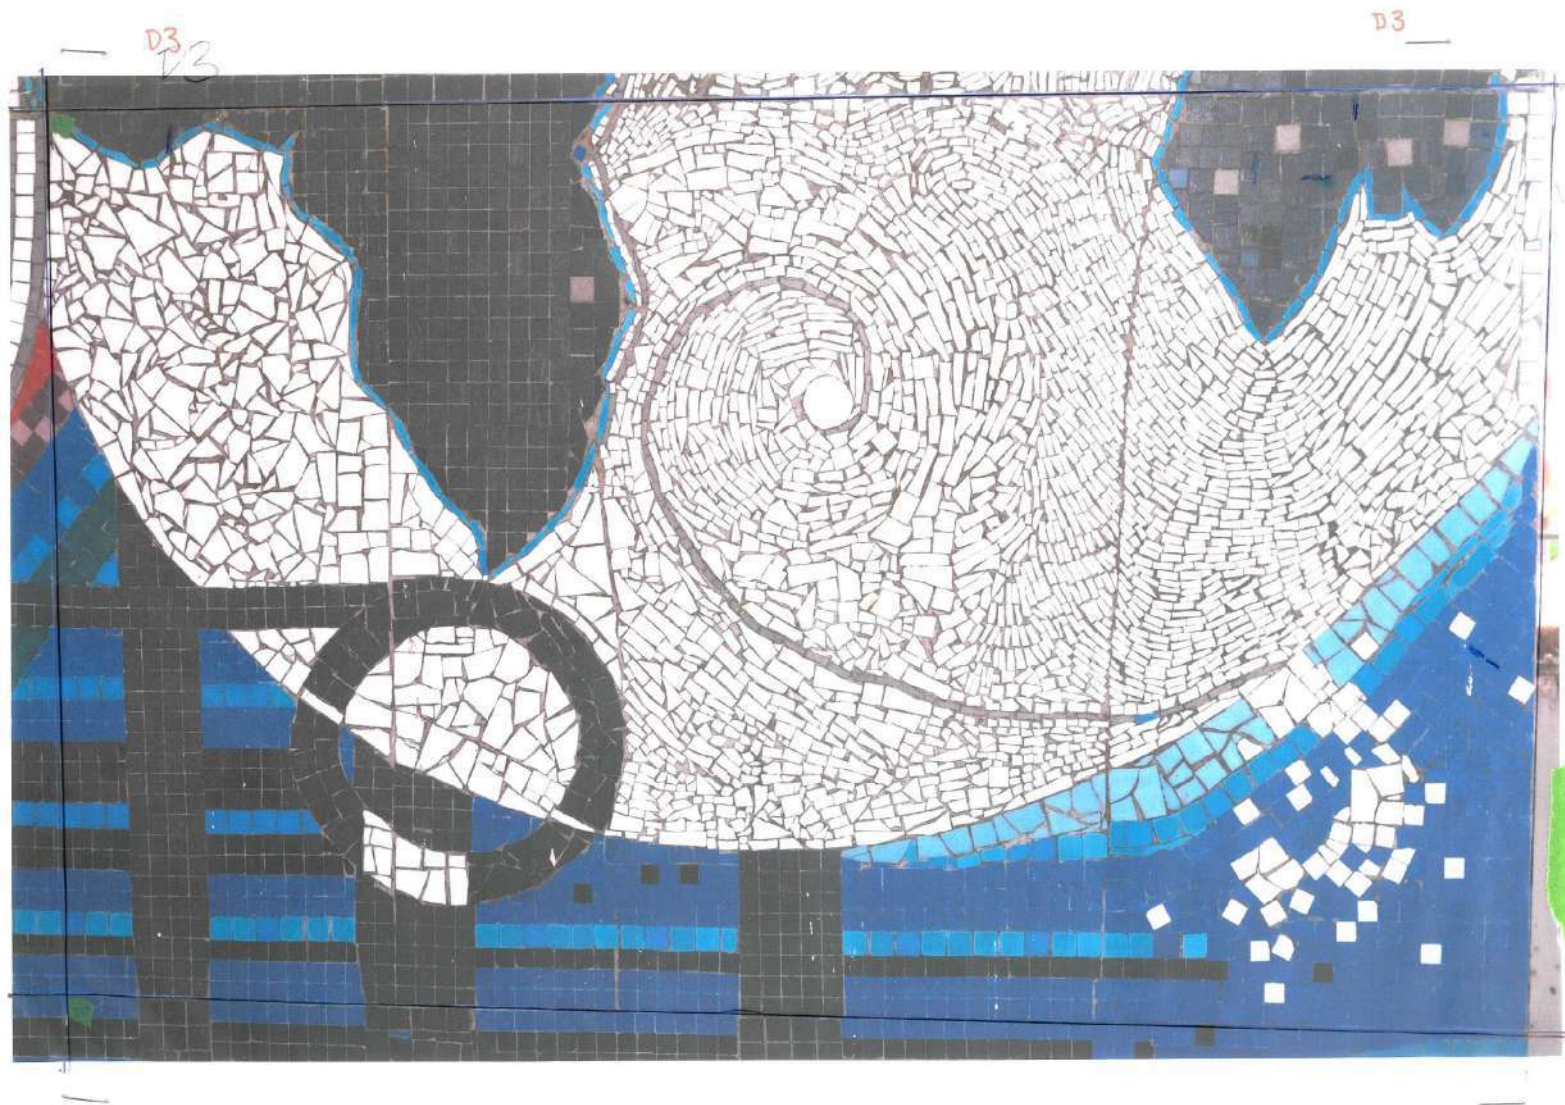
## Panel D3

1520mm x 900mm

General Fair condition

Superficial dirt: 100%\*

Biological growth: 100%\*

Guano: 1%\*

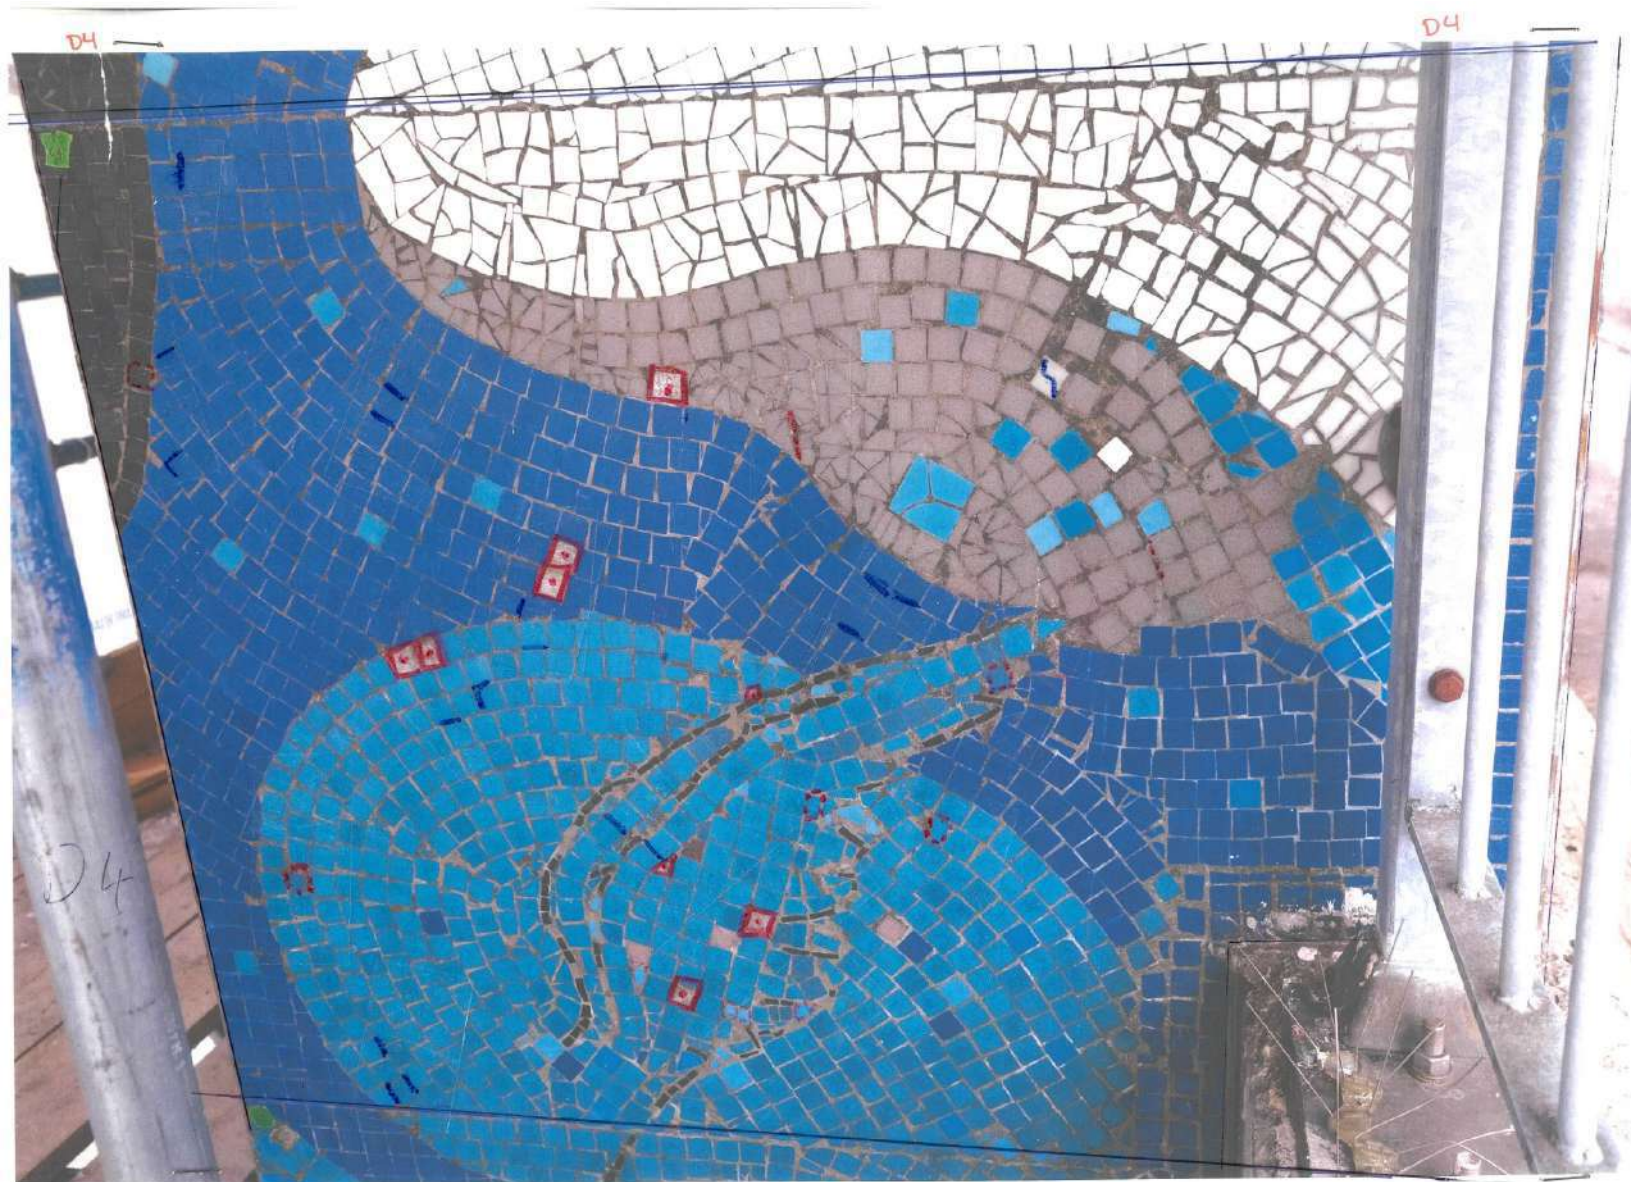
## Panel D4

1205mm x 900mm

General Fair condition

Superficial dirt: 100%\*

Biological growth: 100%\*

Guano: 1%\*

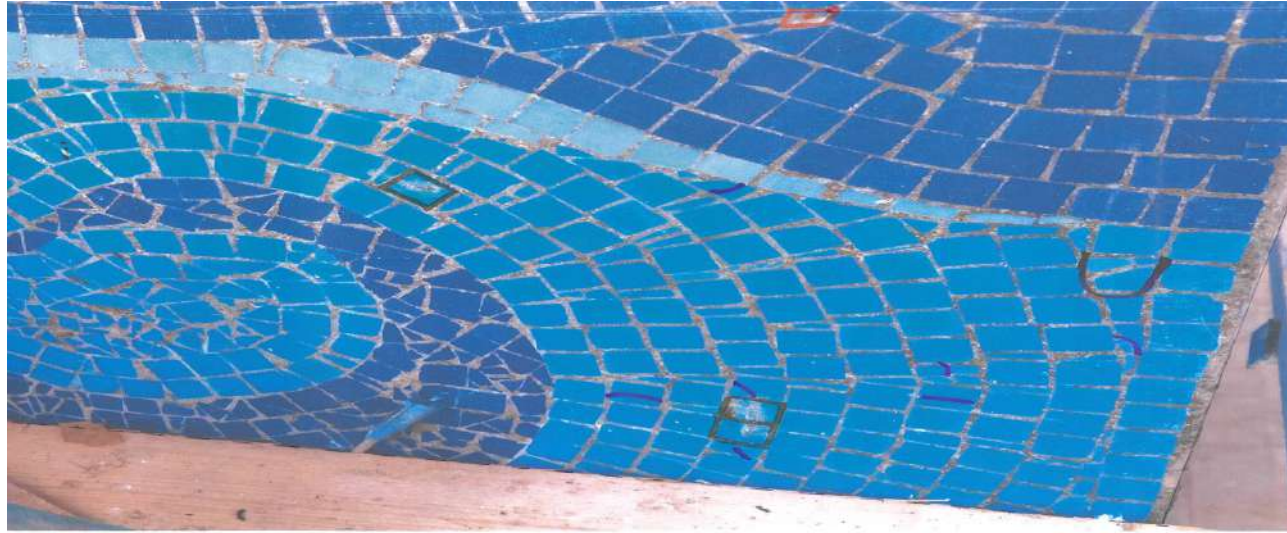
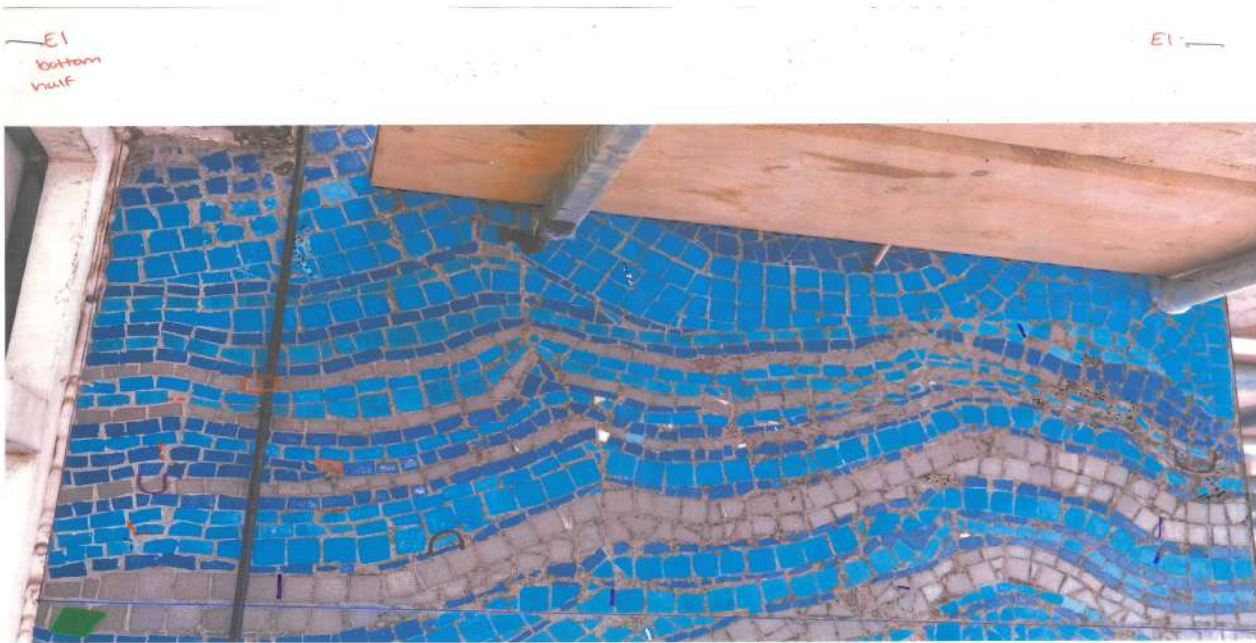
## Panel E1

1180mm x 900mm  
General Fair condition

Superficial dirt: 100%\*  
Biological growth: 90%\*  
Paint marks: 3%\*  
Silicon residues: 2%\*  
Old metal fixings: 2no.

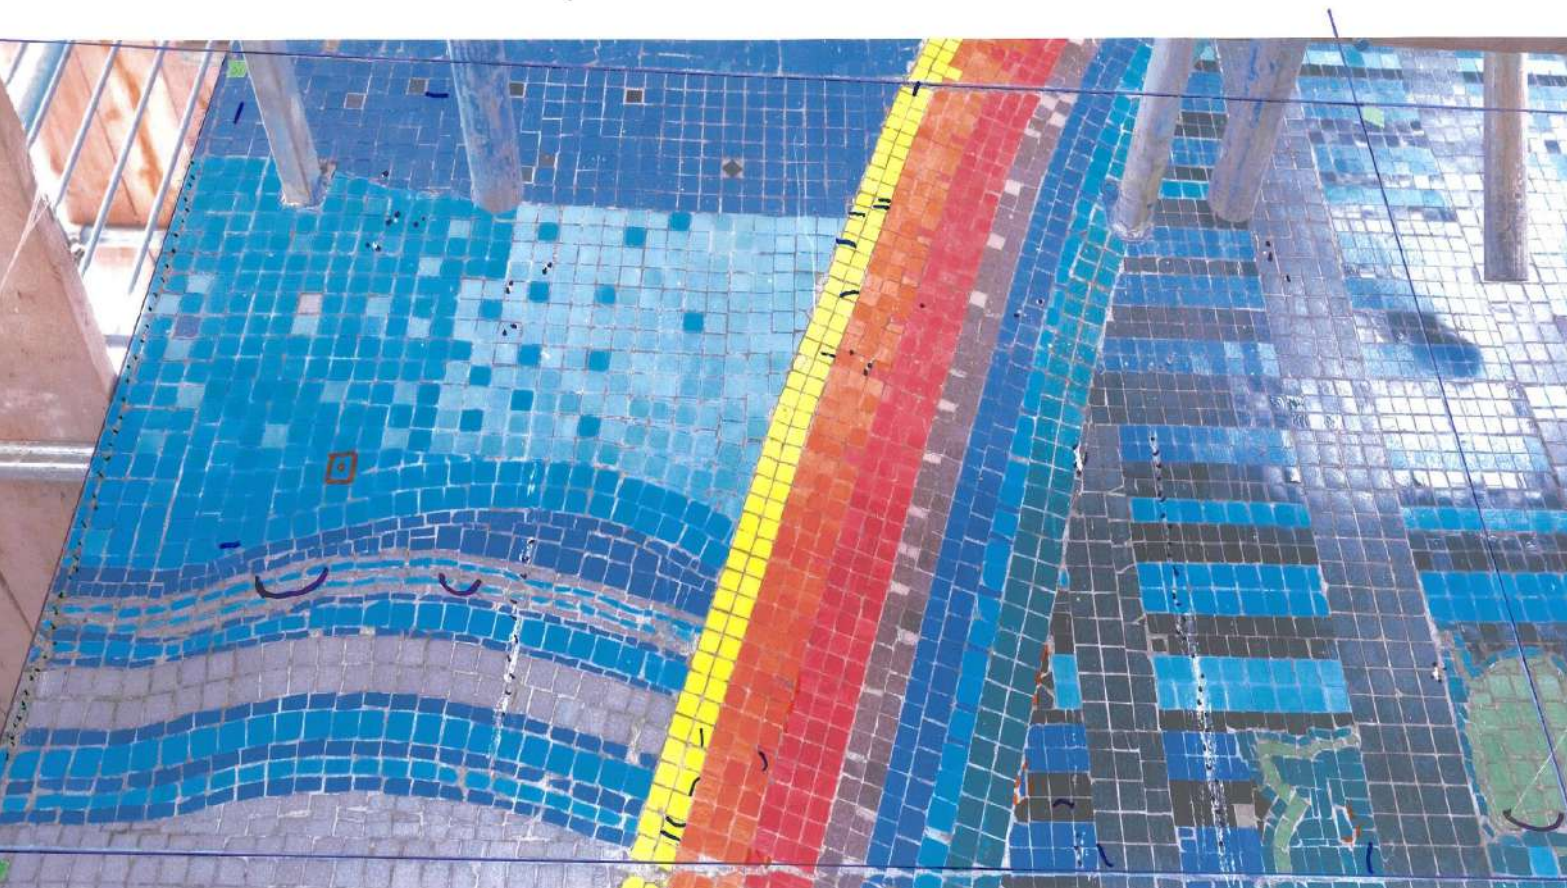
## Panel E2

1520mm x 900mm

General Fair condition

Superficial dirt: 100%\*

Biological growth: 90%\*

Guano: 2%\*

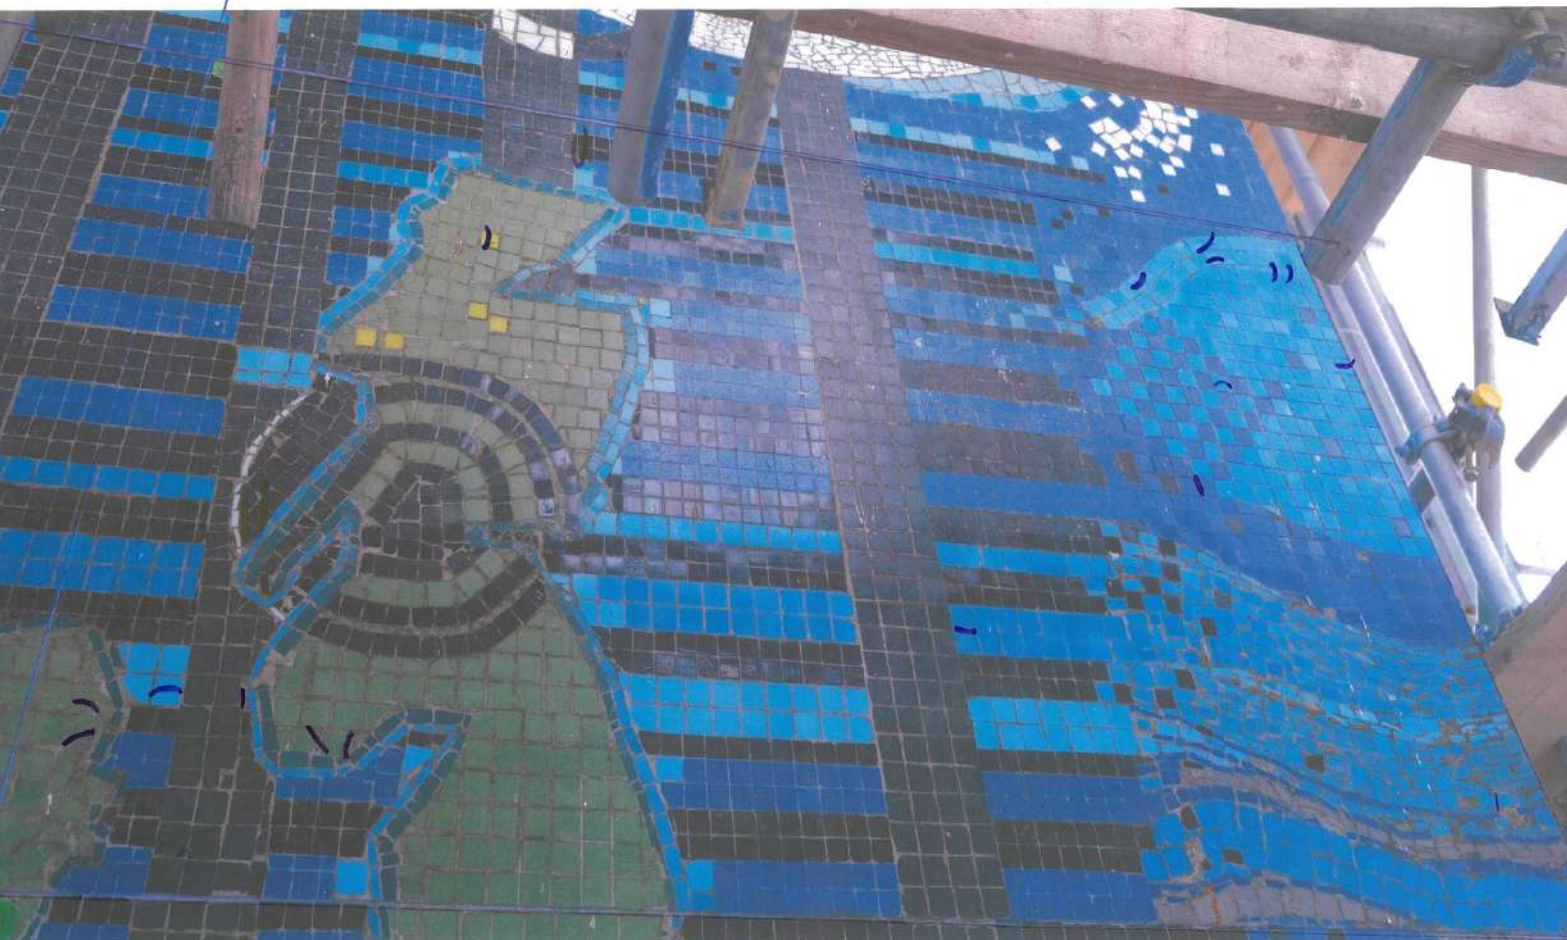
## Panel E3

1520mm x 900mm

General Fair condition

Superficial dirt: 100%\*

Biological growth: 90%\*

Guano: 2%\*

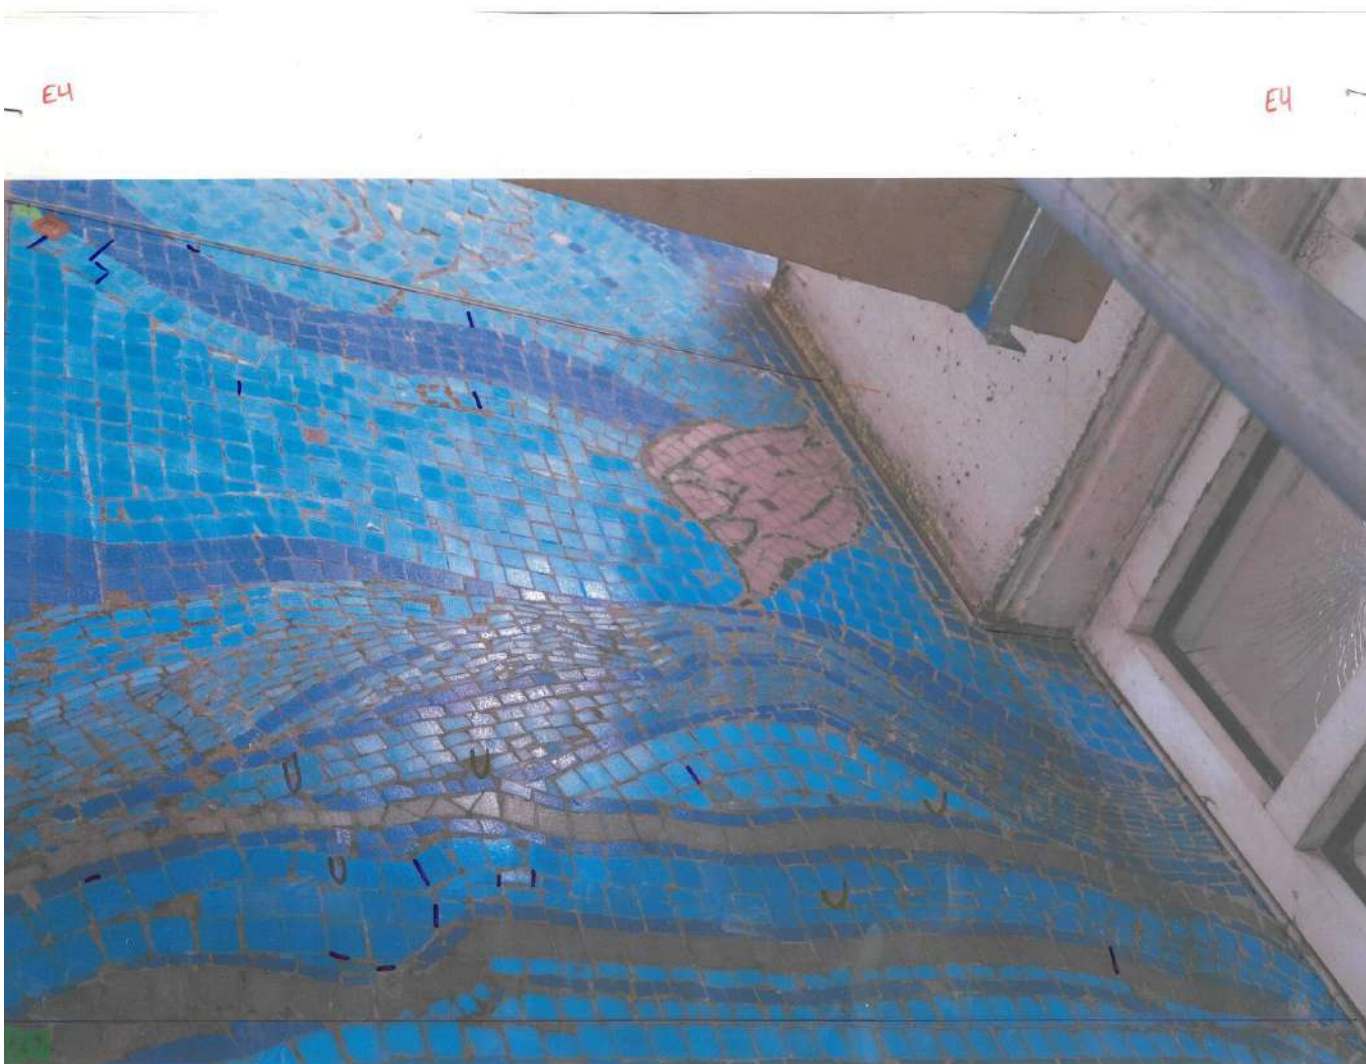
## Panel E4

1200mm x 900mm  
General Fair condition

Superficial dirt: 100%\*  
Biological growth: 90%\*  
Guano: 1%\*  
Paint marks: 3%\*  
Silicon residues: 2%\*

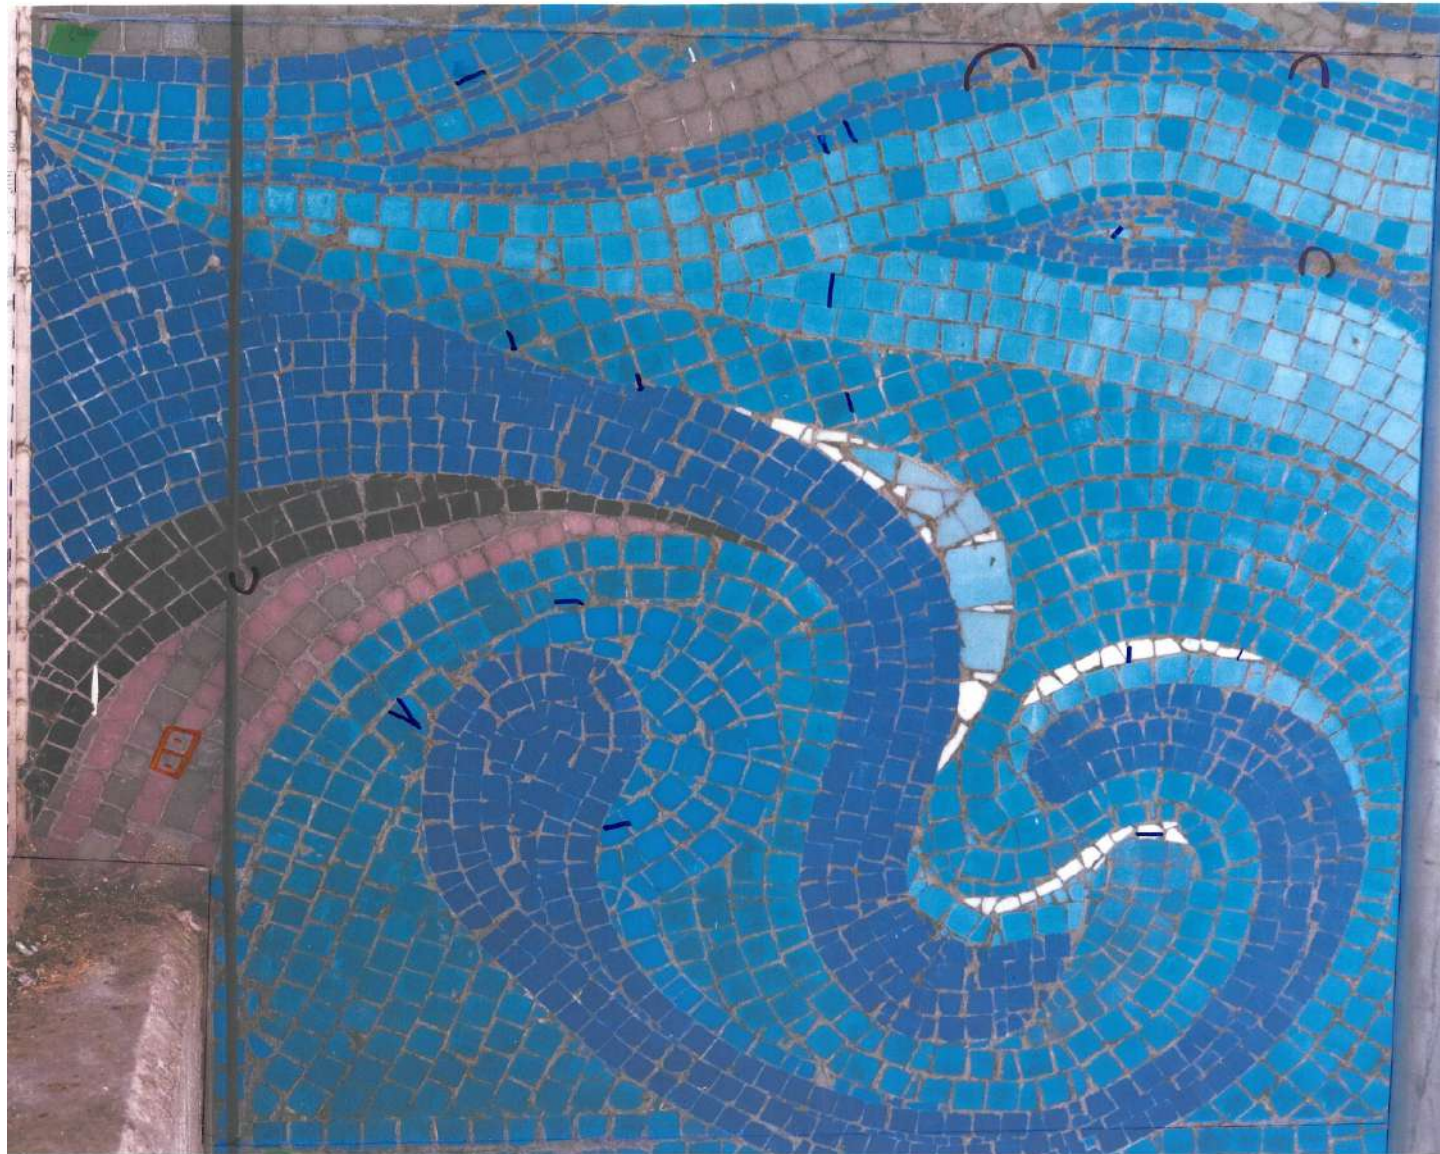
## Panel F1

1180mm x 895mm

General Fair condition

Superficial dirt: 100%\*

Biological growth: 90%\*

Paint marks: 3%\*

Silicon residues: 2%\*

Old metal fixings: 2no.

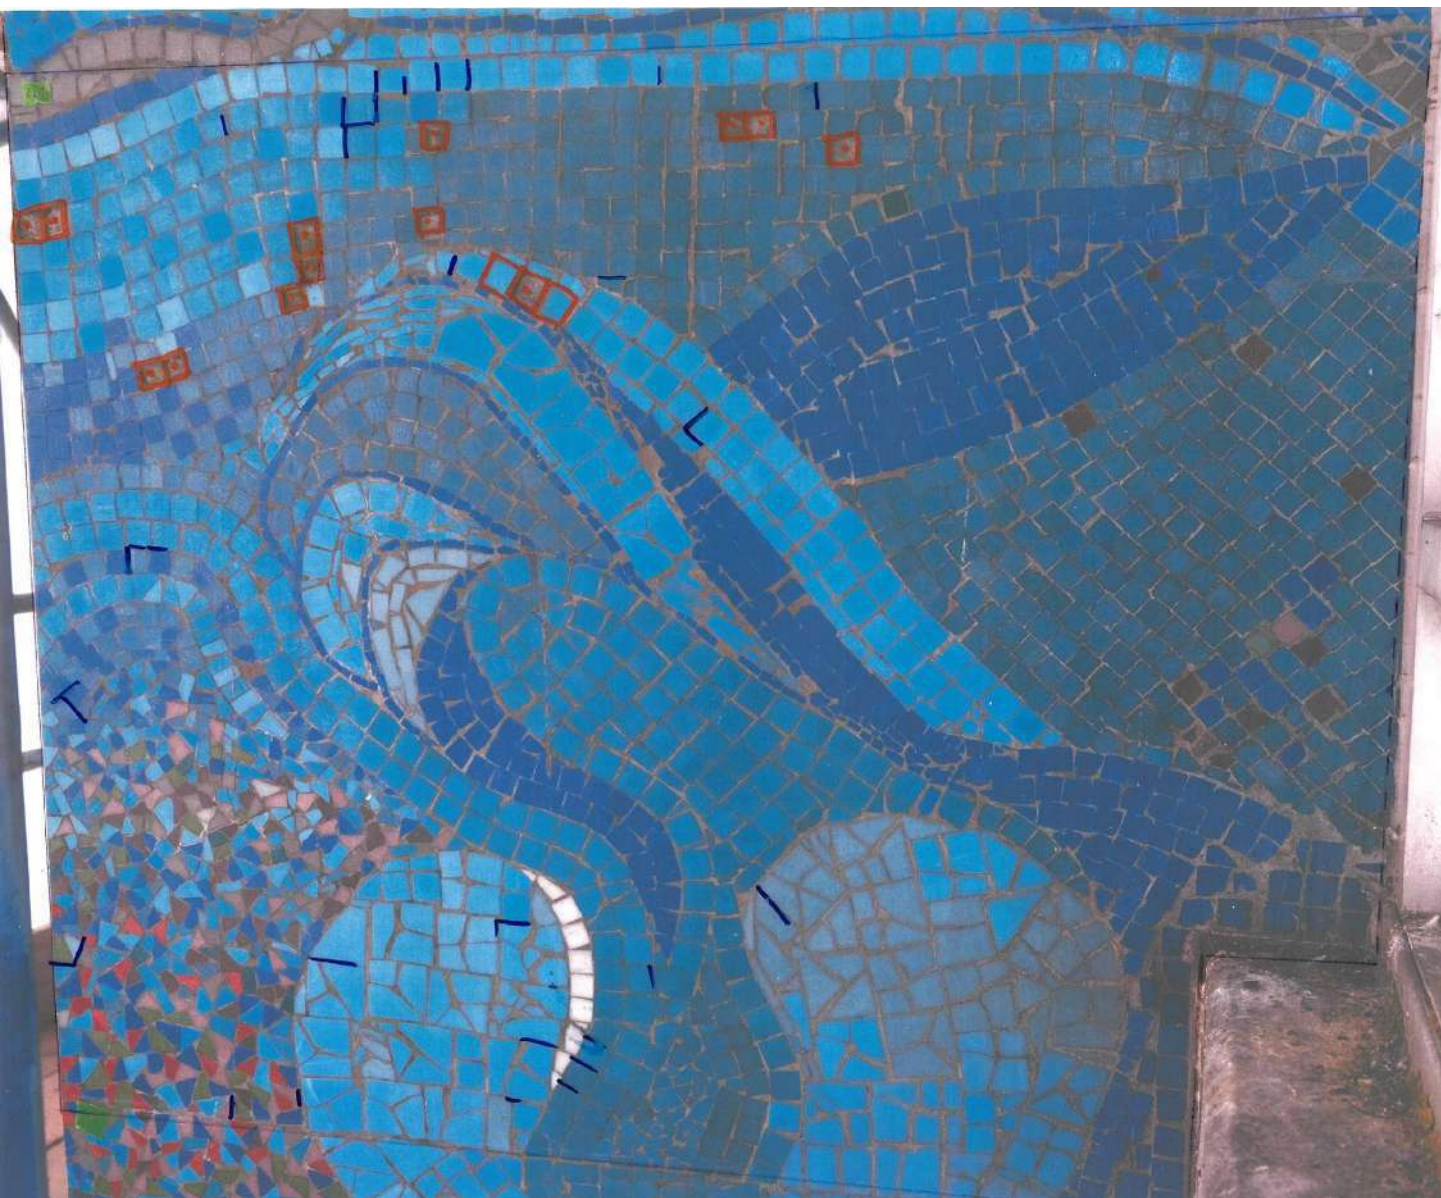
## Panel F4

1200mm x 895mm

General Fair condition

Superficial dirt: 100%\*

Biological growth: 90%\*

Paint marks: 3%\*

Silicon residues: 2%\*

Old metal fixings: 2no.
