# Broadwater Farm Estate

## Mural mosaic

Condition Survey  
September 2023

Authored by Paolo Volpi & Ian Devine  
Reviewed by Adrian Attwood ACR

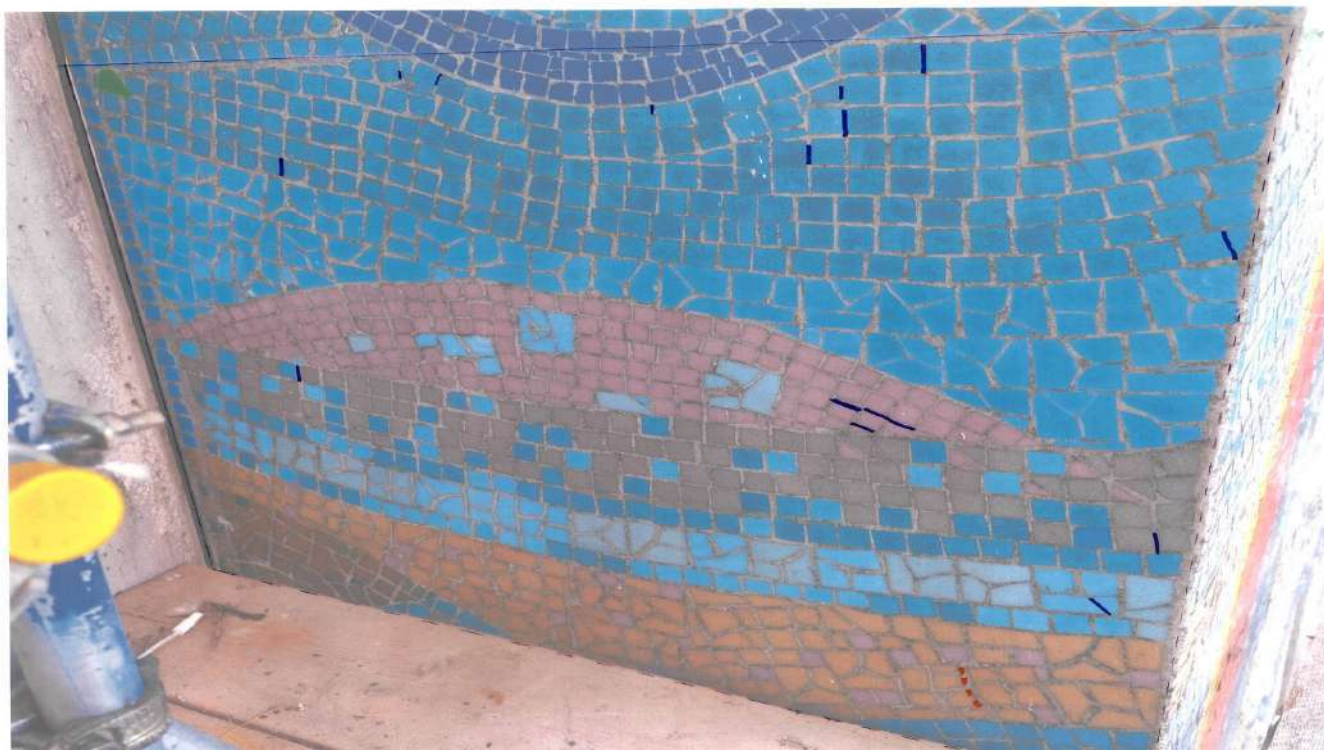
**Panel G1**  
950mm x 900mm  
General Fair condition

Superficial dirt: 100%\*  
Biological growth: 90%\*

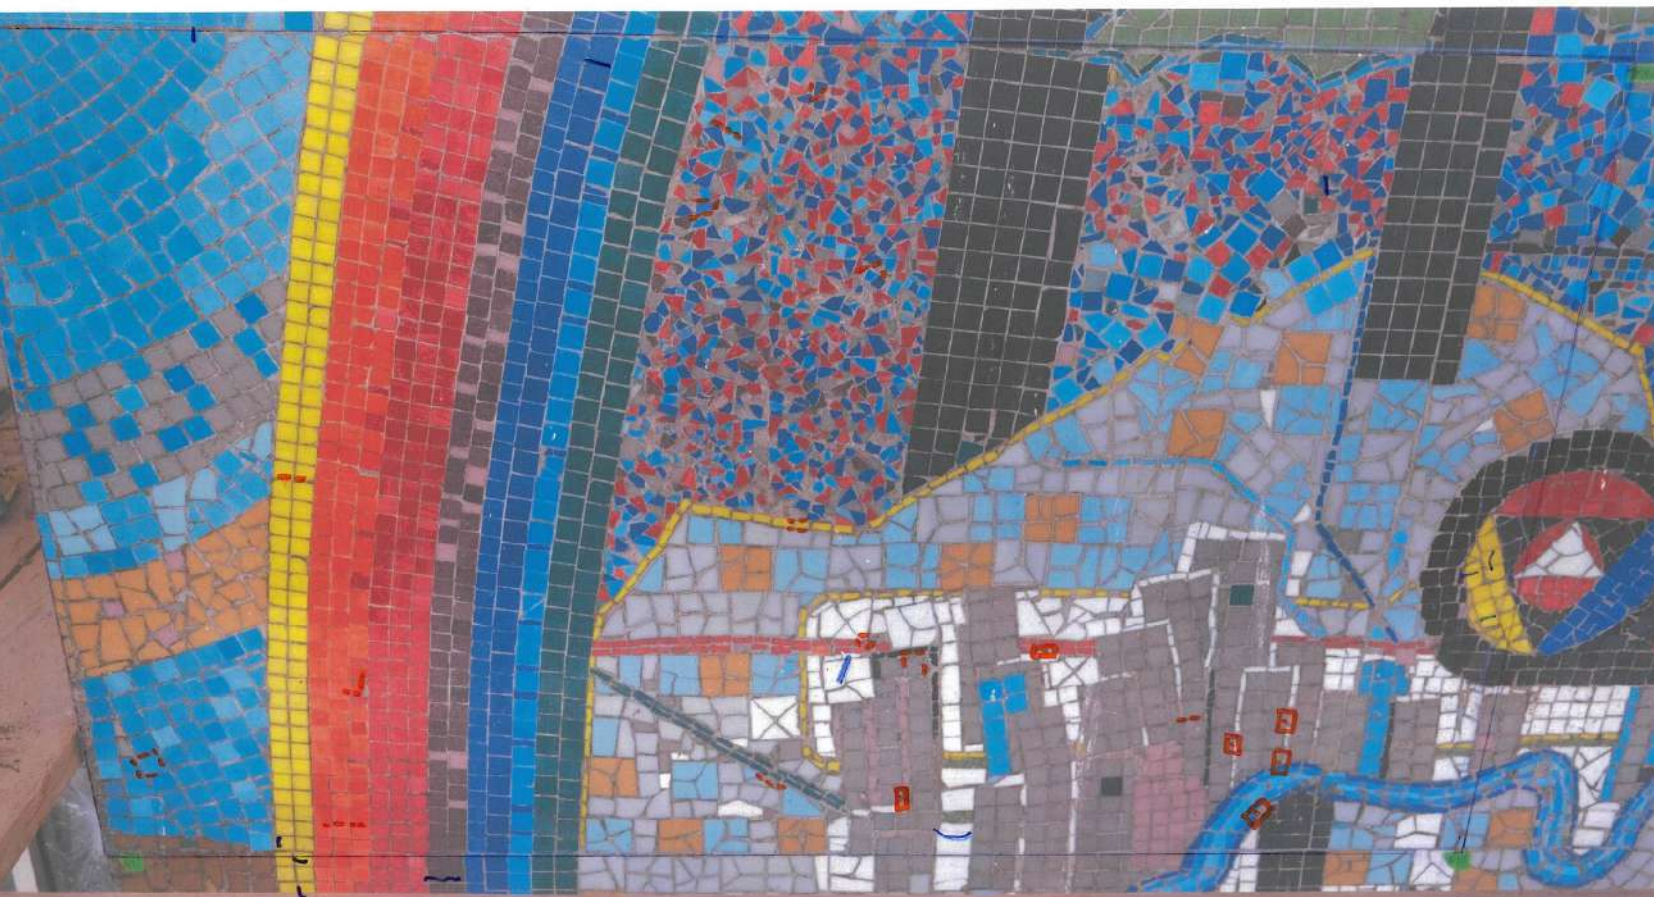
## Panel G2

1520mm x 900mm

General Fair condition

Superficial dirt: 100%\*

Biological growth: 90%\*

Guano: 1%\*

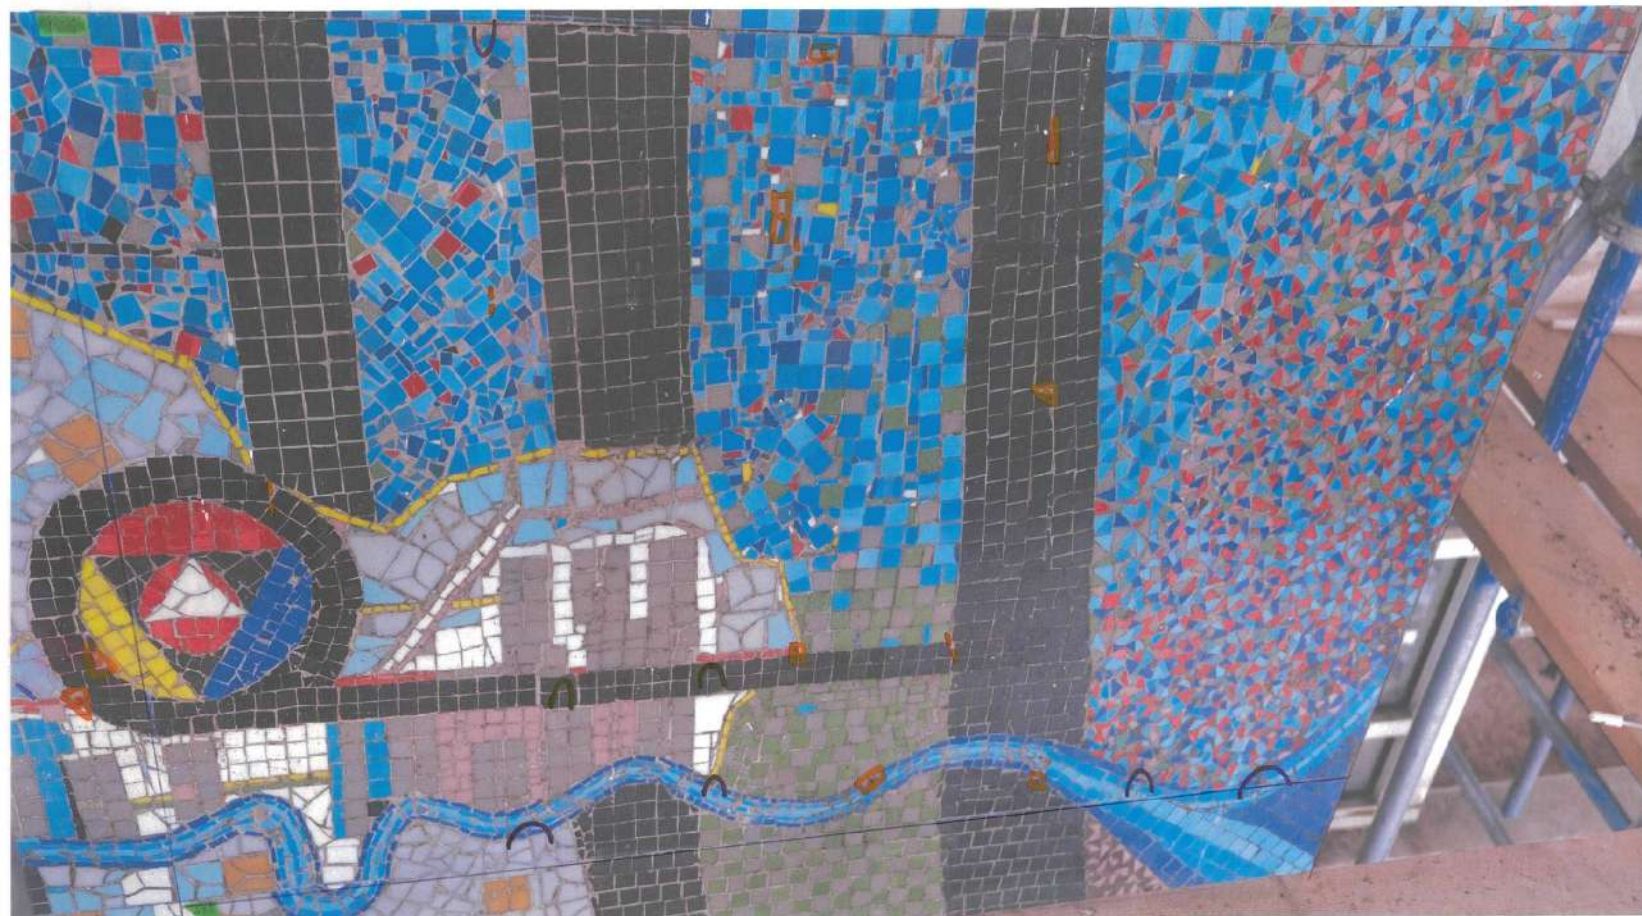
## Panel G3

1520mm x 900mm

General Fair condition

Superficial dirt: 100%\*

Biological growth: 90%\*

Guano: 1%\*

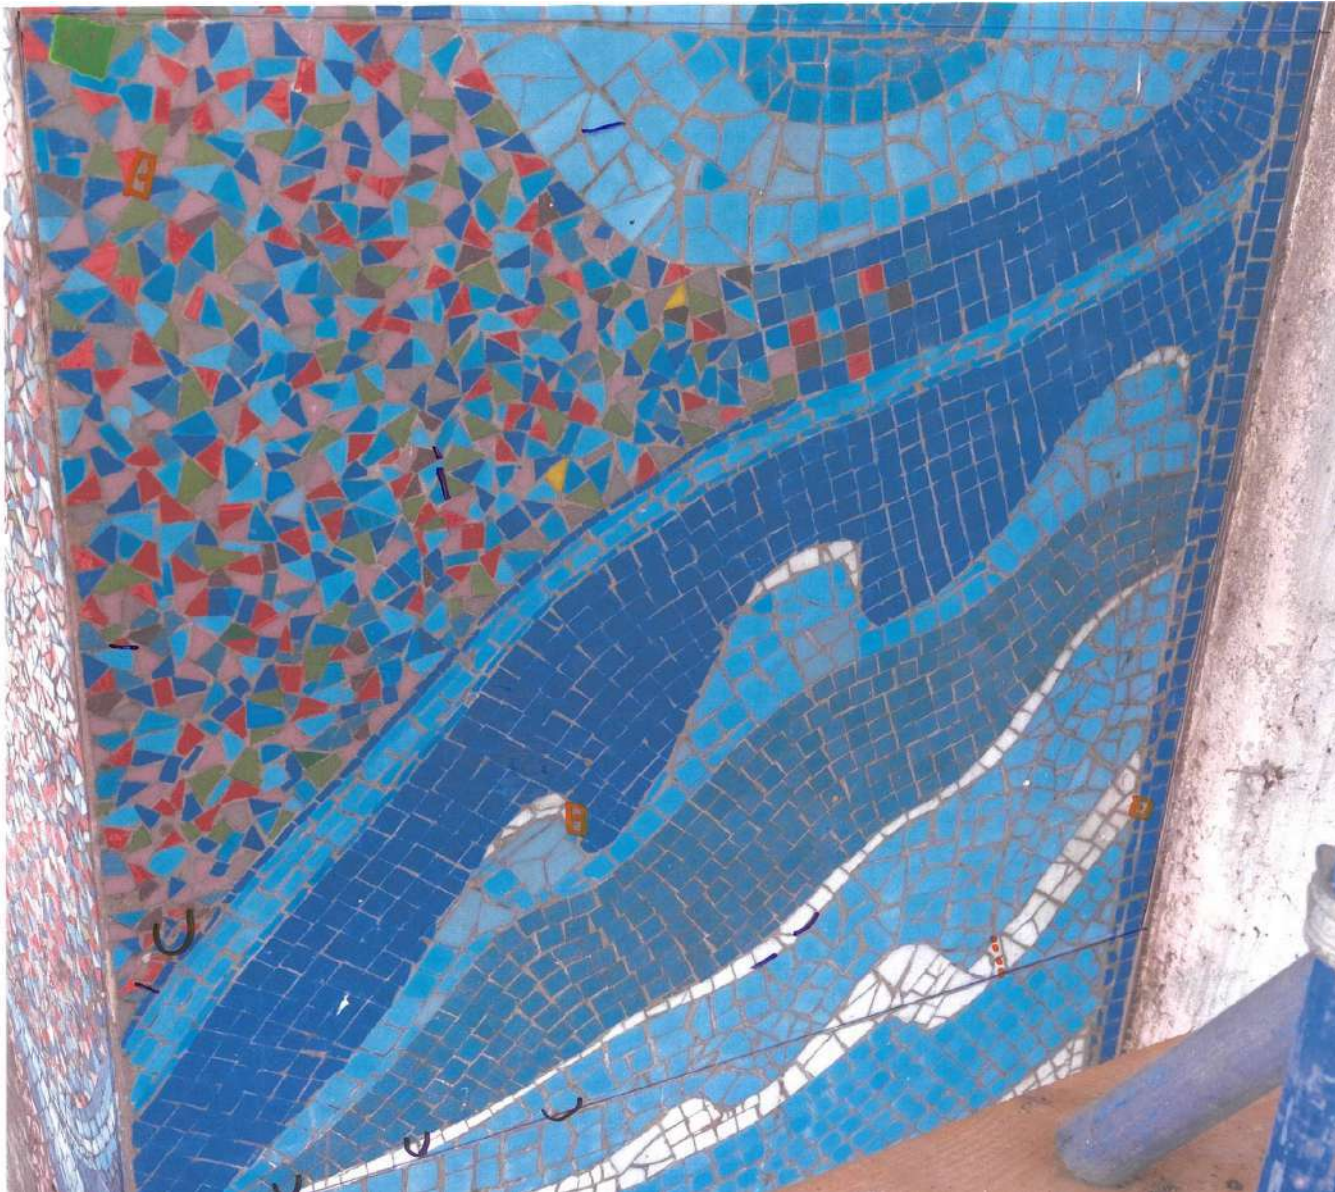
## Panel G4

970mm x 900mm

General Fair condition

Superficial dirt: 100%\*

Biological growth: 90%\*

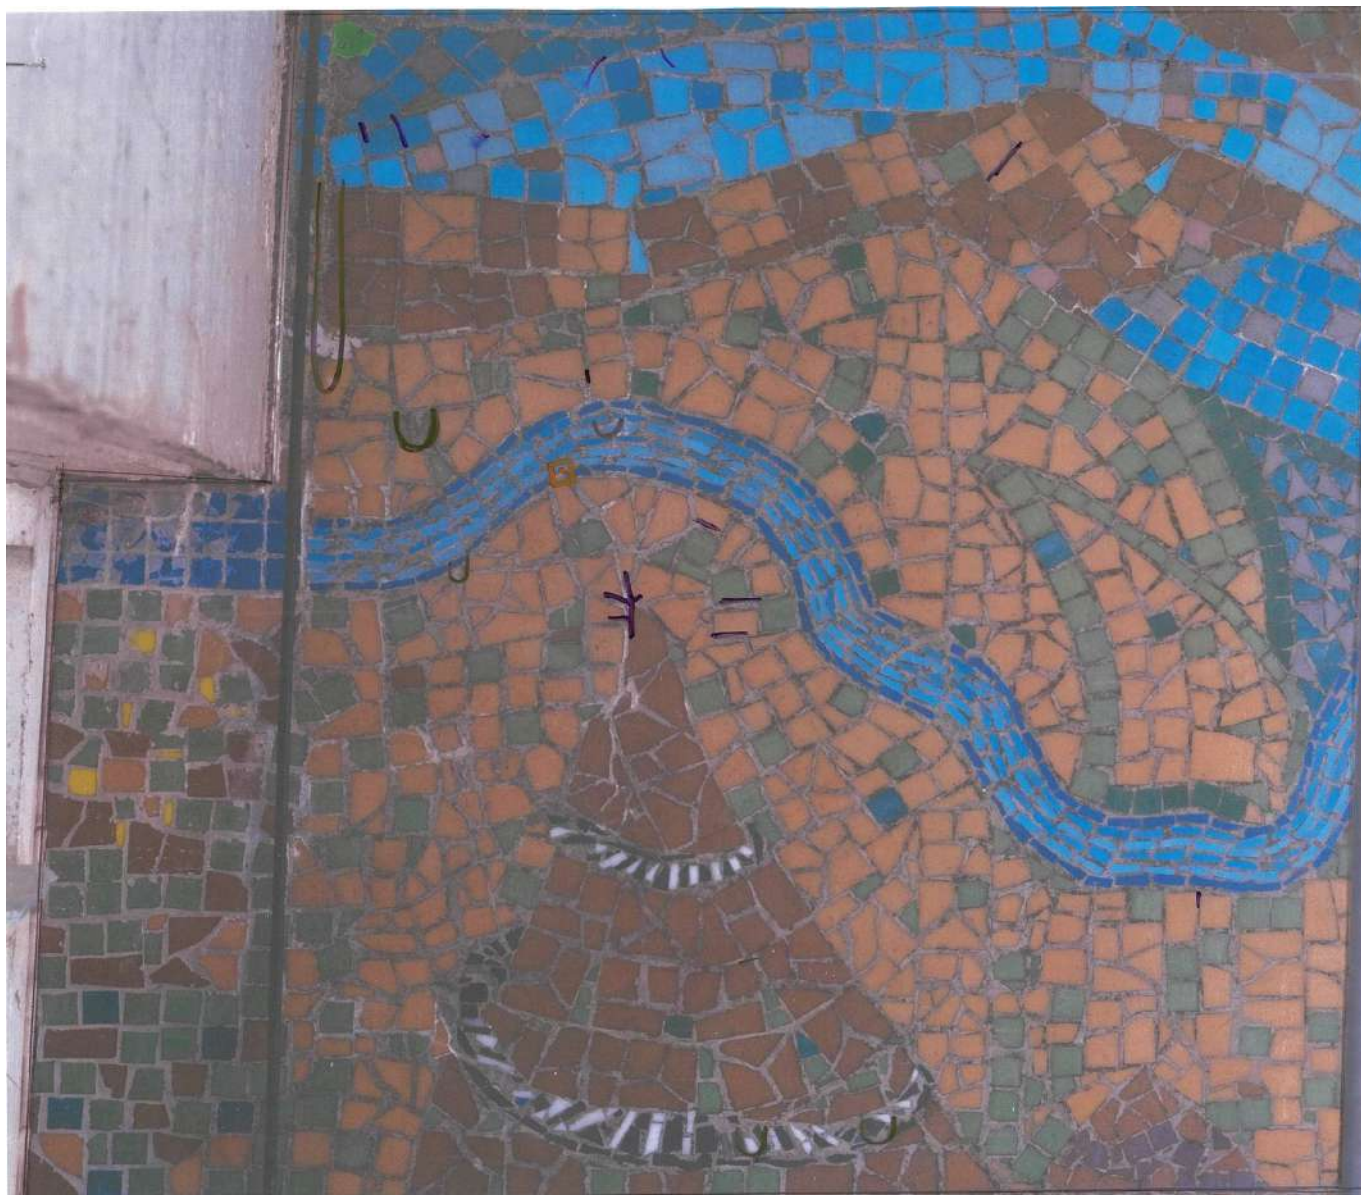
## Panel H1

1190mm x 900mm

General Good condition

Superficial dirt: 100%\*

Biological growth: 50%\*

Paint marks: 3%\*

Silicon residues: 2%\*

Old metal fixings: 2no.

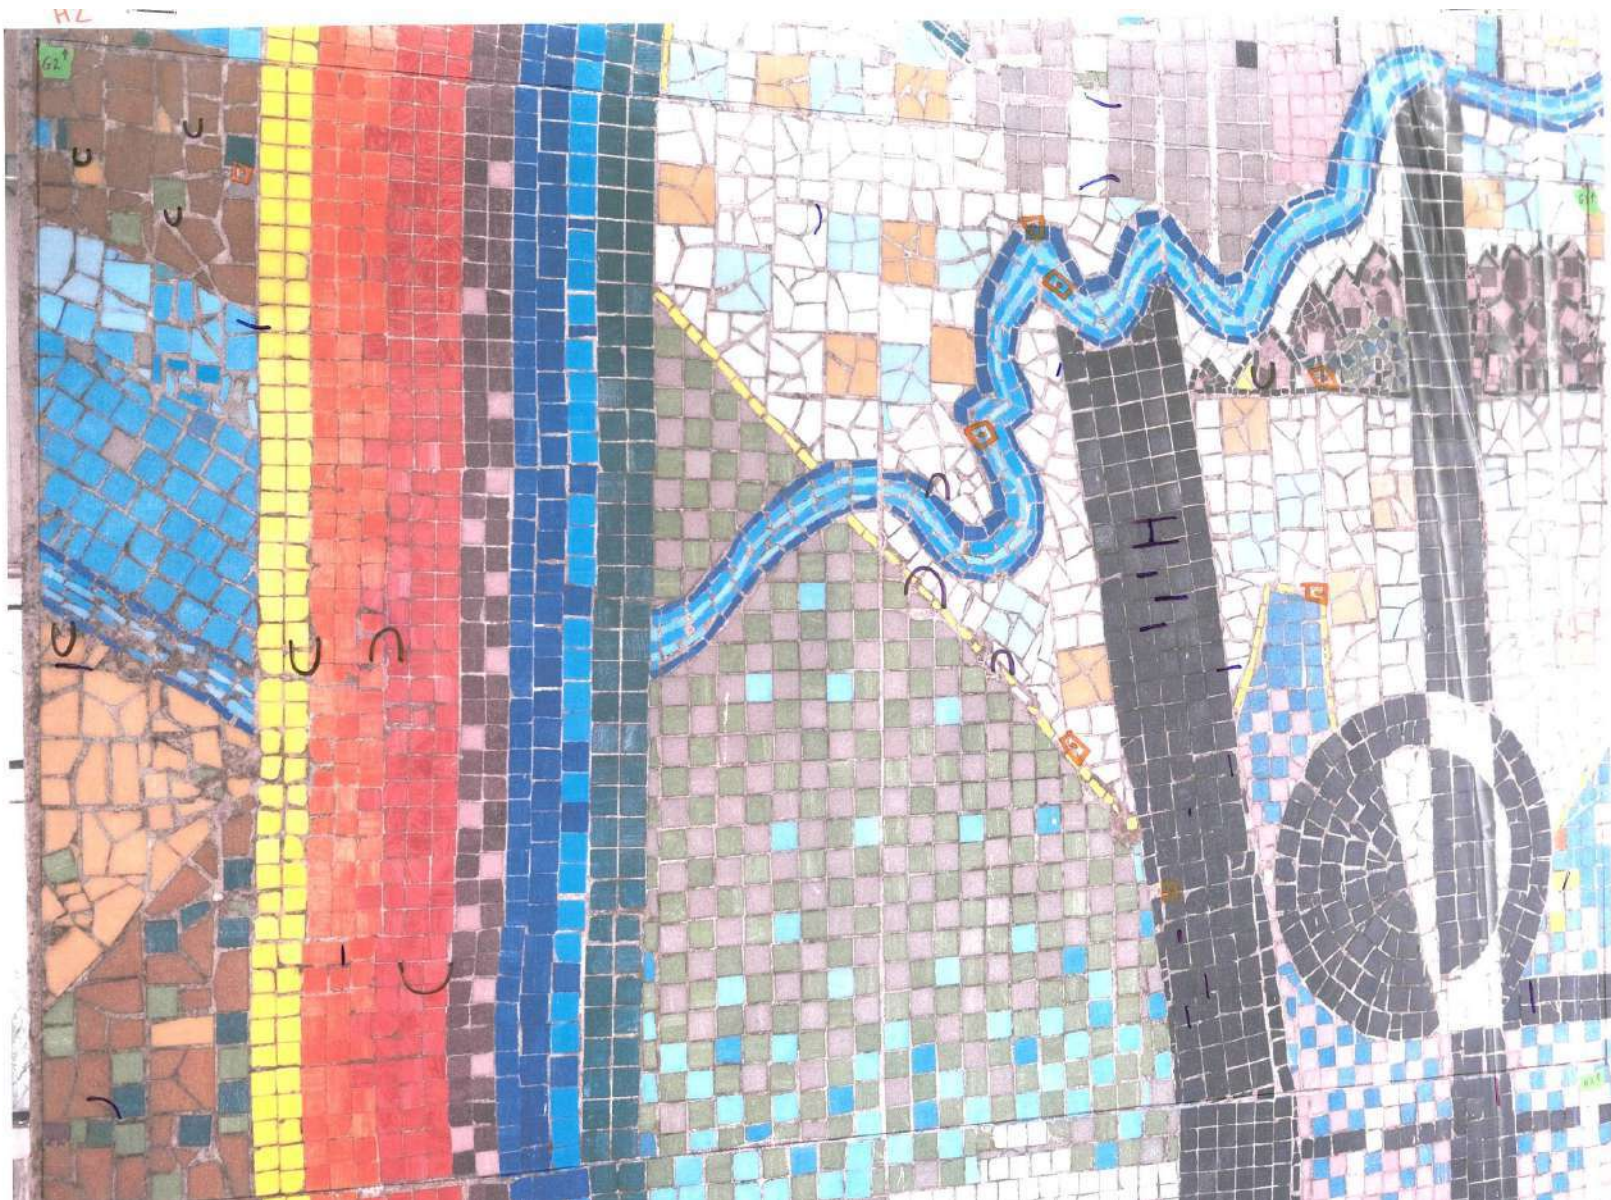
## Panel H2

1520mm x 900mm

General Good condition

Superficial dirt: 100%\*

Biological growth: 50%\*

Guano 1%\*

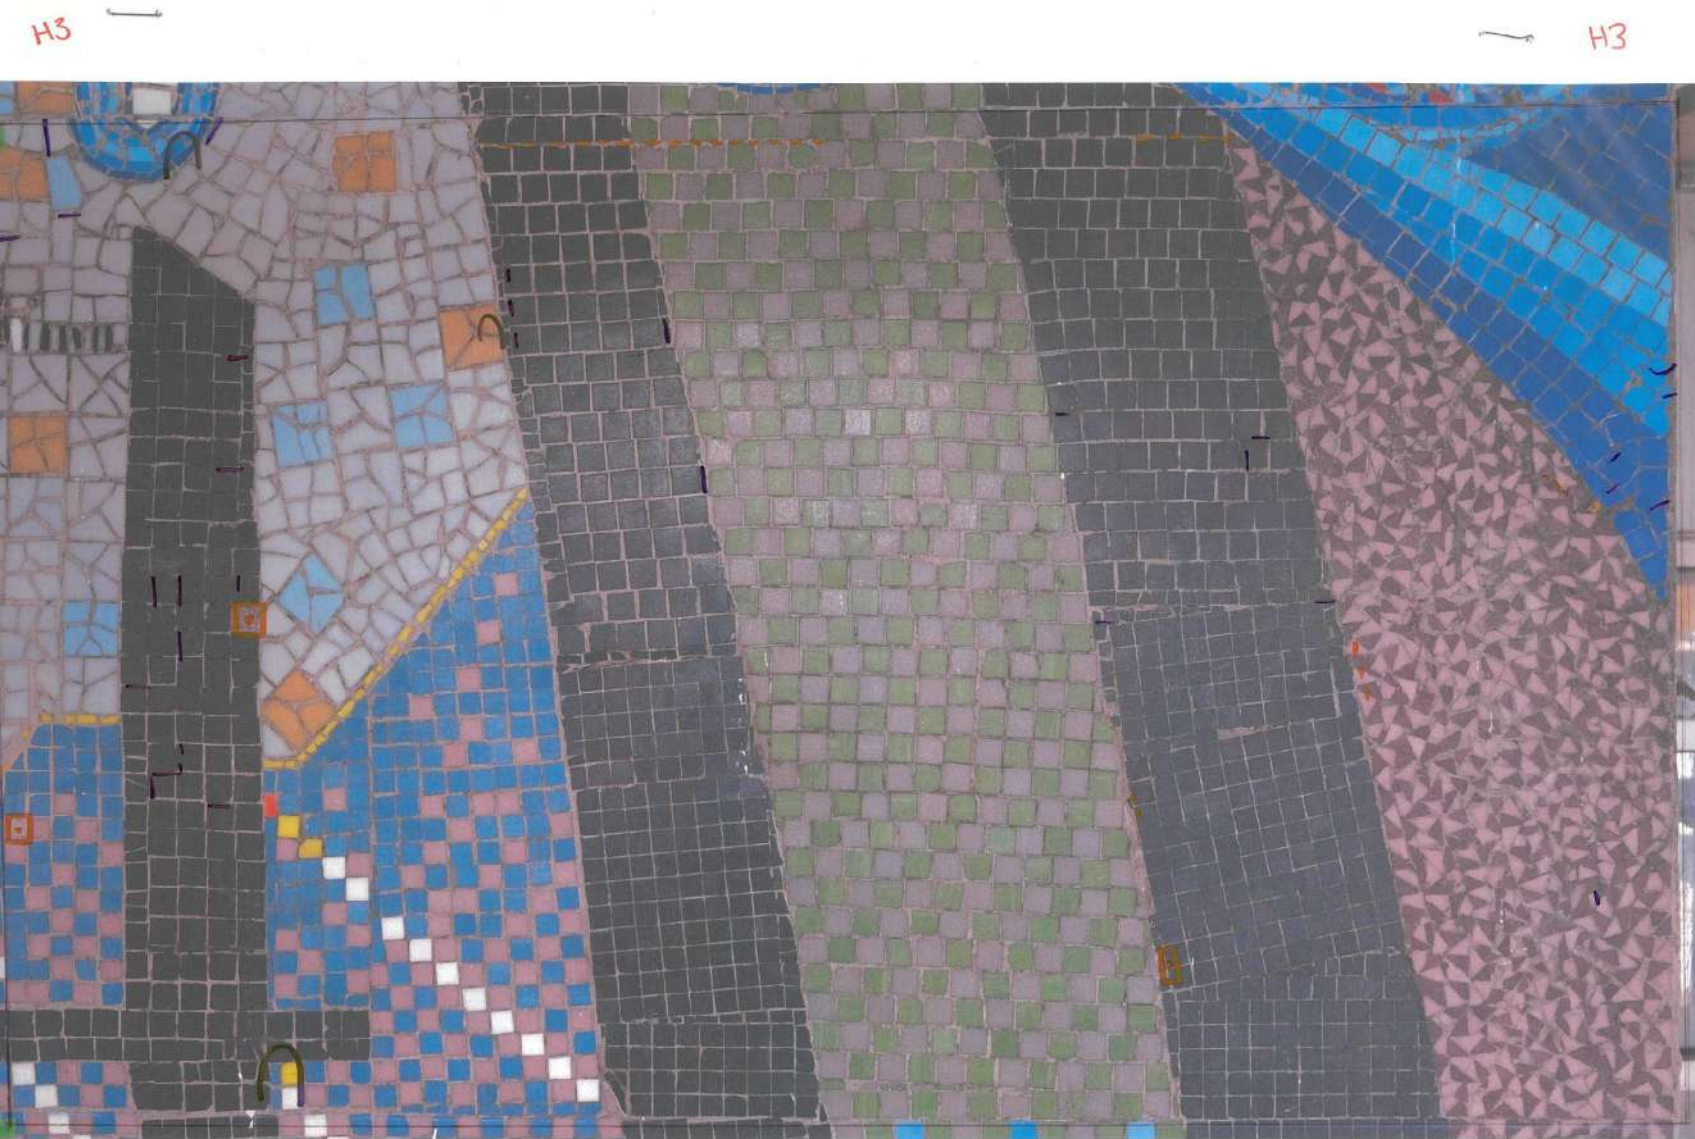
**Panel H3**  
1520mm x 900mm  
General Good condition

Superficial dirt: 100%\*  
Biological growth: 50%\*  
Guano 1%\*

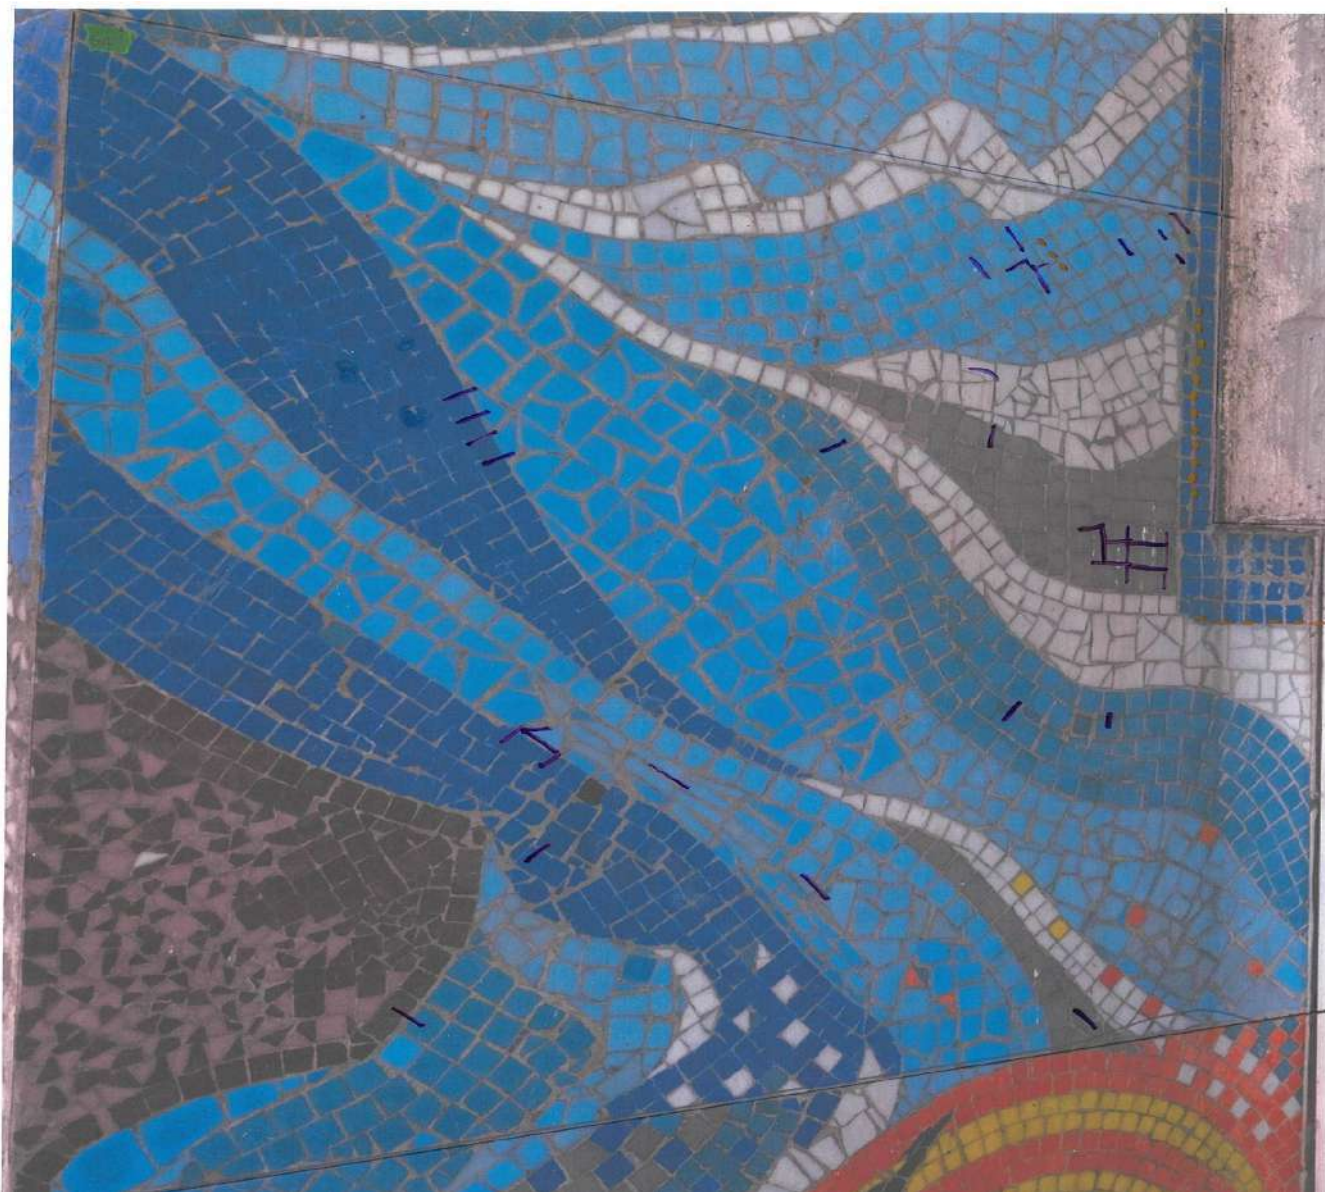
## Panel H4

1200mm x 900mm

General Good condition

Superficial dirt: 100%\*

Biological growth: 50%\*

Paint marks: 3%\*

Silicon residues: 2%\*

Old metal fixings: 2no.

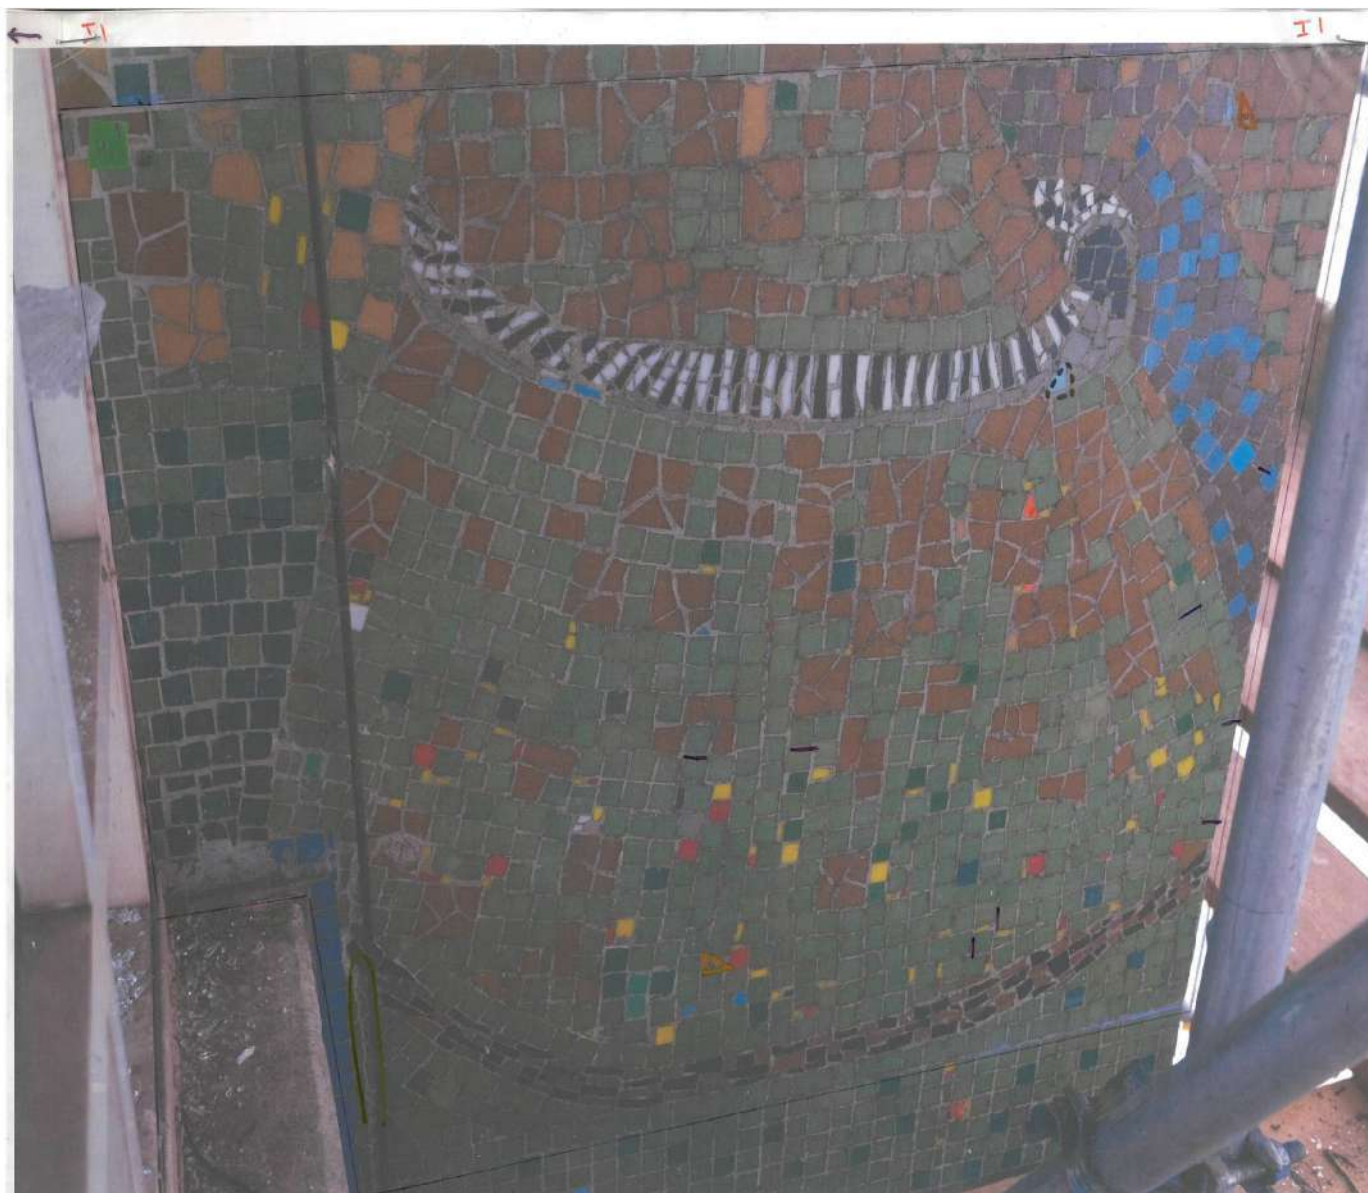
## Panel I1

1190mm x 900mm

General Good condition

Superficial dirt: 100%\*

Biological growth: 50%\*

Paint marks: 3%\*

Silicon residues: 2%\*

Old metal fixings: 3no.

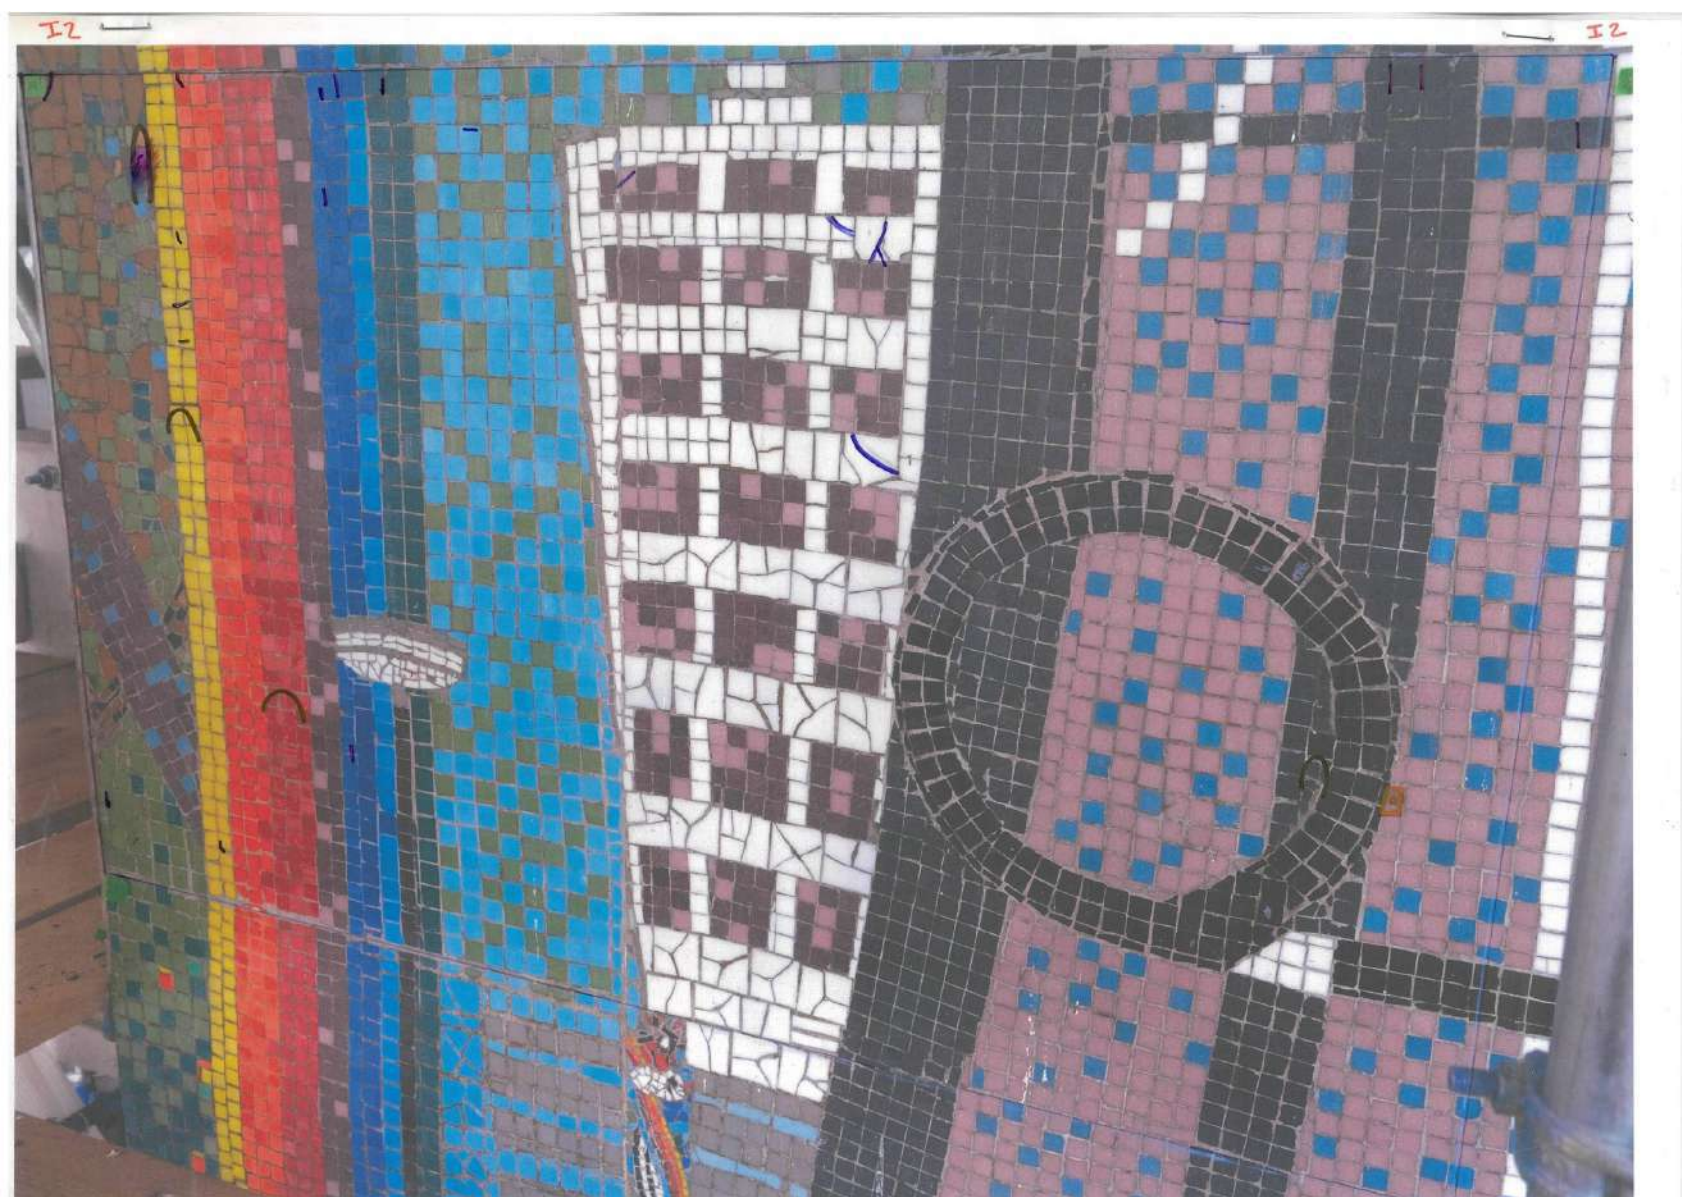
## Panel I2

1520mm x 900mm

General Good condition

Superficial dirt: 100%\*

Biological growth: 50%\*

Guano: 1%\*

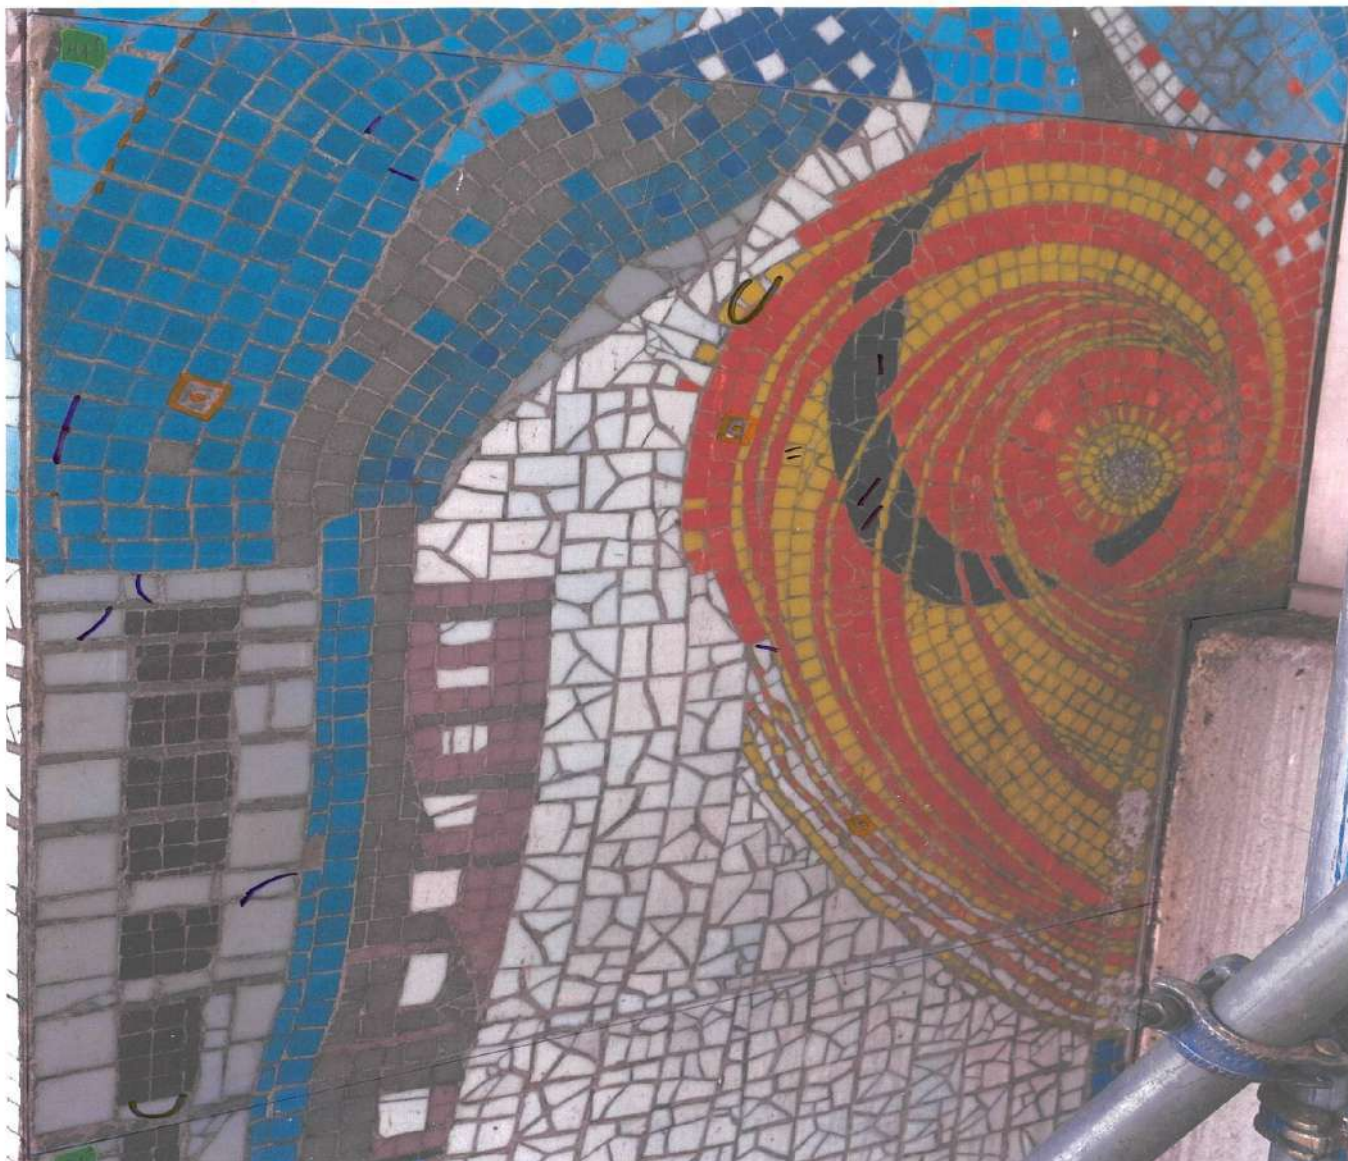
## Panel I4

1200mm x 900mm

General Good condition

Superficial dirt: 100%\*  
 Biological growth: 50%\*  
 Paint marks: 3%\*  
 Silicon residues: 2%\*  
 Old metal fixings: 3no.

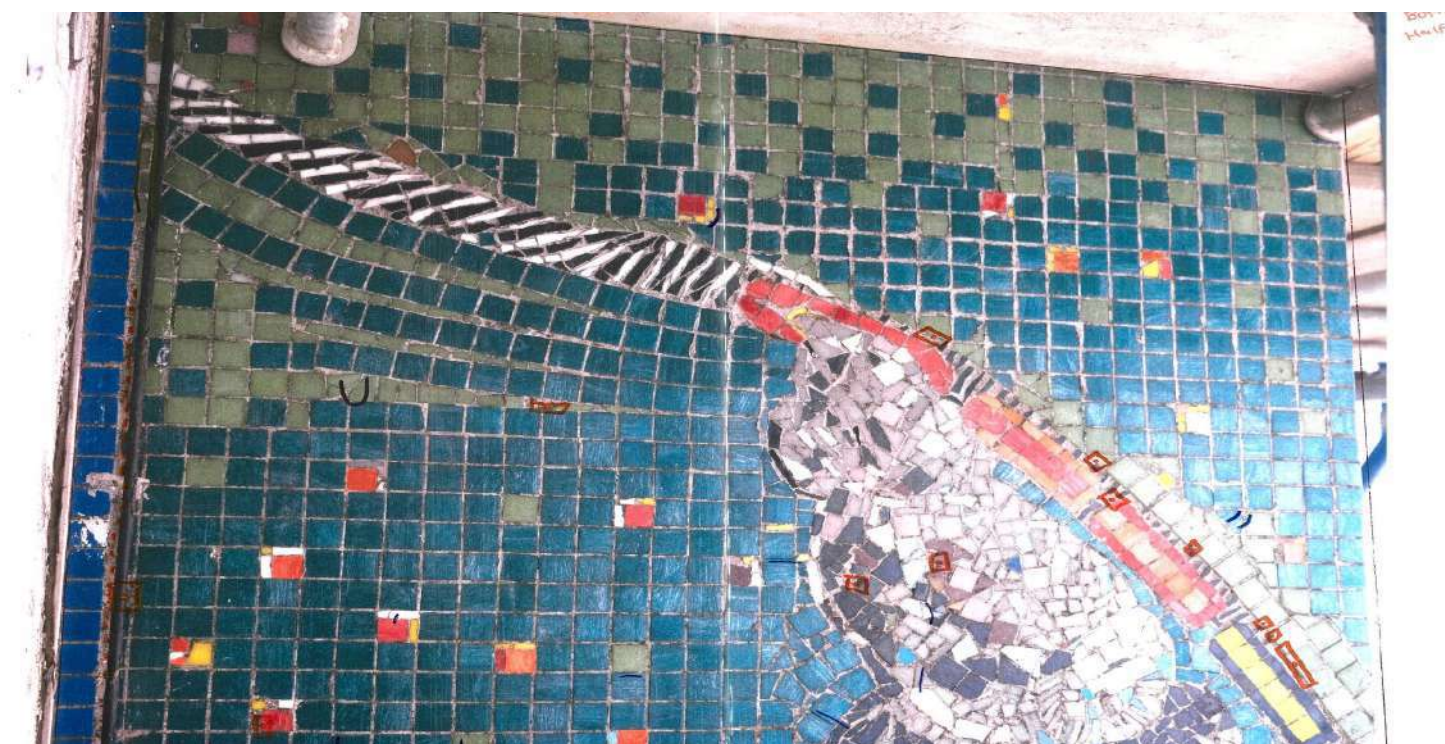
## Panel J1

950mm x 895mm

General Good condition

Superficial dirt: 100%\*

Biological growth: 30%\*

Paint marks: 3%\*

Silicon residues: 2%\*

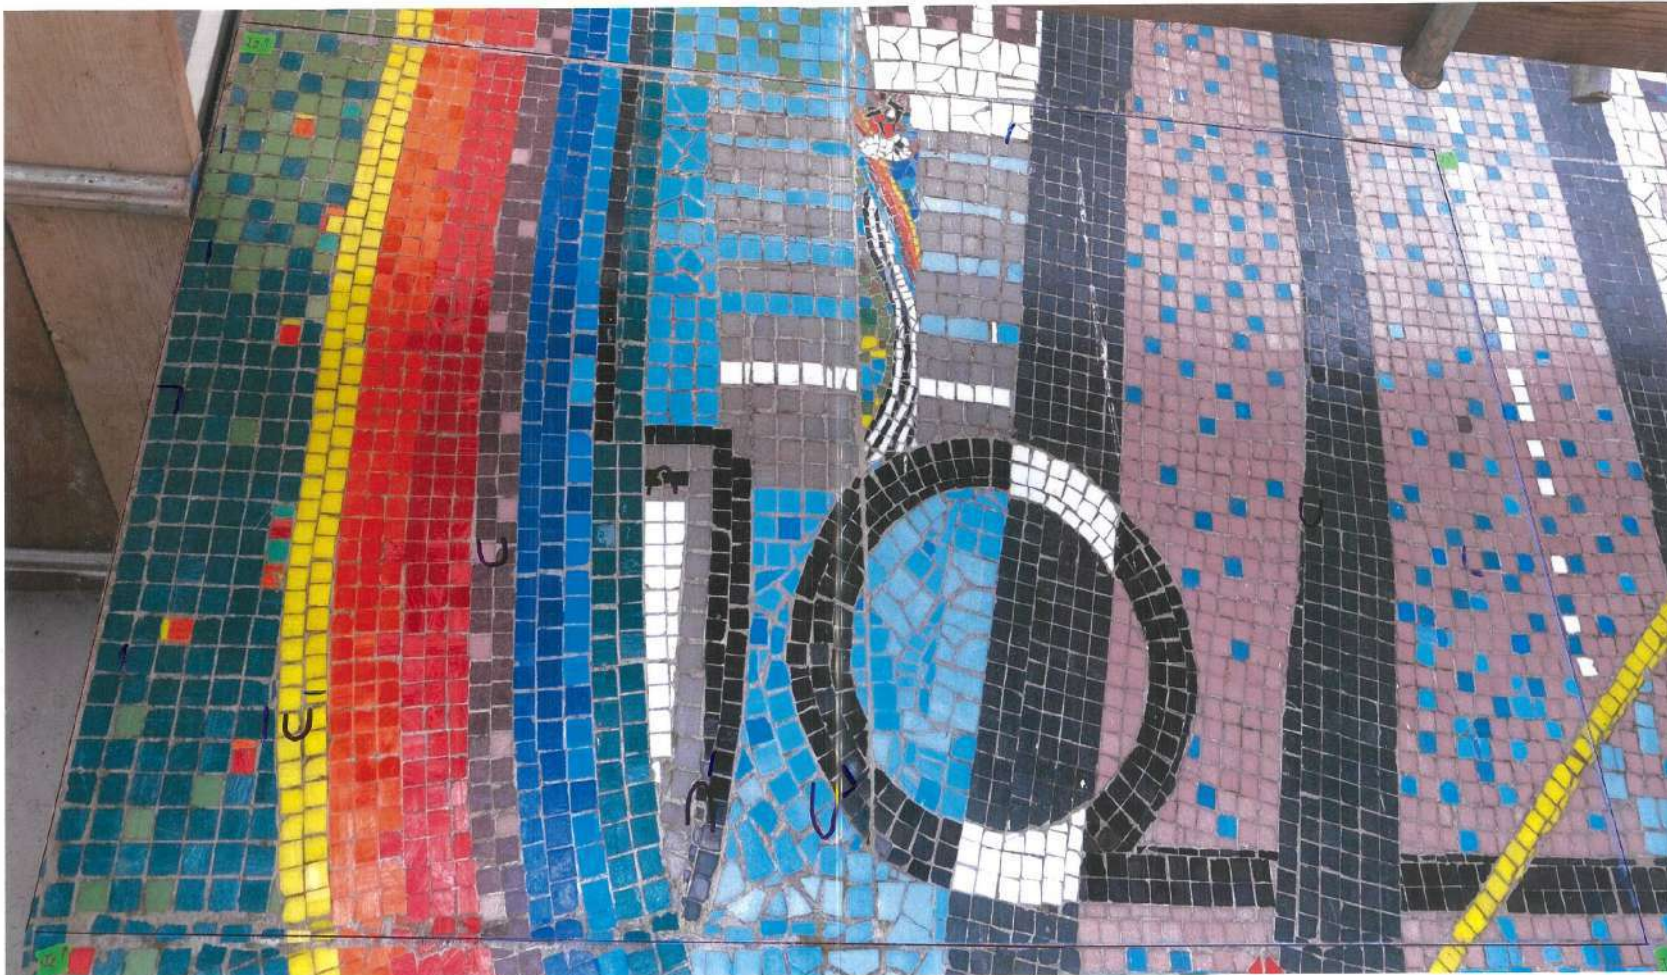
## Panel J2

1520mm x 895mm

General Good condition

Superficial dirt: 100%\*

Biological growth: 30%\*

Guano: 1%\*

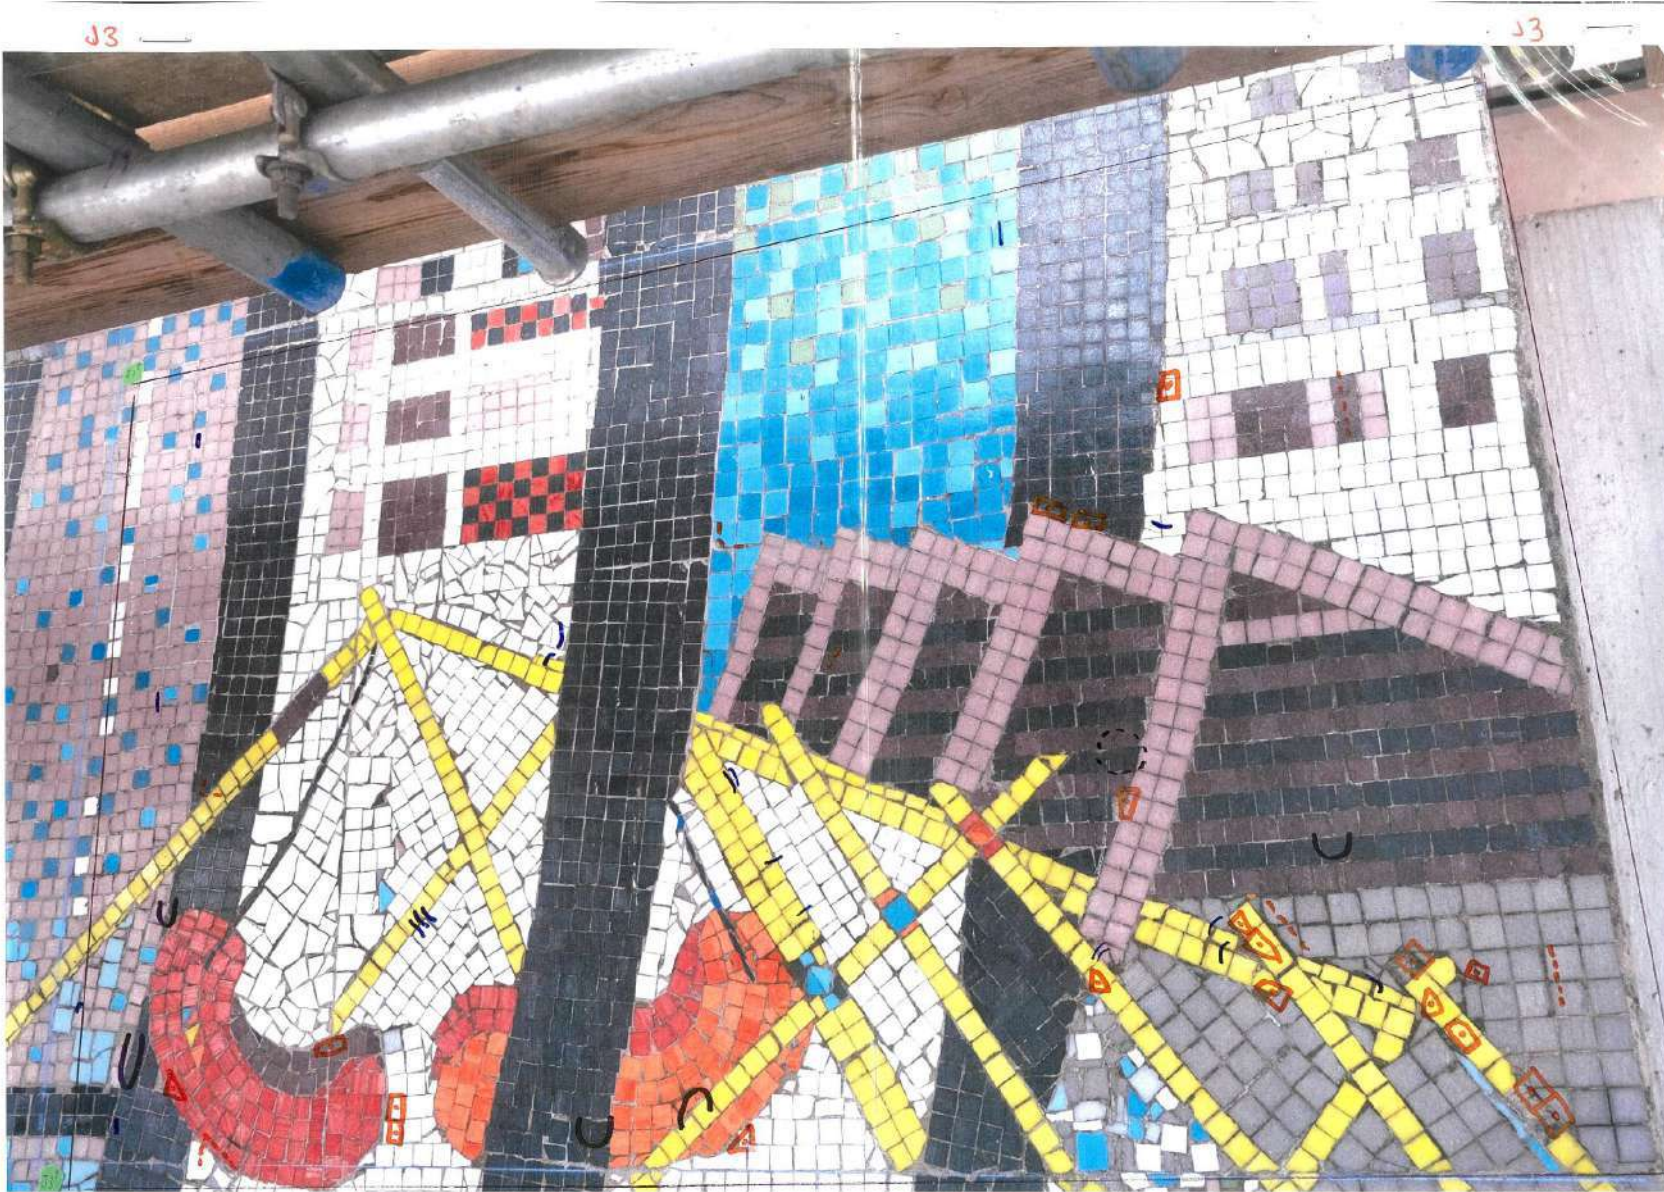
## Panel J3

1520mm x 895mm

General Good condition

Superficial dirt: 100%\*

Biological growth: 30%\*

Guano: 1%\*
