# Broadwater Farm Estate

## Mural mosaic

Condition Survey  
September 2023

Authored by Paolo Volpi & Ian Devine  
Reviewed by Adrian Attwood ACR

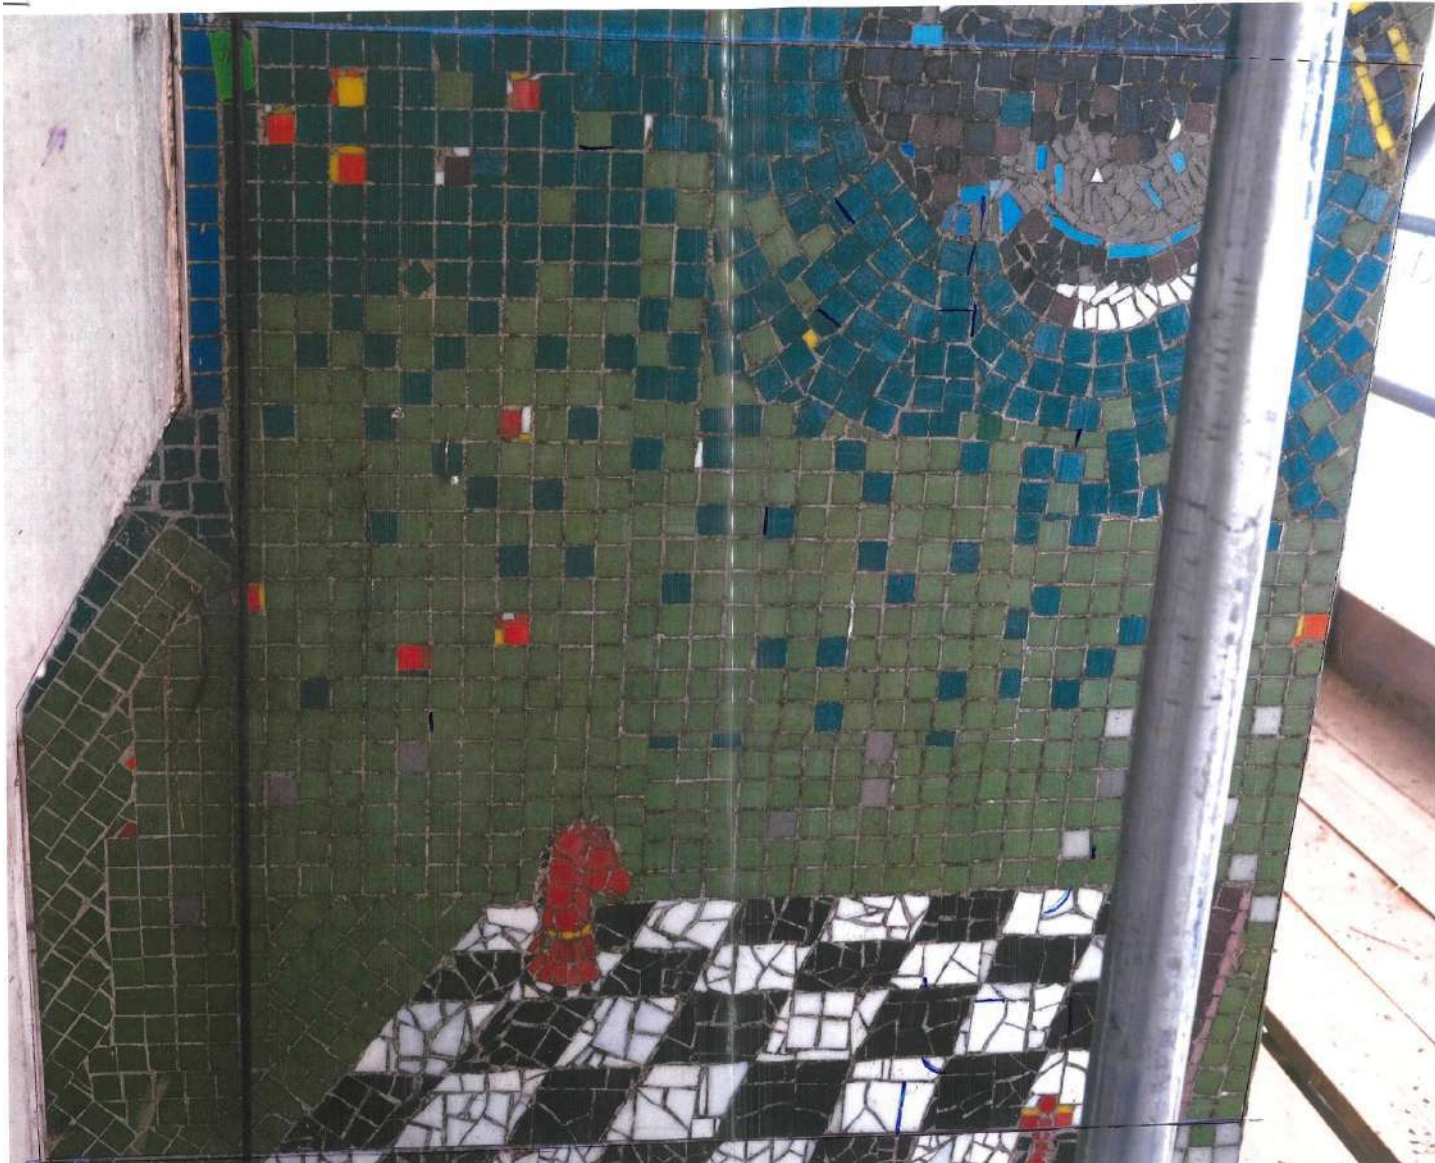
## Panel K1

1190mm x 900mm  
General Good condition

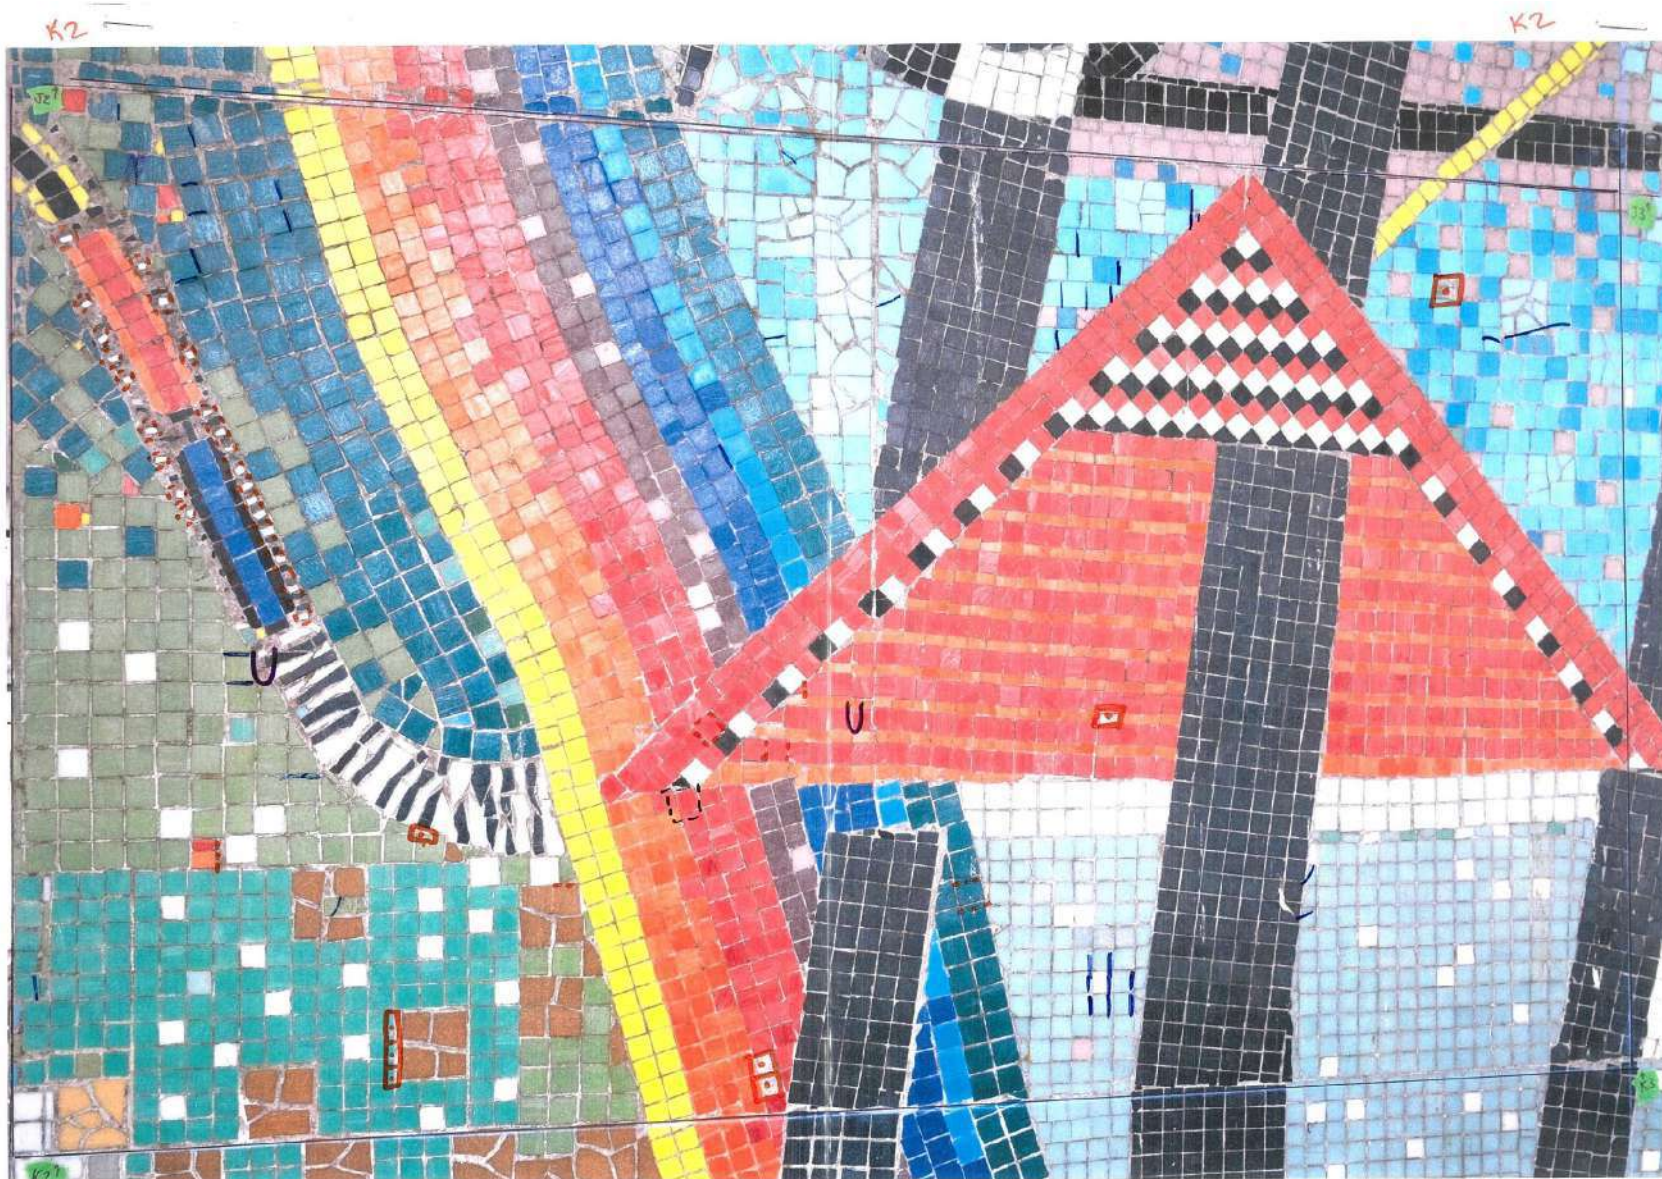
## Panel K2

1520mm x 900mm

General Good condition

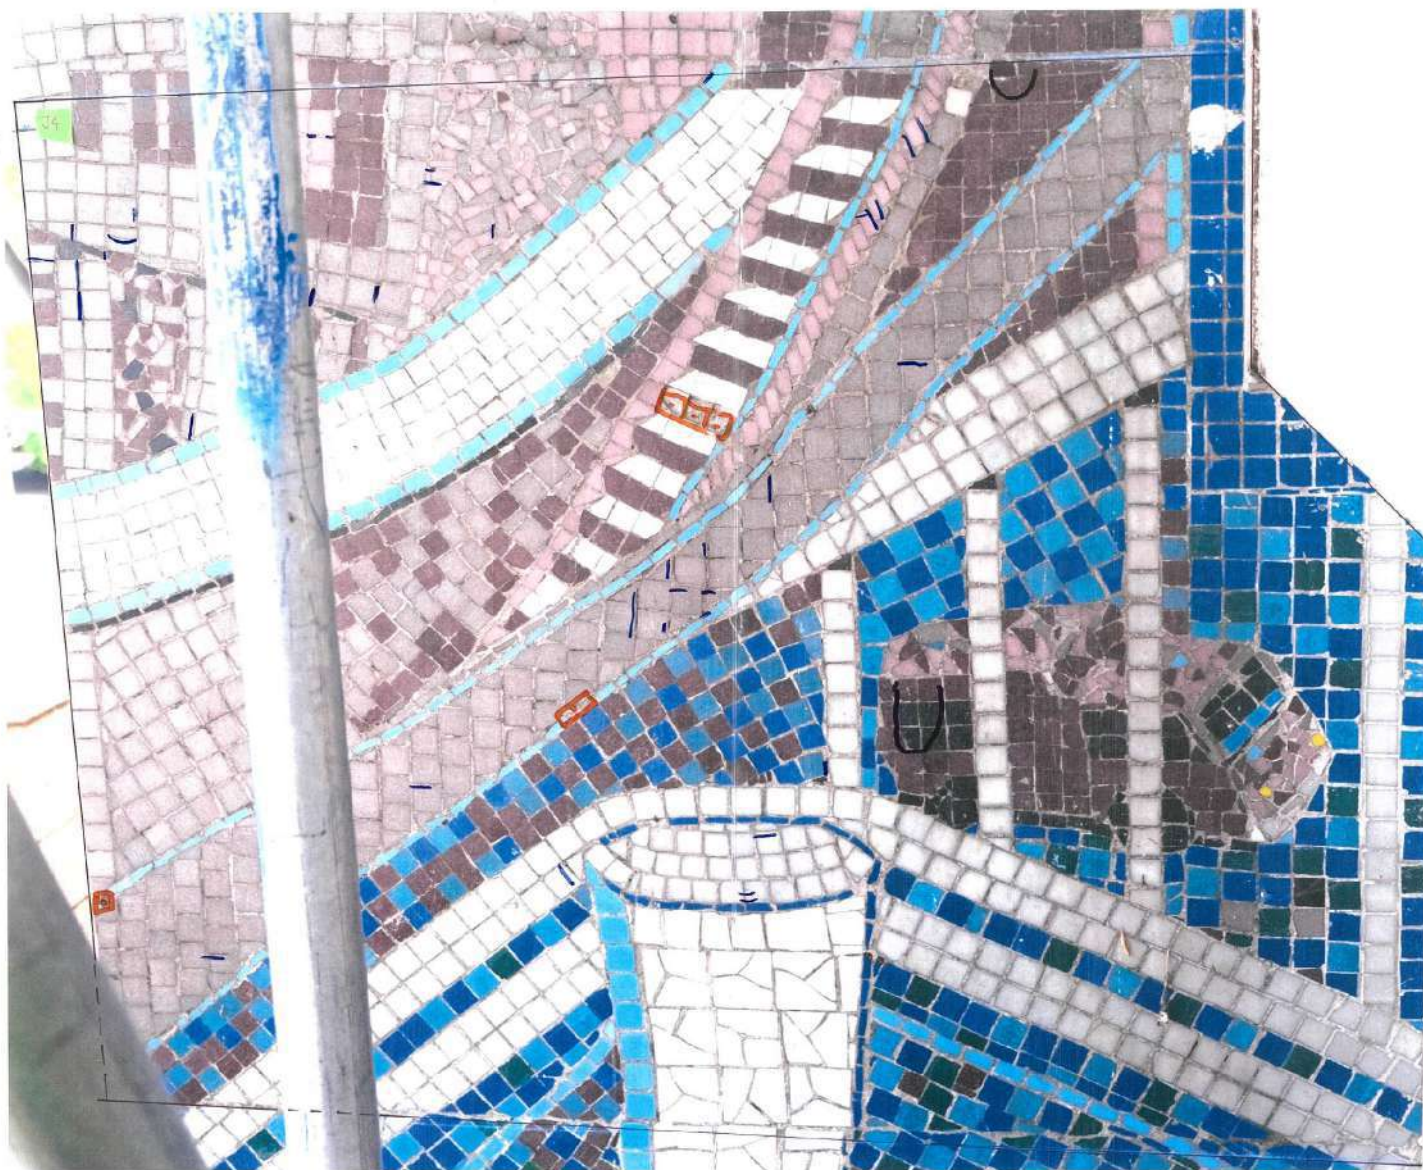
## Panel K4

General Good condition

Old metal fixings: 3no.

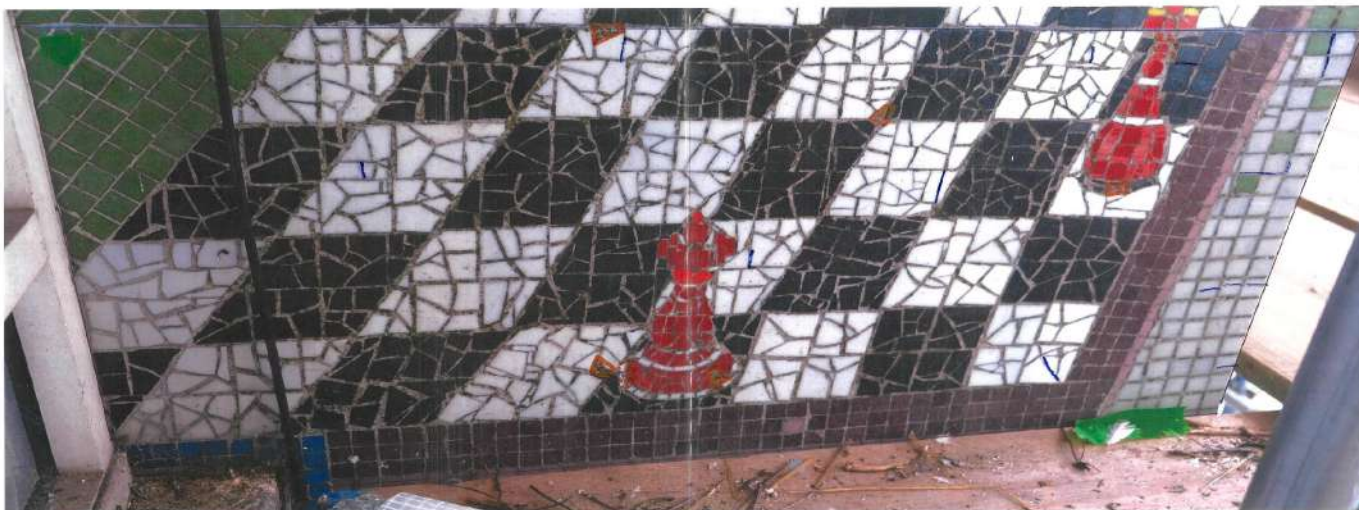
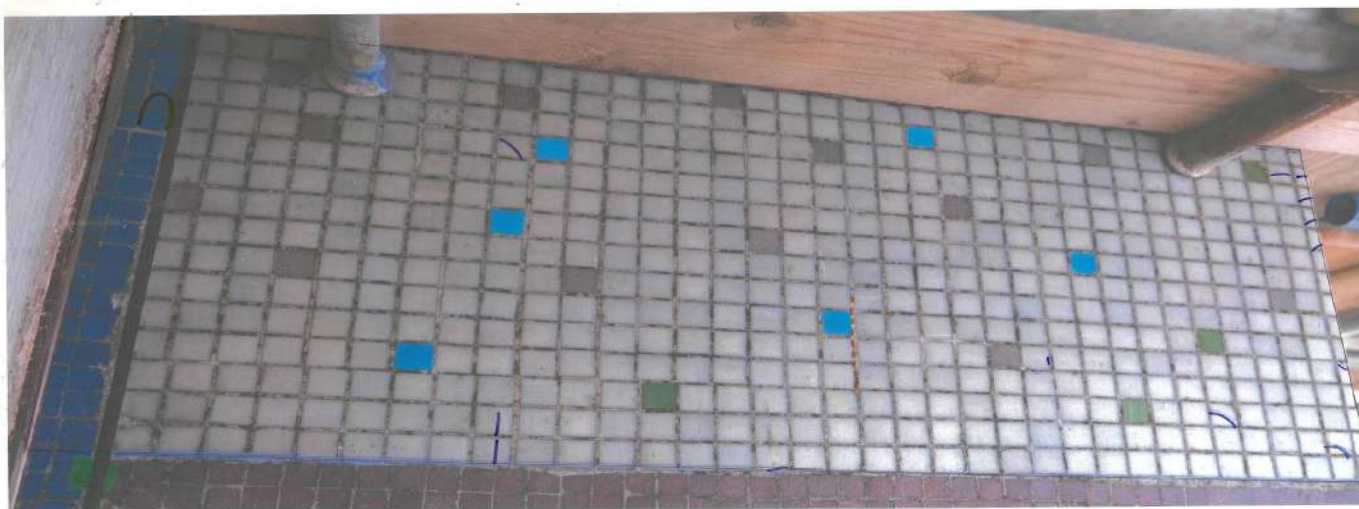
## Panel L1

1190mm x 900mm

General Good condition

Superficial dirt: 100%\*  
 Biological growth: 60%\*  
 Paint marks: 3%\*  
 Silicon residues: 2%\*  
 Old metal fixings: 3no.

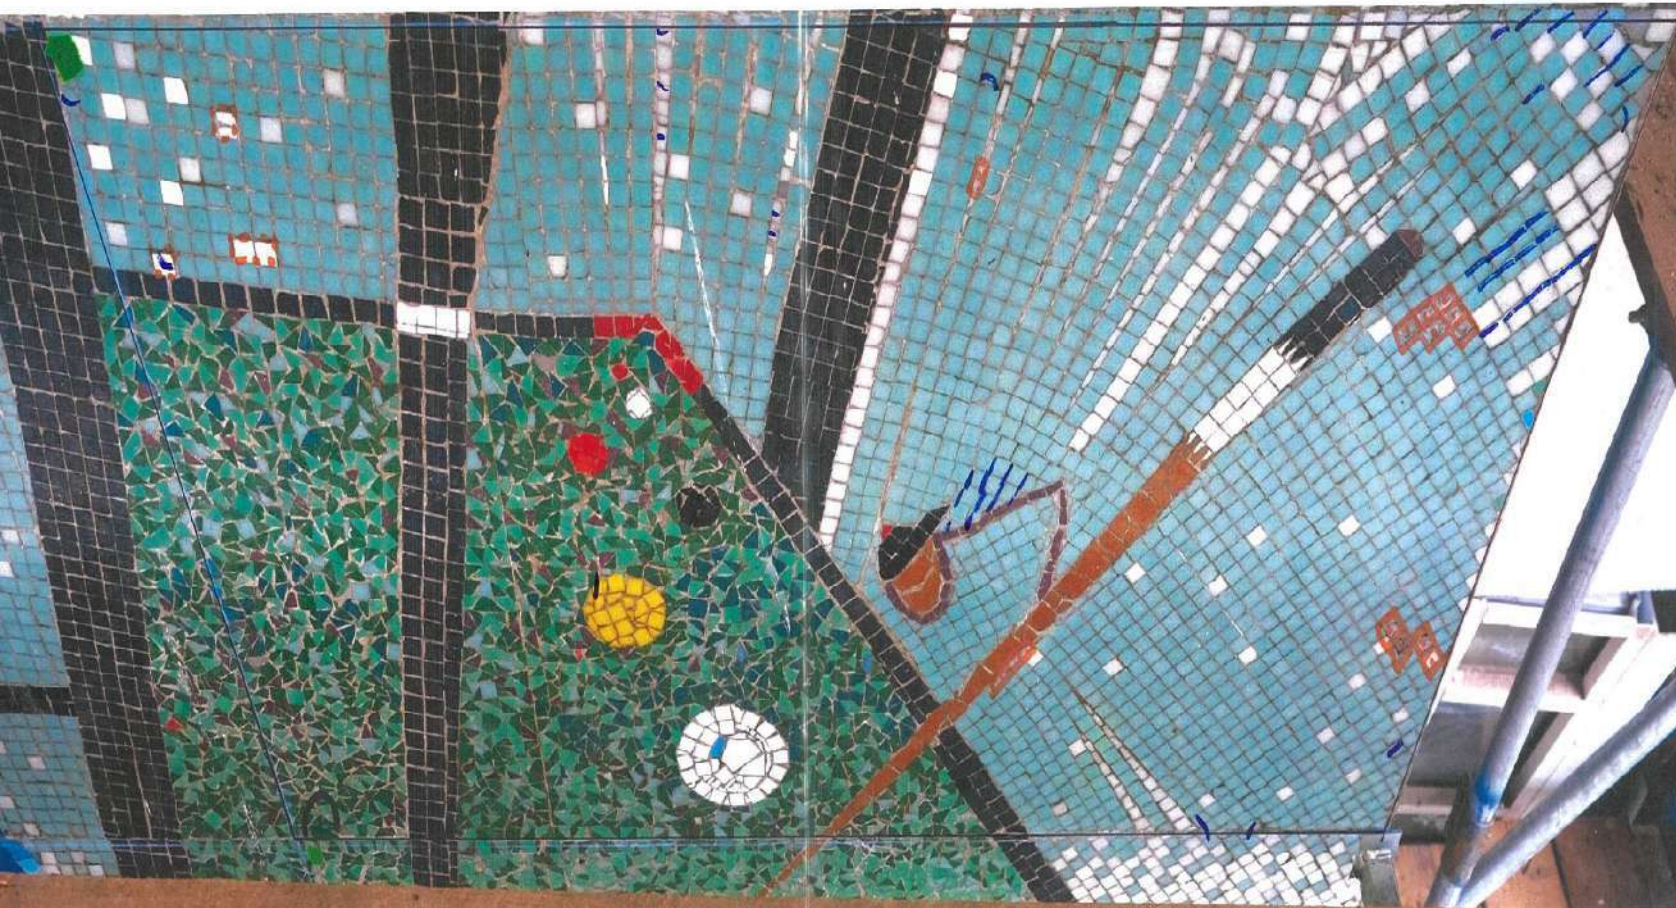
## Panel L3

1515mm x 900mm

General Good condition

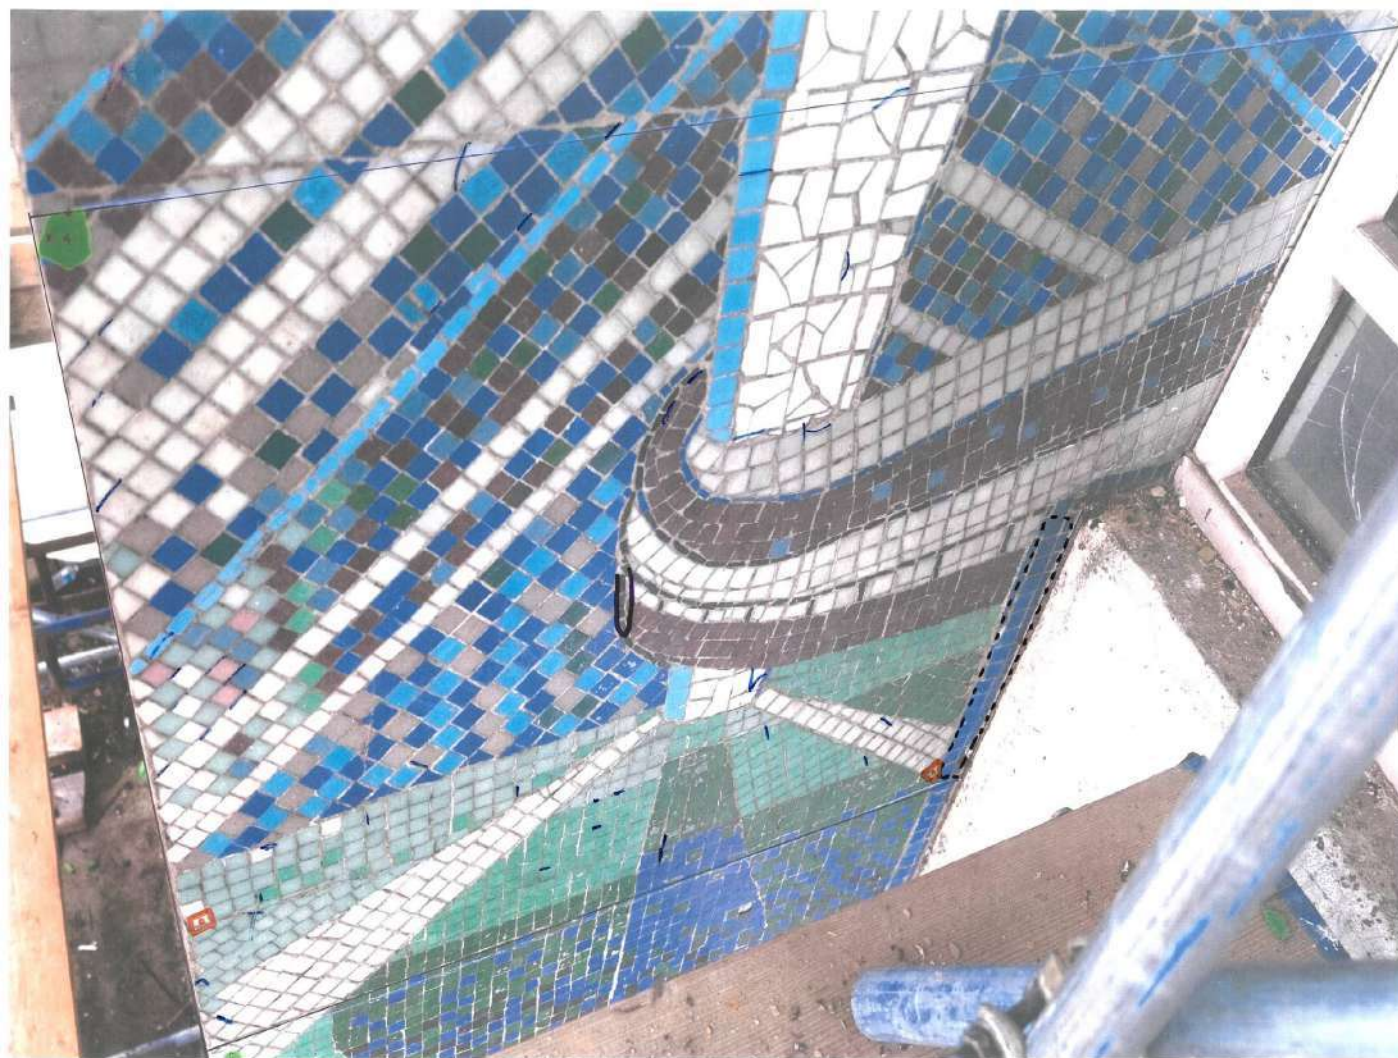
**Panel L4**  
1200mm x 900mm  
General Good condition

Superficial dirt: 100%\*  
Biological growth: 60%\*  
Paint marks: 3%\*  
Silicon residues: 2%\*  
Old metal fixings: 3no.

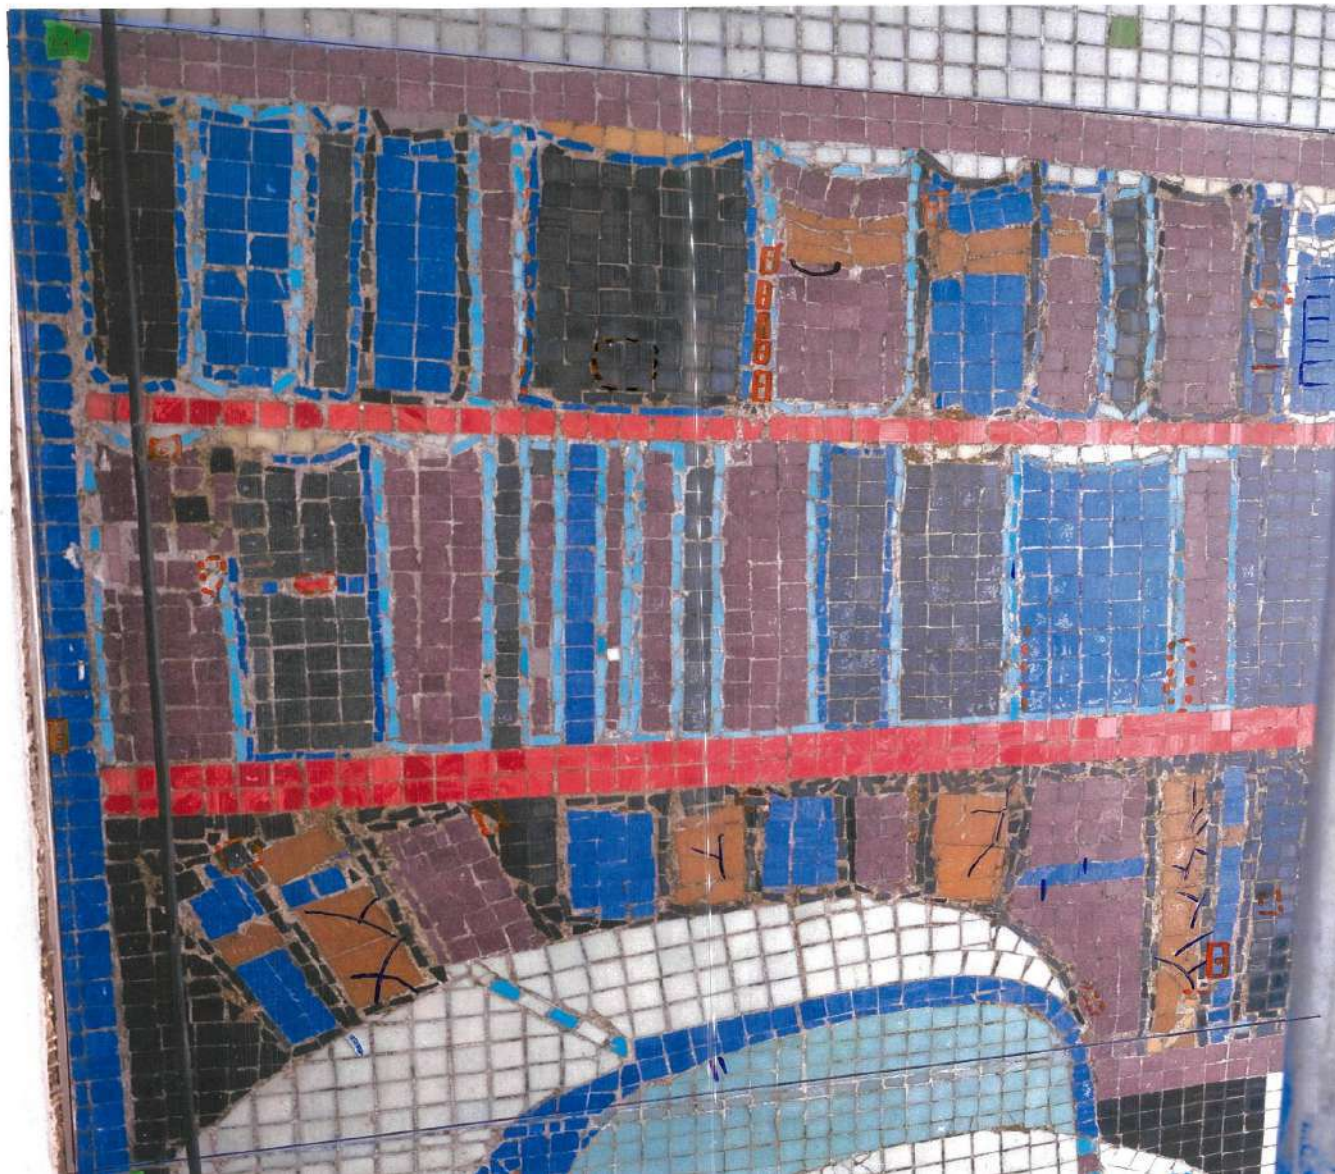
## Panel M1

General Good condition

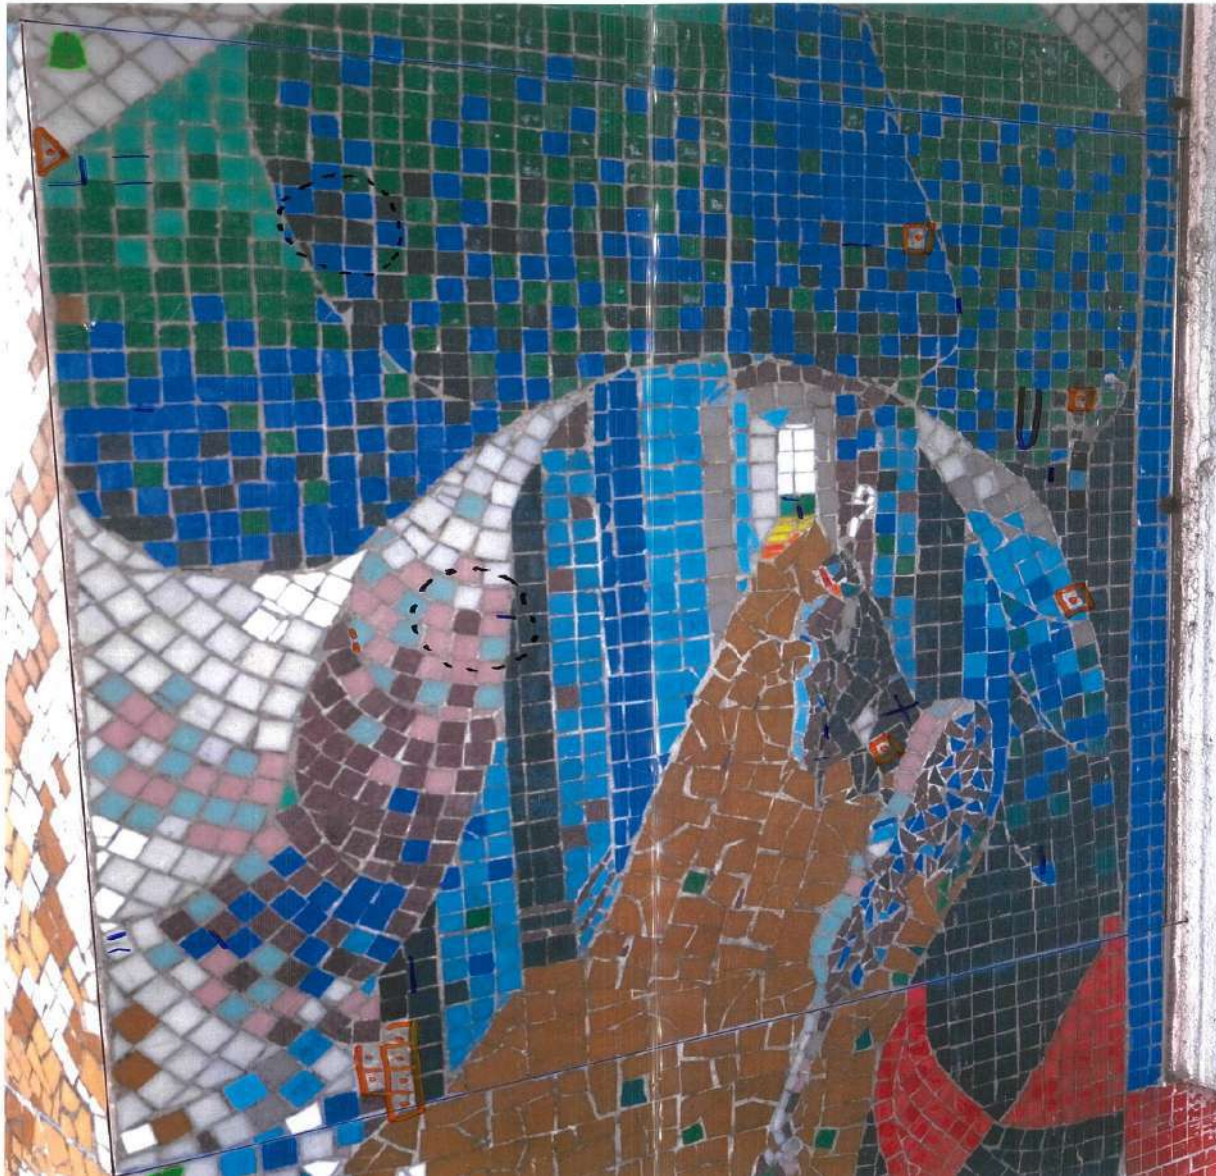
## Panel M4

965mm x 880mm

General Good condition

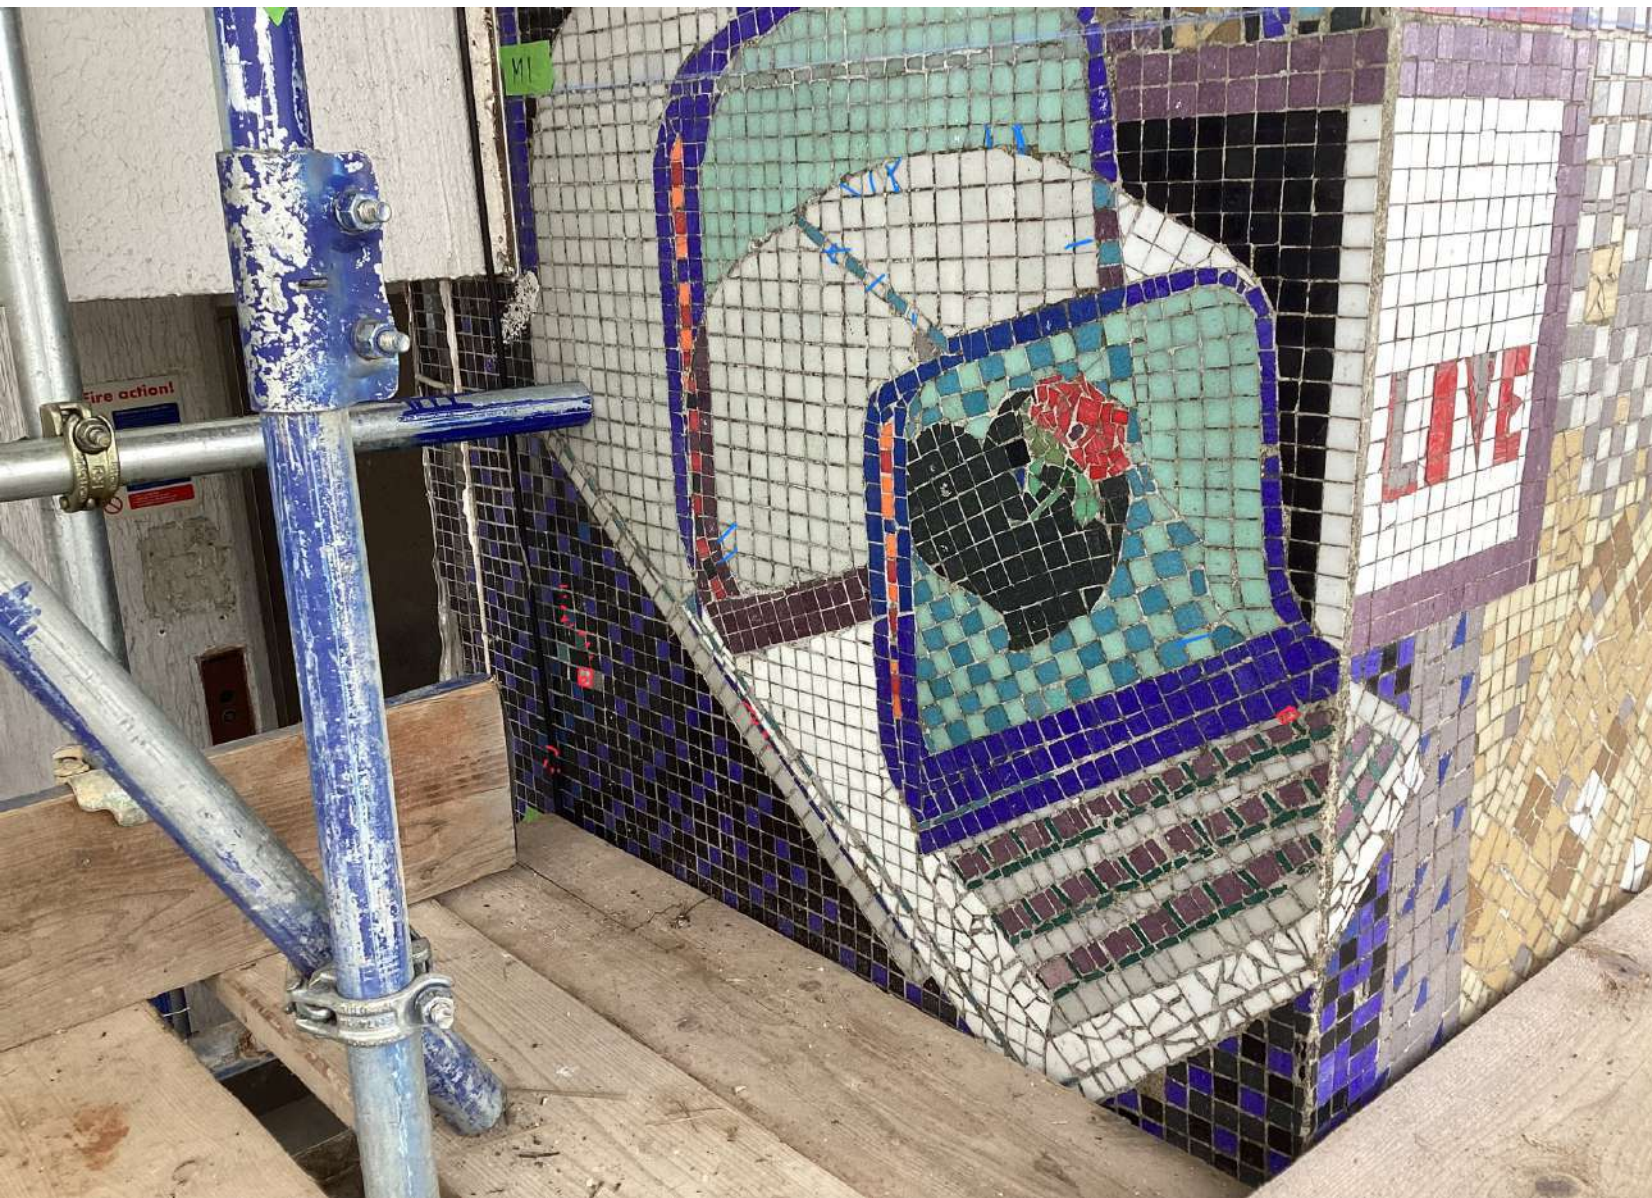
## Panel O1

1200mm x 900mm

General Good condition
