**HARINGEY MTC EXTERNALS AND  
COMMUNAL**

**CONDITION SURVEY REPORT**

**13 – 20, JACK BARNETT WAY,  
N22 6SZ**

26<sup>th</sup> March 2025

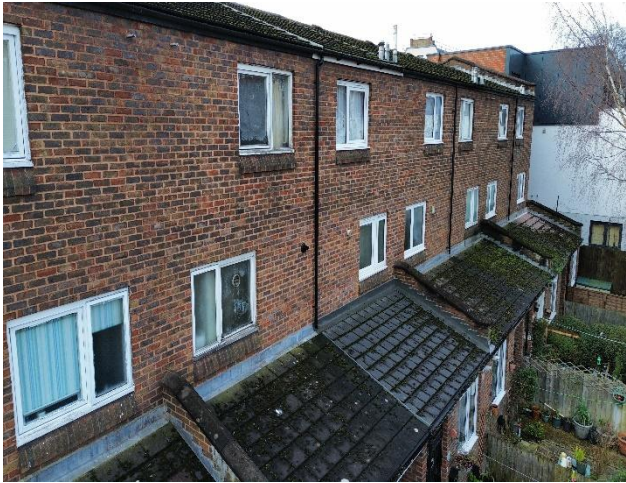
**Photo 1.** Front elevation

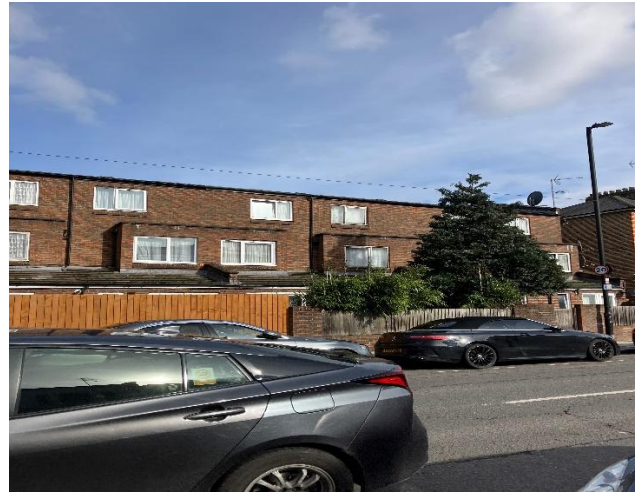
**Photo 2.** Rear Elevation

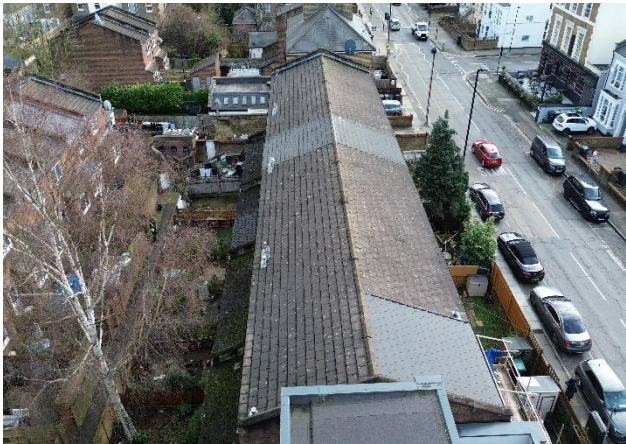
- The main roof was noted to be in fair condition. With some defects noted as follows:
- There have been some temporary repairs carried out near the party wall line in the form of a flash band repair at the junction between Nr 16 and nr 17 Jack Barnet Way. This form of repair generally has a short life expectancy and should be rectified in the short term.

- The roof tiles contain a fair amount of moss growth and lichen growth commensurate with the age of the respective coverings.
- It is understood that there is ongoing water ingress to flat 13, near to the parapet wall, it was noted that the flashing details serving the upper and lower roof were heavily stained. The flashing detailing at number 20 has been recently renewed.

**Photo 3.** Main roof.

- Renew/overhaul the existing guttering and rainwater goods and repair the existing fascia boards.
- Carry out repairs to the roof where there are short term repairs such as flash band or cracked and damaged tiles. Remove all moss and lichen growth.

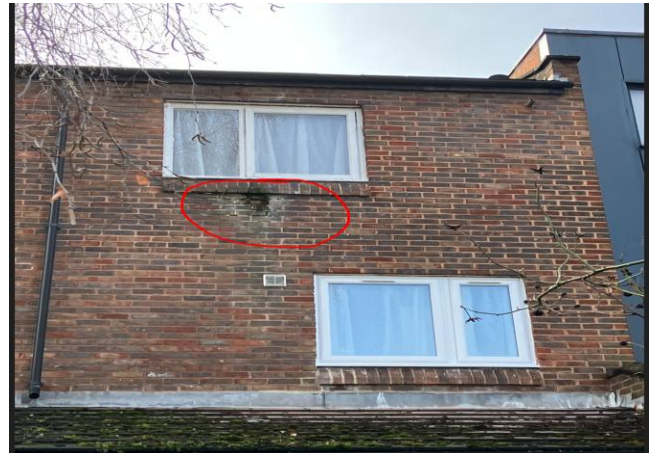
- There is evidence of penetrative damp occurring to the top window on the second floor to Flat number 20, where staining and moss growth was noted to small section of brickwork. This may be caused by an ongoing leak in the guttering above.

**Photo 4.** Staining to brickwork (nr.20)

- Further investigate the parapet gutters and either renew or overlay the existing covering.
- Carry out the necessary masonry and brick repairs, including minor repointing, brick refacing and crack repairs and remove all efflorescence from the building.

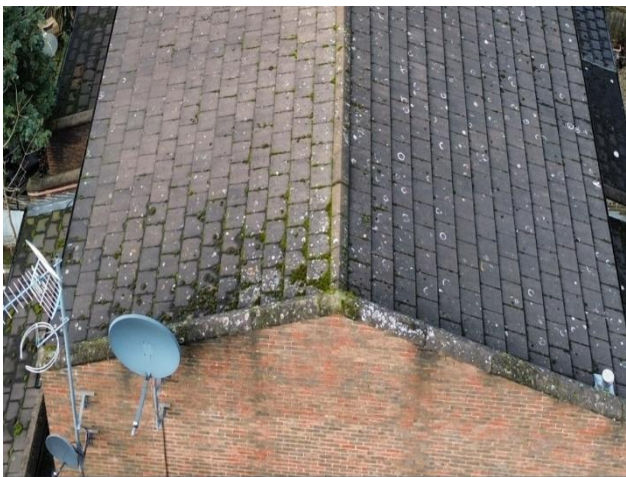
- To the front elevation, there was staining to the parapet walls noted beneath the coping stones serving the main and lower roofs at both first and second floor level suggesting insufficient coping overhangs. This was noted throughout.

**Photo 5.** Staining beneath coping stones.

- Renew the existing coping stones to the front and rear of the roof and to the lower and upper roof level
- Renew all lead stepped flashing details to all parapet walls at first and second floor level.

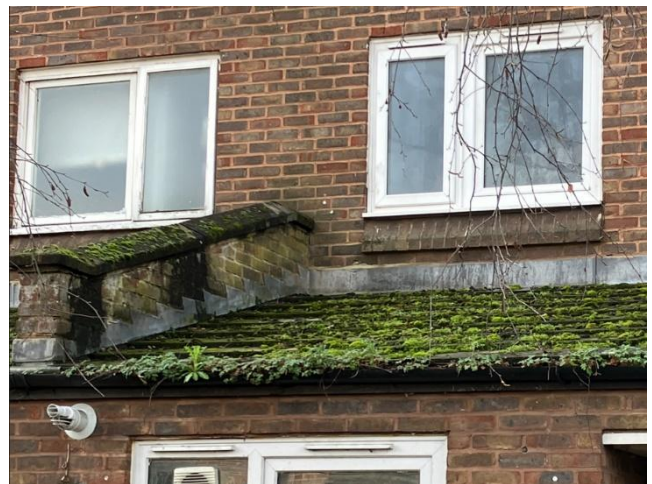
- The coping stones serving the main roof were in fair condition with a high amount of moss growth and lichen growth noted atop. There were some receded mortar joints to the coping stones, there was also staining in the parapet walls directly beneath the copings at both high and low level suggesting the existing coping stones contain an insufficient overhang. This was noted to both the main roof and lower roofs to the front and rear.

**Photo 6.** Moss build up and staining to coping stones.

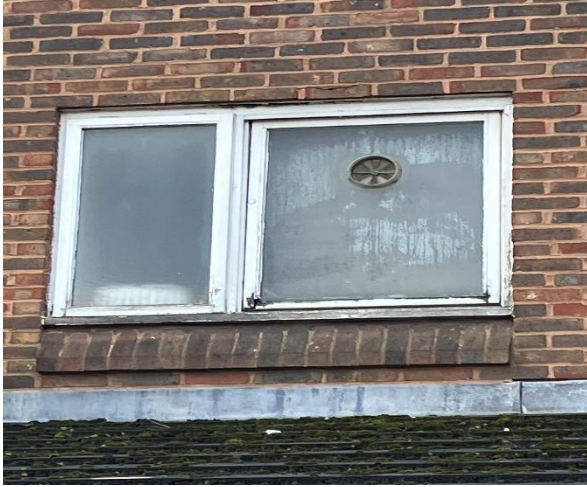
**Photo 7.** Deteriorating timber windows.

- Renew the windows at number 14, 15, 18 and 20 Jack Barnet Way in line with the other properties.
- Carry out the necessary metal care repairs to the existing lintels.

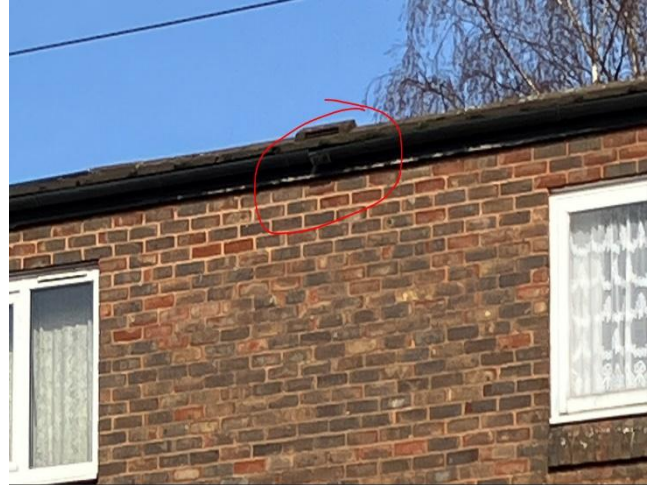
- The external guttering contains some stains at the joints and is undulated, especially to the central section of the rear elevation. There is blockage in the hopper serving nr 14. It is understood that there are leaks to the front elevation directly impacting nr 18 and nr 20 respectively. These are in poor condition.

**Photo 8.** Undulated and loose guttering.

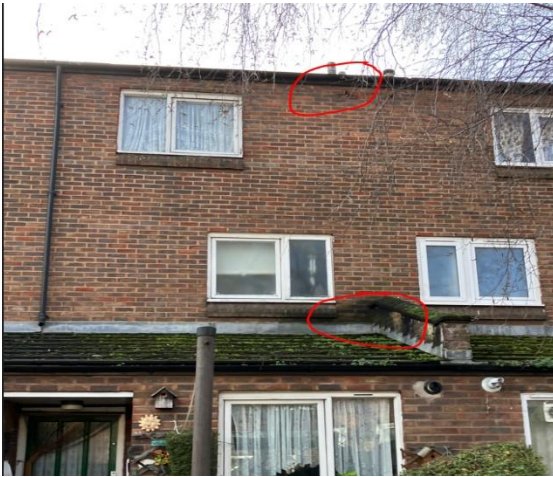
- There is evidence of ongoing penetrative damp occurring at the corner of the lower roof to nr.18. This looks to be the result of either undulations or damage to the guttering directly above, or an overflow pipe which is noted directly above near to the guttering. This leak is currently live.

**Photo 9.** Ongoing leak to front elevation.

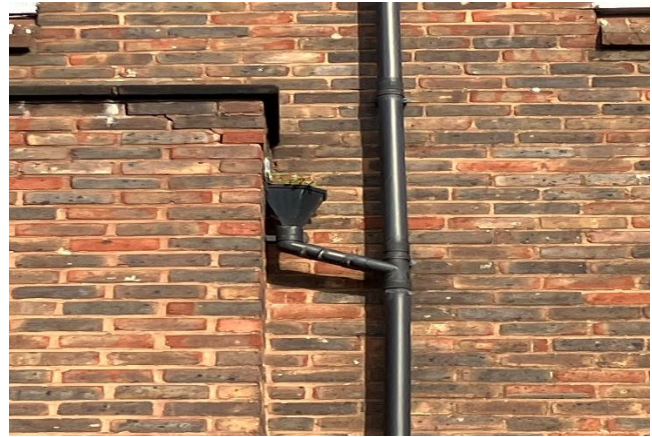
**Photo 10.** Blocked hopper to the rear elevation.

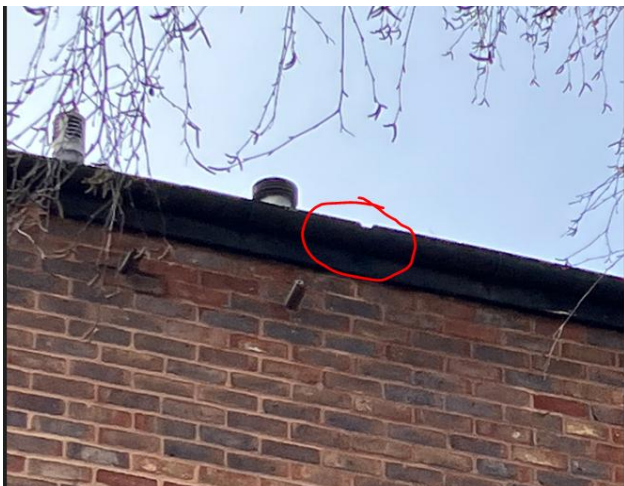
**Photo 11.** Cracks to the guttering (front elevation)

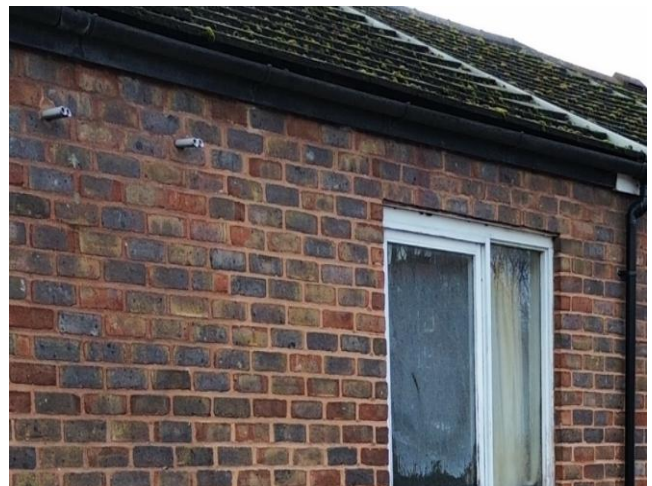
**Photo 12.** Undulated guttering to the front elevation.

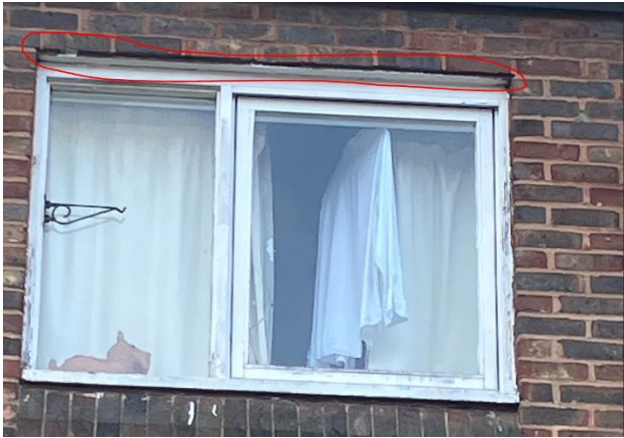
- There appears to be some minor surface rust to the lintels serving the front elevation. This was noted above the majority of window openings (where visible) to all dwelling houses.

**Photo 13.** Surface rust to metal lintels.

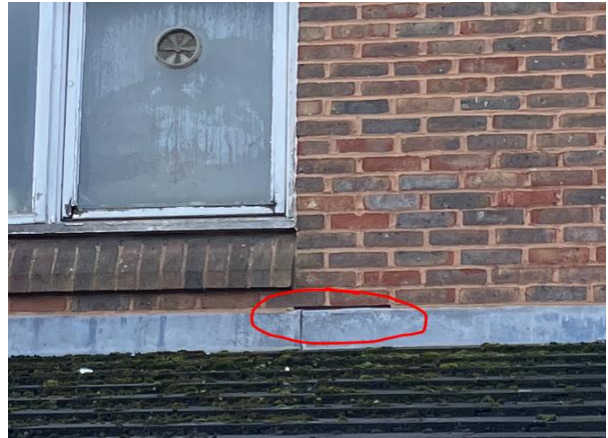
- There are some receded mortar joints to individual bricks in some isolated areas, generally the pointing is in fair condition.

**Photo 14.** Receded mortar joints to the front elevation.

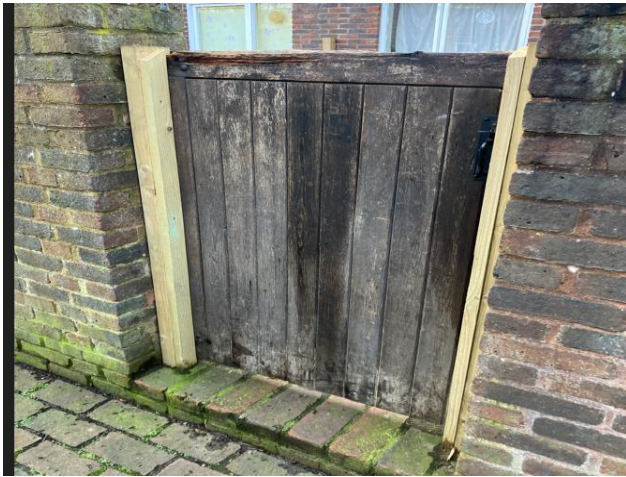
- The timber gates serving individual dwelling houses were in varying conditions. The gate to number 13 contained flaking paintwork and elements of rot and was in poor condition. The external gate serving number 14 was in fair condition with elements of damage and rot occurring to the top of the frame. The timber gateway to number 15 was operable and in fair condition, but small sections of rot were noted to the top of the frame. Number 16 has had a new gate installed and was in good condition. Number 17 contains timber gate which was in fair condition. Number 18 has had a new

**Photo 15.** Localised rot to timber gates.

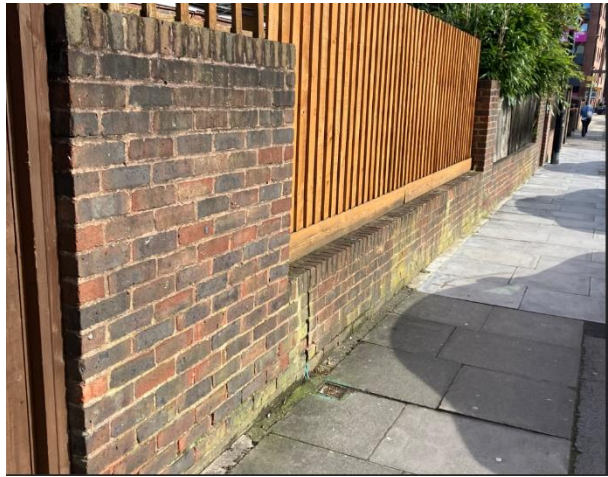
**Photo 16.** Expansion cracking to boundary wall.

- Repoint, reface and repair damage sections of brick boundary walls.
- Scaffold access will be required to the full height and perimeter of the building to complete these recommended works.

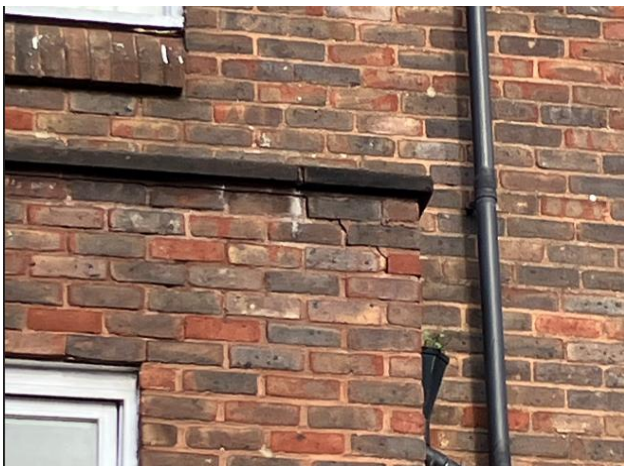
- The walls serving the rear elevation were generally noted to be in fair condition.
- There was cracking of around 2-3mm to the bay window serving nr 14. This was situated from the top of the parapet traversing through three brick courses to the corner.

**Photo 17.** Cracking to rear bay projection.

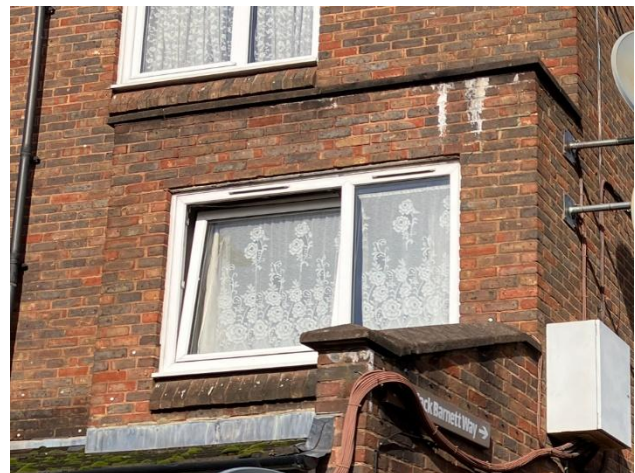
**Photo 18.** Efflorescence staining beneath coping stones.
