# Arboricultural Appraisal Report

## Subsidence Damage Investigation at:

19 Leaside Avenue  
London  
N10 3BT

CLIENT: Sedgwick  
CLIENT REF: 10935870  
MWA REF: SUB251128-17331  
MWA CONSULTANT: Andy Clark  
REPORT DATE: 17/12/2025

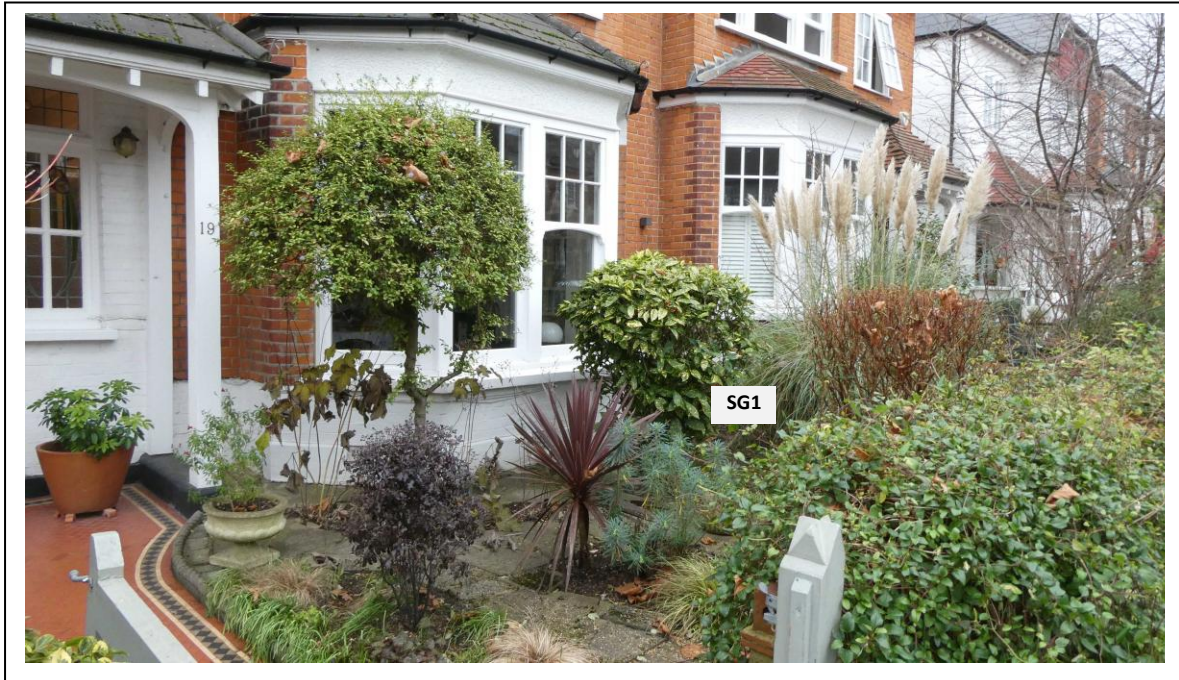
| Tree No. | Species | Height (m) | Dia (mm) | Crown Spread (m) | Dist. to building (m) | Age Classification | Ownership |
|---|---|---|---|---|---|---|---|
| SG1 | Mixed spp. shrub group of mostly Ceanothus, Pittosporum, Aucuba, Pampas, Rose, Hypericum and Cabbage Palm with herbaceous understorey | 1.0 - 2.5 | Up to 60 | Up to 2.0 | 0.8 | Younger than Property | Policy Holder |
| Management history | | Subject to past management/pruning - appears regularly pruned. | | | | | |

View of SG1 group

If an arboricultural solution is to be implemented to mitigate the influence of the trees/vegetation considered to be responsible for the movement/damage, we recommend that the nearby shrubs of the SG1 group and the T3 Laburnum are removed in the first instance.

| Tree No. | Species | Height (m) | Dia (mm) | Crown Spread (m) | Dist. to building (m) | Age Classification | Ownership |
|---|---|---|---|---|---|---|---|
| Recommendation | | Remove (fell) Ceanothus, Pittosporum, Aucuba, Pampas and Rose [to right of bay window] to near ground level and treat stumps to inhibit regrowth.<br>Maintain remainder broadly at no larger than current dimensions by periodic pruning. | | | | | |

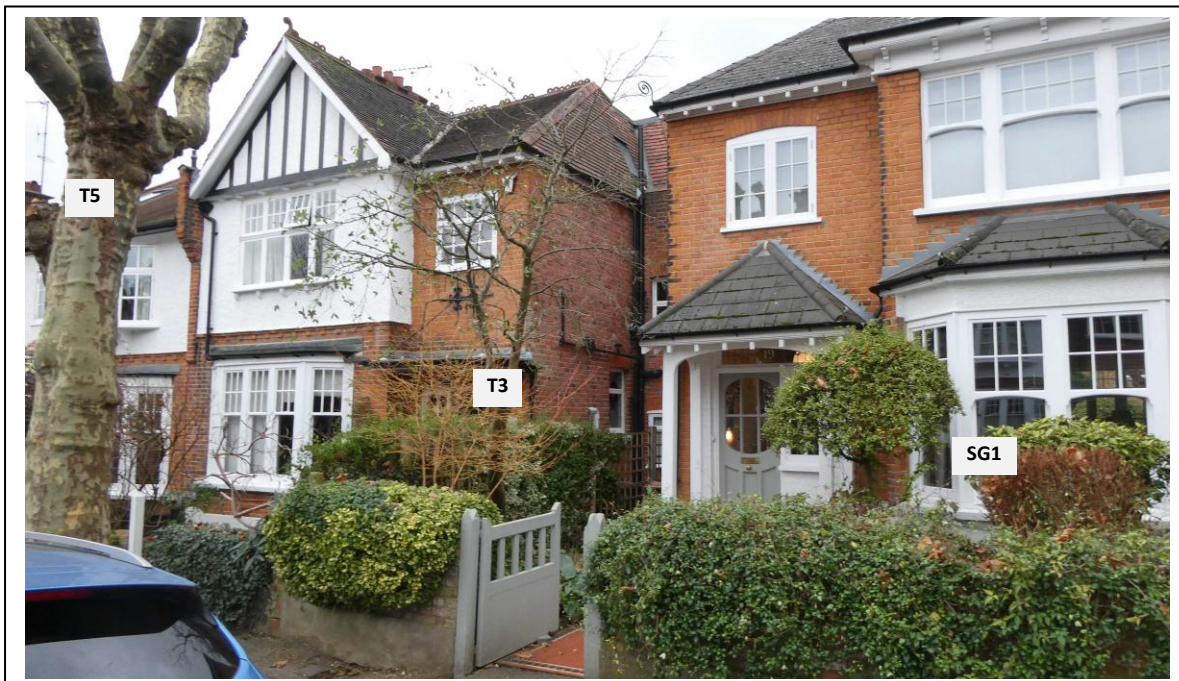
| Tree No. | Species | Height (m) | Dia (mm) | Crown Spread (m) | Dist. to building (m) | Age Classification | Ownership |
|---|---|---|---|---|---|---|---|
| T3 | Laburnum with Dogwood understorey | 6.0 | 140 | 5.5 | 4.2 | Younger than Property | Policy Holder |
| Management history | | Subject to past management/pruning - previously crown reduced. | | | | | |

View of T3 Laburnum with T5 London Plane stem to foreground and SG1 group to right of frame

| Tree No. | Species | Height (m) | Dia (mm) | Crown Spread (m) | Dist. to building (m) | Age Classification | Ownership |
|---|---|---|---|---|---|---|---|
| Recommendation | | Remove (fell) both to near ground level and treat stumps to inhibit regrowth. | | | | | |

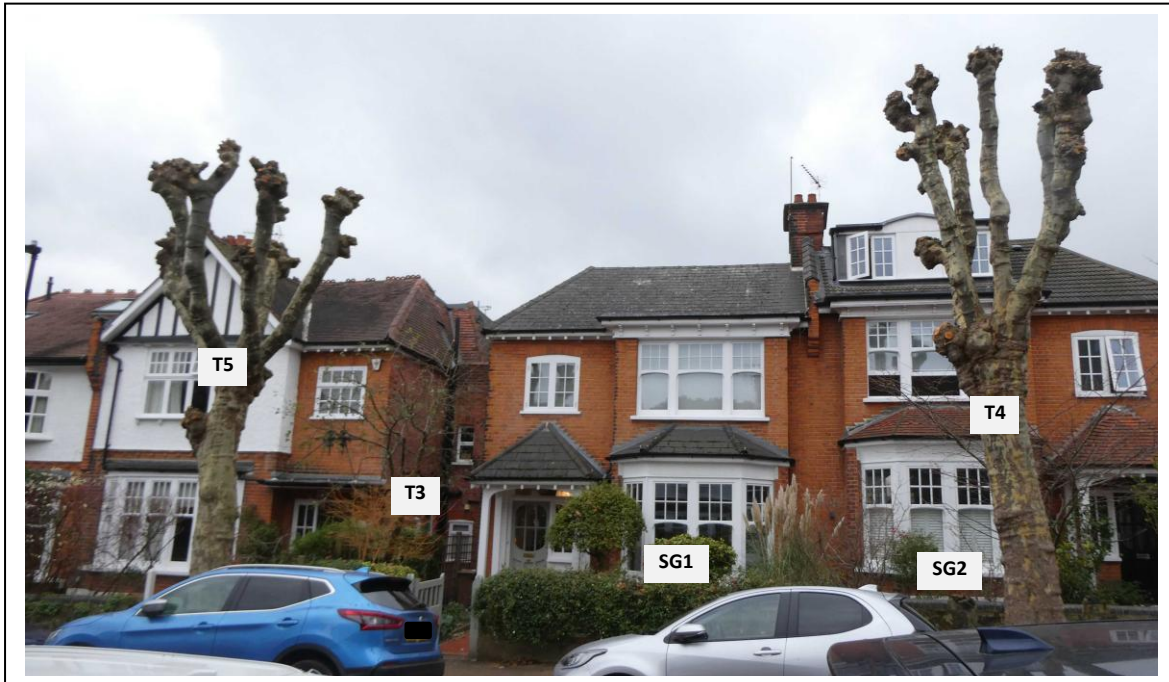
The Local Authority owned T4 London Plane and T5 London Plane are also likely to have an involvement, however the trees have recently been pollarded which will have provided a short-term reduction in their soil moisture uptake. Where movement persists however, or where evidence comes to light to confirm the involvement of T4 and T5 removal may need to be considered.

| Tree No. | Species | Height (m) | Dia (mm) | Crown Spread (m) | Dist. to building (m) | Age Classification | Ownership |
|---|---|---|---|---|---|---|---|
| T4 | London plane | 8.0 | 540 | 3.5 | 7.0 | Younger than Property | Local Authority |
| T5 | London plane | 8.0 | 530 | 5.0 | 7.6 | Younger than Property | Local Authority |

View of T4 London Plane and T5 London Plane with T3 Laburnum and SG1 and SG2 groups visible beyond

| Tree No. | Species | Height (m) | Dia (mm) | Crown Spread (m) | Dist. to building (m) | Age Classification | Ownership |
|---|---|---|---|---|---|---|---|
| Recommendation | | No works required at present (subject to review if movement persists). | | | | | |
