**Re: 59 Glasslyn Road, London N8 8RJ**

**59 GLASSLYN ROAD**

*Geotechnical Interpretative Report*

***CGK/00136/63***

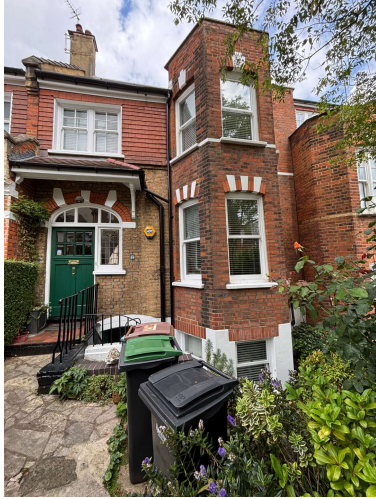
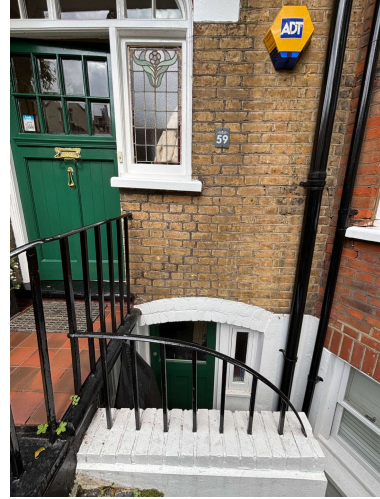
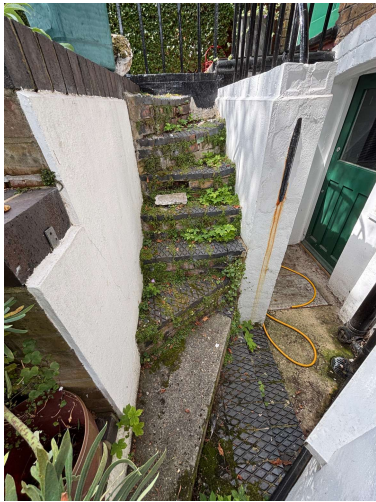
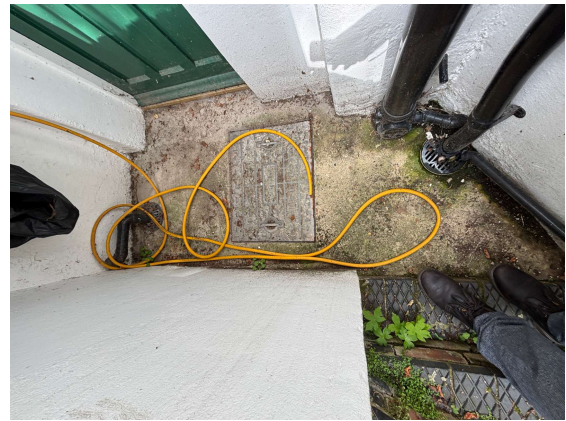
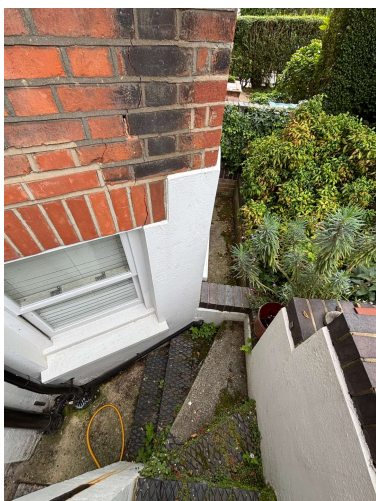
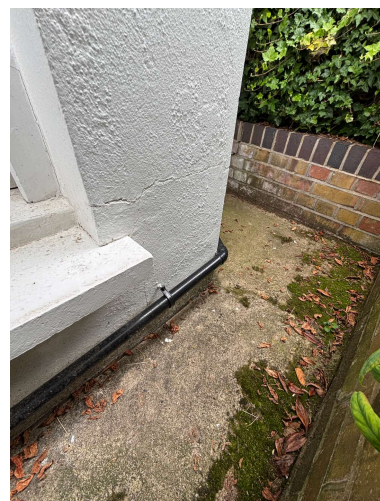
*Client Provided Photographs*

The structure had brickwork exposed at upper ground floor level, and painted white at lower ground floor level. Evidence of cracking of the masonry and possible historical repair works are visible at both upper and lower ground floor levels based on the photographs provided to CGL.

- 📍 There is evidence of cracking/damage, indicative of movement, on the area of white-painted wall adjacent to the window at lower ground floor level. Cracks are predominantly horizontal;
- 📍 Above the lower ground floor window there is evidence of cracking across multiple courses of brickwork where the masonry is exposed. Cracks are predominantly vertical, and appear 'fresh', indicative of recent movement;
- 📍 Exposed masonry adjacent to the front door at ground level (above the lower ground floor door) appears slightly misaligned, and mortar appears to have been repaired; suggesting historical movement; and
- 📍 The brickwork steps to the lower ground floor level appear to exhibit significant degradation and deformation, with weeds growing between courses and paving stones. The corner step appears to have been repaired, as the textured paving stones are missing.

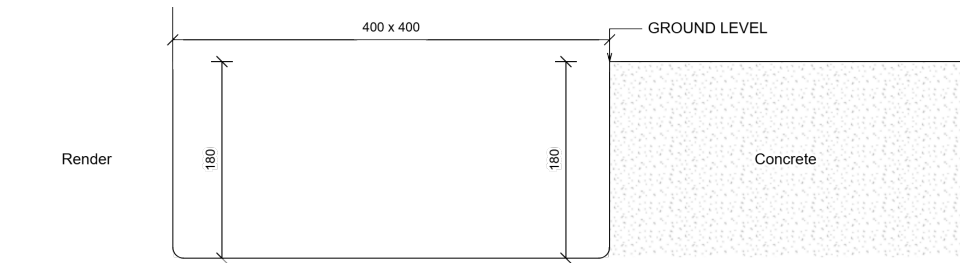
Trial pit abandoned at 180mm

TP abandoned due to mass concrete, foundation possibly joining retaining wall. A second attempt was made with same results, not drawn. A remote BH was completed behind the retaining wall.

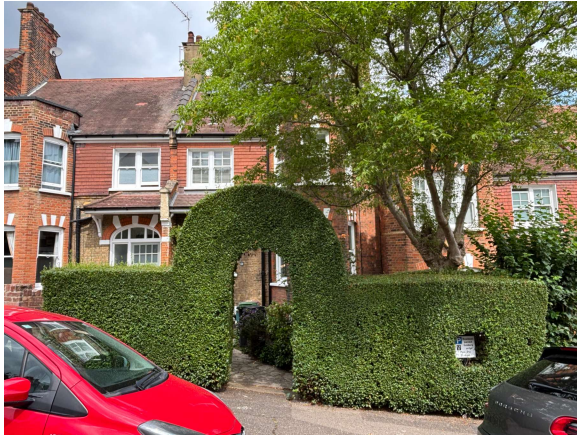
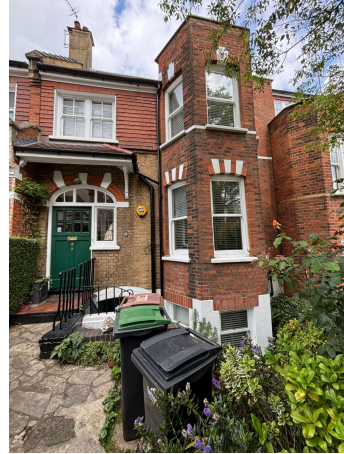
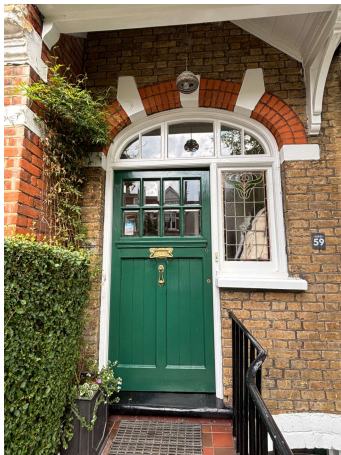
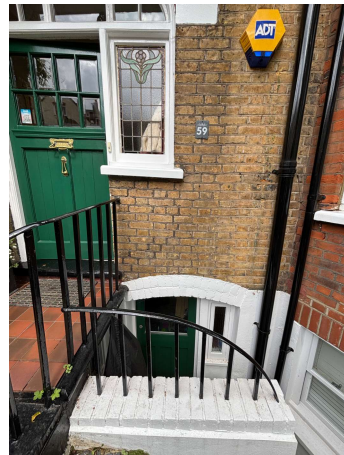
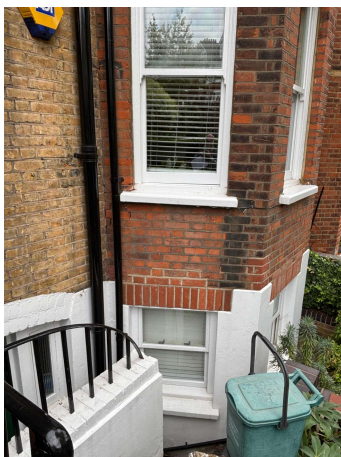
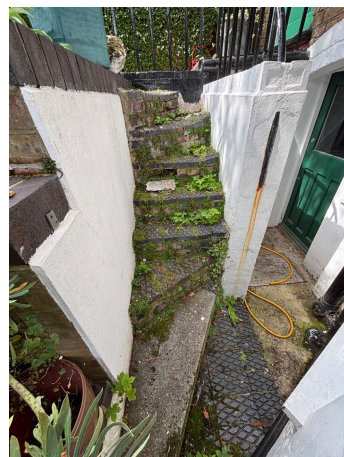
59 Glasslyn Road, N8  
1.08.25  
1

3. On structural stability matters, I confirm that the three storey, splayed bay is affected by vertical lines of crack formations within the window lines of the left hand and right hand splayed brick panels. Crack formations vary from hairline up to 4mm width.

4. To the right hand side base of the elevation, there is a horizontal 4mm wide crack formation through renders at basement window cill level of the centre panel and with some indication of painting-over of the renders and crack.

5. To the main front elevation ground floor storey entrance, there is a brick panel to the right to the entrance, which has received patch repointing in past years, but with that patch repointing taking diagonal form reopened to a current hairline/2mm diagonal crack formation.

7. It should also be noted that the modern construction brick retaining walls, assumed to have been constructed at time of the basement storey development of the front bay, have suffered some vertical distortion and lateral movement, most readily recognised by the bowing of the mid-height brick retaining 215mm wall and the vertical fractures of 12mm up to 20mm wide on the side brick return/boundary walls serving the front garden/lightwell stop. (See photos)

- c. I recommend that ground management procedures are carried out, which will require site investigation in the form of drains survey by CCTV monitoring (and gravity head water test if possible), trial pit at base of bay, foundation data sheet and also subsoil and vegetation roots identifications.

- d. Subject to the results of the site investigation report, any defects to the drains should be repaired and any removal of vegetation by definition of root identification should be removed also.

- e. Under further professional guidance of interpreting the site investigation results and with necessary remedial action taken, I recommend that the ground/subsoil local to foundations is allowed to stabilise for six months prior to any crack repairs carried out, both to external facing brickwork and internal plasterwork. External facing brickwork crack repairs should be treated by modern methods of crack repair such as stainless steel bed joint reinforcement set in place with epoxy resins and concealed thereafter by sympathetic patchwork repointing ie. Helifix system or similar. (See product literature attached)

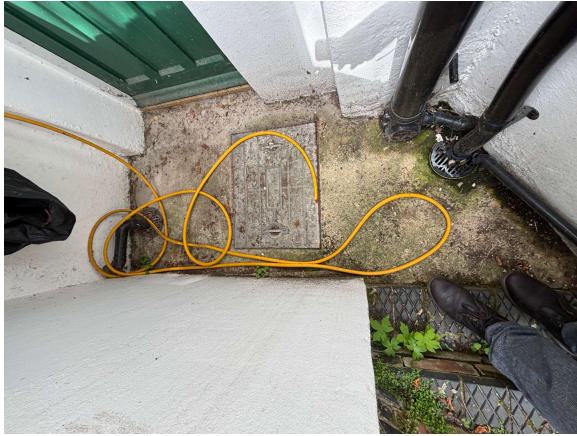
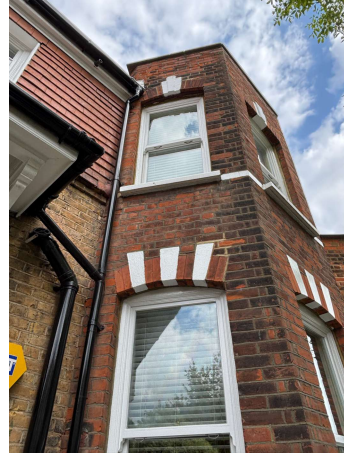
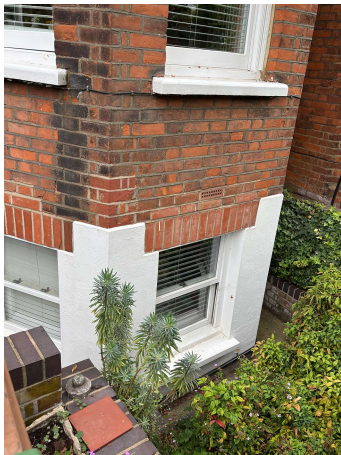
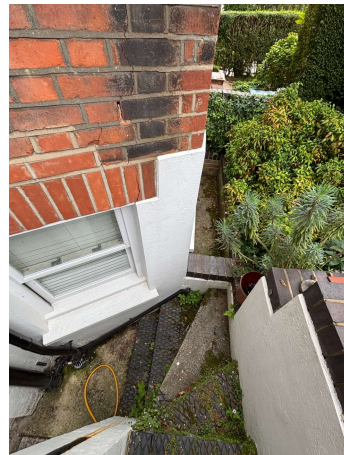
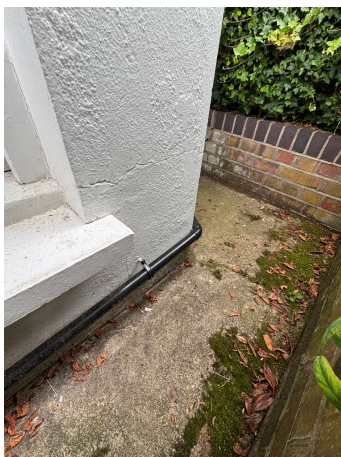
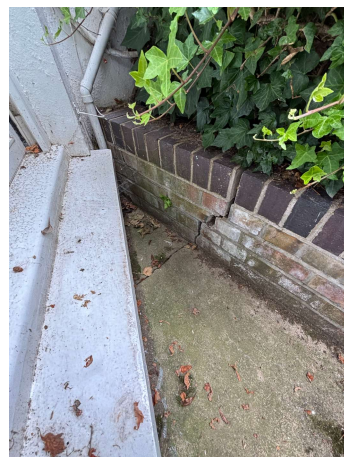
59 Glasslyn Road, N8  
1.08.25  
2

6. The collection of crack formations to the front elevation and bay give an indication of structural movement to the foundations of the bay in recent years, as determined by the client's identification of cracking occurring during that period of time. However, there is likely to have been long-standing/past structural movement, which currently shows in the form of sloping window lines to the main entrance and ground floor storey bay windows.

8. Owing to the collection of crack formations to both the front bay and front garden retaining walls, it is likely that slight structural movement of foundations has developed over a significant period of time to both the bay and retaining walls ie. since basement bay area was developed.

10. Thereafter and for the purposes of this report, I confirm that there is an unidentified specimen tree (height 8m, girth 600mm), situated within the confines of the subject front garden, local to the front boundary, albeit at public highway level and approximately 1.5 metres above the base of the subject front elevation bay. However, owing to the subsoil type in the area, most likely being London Clay and susceptible to desiccation from tree root action, I cannot rule out the possibility of that particular tree causing foundation settlement of the bay/front elevation and retaining walls.
