**“ST DUNSTAN’S COTTAGE”**  
**9 & 9a MUSWELL HILL, HARINGEY N10 3TH**

**HISTORIC BUILDING IMPACT ASSESSMENT**

Updated February 2026

COMPASS ARCHAEOLOGY LIMITED  
250 York Road, Battersea  
April 2025 / Updated February 2026  
Author: Gabriela Williams  
Amendments by Hannah Stralow Rees  
Telephone: 020 7801 9444  
E-mail: [mail@compassarchaeology.co.uk](mailto:mail@compassarchaeology.co.uk)  
Website: [www.compassarchaeology.co.uk](http://www.compassarchaeology.co.uk)  
©Compass Archaeology Ltd.

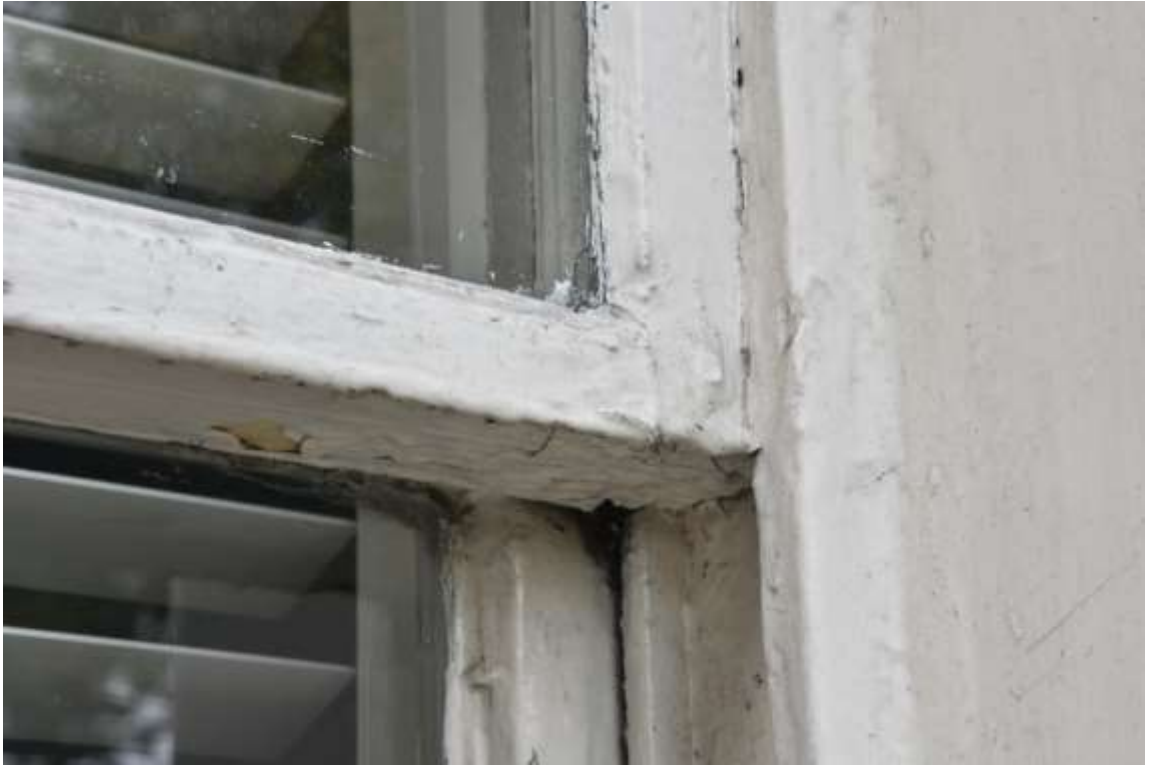
The window surround features several cracks and is damaged in multiple areas. It has been repainted several times, with thickened areas of paint resulting in the decreased

functionality of the window (Figures 18 and 19). The bottom rail of the lower sash measured 60mm in height, whilst the meeting rails were 24mm in height. The glazing bars for this window typically measured 6-7mm in width, but it was apparent from the interior inspection that those within the lower sash had been replaced at some point (see 6.11.2, Area C).

**Figure 18:** Detail of lower left window, thickened areas of repainted window visible.

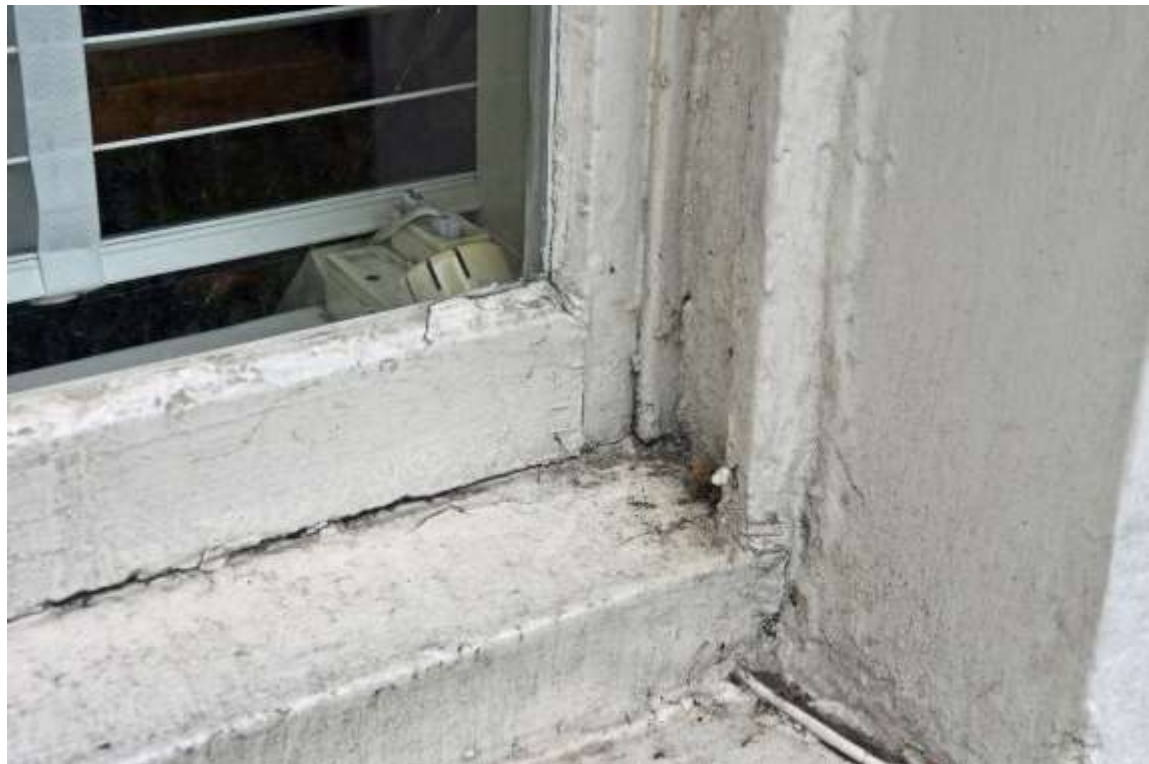
**Figure 19:** Detail of lower left window, areas of repainted and cracking paint visible.

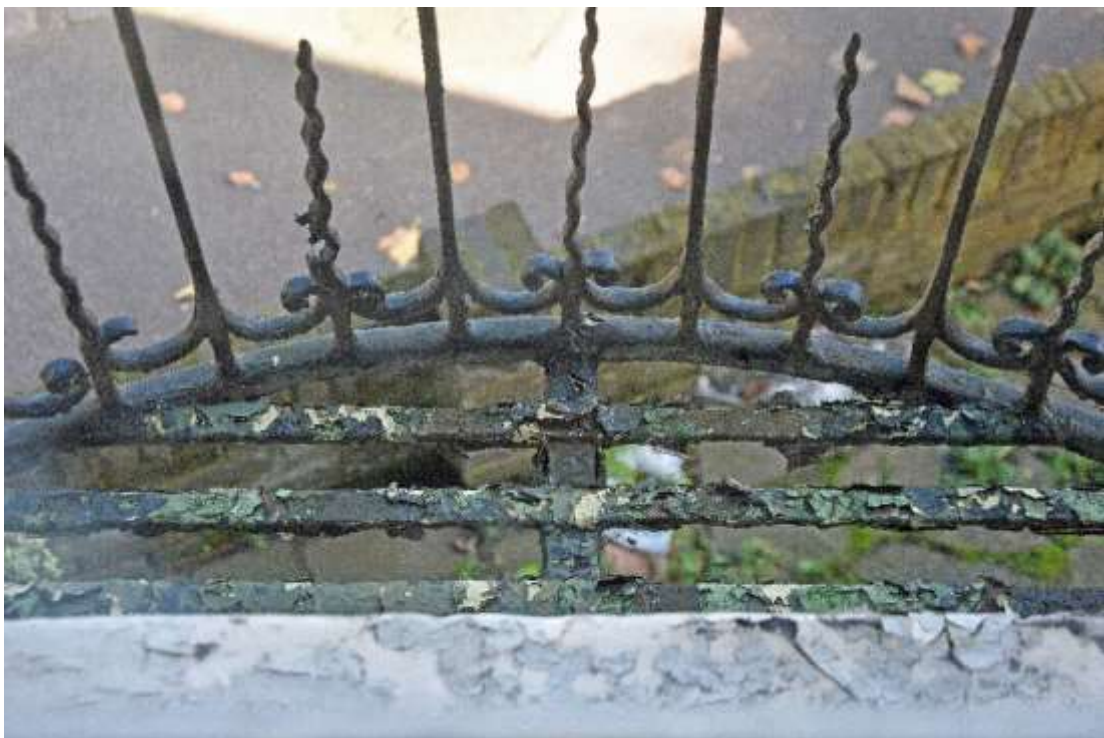
The upper right window's surround features several cracks and the paint is flaking in several areas. The bottom rail of the lower sash measured 53mm in height, whilst the meeting rail was 23mm in height. The glazing bars for this window measured 7mm in width.

**Figure 28:** Detail of Upper Right window balconette, flaking paint visible. Damaged paint on the window frame visible in the foreground.

This window features a matching wrought iron segmental balconette to the upper left window (Section 6.3.4). As previously mentioned, these balconettes date to approximately 1855-1910, and are not original to the construction of the house. The upper right window's balconette features more significant damage than the left; with a spike missing from the design, warping of the metal, and extensive flaking of the existing paint (Figure 28, previous).

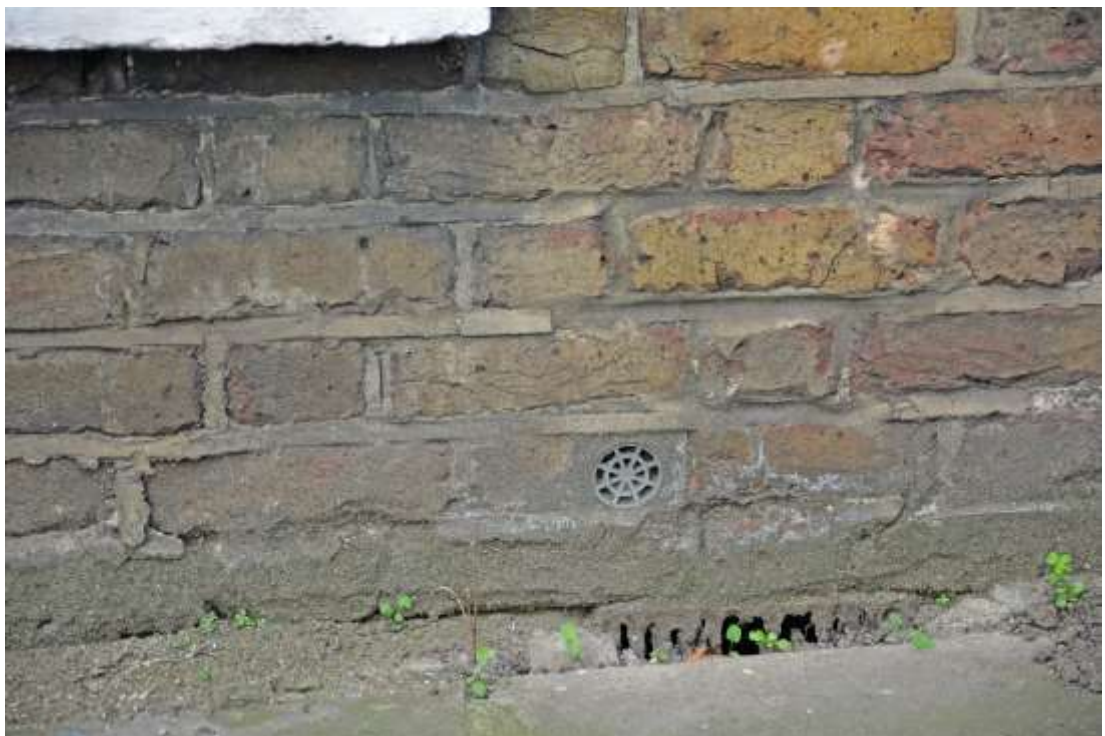
The frontage of 9 Muswell Hill has been constructed from standard yellow stock bricks, and reflect the original construction of the residence (Figure 37). The brickwork does however appear to have been repointed at a later date. Also several bricks to the base of the front façade have been replaced at a later date to allow for the installation of airbricks. Some of these now require further attention (Figure 38).

**Figure 38:** Detail of airbricks on the front of the residence, example taken from below lower right window.

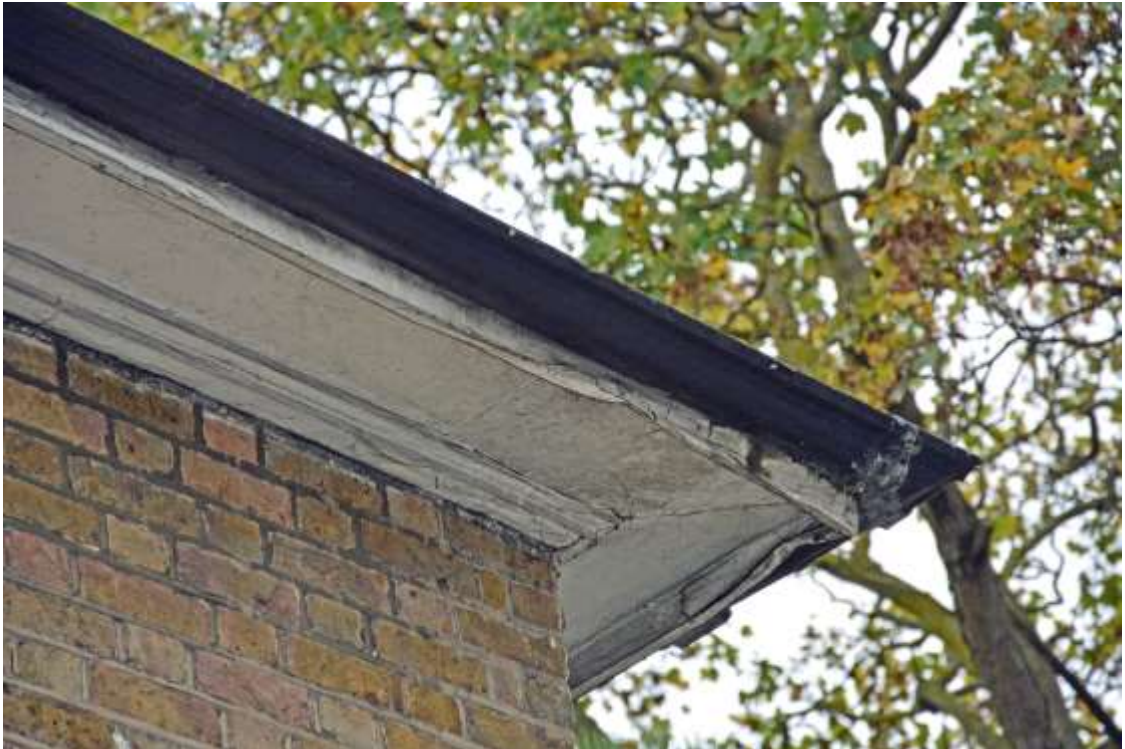
The roof is a low pitched, hipped slate roof with eaves soffit. The soffits and fascia have visible signs of deterioration, with repainting and some repair or replacement required (Figure 39). Similar levels of deterioration can be observed throughout the property, with an example provided as Figure 40.

**Figure 39:** Existing condition of the soffits and fascia, right corner of the front façade.

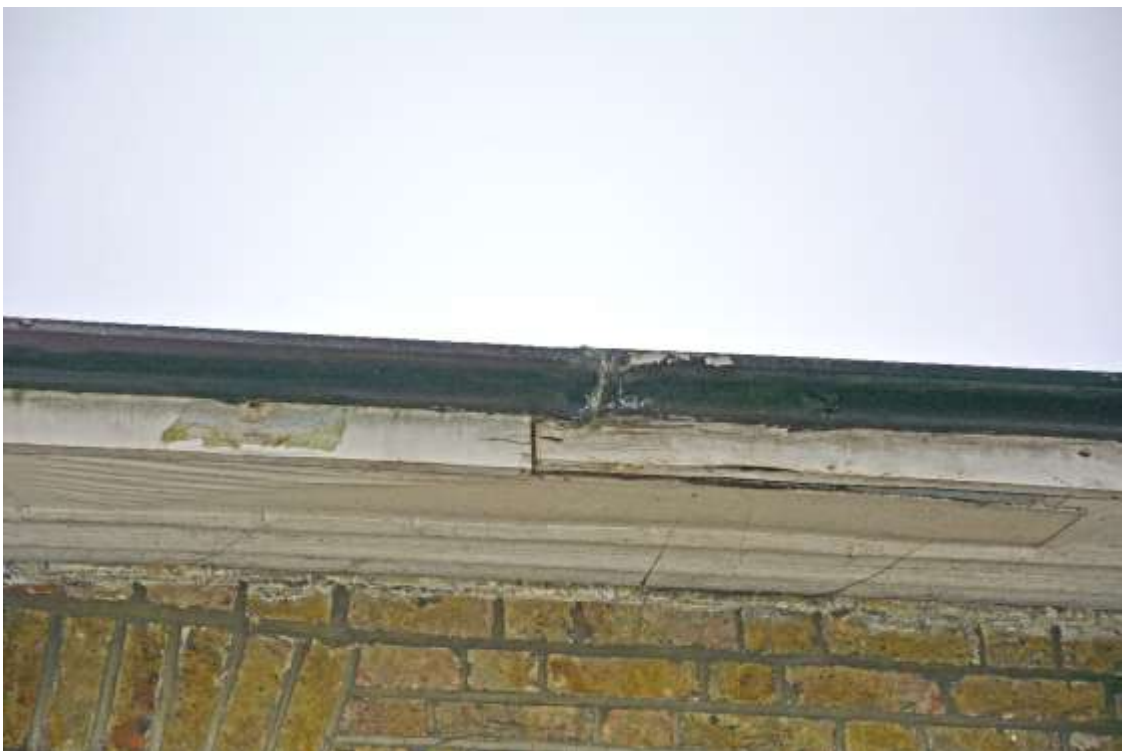
**Figure 40:** Existing condition of the soffits and fascia, to the rear of the property.

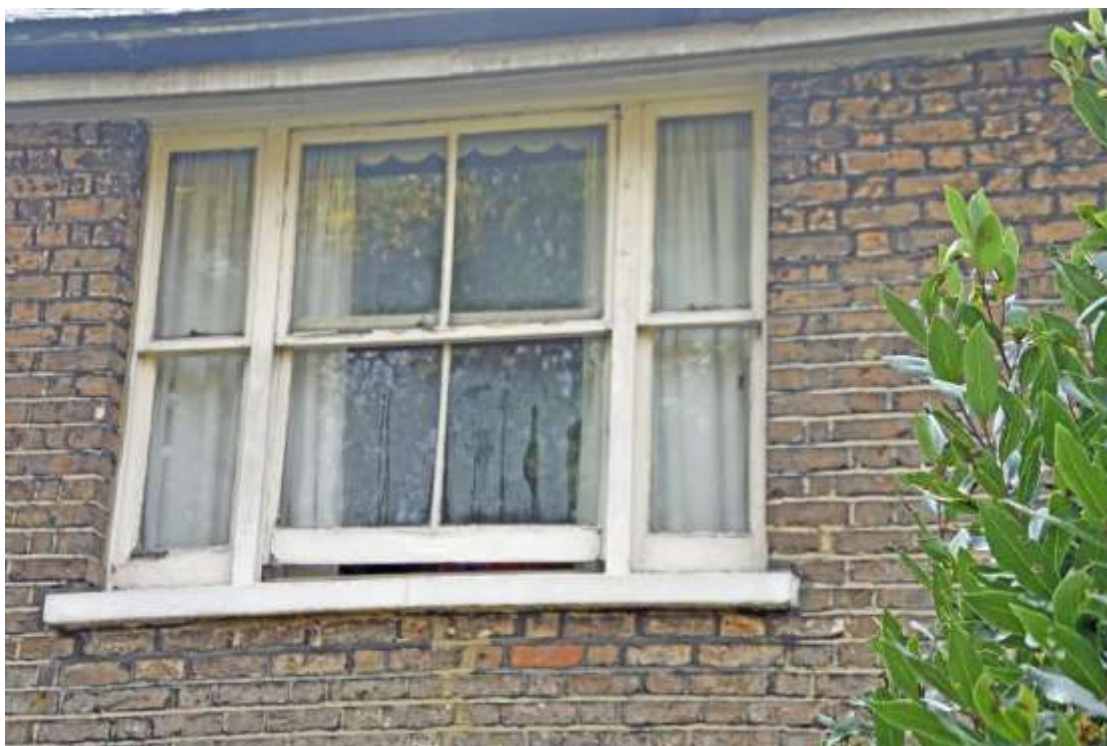
The condition of this window is poor with significant flaking and damage visible throughout the frame. As previously mentioned, the outer sashes of the window are not operational due to repeated re-painting although the opening fixtures are still present.

**Figure 59:** Photograph of the upper right window on the northern side elevation. Taken 22.10.24.

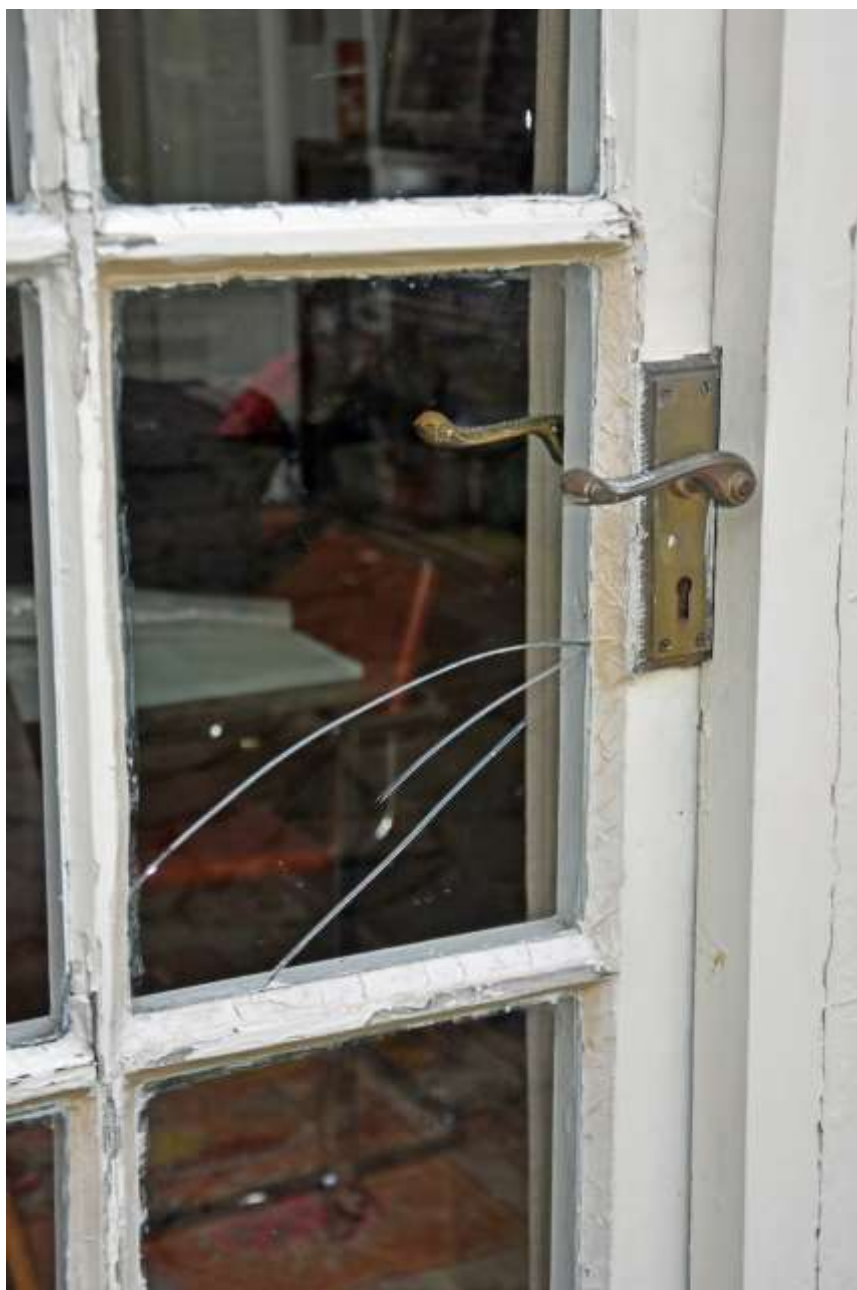
represents a replacement, of similar style and standard size, sometime in the last 54 years. The current condition of the door is poor, with significant peeling and cracking to the frame observable. One pane of glass also features a large crack which has split into three separate fractures within the pane (Figure 68).

**Figure 68:** Detail photograph of cracked pane within the garden door on the rear elevation. Taken 22.10.24.

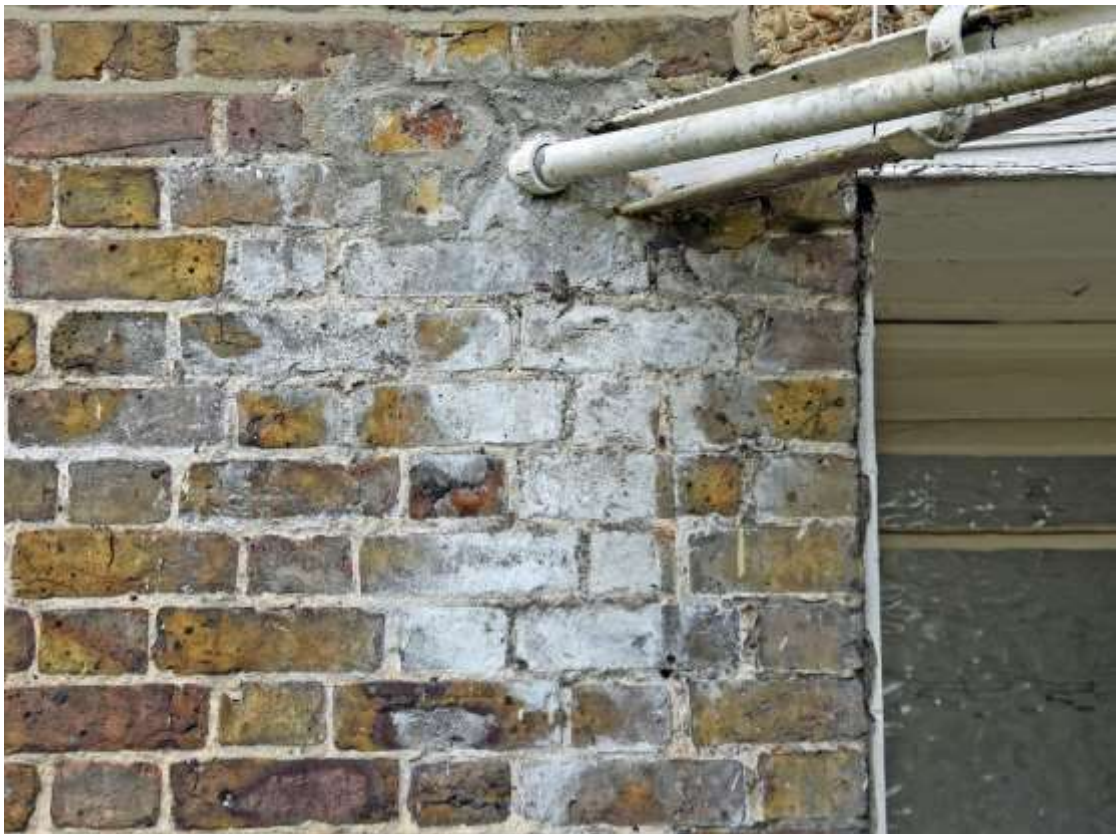
A significant feature within the rear elevation of 9 Muswell Hill is the presence of a first floor entrance. This door is a remnant from when the main house was divided by floor into two separate flats. In order to facilitate this change a new main entrance for the upstairs flat was introduced to the rear of the property with an external staircase to provide access. Meanwhile, it is assumed that the indoor staircase was wholly removed to separate the two residences. When the main building was restored into a single home the interior staircase was replaced (before 1970; see also Section 6.11.3) and the exterior staircase was removed. However, the steel beam supports and thick concrete floor base for the stairs can still be seen within the rear elevation (Figures 72, 73, Page 52) directly below the door – which was also left *in situ*. There is also a prominent area of damaged brickwork on the rear elevation where the steel supporting beam was implanted into the wall (Figure 74, Page 52).

**Figure 74:** Detail Photograph of damaged brickwork due to the installation of the steel beams for the external stair case – rear elevation. Taken 22.10.24.

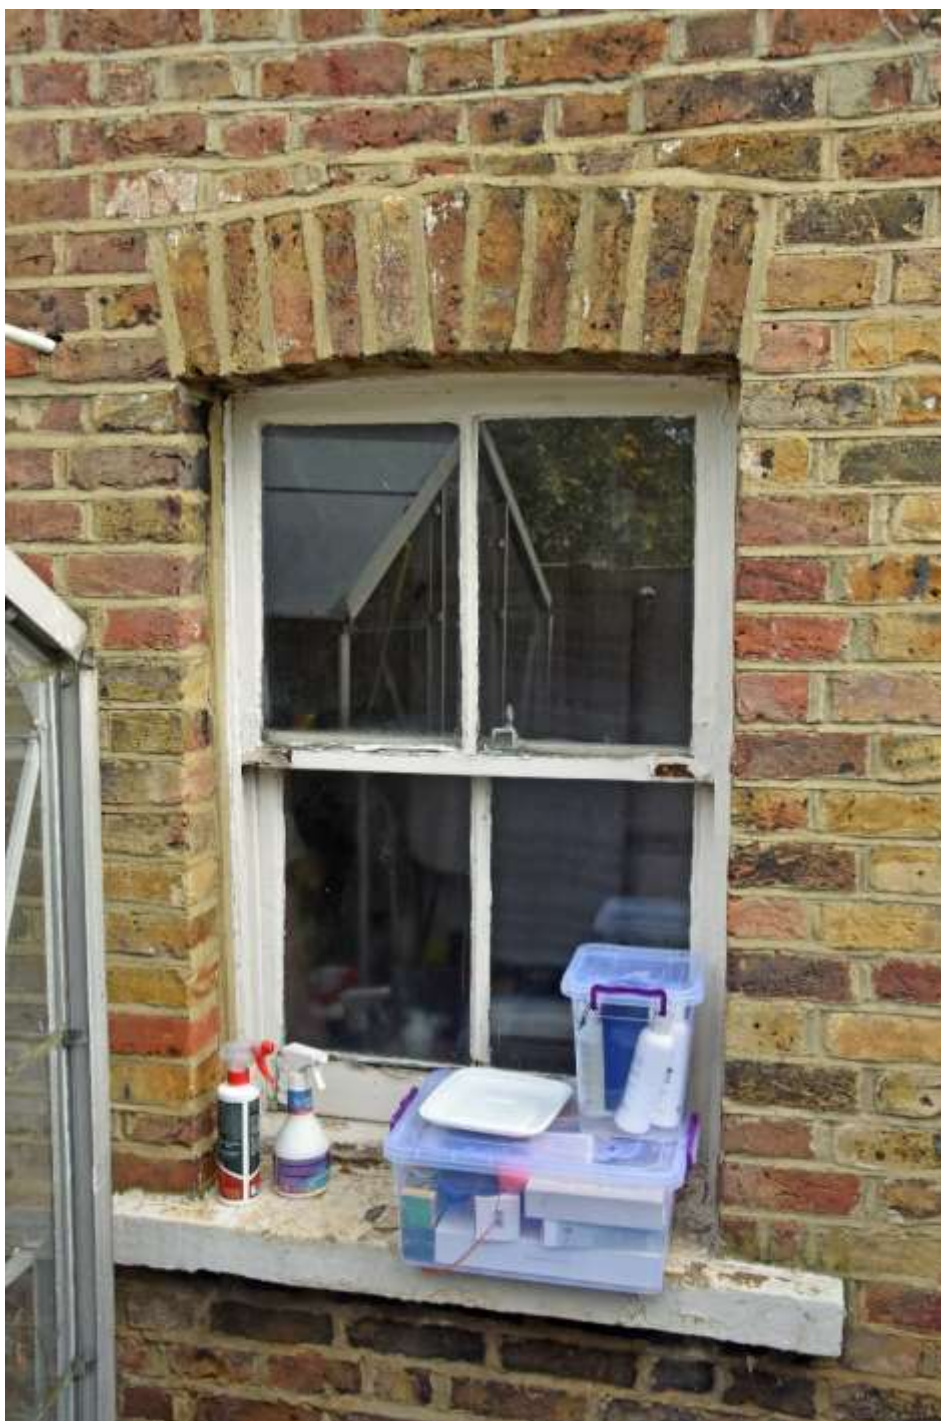
The condition of this window was poor with noticeable areas of rot and significant paint peeling across areas of the frame. The brickwork surrounding the window is consistent and a single row of vertical stretchers frames the upper boundary of the window as seen in other areas. However, no closer bricks are visible within the brickwork framing either side of the opening, so it is possible that the window was inserted at a later date rather than during the construction of the extension – perhaps when the presumed window in the adjacent wall as described under 6.6.2 was blocked. The window has also not been framed in white in the same style as other windows to the rear of the residence, with the brickwork left exposed.

**Figure 81:** Photograph of the lower right window (9a) of the rear elevation. Taken 22.10.24.

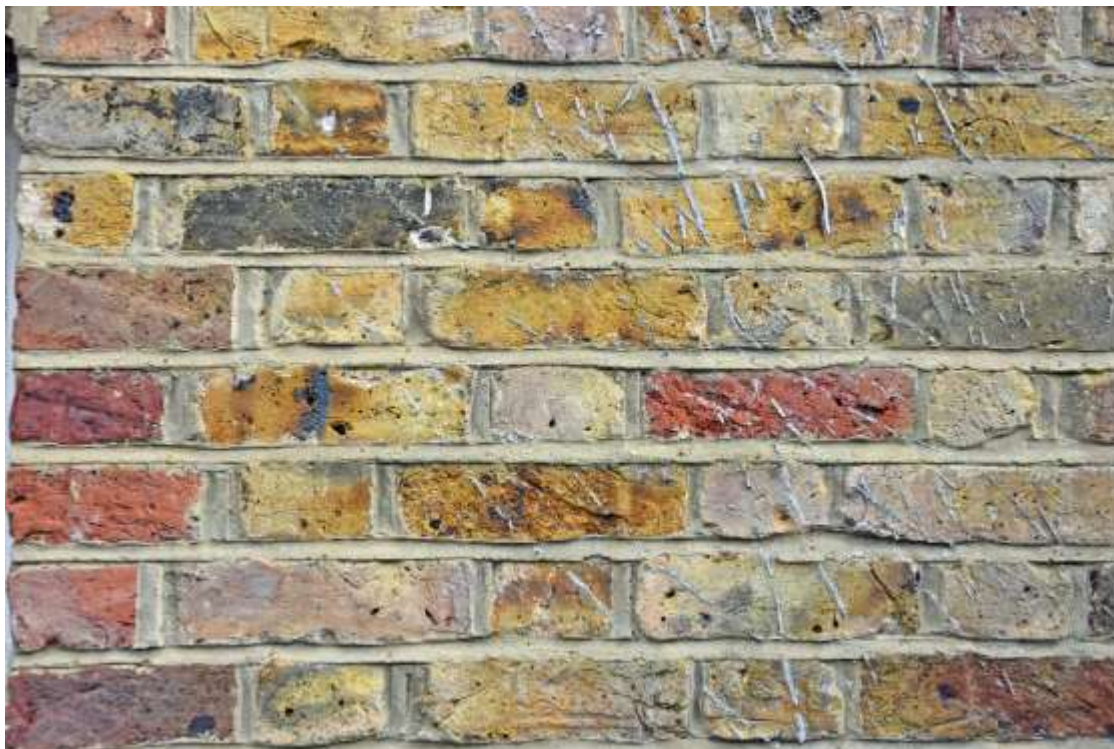
Generally the condition of the remaining brickwork is good, although with some areas in need of repointing. Plant action can be observed on the right corner of the rear elevation which was due to previous ivy growth on the building's exterior (Figure 82). The brickwork in this area is also noticeably different to the remaining brickwork, although this is discussed further in Section 6.6.

**Figure 82:** Detail Photograph of the brickwork to the right corner of the rear elevation, attachments from previously existing ivy observable. Taken 22.10.24.

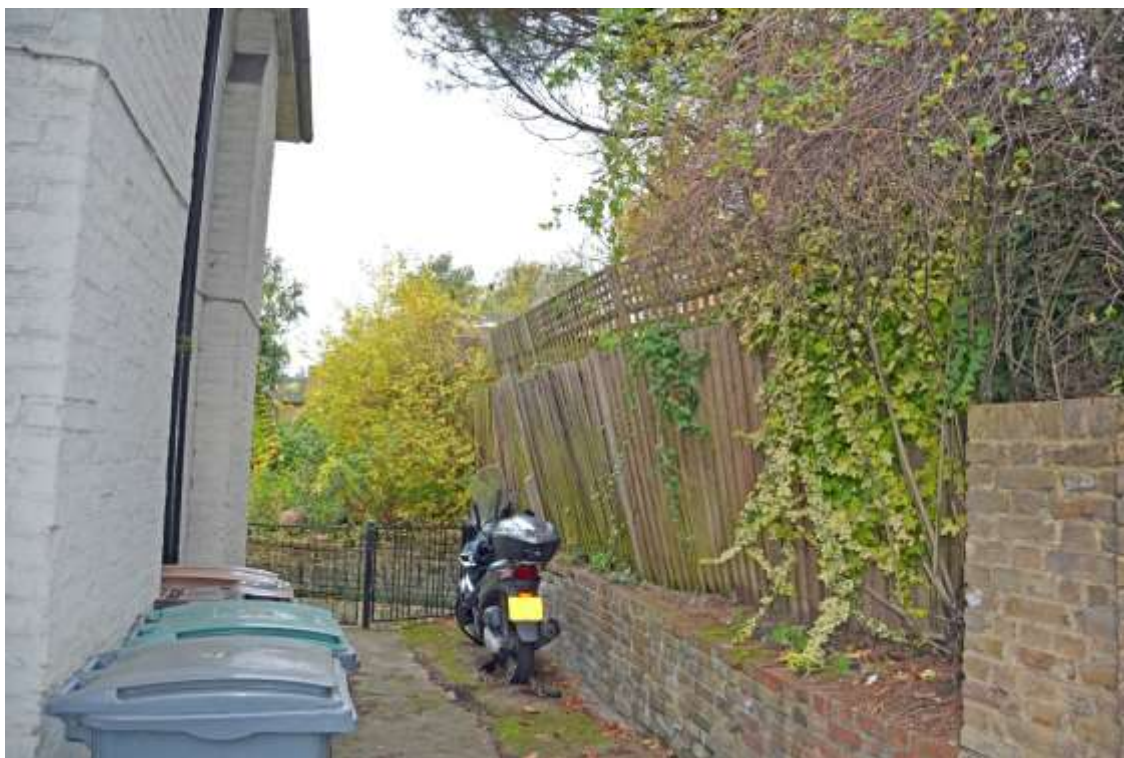
**Figure 103:** Overview of side access area and damaged fence. Taken 01.11.24.

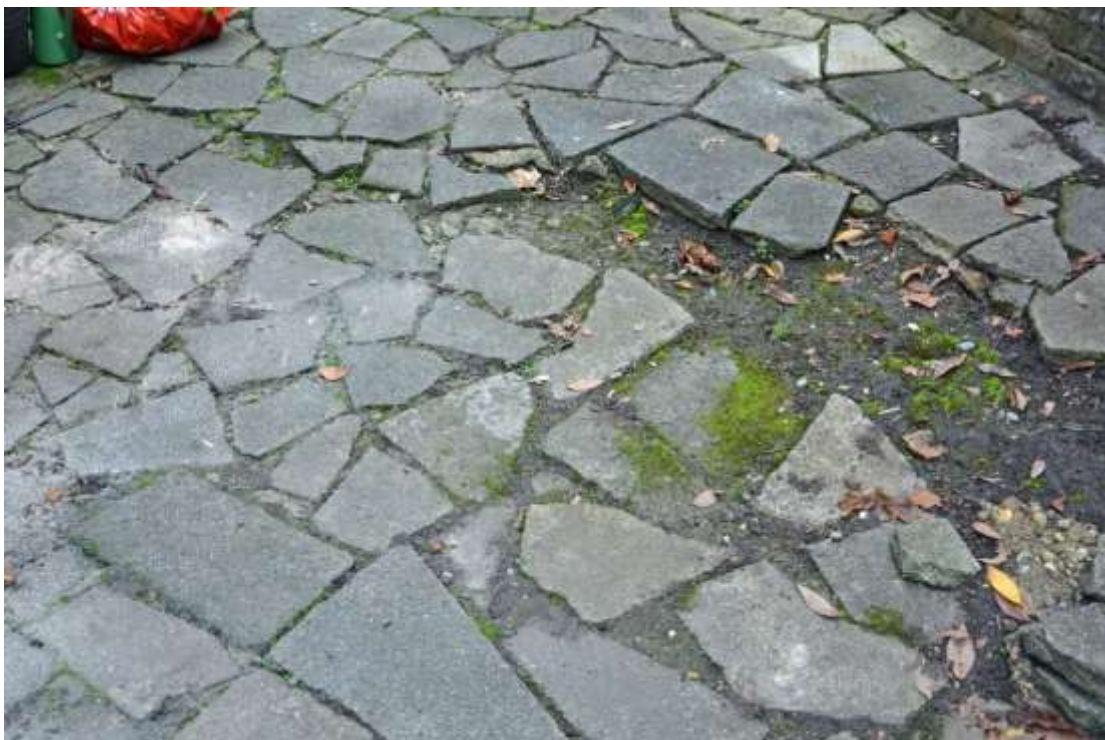
**Figure 106:** Current condition of rear garden patio paving. Taken 01.11.24.

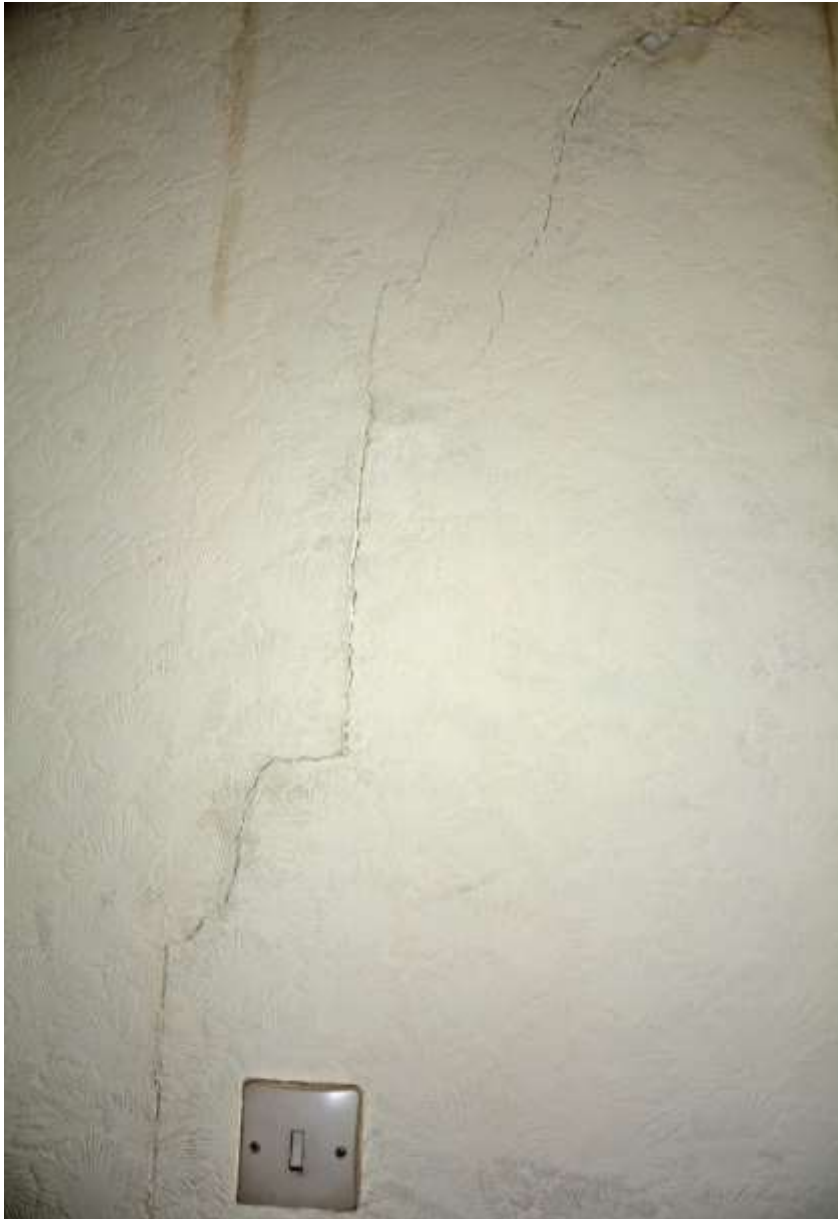
**Figure 126:** Detail Photograph of the existing wall directly to the right of the front door. Cracks visible in the wall and wallpaper. Taken 01.11.24.

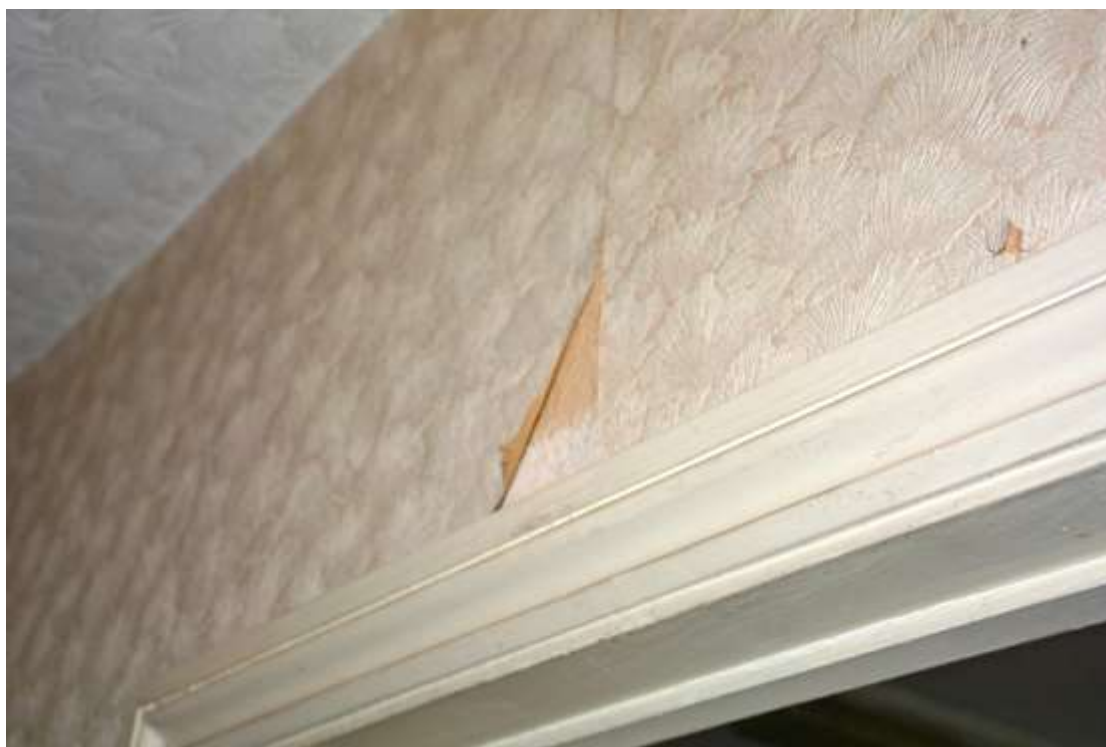
**Figure 138:** Detail Photograph of door frame and wallpaper condition in Area D. Taken 01.11.24.

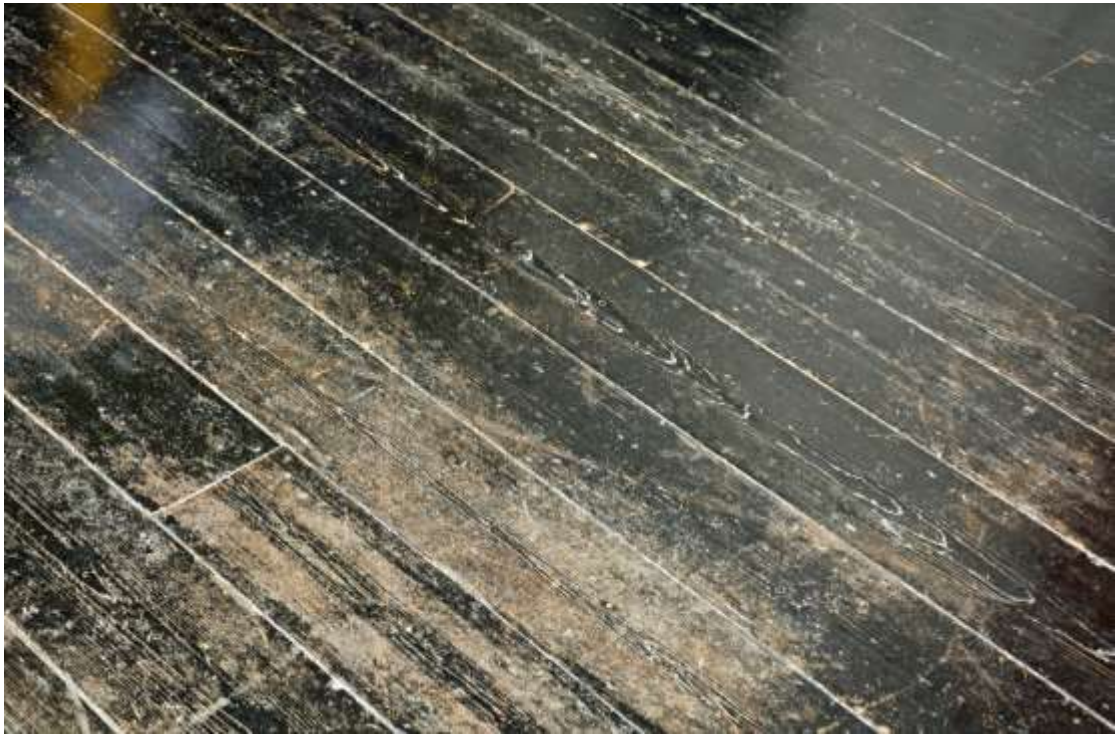
**Figure 186:** Photograph detailing the condition of the flooring in Area Q. Taken 01.11.24.
